**Bill Burton Fishing Pier  
Cambridge, Maryland  
Modified Underwater Inspection Report  
February 2022**

EBA Engineering, Inc.  
6100 Chevy Chase Drive, Suite 200  
Laurel, Maryland 20707

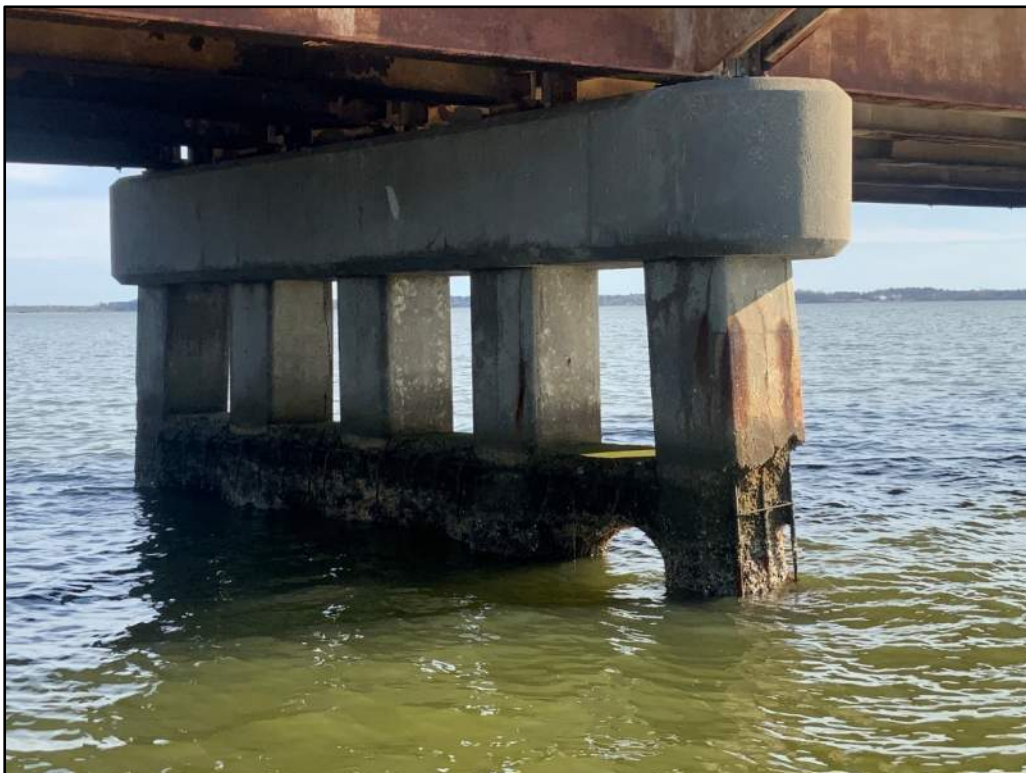
*Photo 10: Typical Spalling and Exposed Reinforcement on Strut (Bent 149 Shown).*

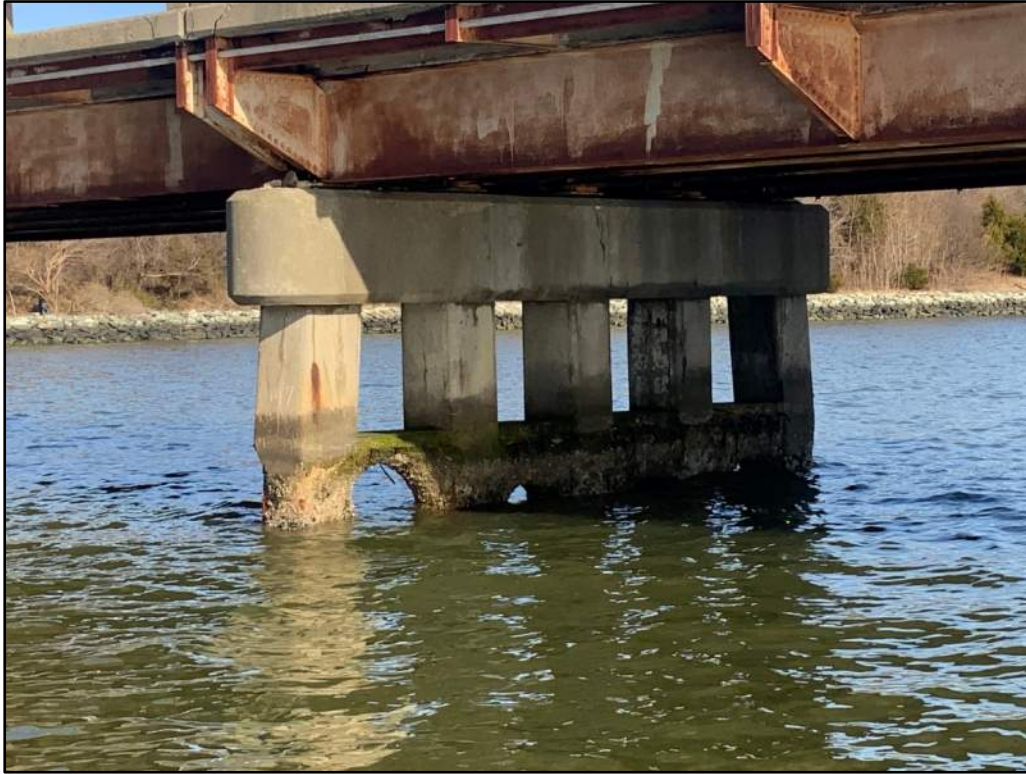
*Photo 11: Typical Spalling and Exposed Reinforcement on Strut (Bent 147 Shown).*

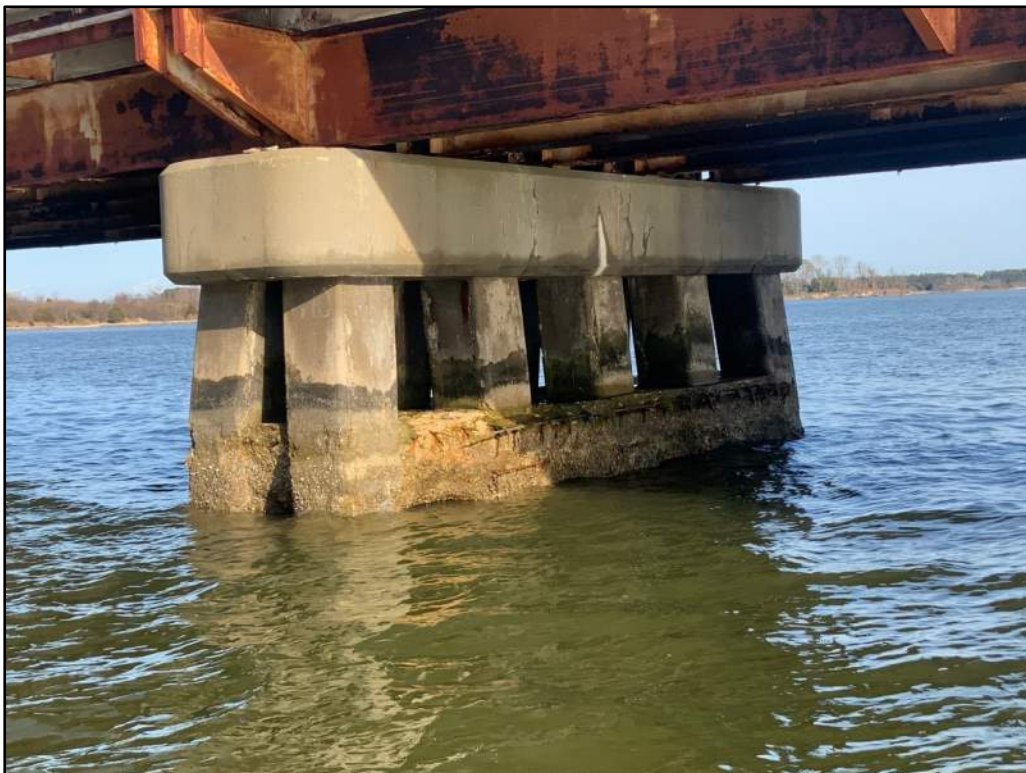
*Photo 12: Typical Spalling, Exposed Reinforcement, and Missing West and East Ends on Strut (Bent 111 Shown).*

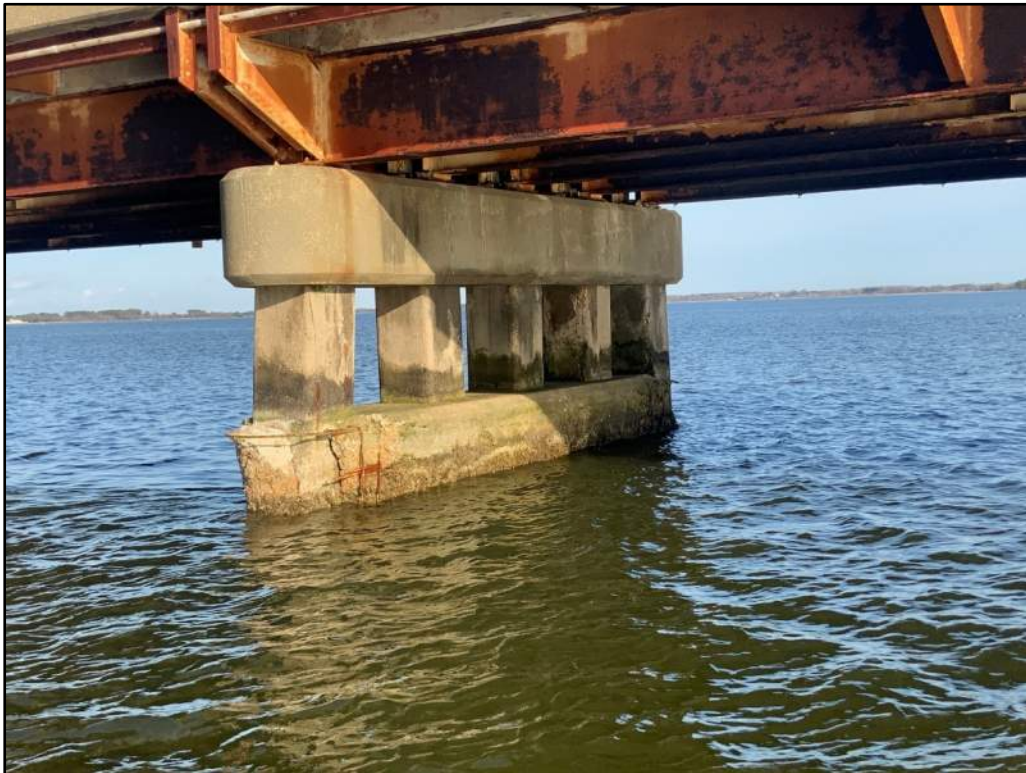
*Photo 13: Typical Spalling and Exposed Reinforcement on Strut (Bent 28 Shown).*

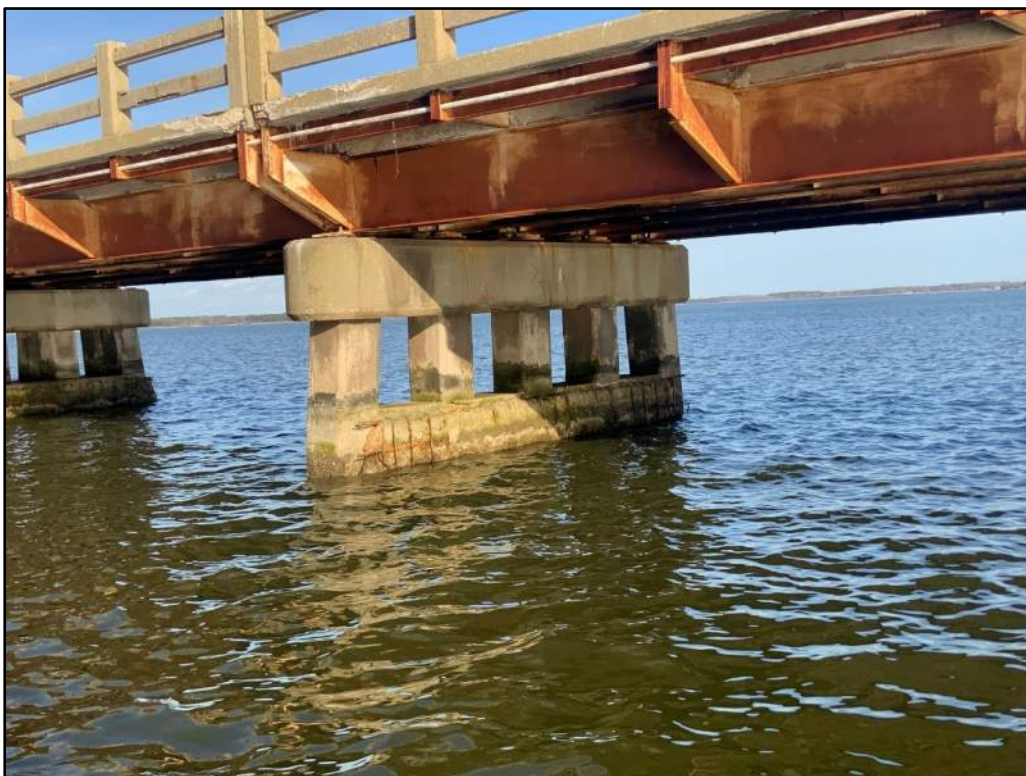
*Photo 14: Typical Missing Strut on East and West Faces (Bent 39 Shown).*

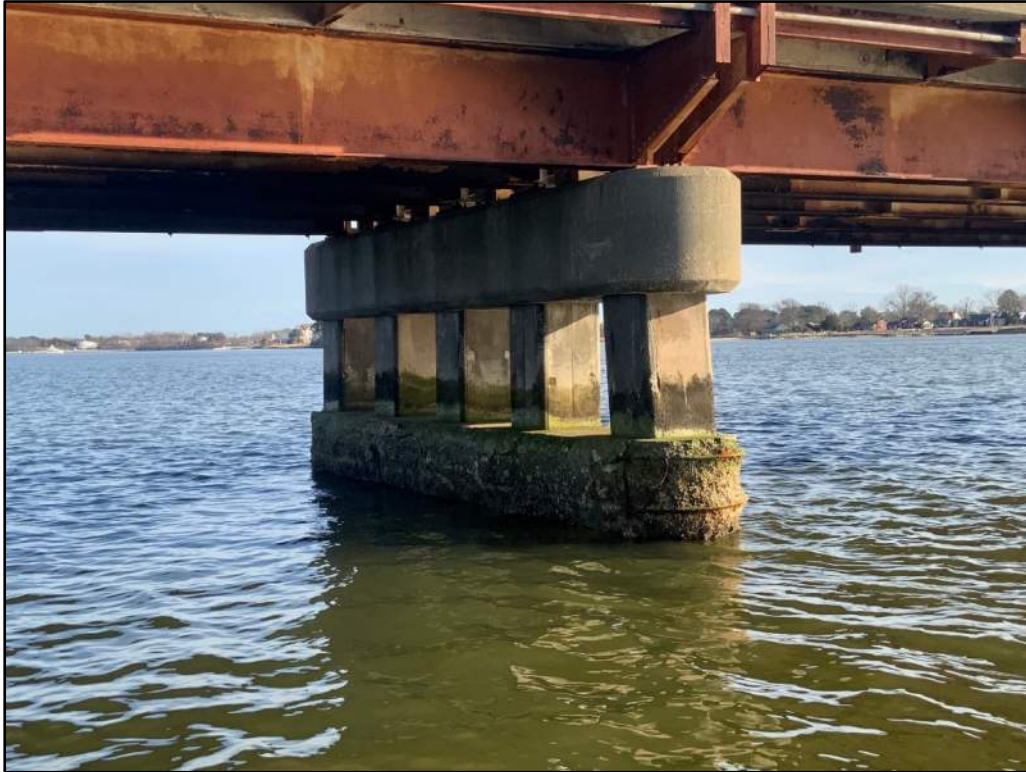
*Photo 15: Typical Spalling and Exposed Reinforcement on West and East Ends of the Strut (Bent 30 Shown).*

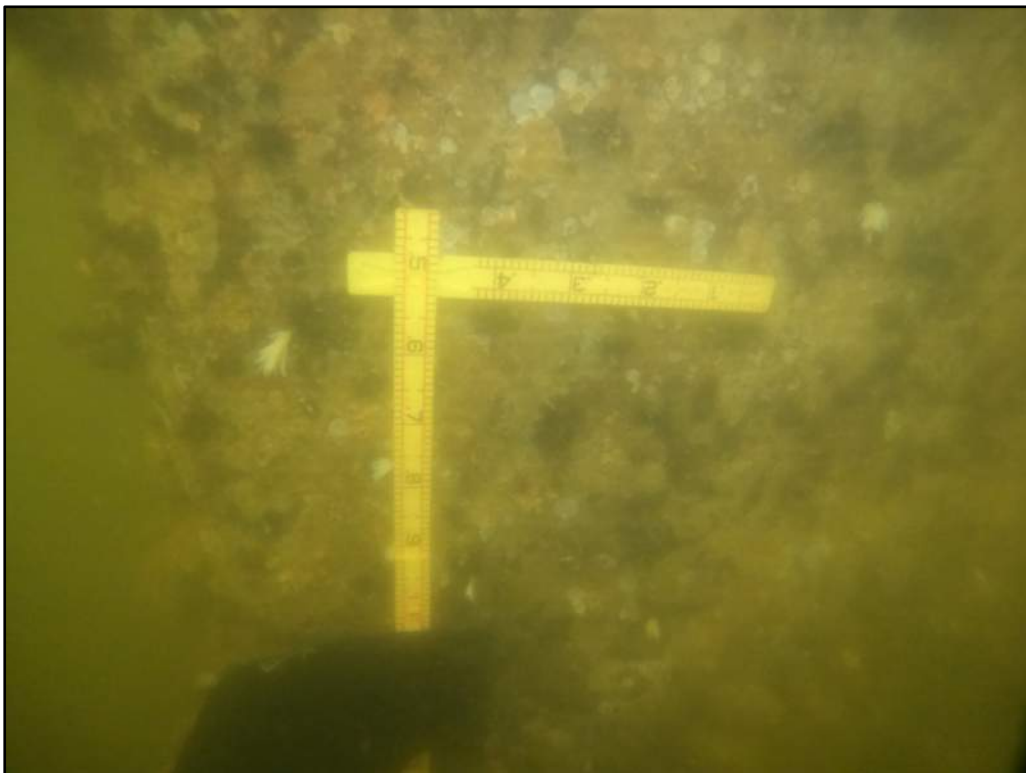
*Photo 16: Typical Condition of Pile Underwater (Bent 30, Pile 1 Shown).*

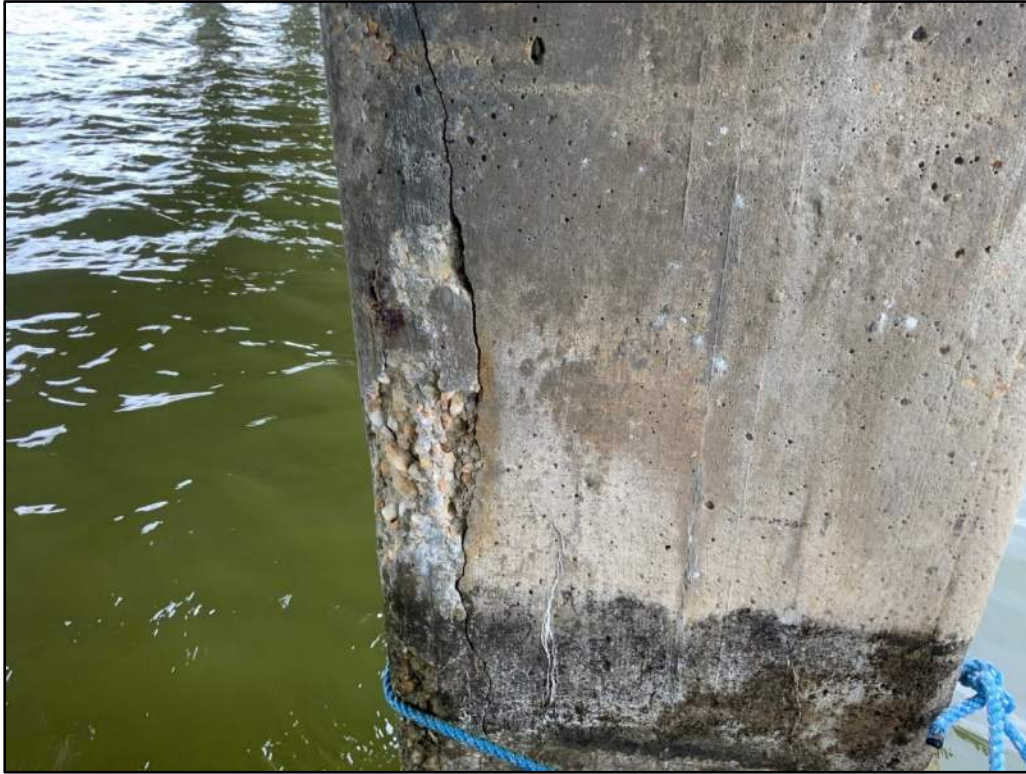
*Photo 17: Bent 130, Pile 1, Corner Spall and Delamination.*

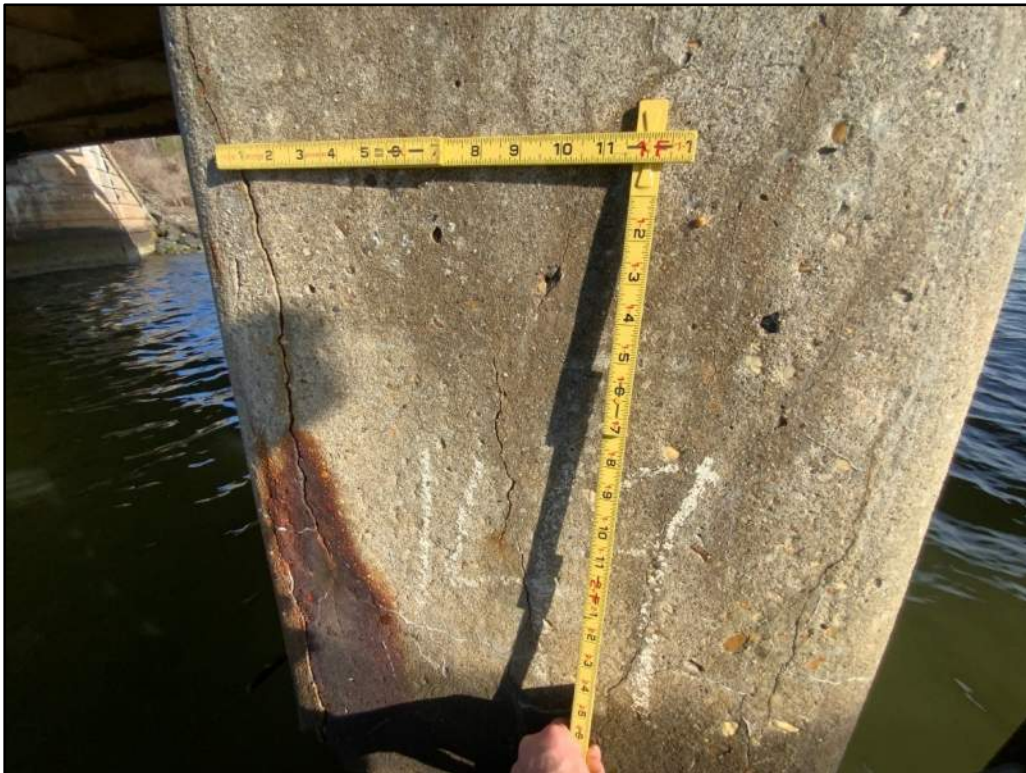
*Photo 18: Typical Vertical Cracking at the Top of Pile (Bent 150, Pile 5 Shown).*

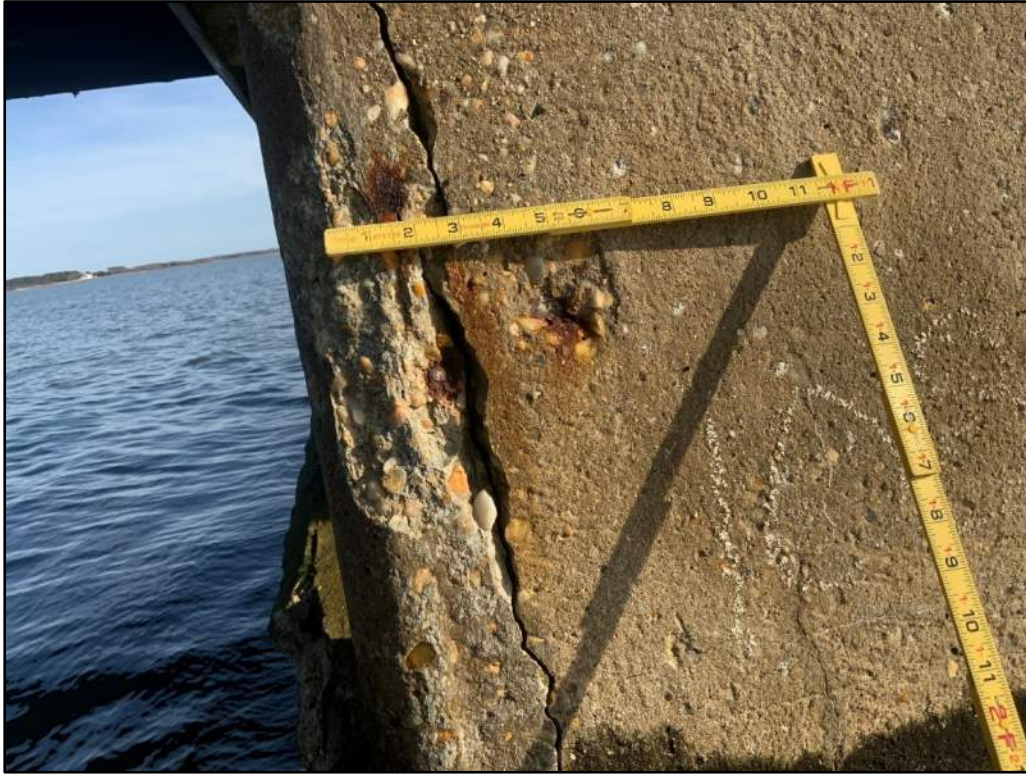
*Photo 19: Bent 109, Pile 5, Area of Spalling and Delamination at the Top of Pile.*

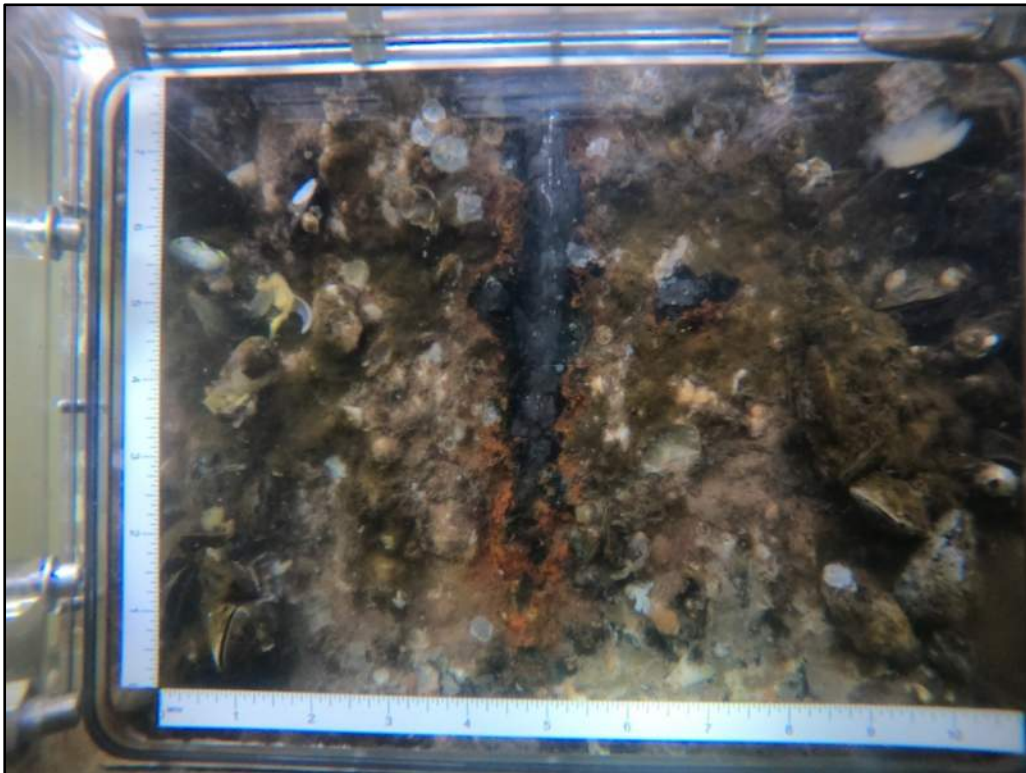
*Photo 20: Bent 148, Pile 4, Area of Abrasion with Exposed Reinforcement (Underwater).*

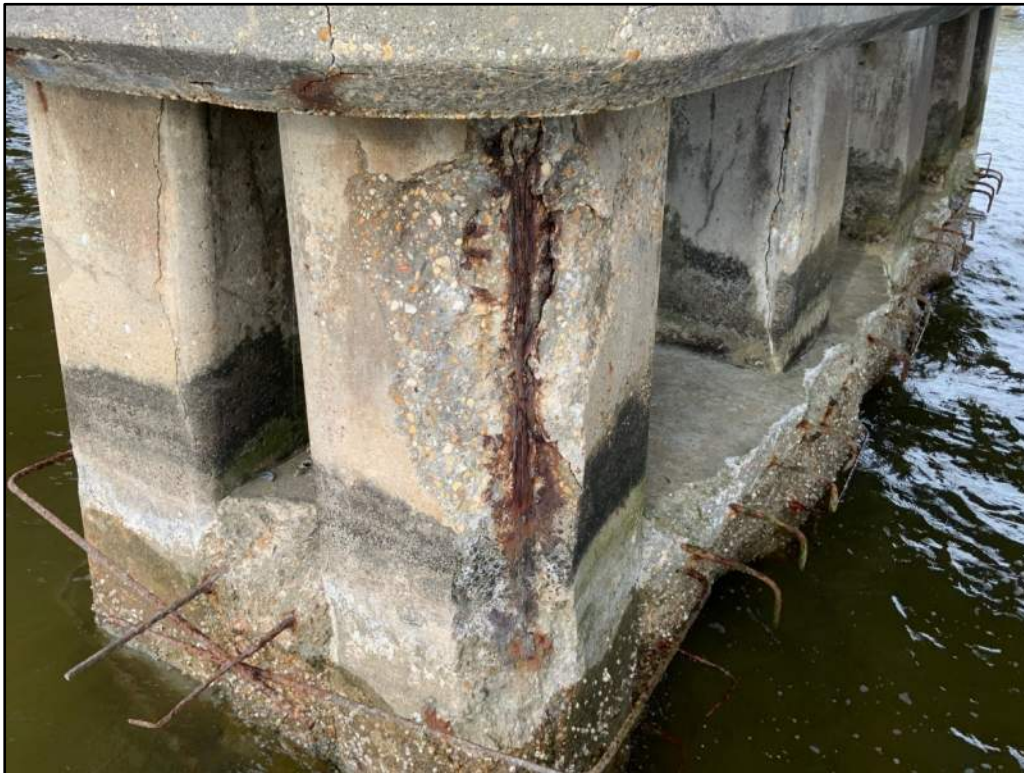
*Photo 21: Bent 8, Pile 5, Corner Spall with Exposed and Corroded Reinforcement.*

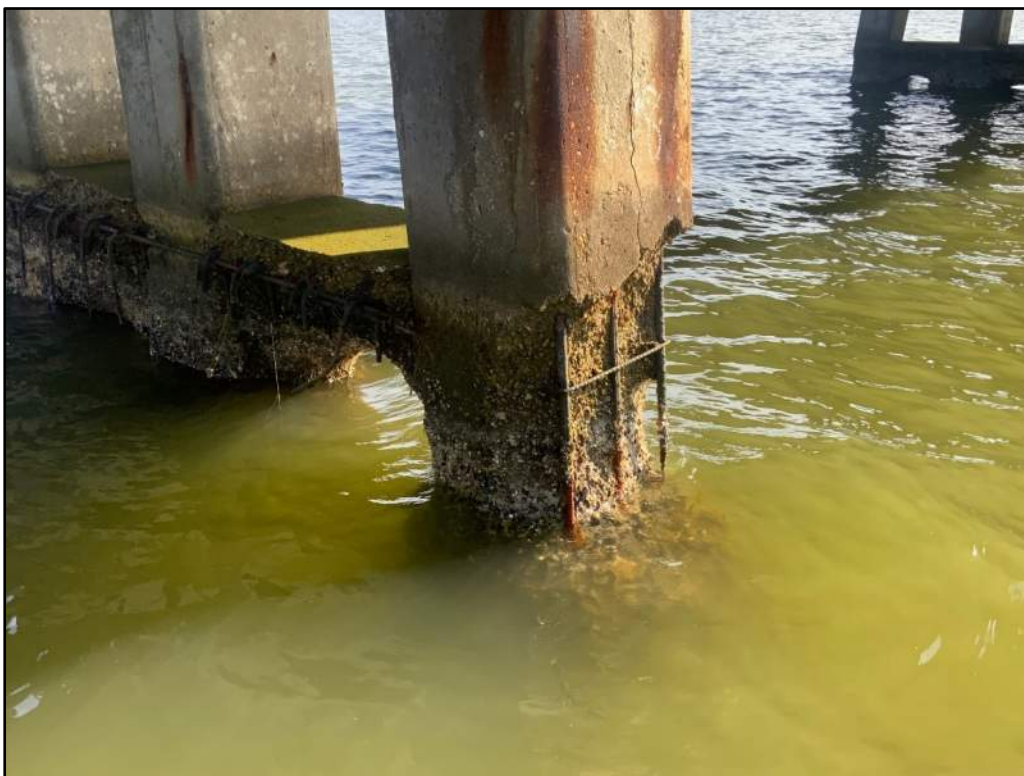
*Photo 22: Bent 149, Pile 5, Spall with Exposed, Corroded, and Debonded Reinforcement.*

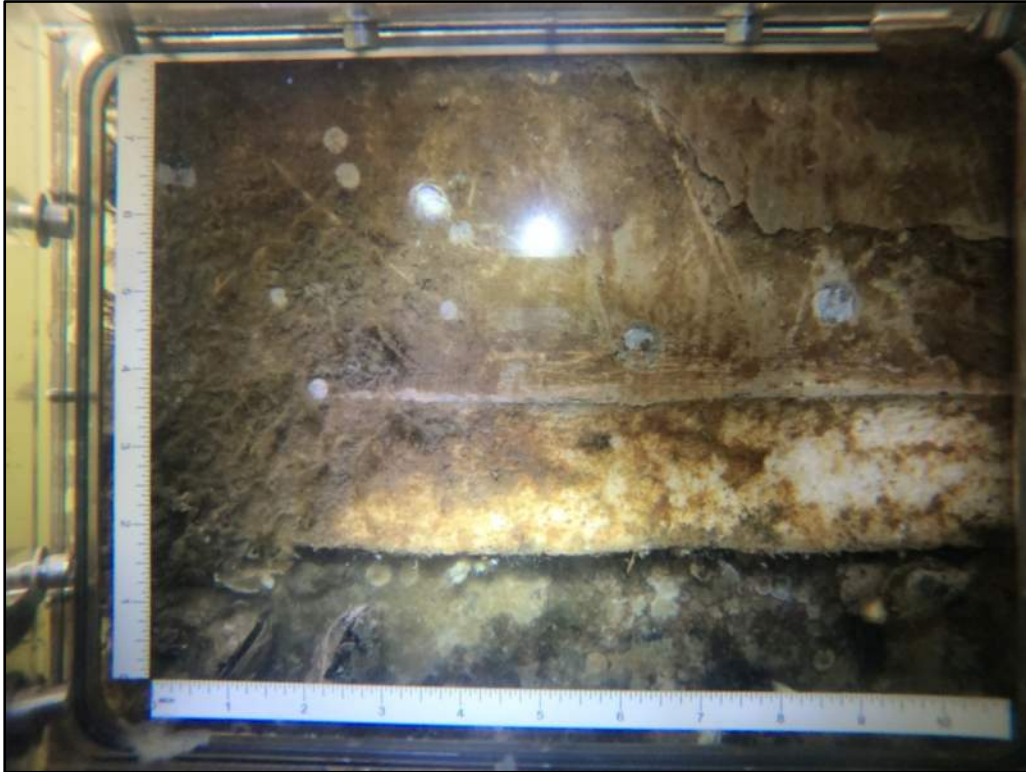
*Photo 23: Typical Condition of Square Epoxy Jacket Underwater (Bent 130, Pile 4 Shown).*

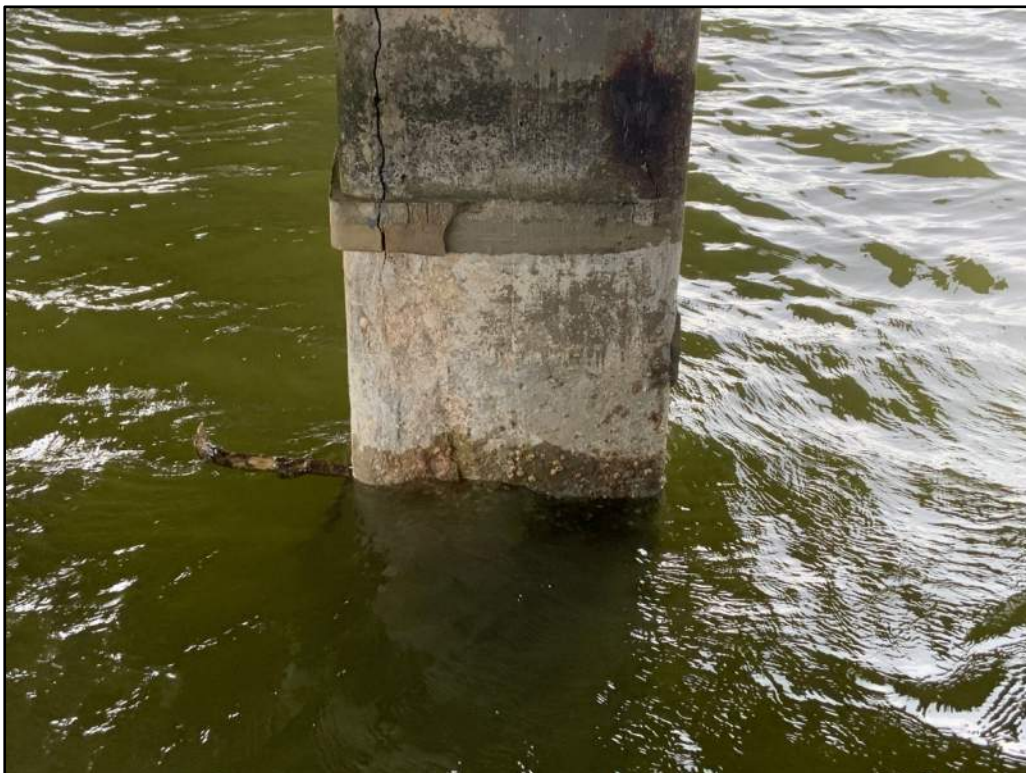
*Photo 24: Bent 130, Pile 2, Missing Jacket and Abrasion in the Tidal Zone.*

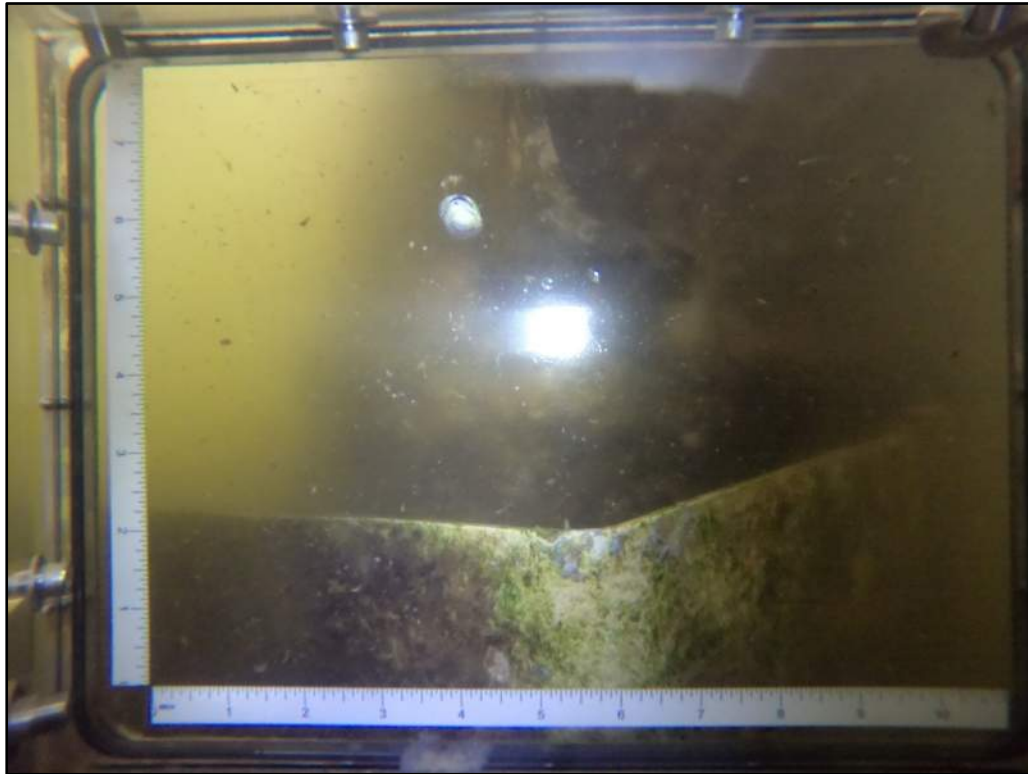
*Photo 25: Bent 130, Pile 2, Failed Square Epoxy Jacket (Underwater).*

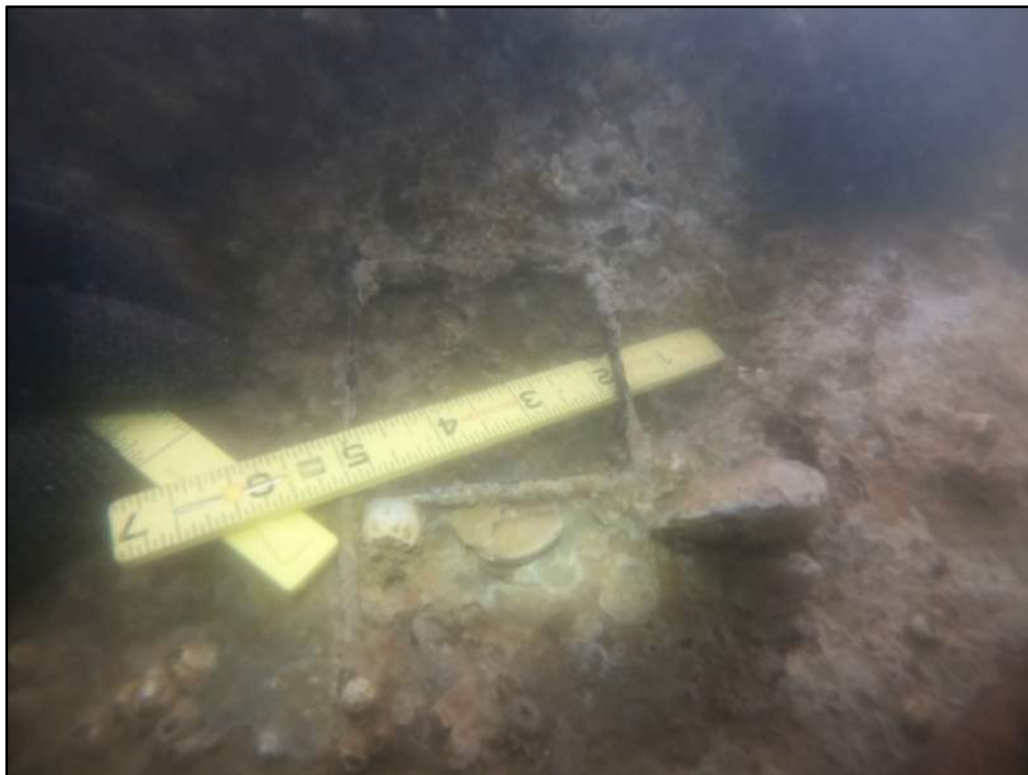
*Photo 26: Bent 40, Pile 1, Void at the Top of the Grout Filled Fabric Bag Repair (Underwater).*

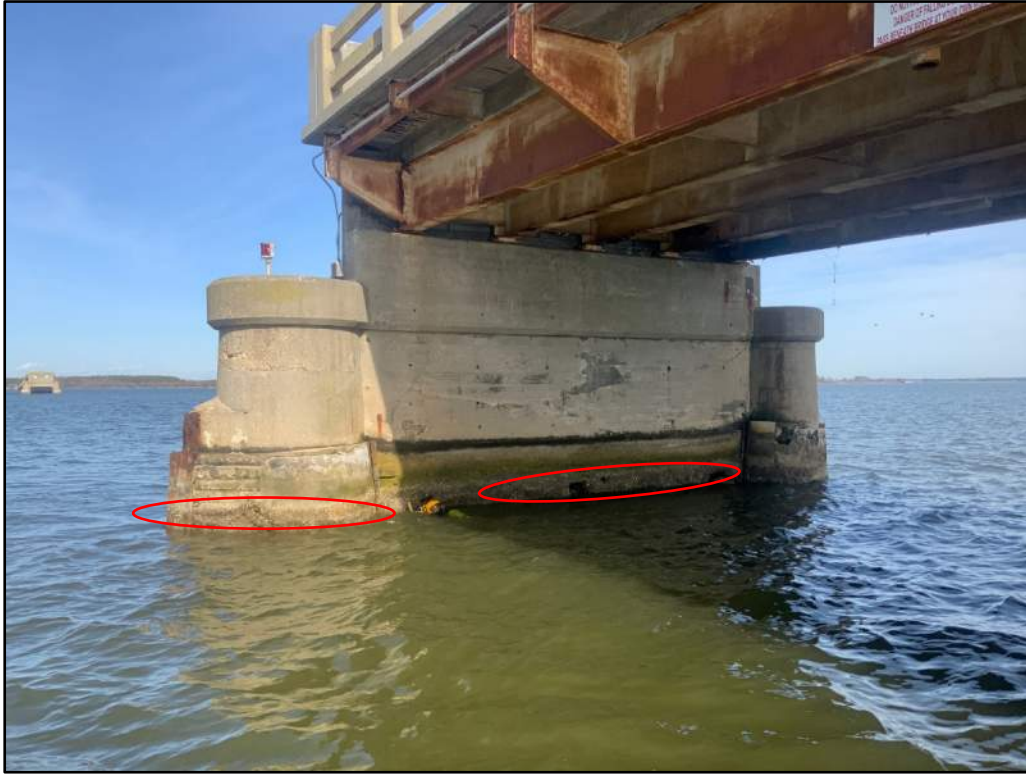
*Photo 27: Pier Wall 1 (Bent 56), Scaling and Voids at the Waterline.*

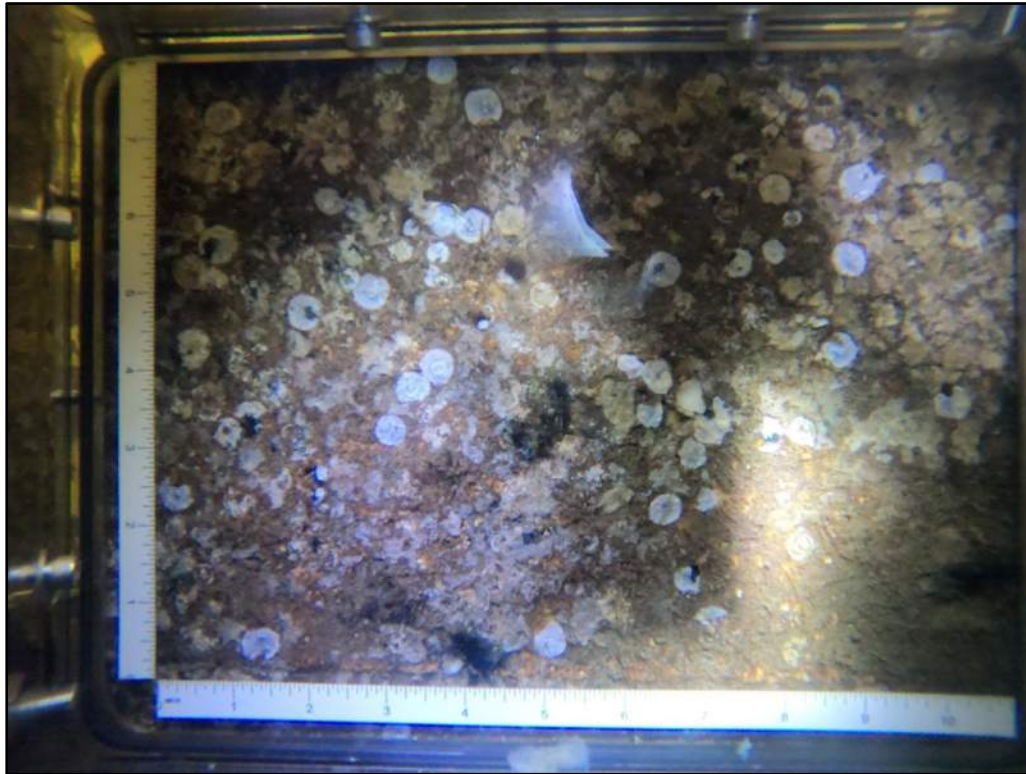
*Photo 29: Pier Wall 6 (Bent 57), Typical Condition of Reinforced Concrete Strut (Underwater).*

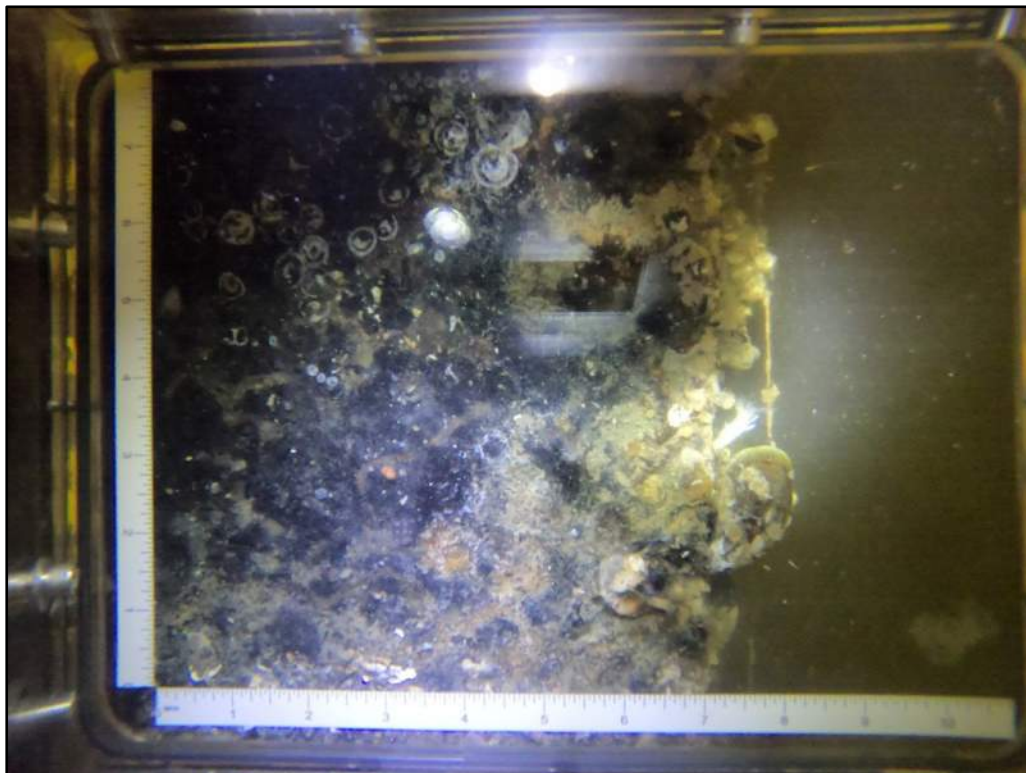
*Photo 30: Pier Wall 6 (Bent 57), Typical Condition of Footing (Underwater).*

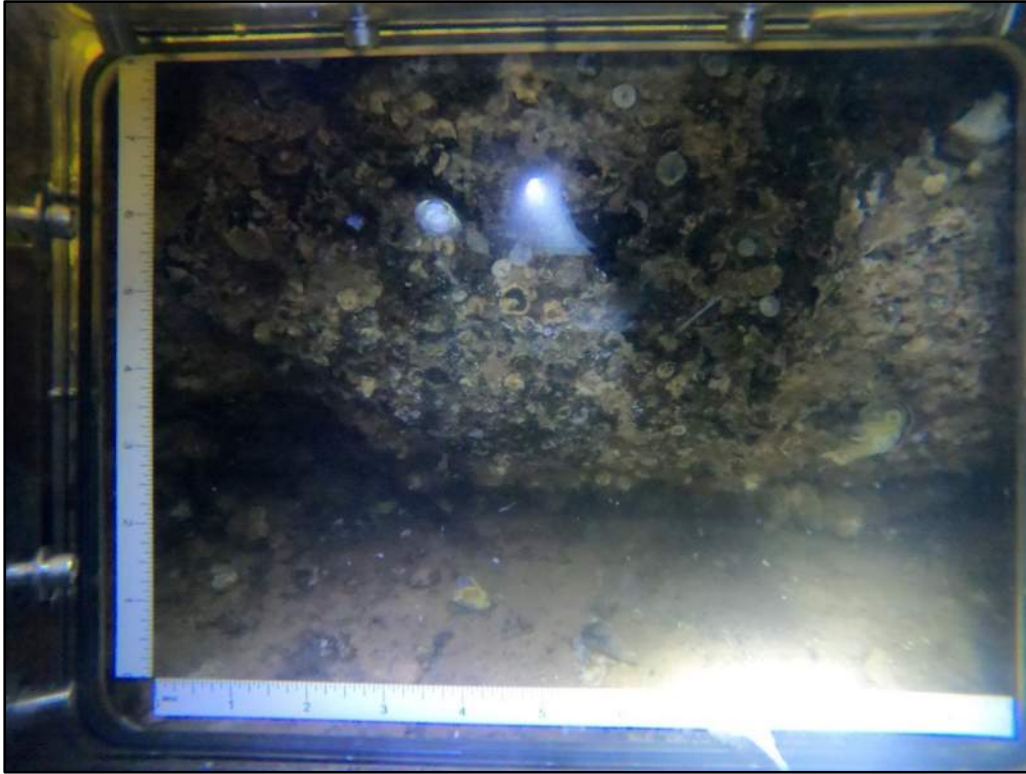
*Photo 31: Pier Wall 6 (Bent 57), Void at Footing Subfooting Interface (Underwater).*

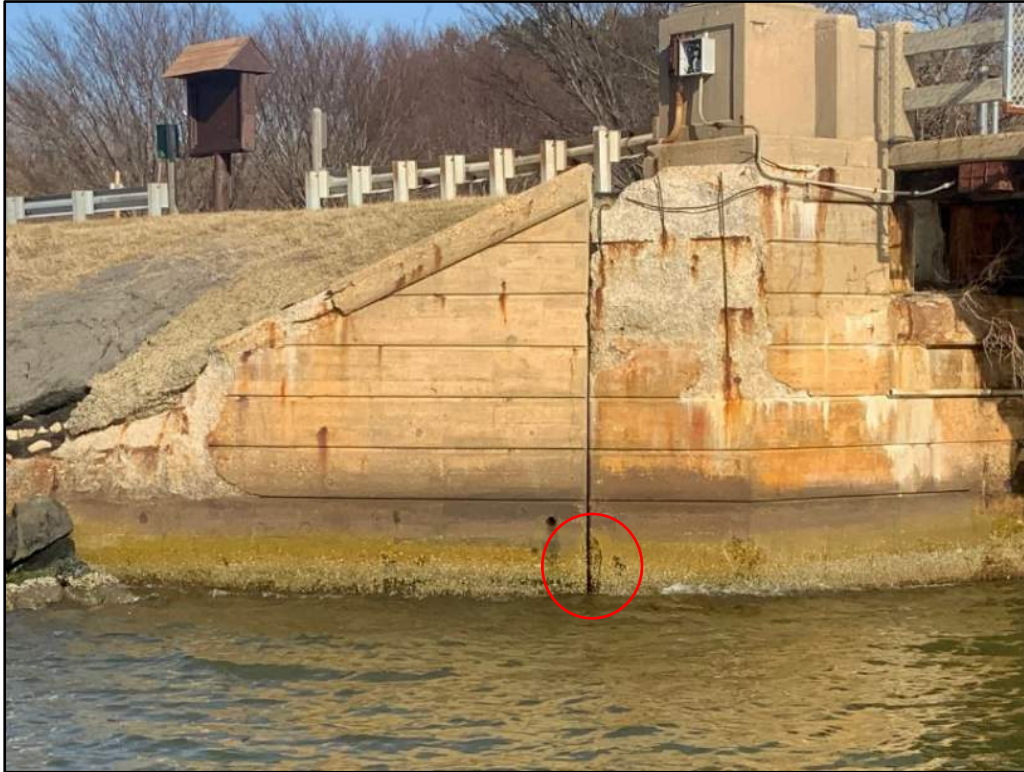
*Photo 33: North Abutment (Bent 151), Spalling at the Waterline.*

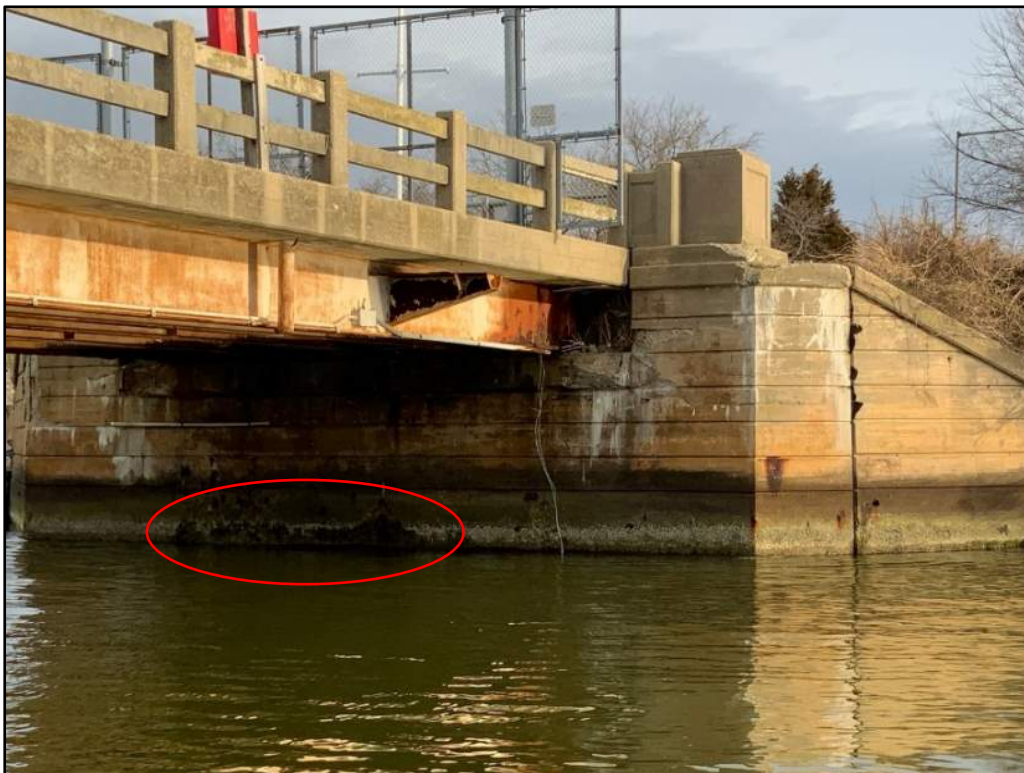
*Photo 34: North Abutment (Bent 151), Spalling at the Waterline.*

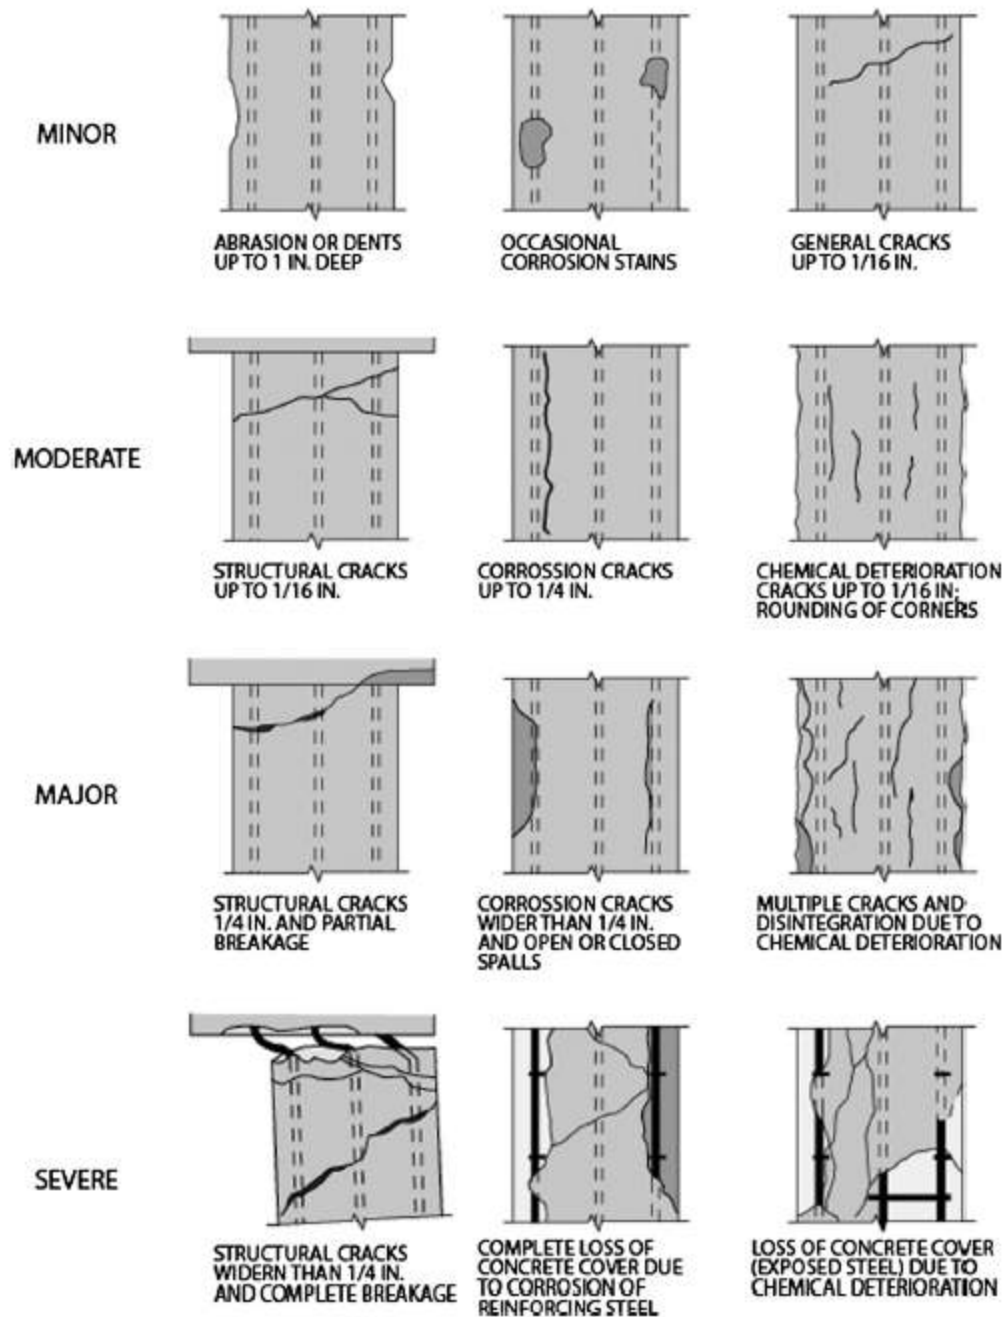
Fig. 2-4. Damage ratings for reinforced concrete elements  
 Source: Courtesy of CH2M HILL, Inc. and COWI, Inc., reproduced with permission.
