Bill Burton Fishing Pier Trappe, Maryland Rehabilitation / Replacement Recommendations April 2022

Preamble

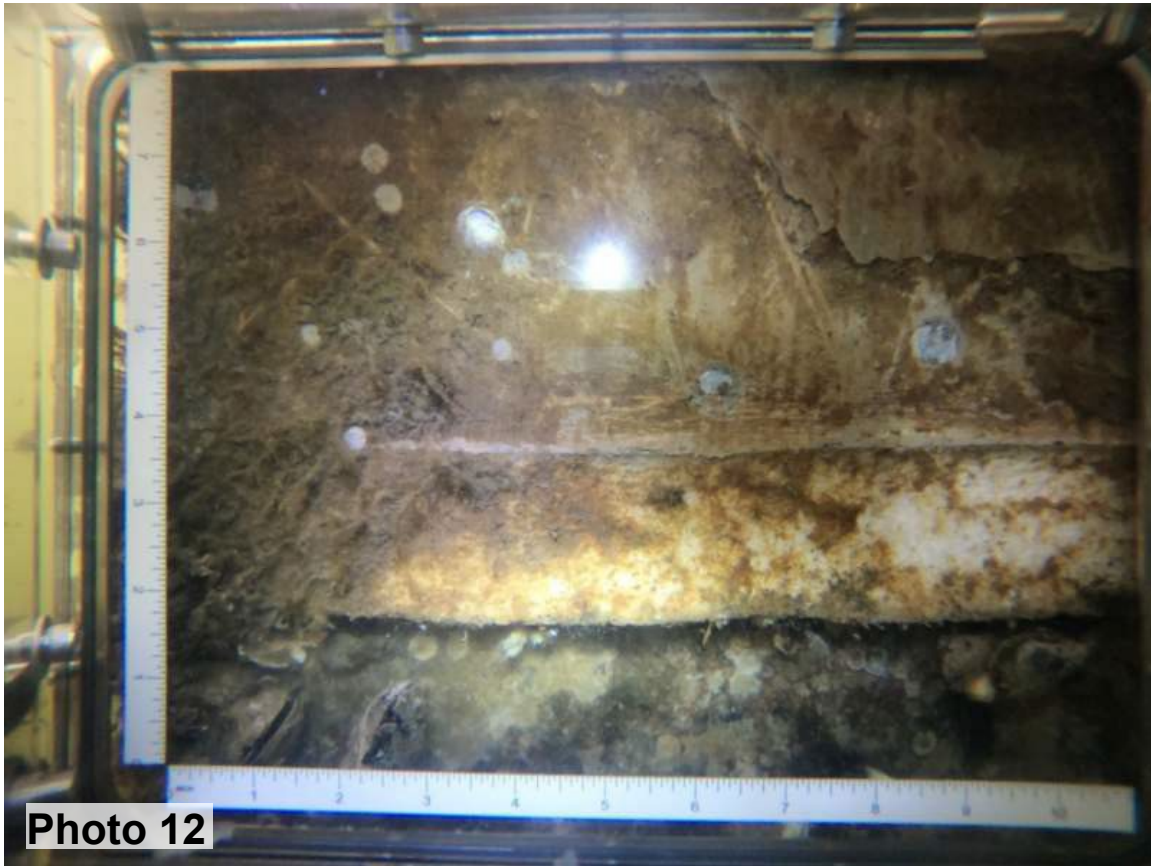
Photo 12

Marine Solutions' limited underwater inspection of February 2022 confirmed our suspicion of **crumbling concrete** in many areas of the structure below the water surface (see photos 12 thru 17). We believe this condition is prevalent throughout the structure. These defects can cause **sudden failures**, often with little to no warning, making them unpredictable. In addition, they are very costly to repair due to the need for special underwater construction methods and materials and limiting environmental regulations for construction work in water.
