# Hurricane Ike

Nature's Force vs. Structural Strength

**Institute for  
Business &  
Home Safety®**

September 2009

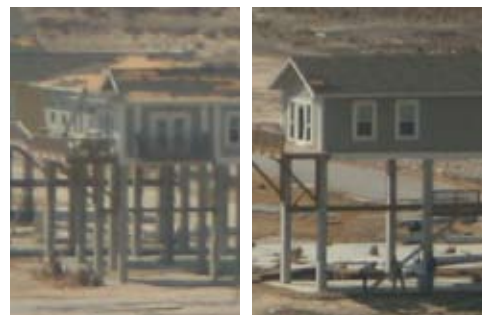
These two homes were exposed to essentially the same wind conditions. The house on the right lost a few shingles, while the house on the left lost most of the roof cover. Two different products with the same nominal rating performed quite differently in real-world conditions.

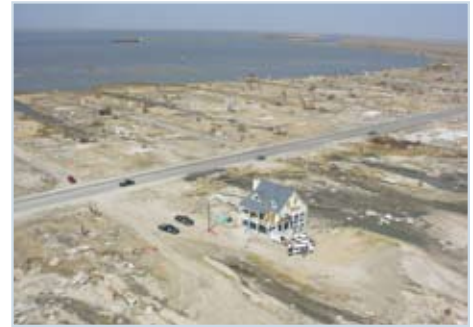
**Figure 15** This home was dubbed the “Last House Standing” by the media, but did not perform as well as the houses built to the IBHS **Fortified...for safer living®** standard.

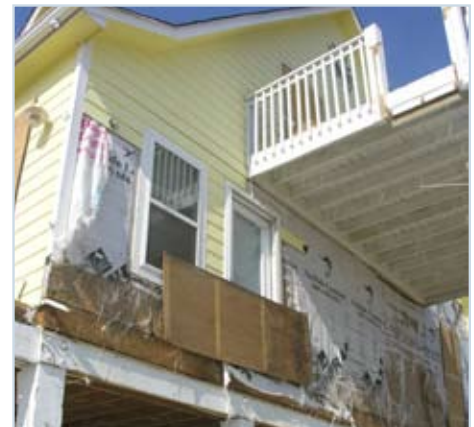
- The wall of the first habitable floor on the seaward side of the house had begun to fail (Figure 16). It was clear that waves were striking the building at a level slightly above the floor beams; as a consequence the bottom of the wall was partially pushed in.

**Figure 16** The wall of the first habitable floor on the seaward side of the “Last House Standing” had begun to fail when IBHS inspectors visited the site.

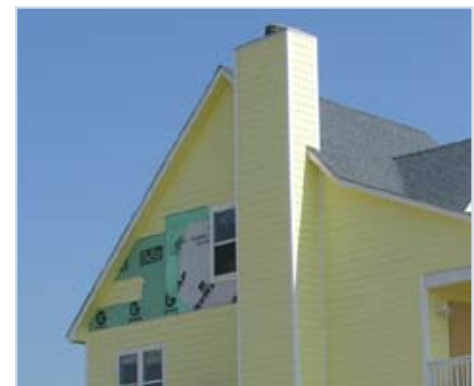
- There were missing exterior wall cement board panels on both the seaward and inland sides of the home (Figure 17). The owner complained that the siding had been fastened to the wall wood structural panels instead of the wall framing members.

**Figure 17** The “Last House Standing” was missing exterior wall cement board panels on both the seaward and inland sides of the home.

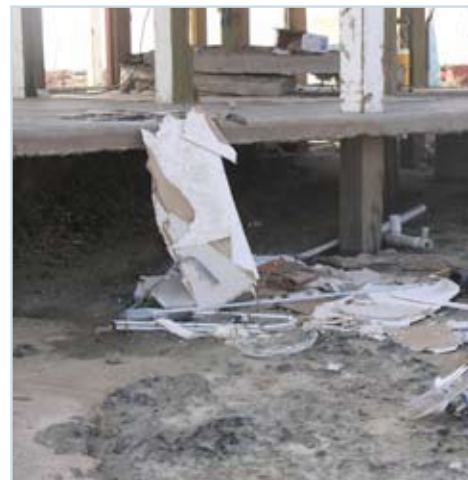
- The concrete slab at ground level was significantly undermined (Figure 18). It is likely that the slab will have to be broken up and removed in order to properly fill and compact soil under the slab.

**Figure 18** The concrete slab at ground level on the “Last House Standing” was significantly undermined by the effects of Hurricane Ike.

Many coastal engineers very much oppose large concrete slabs being poured under elevated coastal homes. As was observed with the “Last House Standing,” it is possible to have significant undermining of the slab, which would require demolition of that slab. In some cases, the loads the slab imposes on the structure could pose a significant risk to the structure itself. The clear preference is for large concrete segments that are essentially giant pavers. These could be moved about by the surge, and then replaced after soil/sand under the house is replaced and compacted.

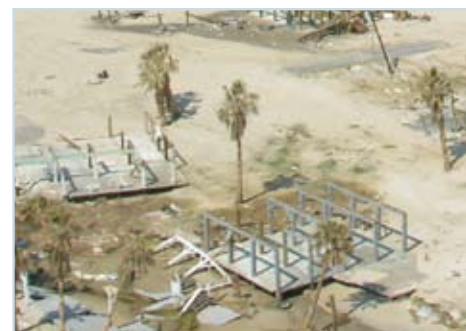
**Figure 19** Houses near the Gulf of Mexico where the piles terminated at the bottom of the first floor tended to be completely wiped out by the storm surge.

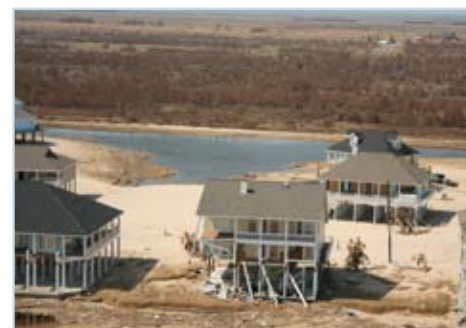
A number of houses near the coast clearly had piles that continued through the height of the first floor (Figure 20). In these houses, the upper floors appeared to remain intact, but frequently the bottom floor and parts of the walls on the bottom floor were completely missing.

**Figure 20** A number of houses near the coast clearly had piles that continued through the height of the first floor. In these houses, the upper floors appeared to remain intact, but frequently the bottom floor and parts of the walls on the bottom floor were completely missing.

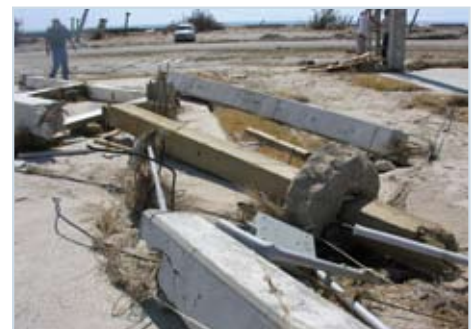
**Figure 21** One of the porch columns from a traditionally built house across the street from the **Fortified** homes on Bolivar Peninsula. Some of the posts that broke away from the houses damaged by storm surge became sizeable battering rams, capable of damaging surrounding properties.

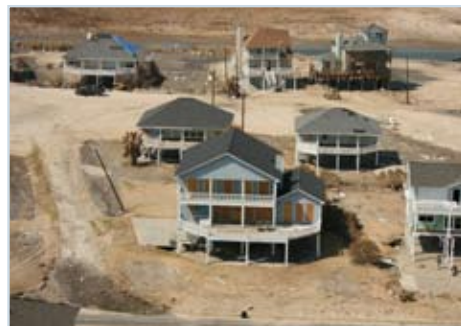
**Figure 22** Aerial photos taken after Ike showed close to 90 percent of the homes near the coast toward the western part of Bolivar Peninsula had an extensive loss of hip and ridge shingles.

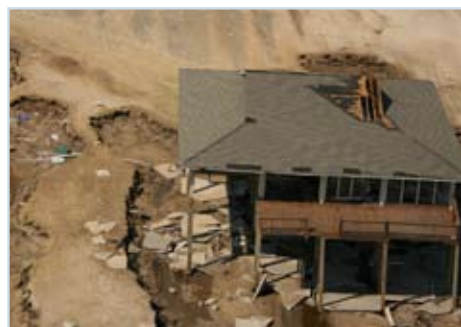
**Figures 23** Damage to drip edges and adjacent eave shingles was evident in IBHS analysis of aerial photographs taken after Ike.

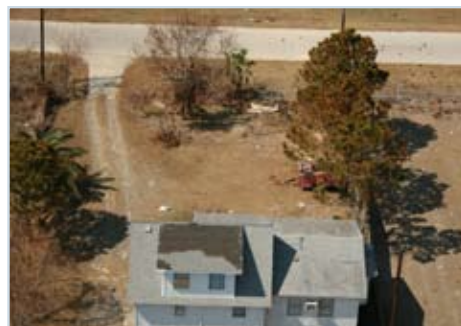
**Figure 24** In many cases of roof damage, underlayment survived during hurricane conditions where shingles did not.

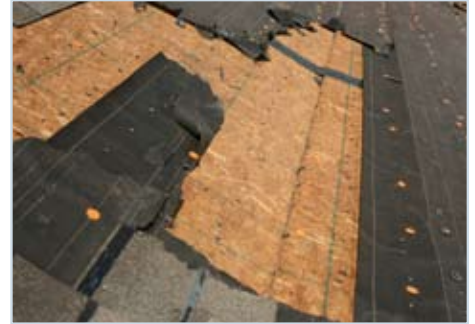
**Figure 25** Flashing should have been installed at the joint where OSB sheathing panels overlapped on the primary slope of this traditionally built home, beginning at the ridge. This picture clearly shows that water collected and ran down through the gap between the sheathing.

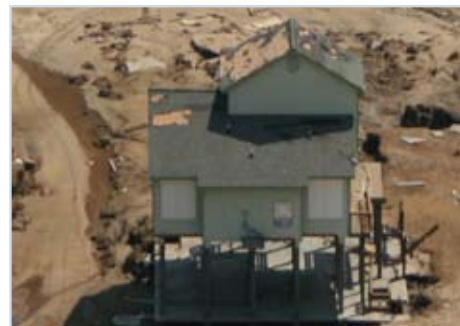
**Figure 26** The 15-pound felt underlayment in this home did not survive hurricane conditions after the shingles were lost. This problem was addressed in the *Fortified* homes through the use of tape over the seams to provide backup water protection.

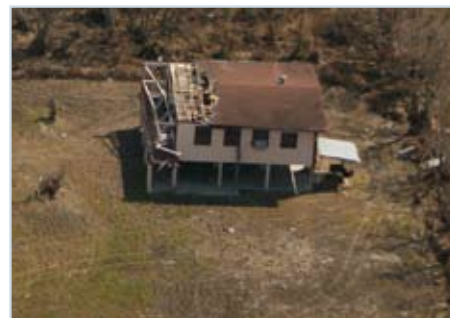
**Figure 27** Losses of roof sheathing at gable ends were frequently observed toward the western end of the Bolivar Peninsula, where the 3-second gust wind speeds were likely less than 110 mph.

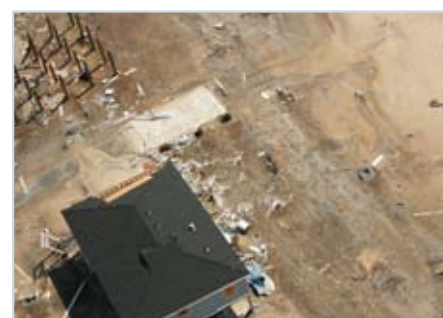
**Figure 28** Gable end failures, and particularly of roof sheathing loss at gable ends, were a frequent source of damage. In several cases, it was clear that outriggers supporting sheathing had been notched, and in some instances, underlying rafters or trusses also probably were notched.

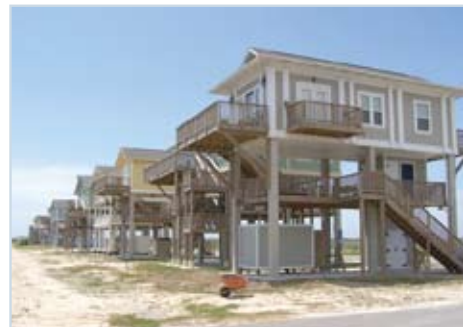
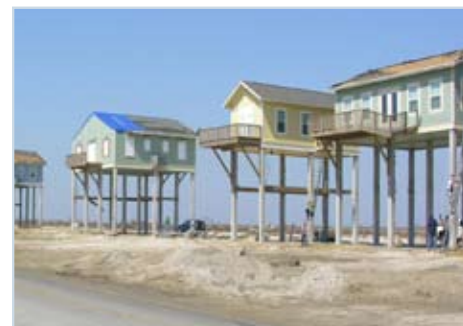
**Figures 29 and 30** Ground level views, looking west, of the *Fortified* houses before and after Hurricane Ike. It is clear that all storage areas and decks were totally destroyed by the storm surge.

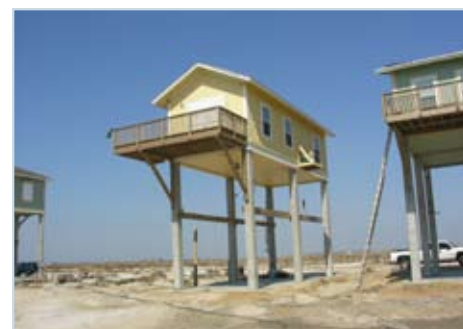
**Figure 31** While all of the decks did break away, it is clear that deck connections were not what typically would be considered a breakaway connection in the Coastal Construction Guidance from FEMA and the NFIP.

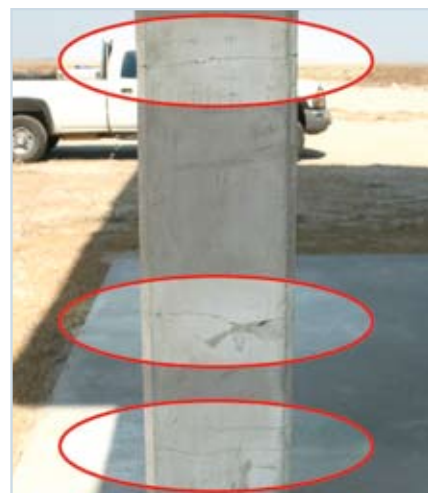
**Figure 32** These horizontal cracks are indicative of the columns experiencing large tension forces from uplift on the decks when they were impacted by the storm surge with waves. If the cracking had been due to lateral loads, it would have produced diagonal cracks across the cross-section.

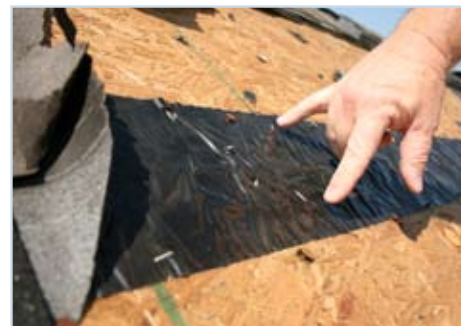
**Figure 33** Here staples were used in an apparent attempt to keep the secondary water barrier tape in place, likely due to the fact that the tape was not sticking well when it was first applied.

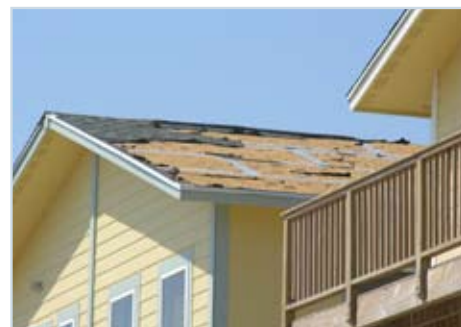
**Figure 34** Workers opted to use a different type of secondary water barrier tape than was used on one of the last *Fortified* houses in the row on Bolivar Peninsula.

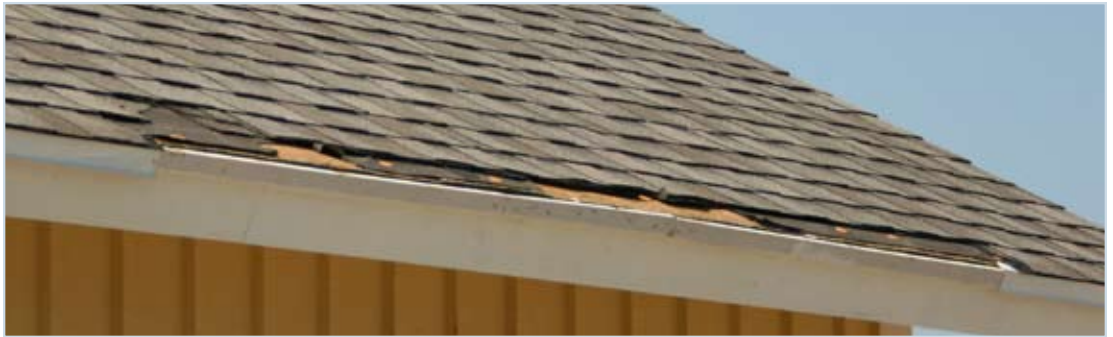
**Figure 35** Drip edges may be vulnerable to corrosion and may play a role in eave shingle failures when they are not attached with enough fasteners. In this photo, the drip edge is deflected upward and may have contributed to the lifting of shingle tabs immediately adjacent to the eave.

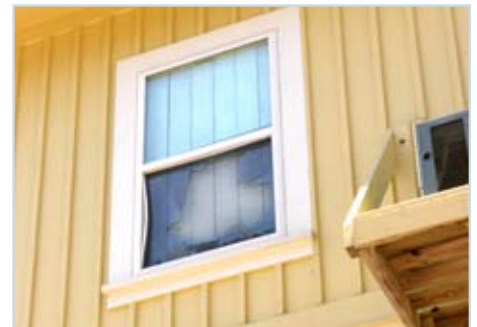
**Figure 36** Only one outer pane was broken and no inner panes were damaged on the impact-resistant windows used in the 10 **Fortified** houses that survived Hurricane Ike.

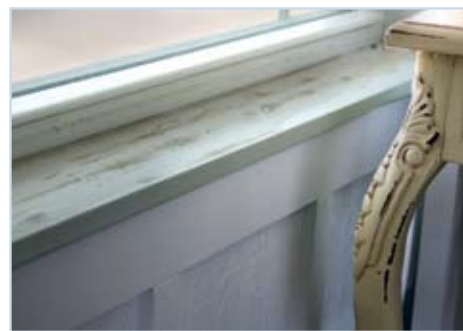
**Figure 37** Even during a Category 2 hurricane, where rainfall rates never exceeded a rate of about 1 inch per hour, wind-driven rain leaked into the house through windows and doors.

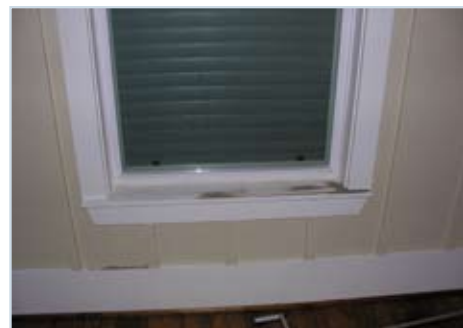
**Figure 38** Water got inside this window, despite the presence of a hurricane shutter and the use of impact-resistant glass.

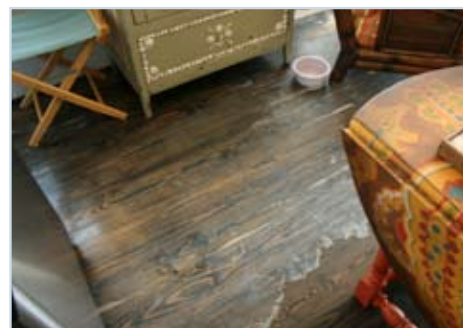
**Figure 39** The silt line on the floor on this home is evidence of just how much water got inside. The use of water-resistant materials, such as wood flooring, prevented widespread water damage.

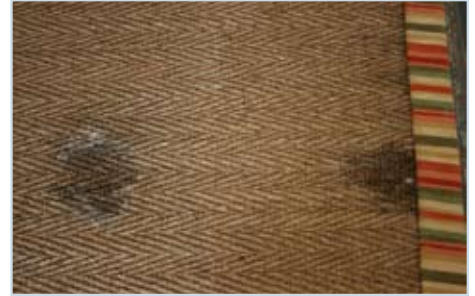
**Figure 40** The builder's decision to use wood panels and boards for floors, ceilings, inside wall surfaces and outside wall surfaces in the **Fortified** houses resulted in significantly reduced losses and damage from water intrusion. The only sign of any mold or mildew was to area rugs that had gotten wet.

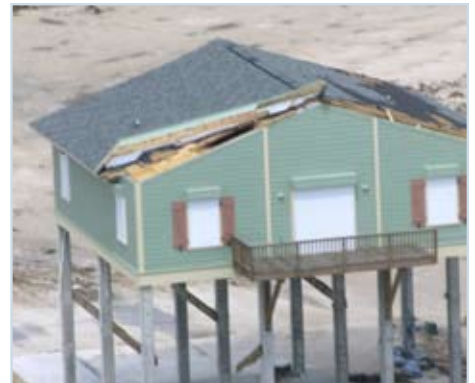
**Figure 41** The gable end roof sheathing failure on this home was unique among the **Fortified** houses with similar roof styles.

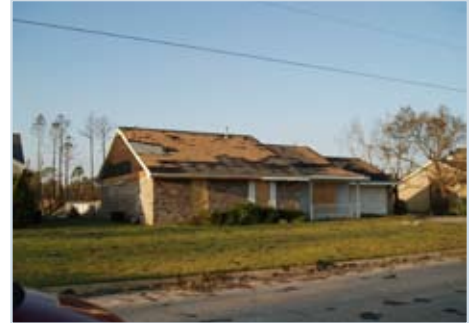
The loss of roof cover and underlayment can lead to significant water intrusion.

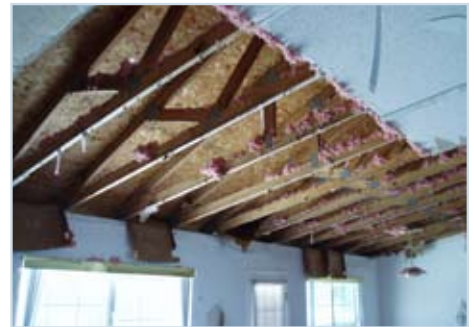
Collapsed ceiling due to water intrusion from roof cover damage.

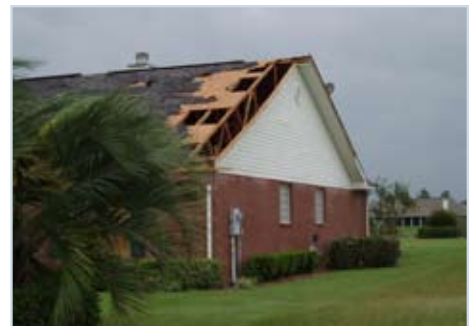
Loss of roof sheathing allows water and wind inside.

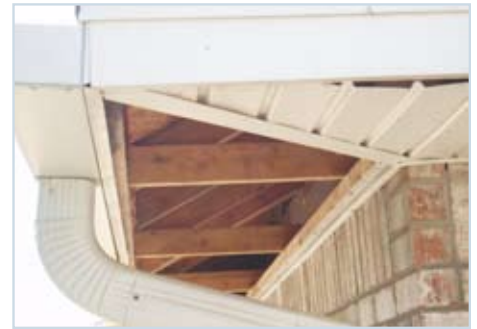
Loss of soffit materials allows wind and water to be blown into an attic.

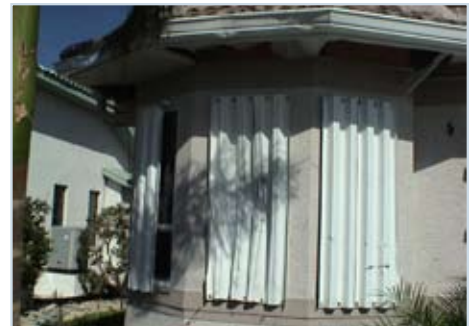
These shutters took a beating from roof tiles that were blown off a neighboring house, but still managed to protect the openings.

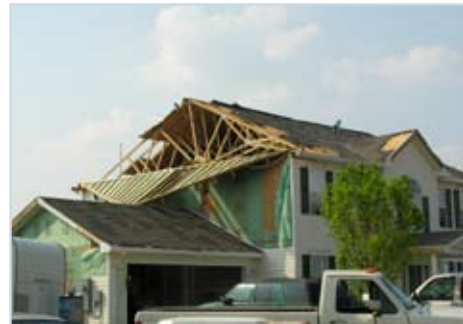
Gable end wall and roof sheathing damage.

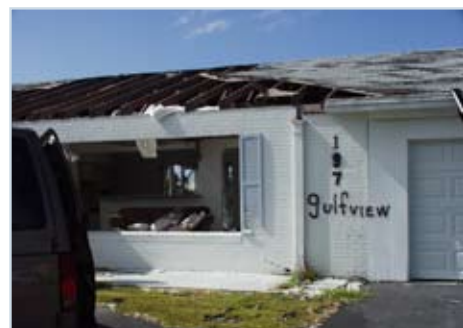
The large porch on this house was blown away and left a large hole in the main roof.
