Surviving Nature's Fury: Performance of Asphalt Shingle Roofs in the Real World

Zhuzhao Liu, Research Engineer, Institute for Business & Home Safety, 4775 E. Fowler Ave., Tampa, FL 33617, zliu@ibhs.org

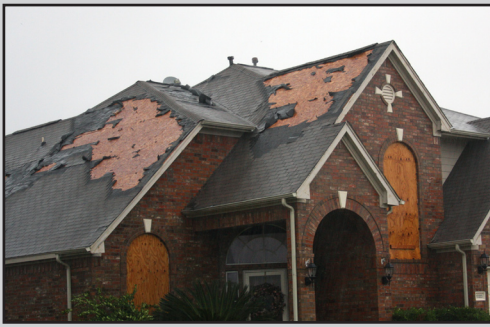
WIDESPREAD DAMAGE TO ROOF SHINGLES

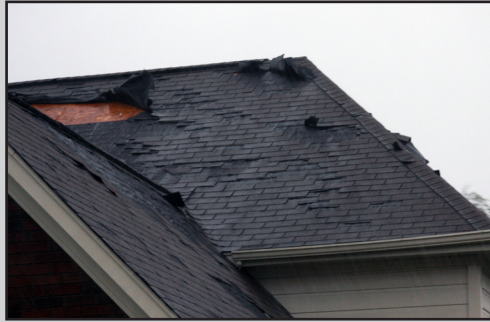
A LARGE NUMBER OF SHINGLES BLOWN OFF

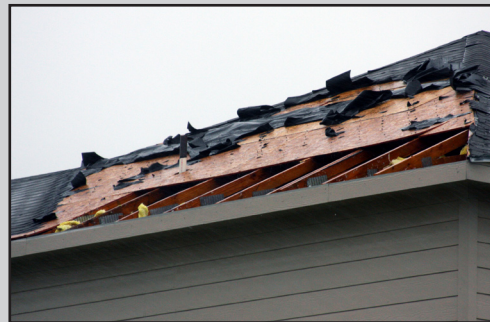
HEAVY DAMAGE AS A RESULT OF SHINGLE AND SHEATHING LOSS

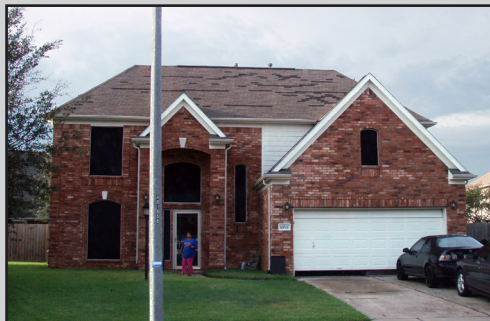
WIND UPLIFT OF INDIVIDUAL TABS AND SHINGLES

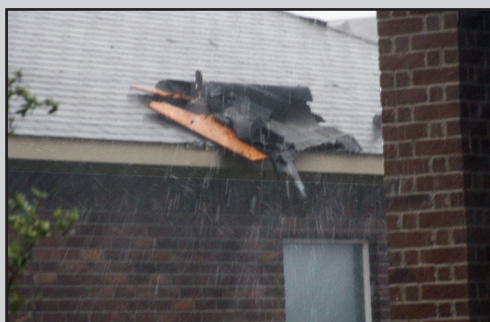
FIGURE 6: TYPICAL TYPES OF DAMAGE TO ROOF SHINGLES OBSERVED BY ON-SITE INVESTIGATION TEAMS

SEALANT BONDS
