11.30.18 Earthquake Emergency Repairs

Saturday, December 01, 2018

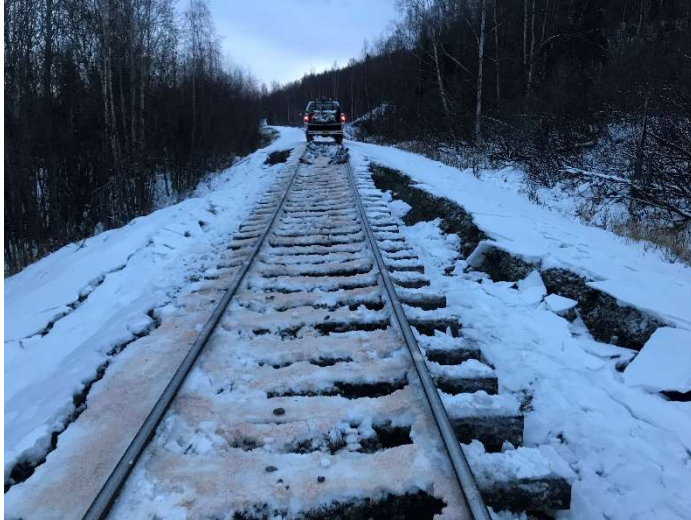
Photo 1: Ice melt placed above the mainline at ≈MP 138.5, looking RR North.

Procured ice melt from Lowes in Wasilla, AK and transported to the ≈MP 138.5 disaster site. Ice melt was placed above ≈126 feet of rail within the depression. Material was removed from between ties using hand tools to allow track crews to jack and shim the affected section of rail closer to its pre-disaster elevation.

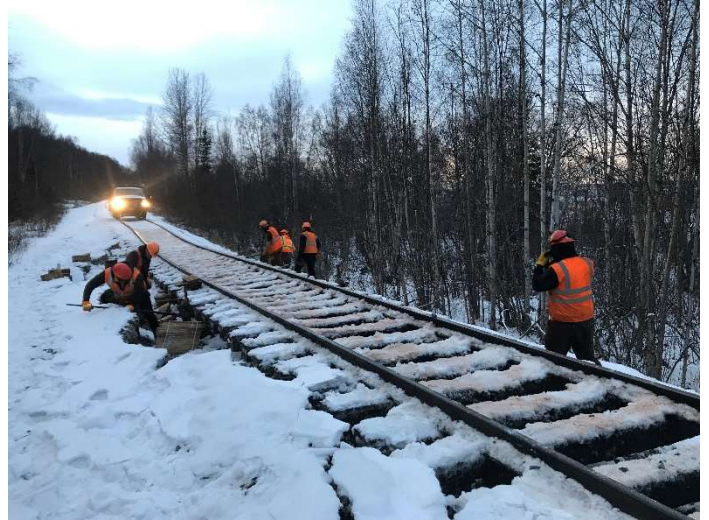
Photo 2: ARRC MOW forces jacking and shimming the affected section of rail at ≈MP 138.5, looking RR South-Southwest.

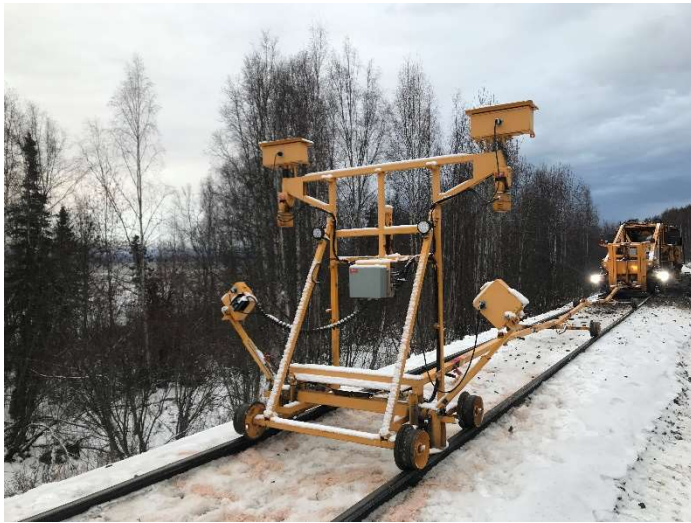
Photo 3: The ET20 realigning and raising the rail at ≈MP138.5, looking RR North-Northwest.

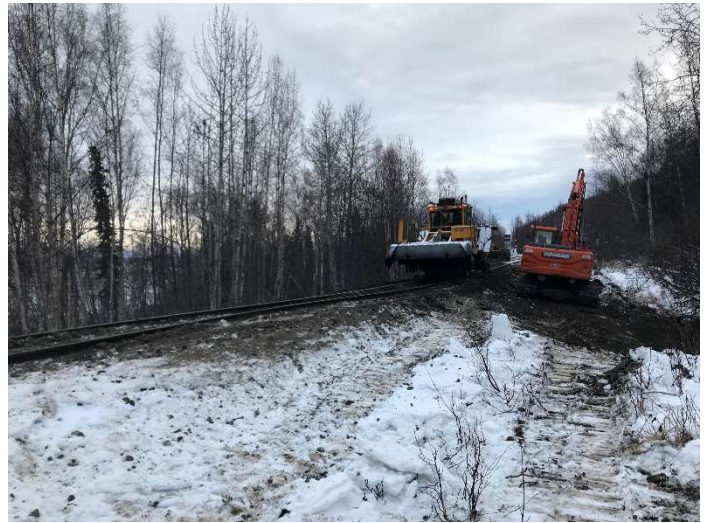
Photo 4: The BR20 and the DX180LC working at the ≈MP 138.5 worksite, looking RR North.
