U.S. CHEMICAL SAFETY AND HAZARD INVESTIGATION BOARD

INVESTIGATION REPORT

REFINERY EXPLOSION AND FIRE

REPORT NO. 2005-04-I-TX

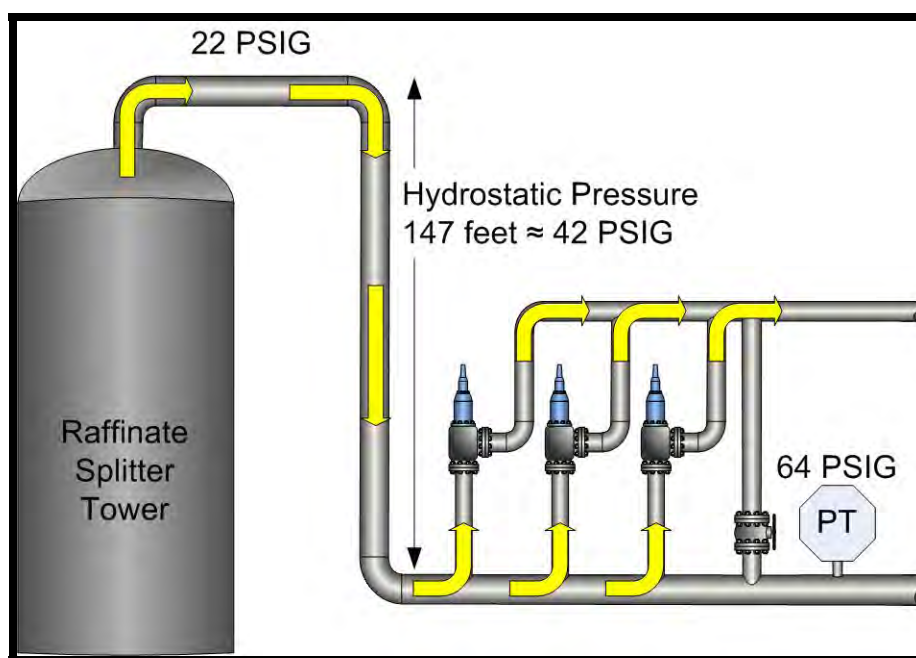
Figure 8. Hydrostatic head of liquid in overhead piping leads to the three relief valves opening

The minimum closing (blowdown) pressure for the three safety relief valves to stop flowing was 37.2 psig (256.5 kPa). Computerized control system data indicate that all three safety relief valves were fully open and flowing at capacity for slightly longer than six minutes. An average pressure of 61 psig (421 kPa) at

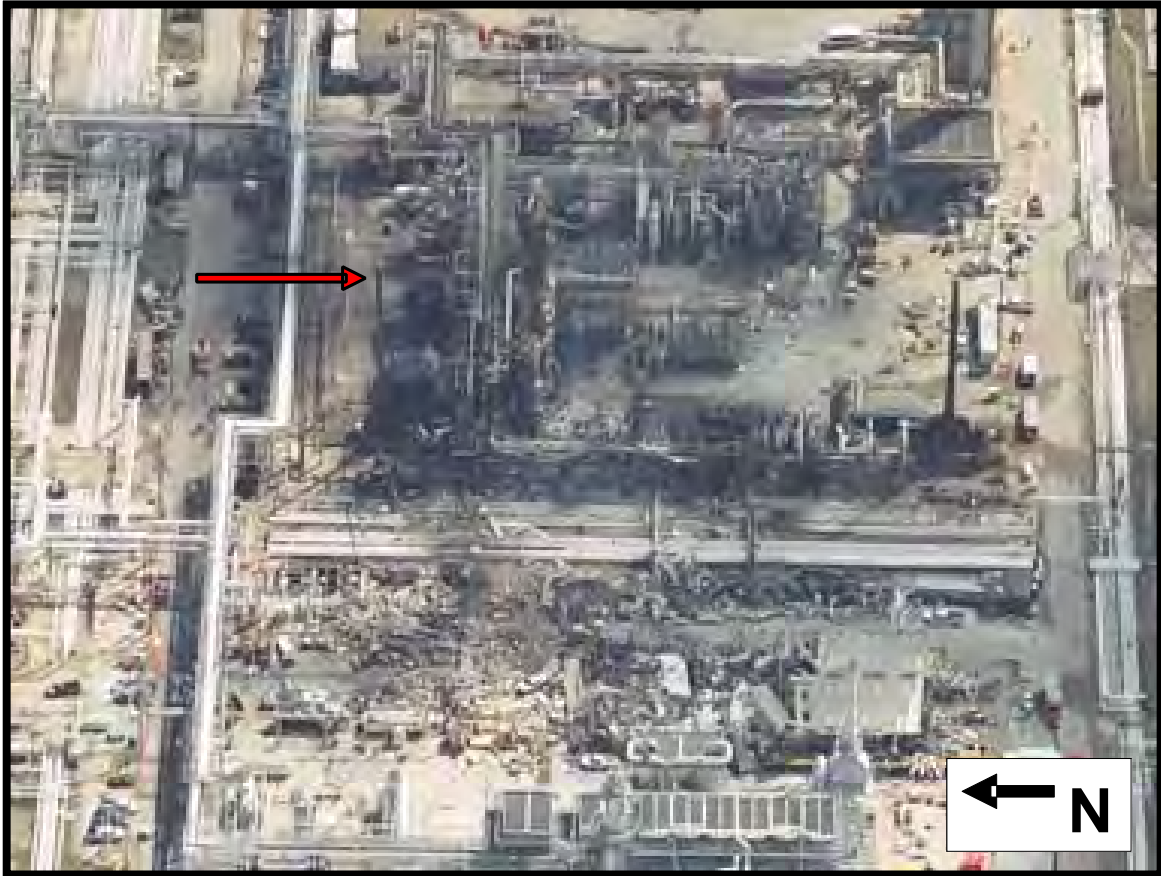
Figure 10. The darkened areas in and around the ISOM unit had the heaviest fire damage; the red arrow points to the top of the blowdown stack

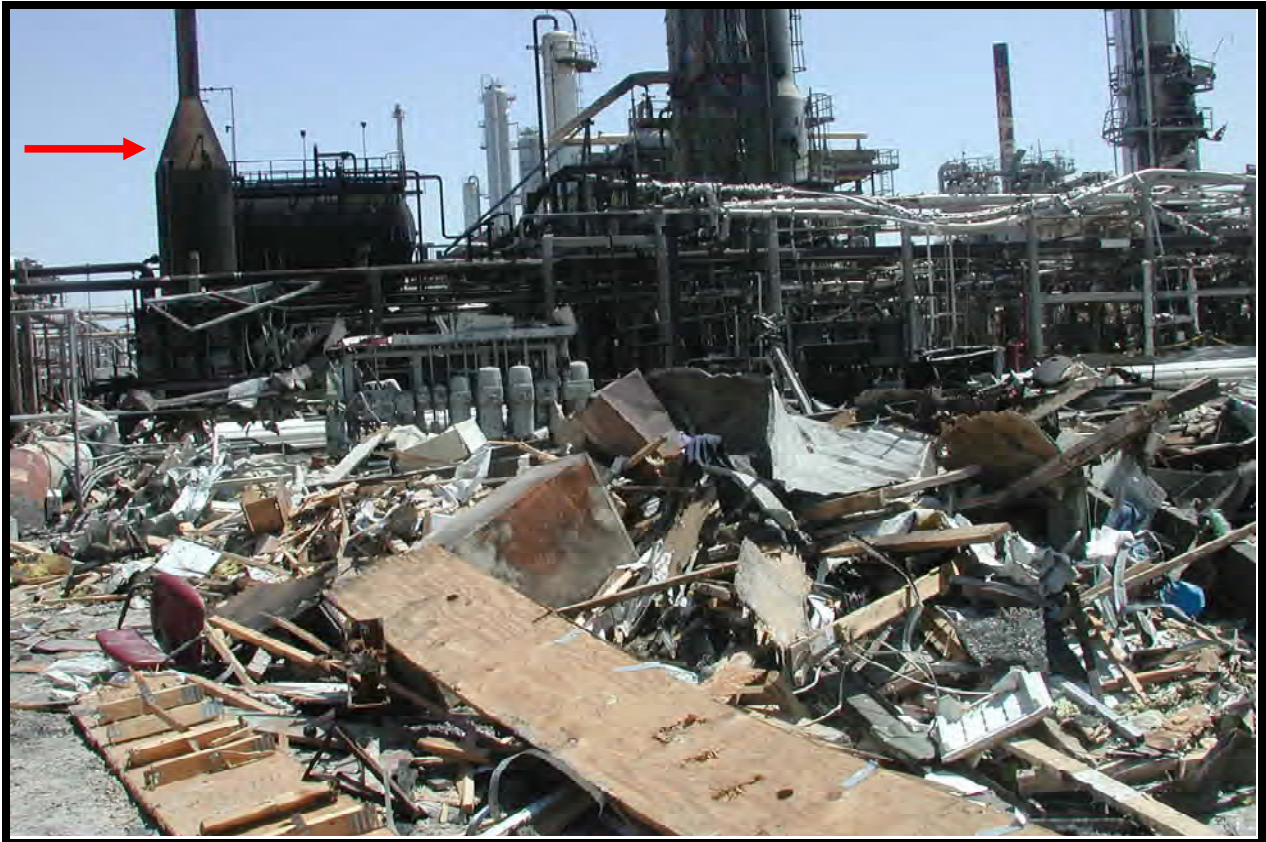
Many of the approximately 70 vehicles in the vicinity of the ISOM unit were damaged and a number were destroyed. More than 40 trailers were damaged; 13 were destroyed. On June 30, 2006, the CSB released a detailed analysis of the trailer damage, which can be viewed or downloaded from the CSB website, www.csb.gov.

Figure 13. Destroyed trailers west of the blowdown drum (red arrow in upper left of the figure)

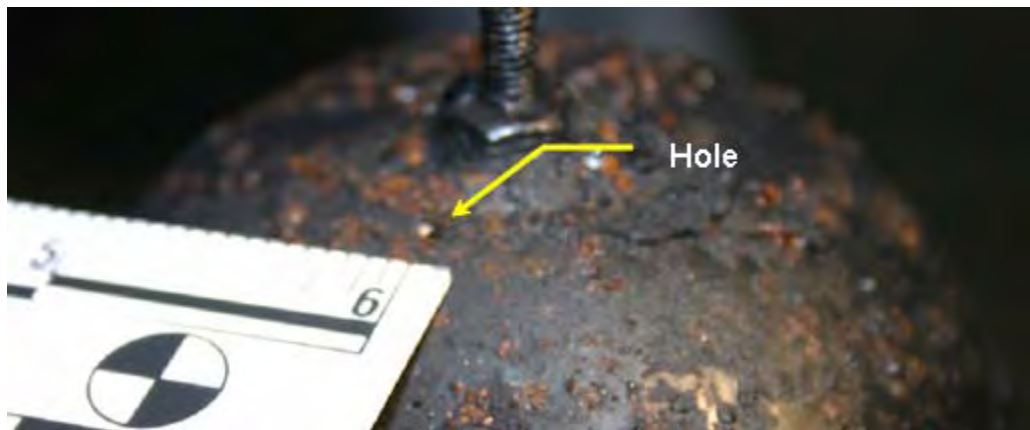
Figure S- 6. Close-up of LSH-5020 float, showing corrosion and hole
