REPORT

HILLSIDE EVALUATION AND PRELIMINARY DESIGN OLYMPIA CAPITOL CAMPUS, OLYMPIA, WASHINGTON (08-076)

March 17, 2010

083-93287.400

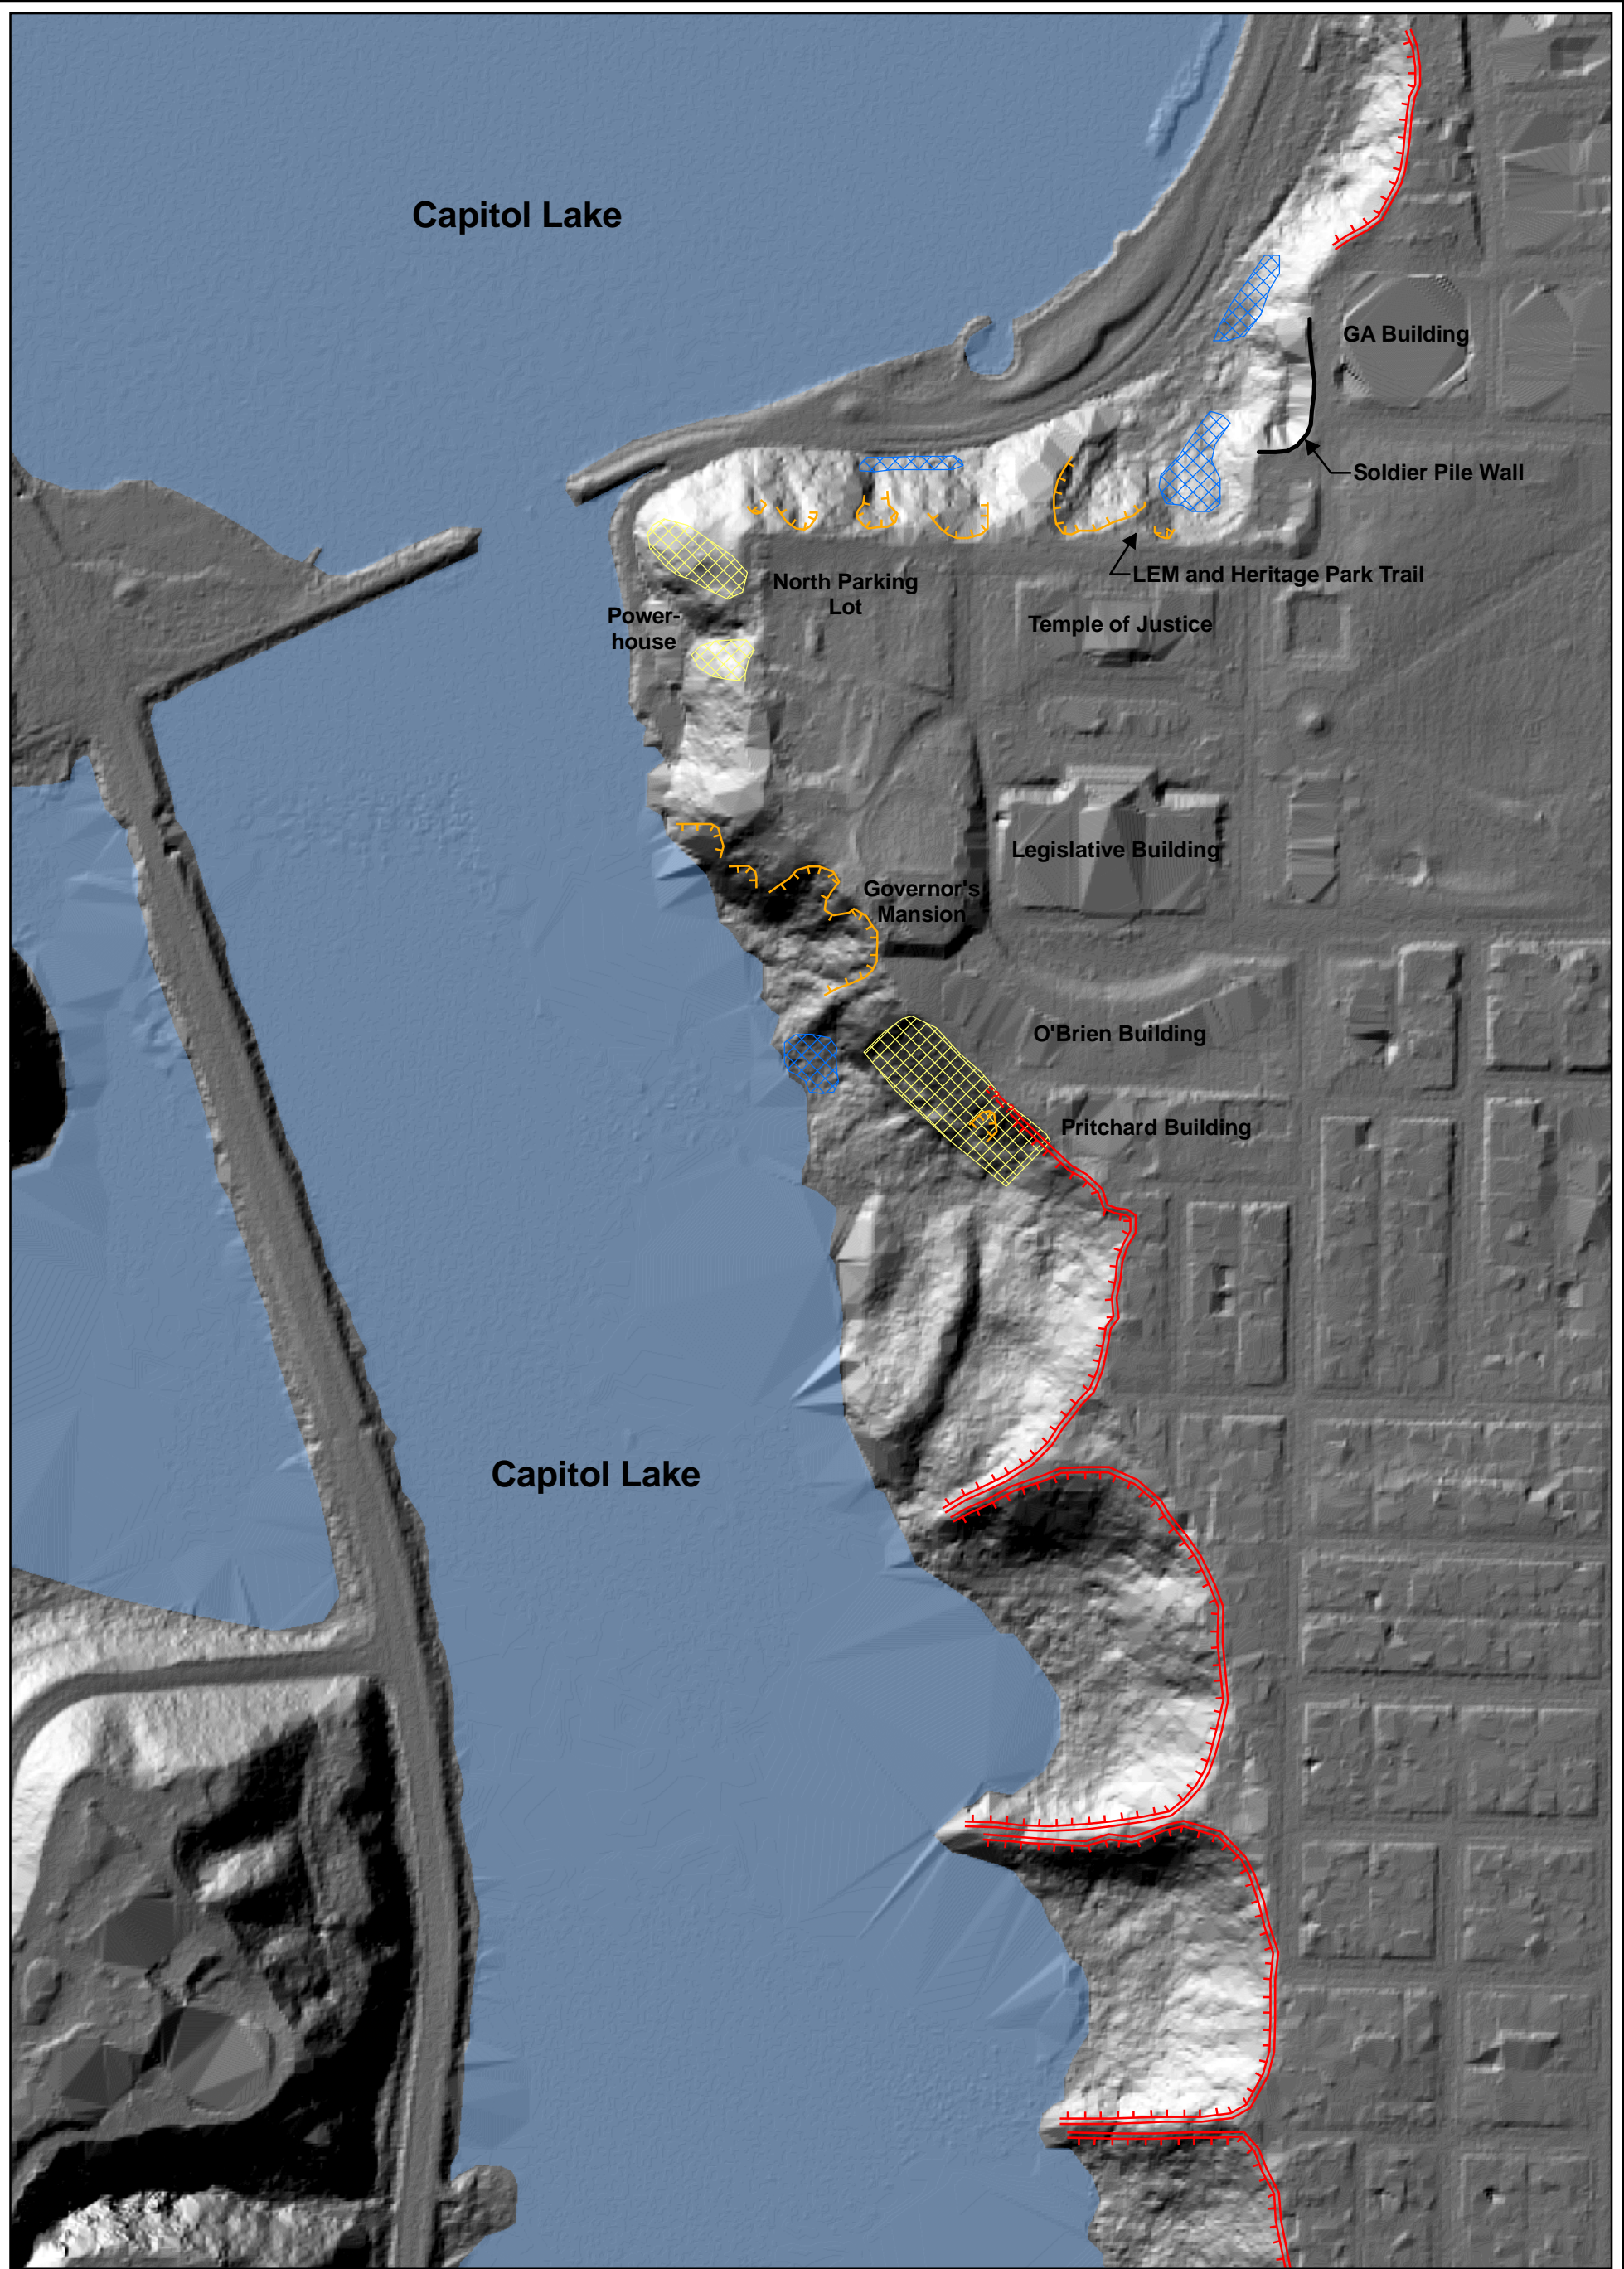
Geomorphic features identified from LiDAR interpretation, ground surface observations, and literature reviews are shown on the LiDAR image, Figure 4. The LiDAR image shows an upland area that is heavily modified, surrounded by natural and modified slopes on the west and north edges of the campus. All slopes around campus have geomorphic evidence of smaller, surficial slope failures that are usually visible on LiDAR. These smaller features are typically about 30 to 80 feet wide and about 50 to 100 feet long. Multiple west-facing scallops at the southwest edge of the campus reflect a series of very large, ancient, natural landslides that were likely initiated several thousand years ago, after the Vashon-age glaciers retreated and the Deschutes River down cut its channel. These large slides show a steeper edge or "scarp" at the top of the slope and a flatter accumulation zone near the middle to lower parts of the slope. The ancient landslide features are about 500 to 900 feet wide (north to south) and about 300 to 400 feet long (east to west, direction of movement).

Indications of ancient deep-seated landslides are visible on the LiDAR image west and south of the Pritchard and O'Brien Building slopes and possibly on slopes west and north of the GA building (Figure 4). Campus slopes in these areas typically show a scarp at the top of the slope and a flatter accumulation zone near the middle to lower parts of the slope. These ancient landslide features are about 500 to 900 feet wide and about 300 to 400 feet long. These deep-seated landslides near the campus may have occurred after the retreat of the Vashon-age glacier in the south Sound and were caused by downcutting and erosion of the toe of the slope by the Deschutes River. The vegetation and geomorphology of the ancient landslide near the Pritchard and O'Brien Buildings does not show evidence of recent movement, and we did not find records of reported landsliding in this area. It is possible that these large ancient landslides are currently stable. However, changing groundwater conditions, human activities, and seismic loading have the potential to initiate movement of these types of slides. In addition, these areas may be subject to shallow surface slides even if the deep-seated landslide feature is stable. Deep-seated failures usually move at a slower rate than shallow slides.

Slopes west of the Governor's Mansion, above the Powerhouse, and on the north side of campus are steep and irregularly sloped and show evidence of many small, shallow slope failures (Figure 4). The slopes north and east of the Law Enforcement Memorial show a series of overlapping features possibly reflecting a combination of recent human-induced slope failures and older natural landslides. The slopes north and east of the Powerhouse have been heavily modified by human activities such as historical grading, including grading for the Powerhouse construction, parking areas, the railroad embankment, and the Heritage Park Trail. These modifications may have contributed to some of the shallow slope failures.
