Mitigation Assessment Team Compendium Report

2017 Hurricane Season

Building Performance Observations, Recommendations,
and Technical Guidance

FEMA P-2054 / September 2019

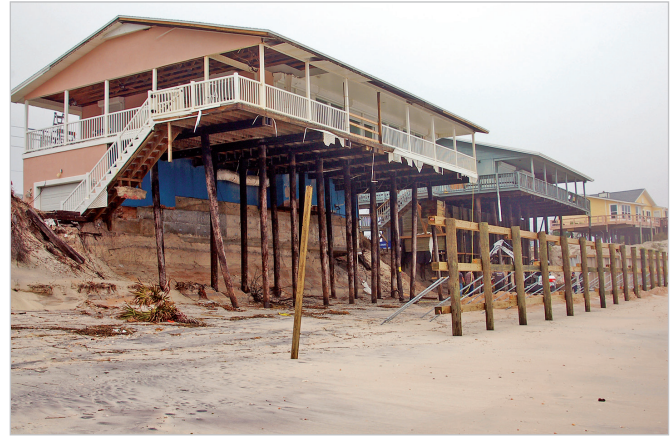
Figure 3-1: Undermined houses constructed on top of the dune in Vilano Beach, FL.

These houses survived the undermining, even though approximately 10 to 15 feet of dune height was lost beneath the houses. The pilings farther seaward are for a seawall under construction at the time of the MAT visit (February 2018).

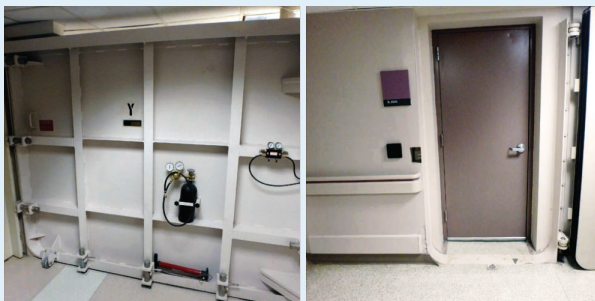
Flood doors in basement that subdivide basement areas within the main building.

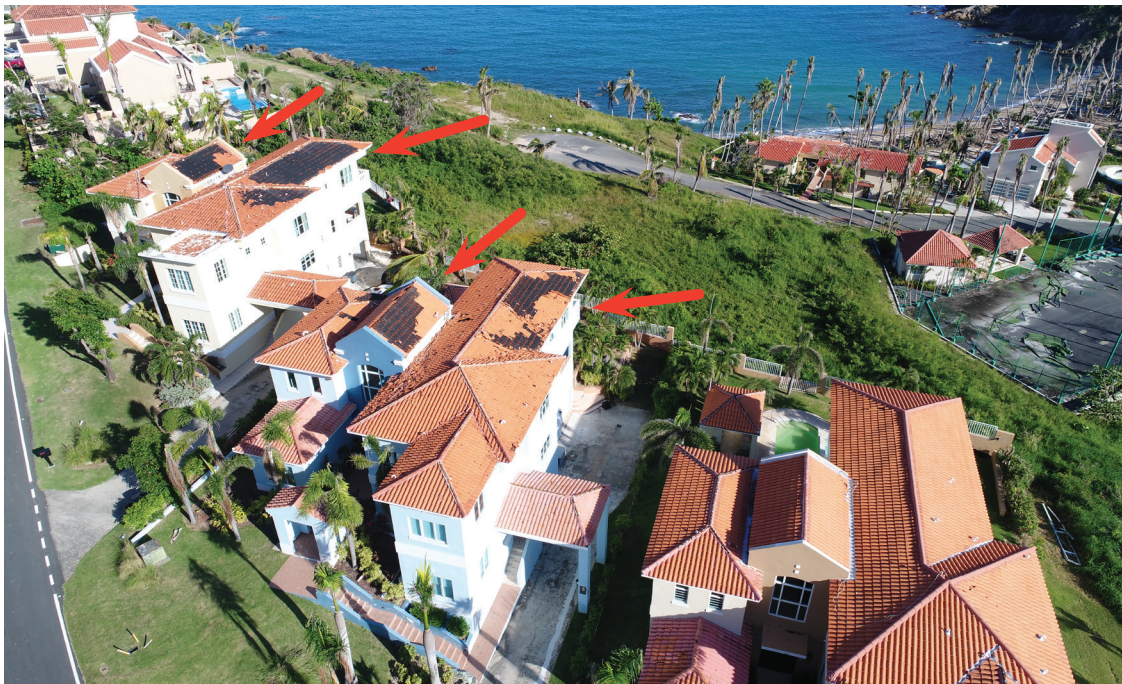
Figure 3-2: Roof damage from wind speed-up effects

These homes are located in Palmas del Mar in Humaco along the eastern coastline.

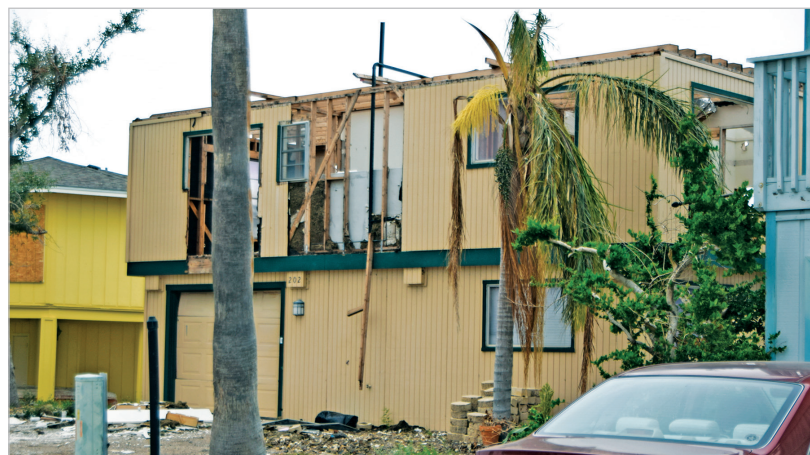
Roof structure loss and collapse of the second-floor exterior wall and adjacent deck.

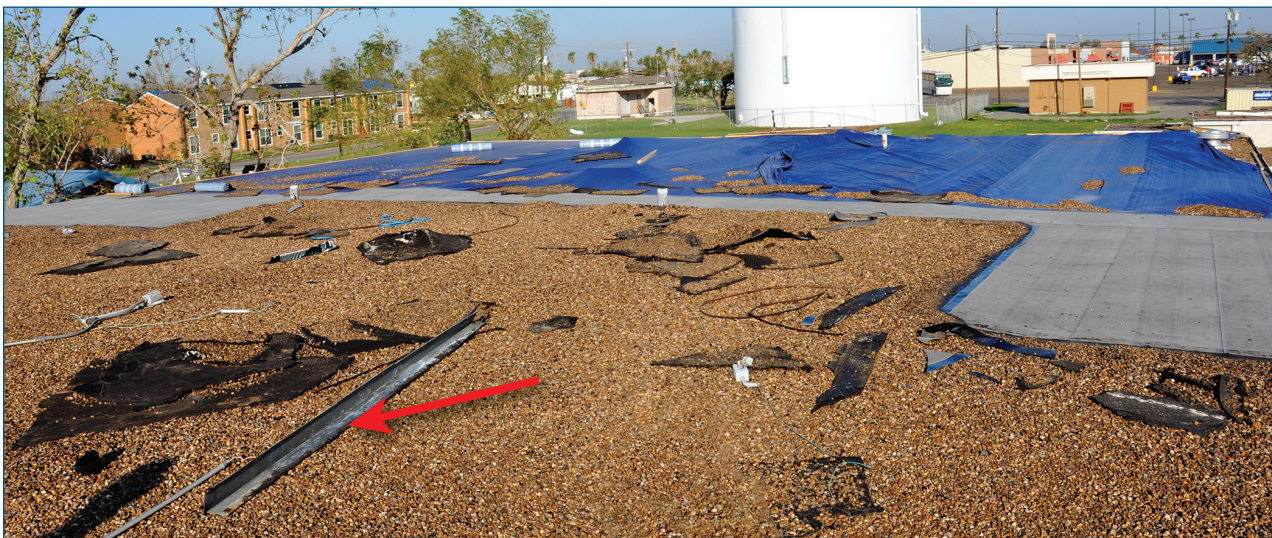
Figure 3-10: View of emergency repairs

At this older medical center, the roof above the emergency room area needed emergency repair work. The red arrow indicates a section of metal edge flashing that blew onto the roof.

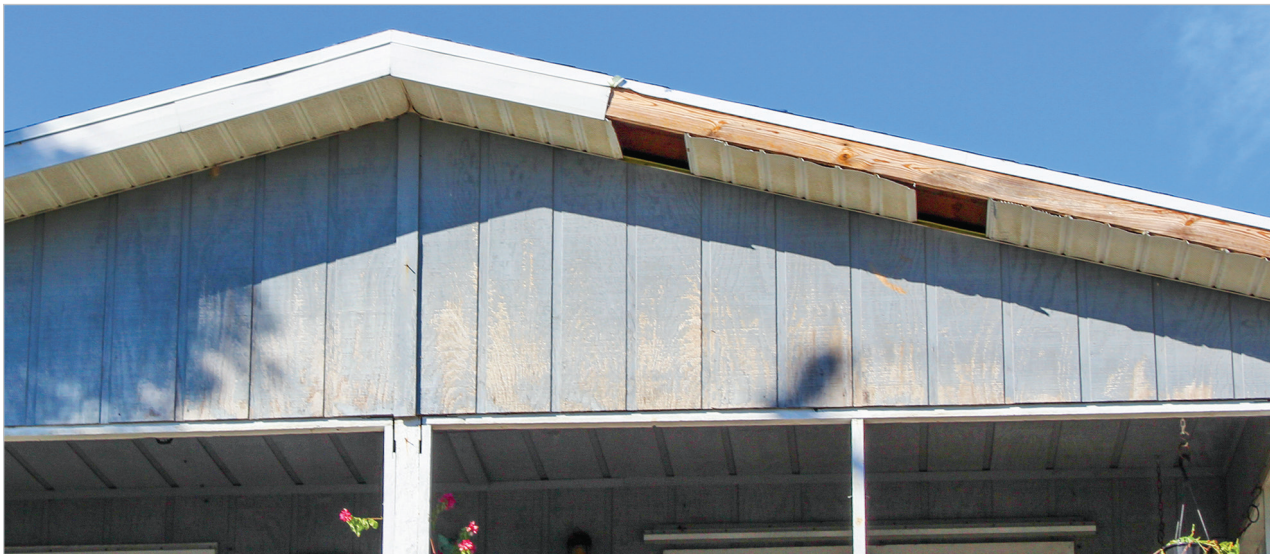
Figure 3-11: House with metal soffit loss below missing fascia cover

cases, vinyl soffit failure also was associated with fascia cover loss as shown in Figure 3-11. The loss of the fascia cover could have resulted in more wind exposure on the edges of soffits, affecting their performance. Refer to Florida Recovery Advisory 2, *Soffit Installation in Florida* (2018c) for guidance on FBC-compliant soffit installation.
