Mitigation Assessment Team Report

Hurricanes Irma and Maria in Puerto Rico

Building Performance, Observations, Recommendations,
and Technical Guidance

FEMA P-2020 / October 2018

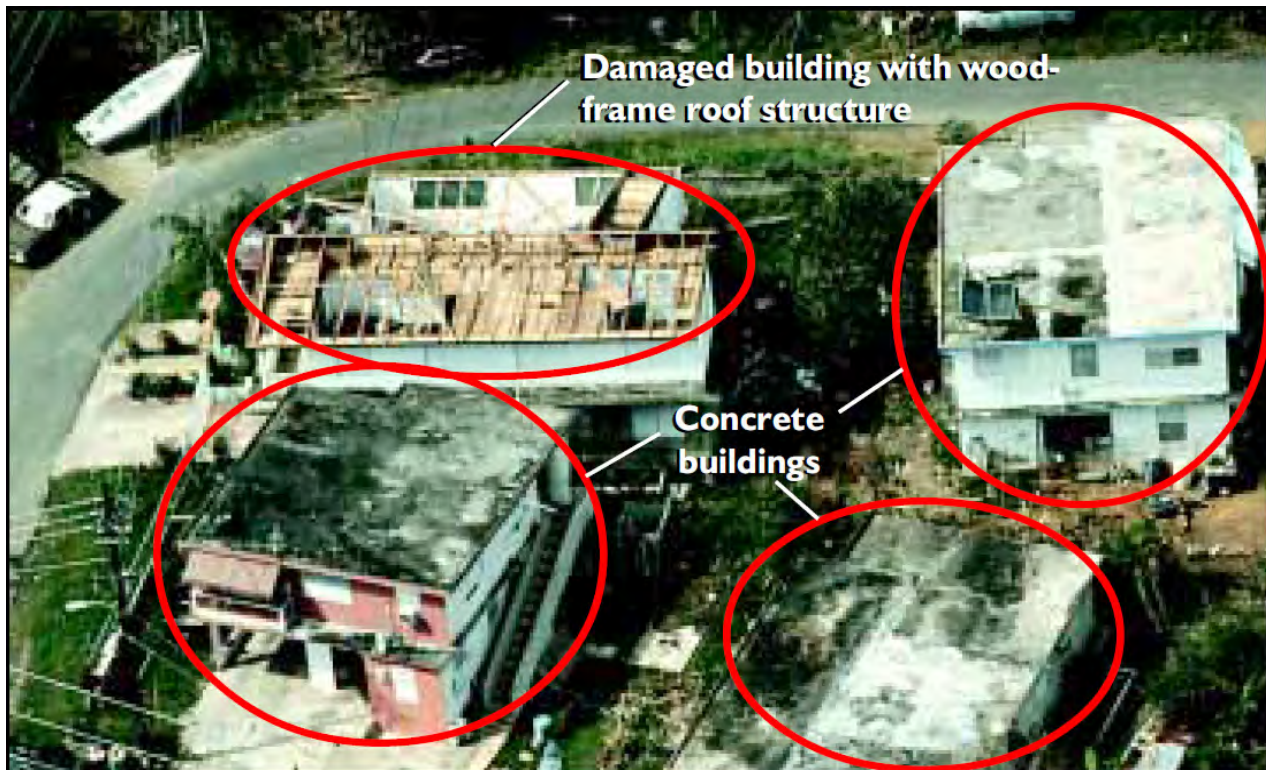
Most structural damage observed by the BPAT after Georges was to low-rise residential buildings (Figure 1-13). Many of these were informally constructed homes³ not designed or constructed to current building standards. Wood-framed buildings in general were found to perform poorly and made up a significant portion of damage caused by severe winds. The lack of proper wood-framed construction techniques did not provide adequate load path connections and lowered building survival odds. Failures often occurred at connection points, often near the roofline. Code-compliant houses typically sustained limited structural damage from Georges's winds, which were below design speeds.

Figure 1-13: Examples of observed damage by the BPAT after Hurricane Georges in 1998. Source: (FEMA, 1999a).

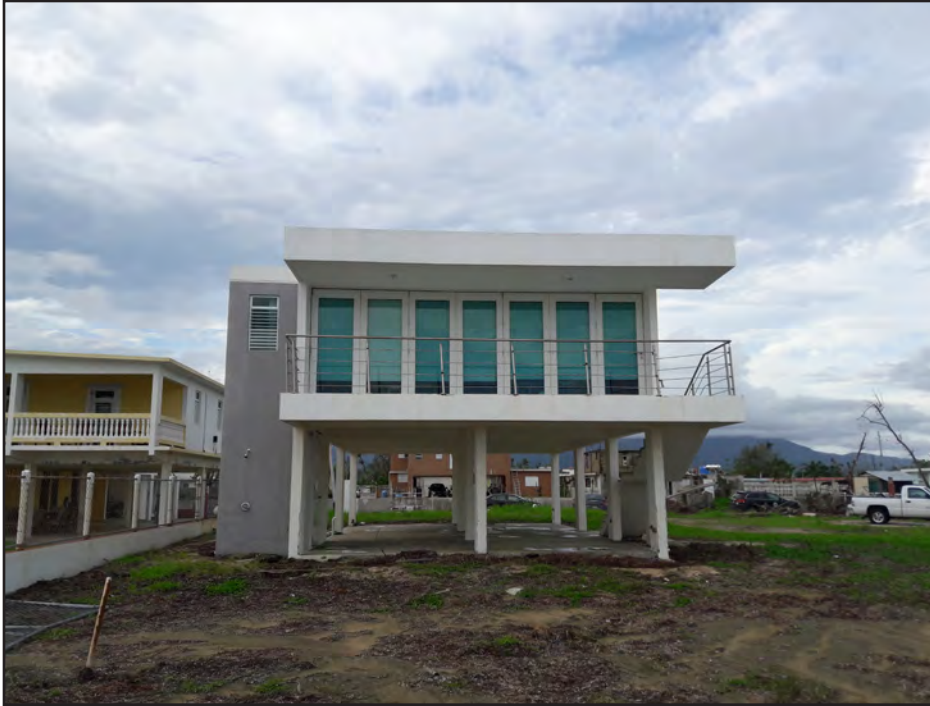
Figure 3-1: Elevated concrete house in Punta Santiago that performed well.

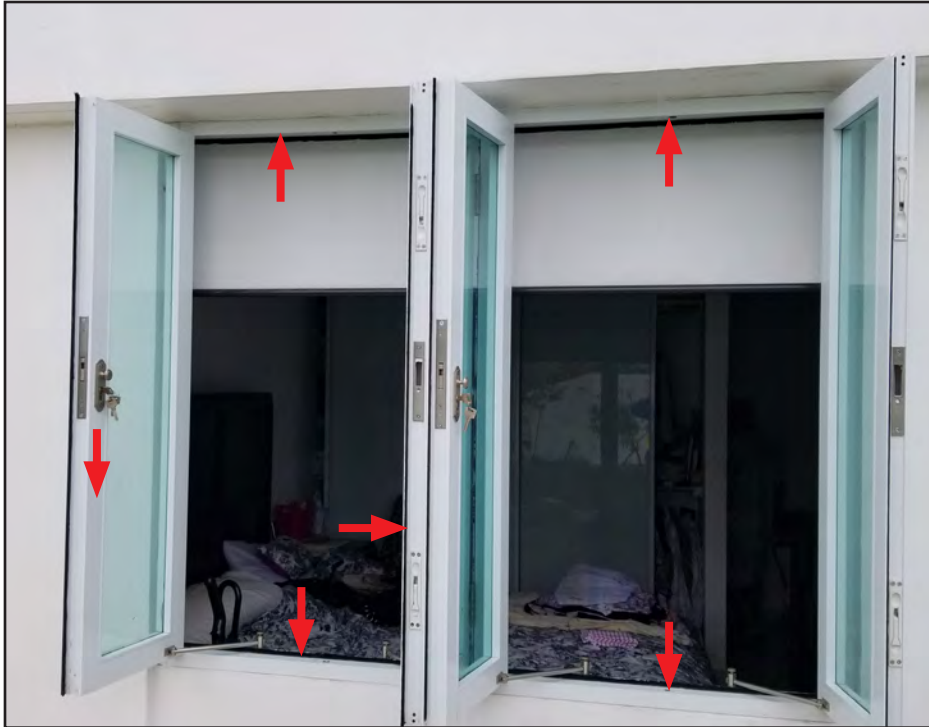
Figure 3-42: Concrete single-family home with casement windows. Windows seal around opening (red arrows) and lock from inside to prevent water intrusion.

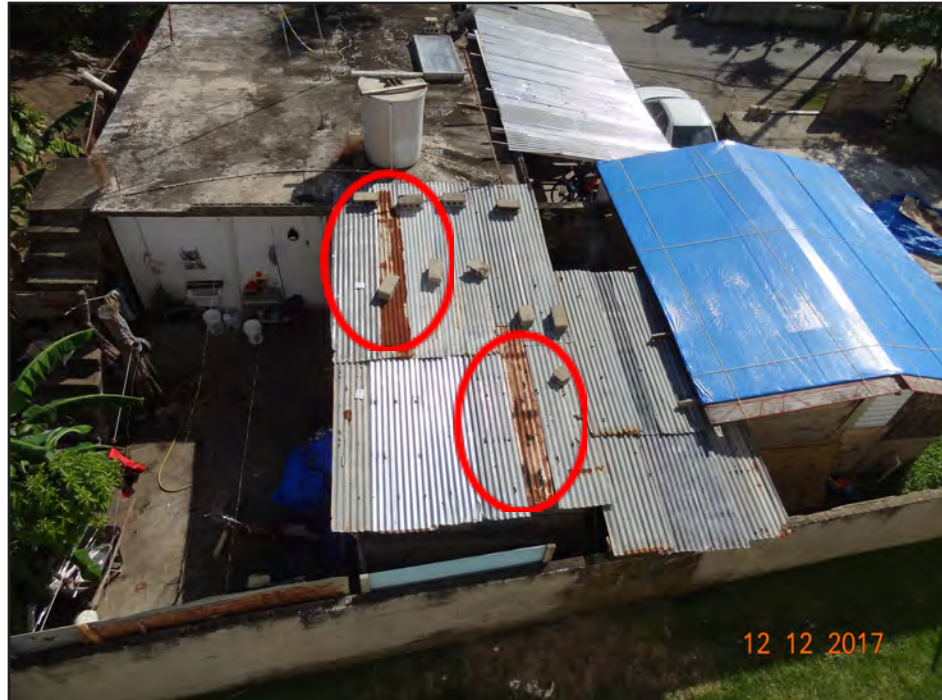
Figure 3-53: Residence with metal roof covering damage.

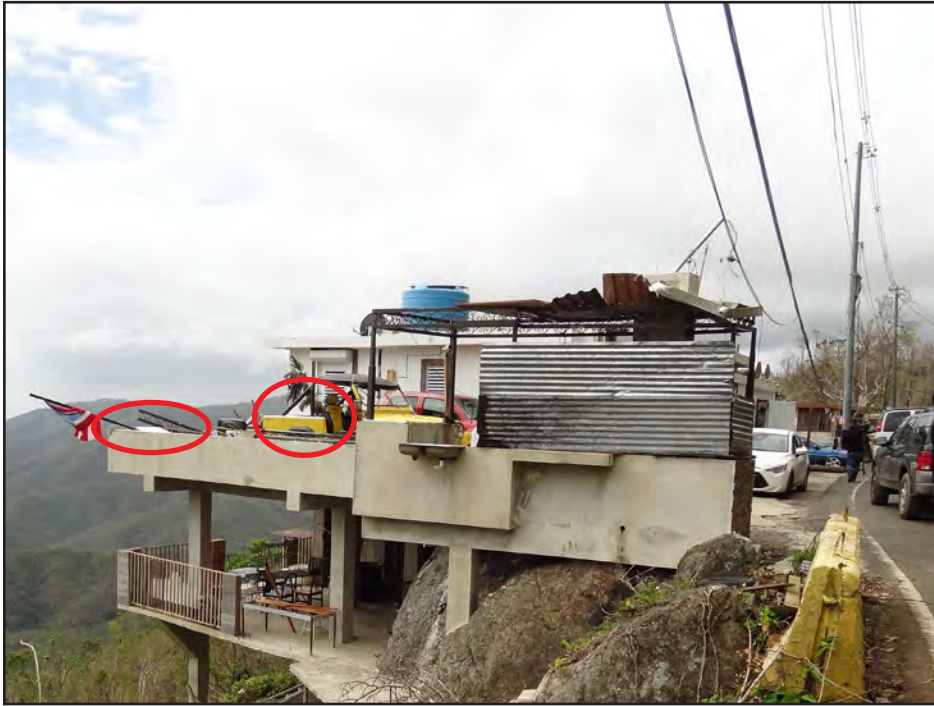
Figure 3-61: Hillside house in Jajome Alto, Cayey. The main building demonstrates good performance under wind speed-up effects, while the informally constructed canopy suffered partial failure (canopy debris, red circles).

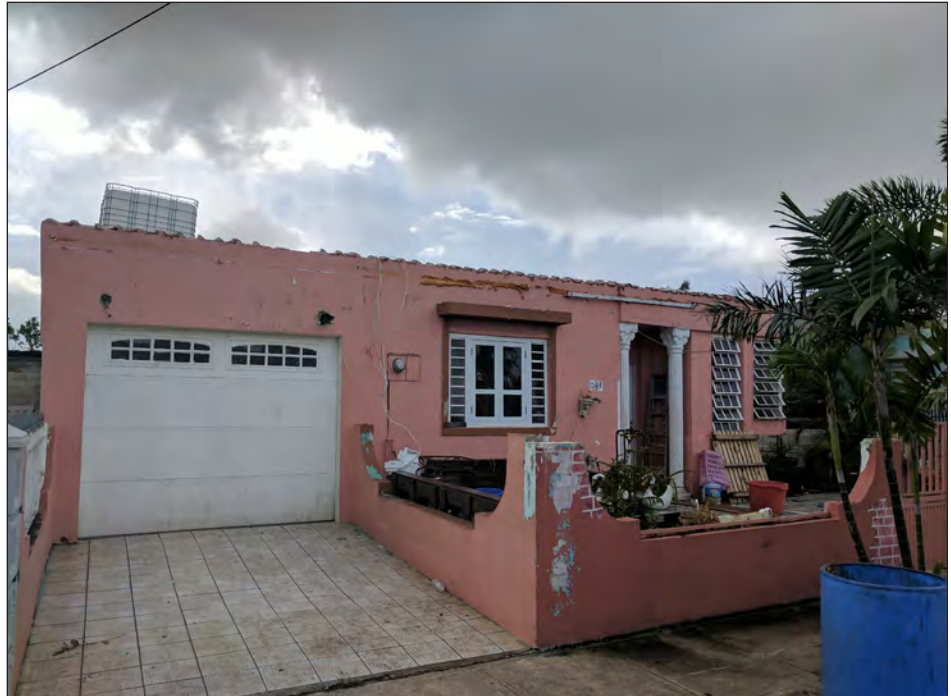
Figure 3-75: NSHP house in Campanilla has an informally constructed addition which lost its entire roof covering.

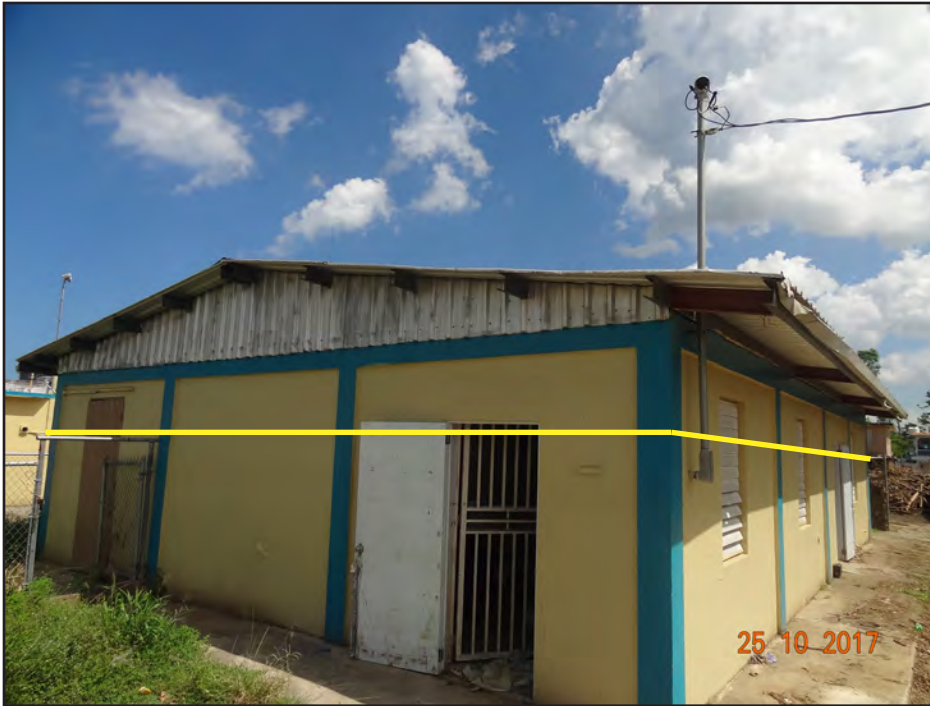
Figure 4-6: Luis M. Santiago School with location of high water mark (yellow line) from Maria.

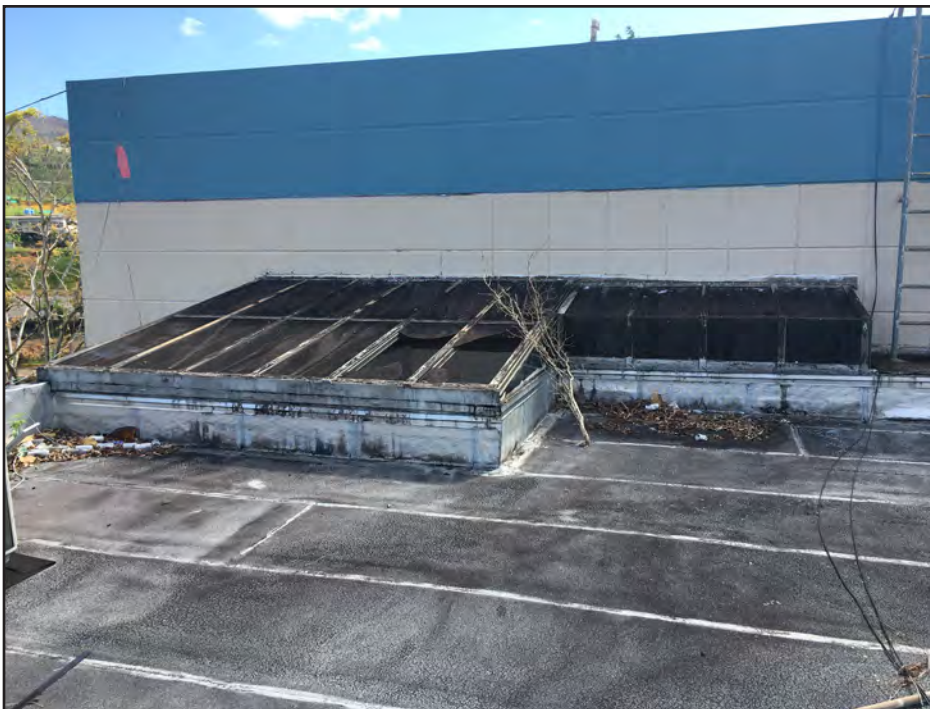
Figure 4-19: Broken skylight glazing at a high school in Canóvanas.

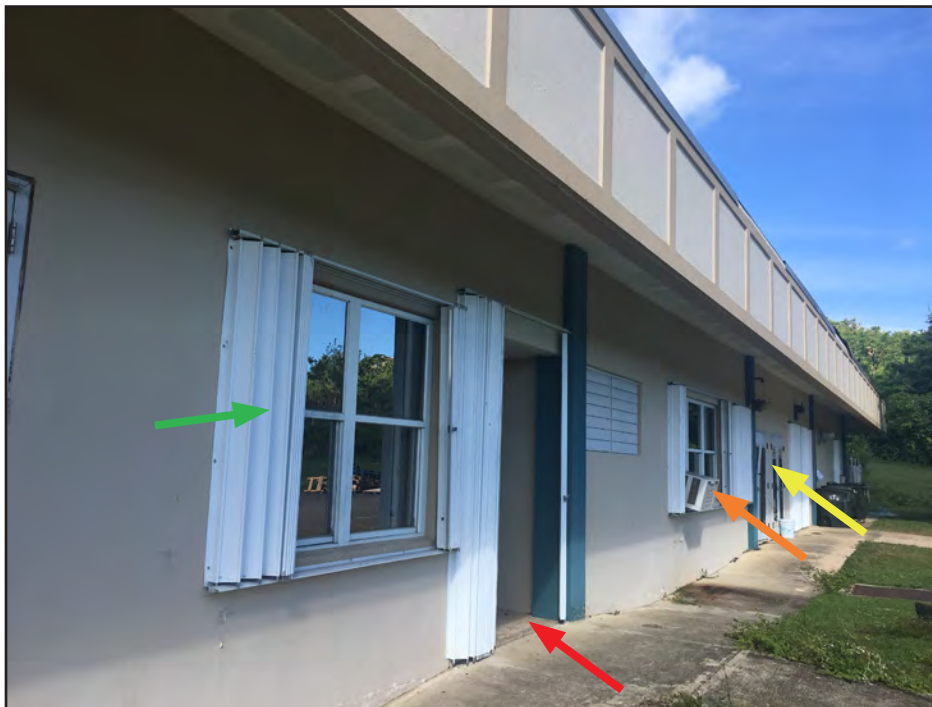
Figure 5-18: Successes and problems related to installation of shutter systems over glazed doors and windows, including a shutter system properly installed (green arrow), a shutter system with a track missing at a glazed door (red arrow), a window air conditioning unit preventing a shutter being deployed (orange arrow), and a pair of glazed doors without glazing protection (yellow arrow).

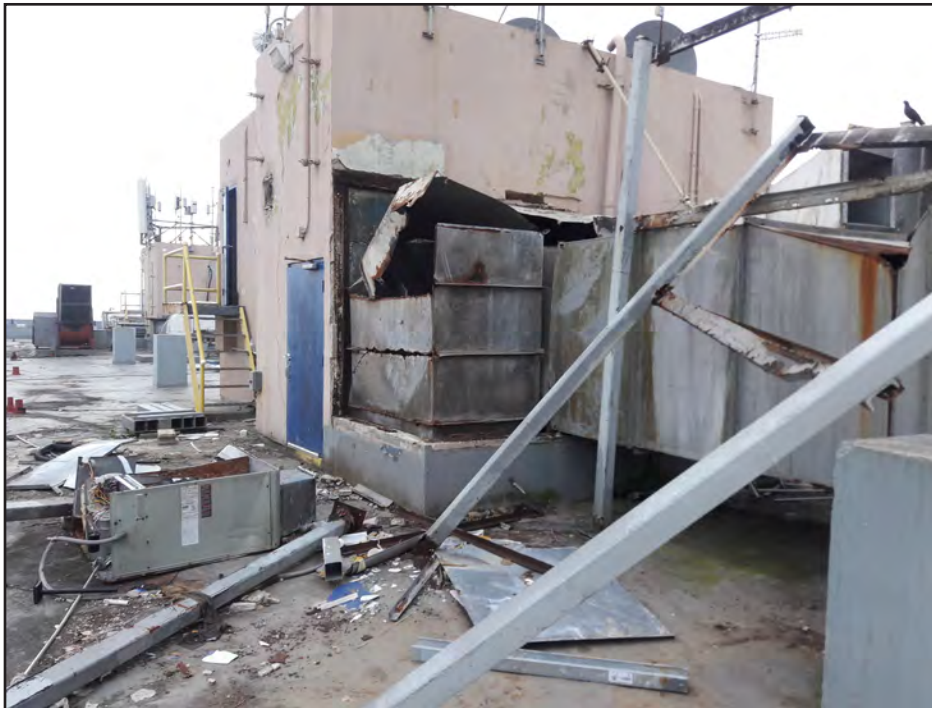
Figure 5-24: Damage to rooftop HVAC equipment at Pavia Hospital Arcibo.

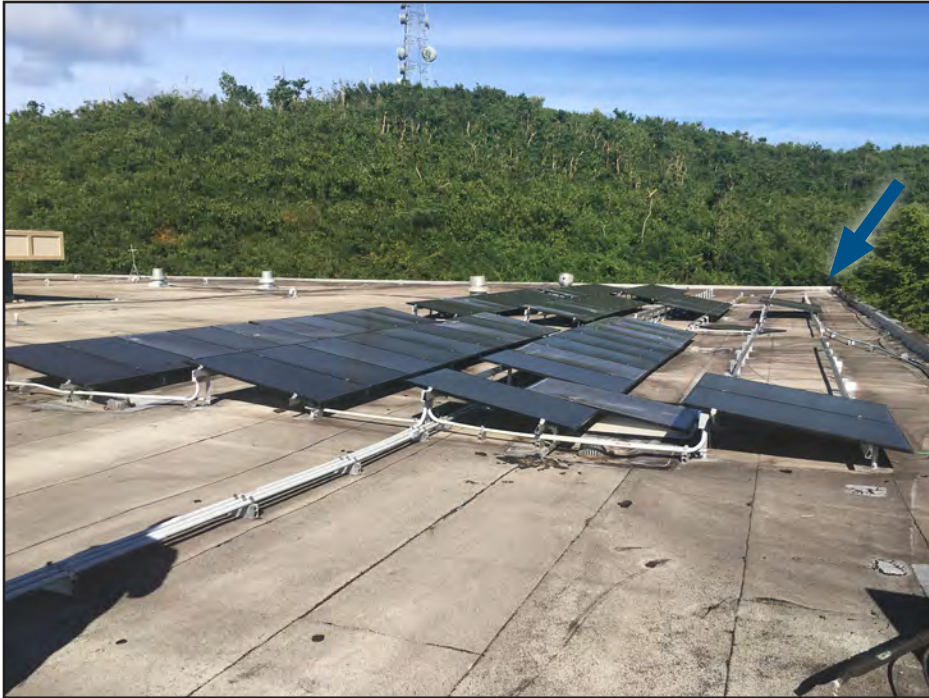
Figure 5-31: Rooftop solar array at east corner of hospital roof. The blue arrow indicates the direction of the strongest winds based on debris fields observed around the hospital.

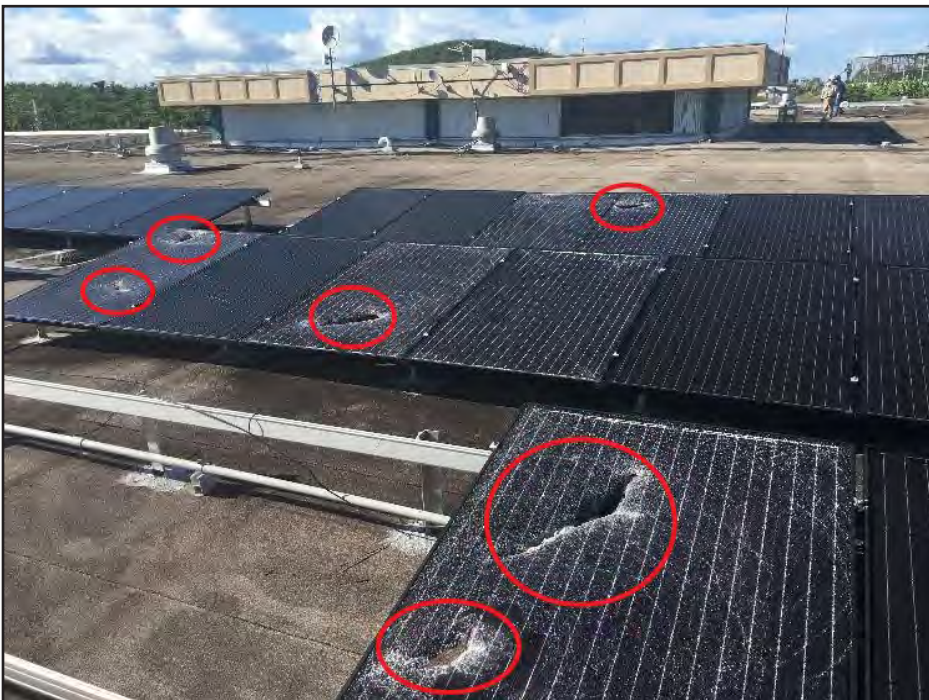
Figure 5-32: Rooftop solar array at east corner of hospital roof showing damage from wind-borne debris impacts (red circles).

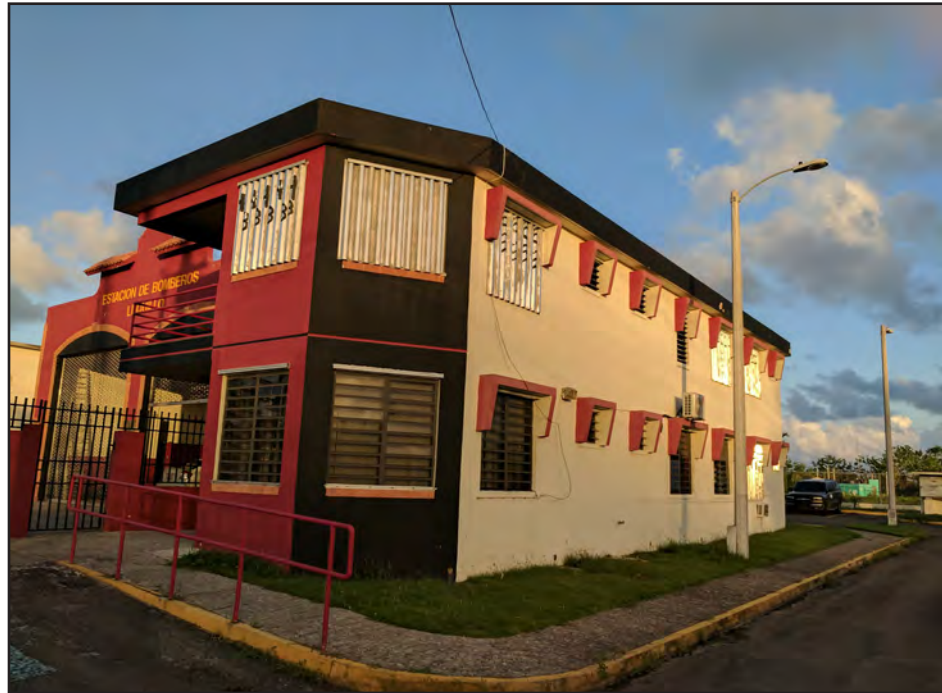
Figure 5-50: Metal shutters installed at the Florida Fire Station successfully protected the facility’s openings.

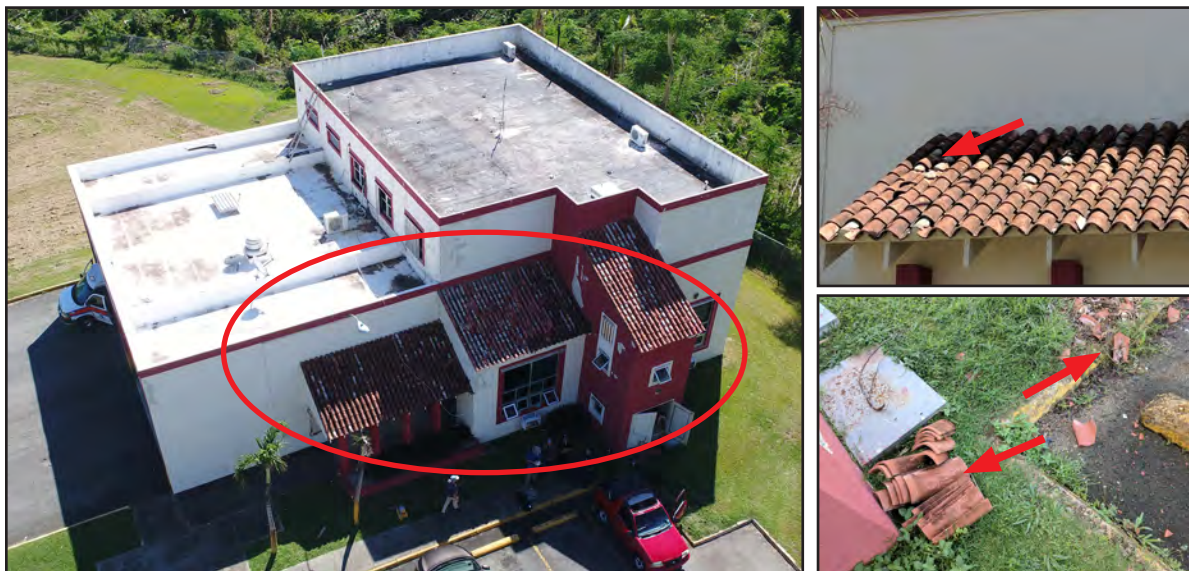
Figure 5-52: Damage to tile roof (red oval) covering at the Palmas del Mar Fire Station. Red arrows indicate broken tiles.

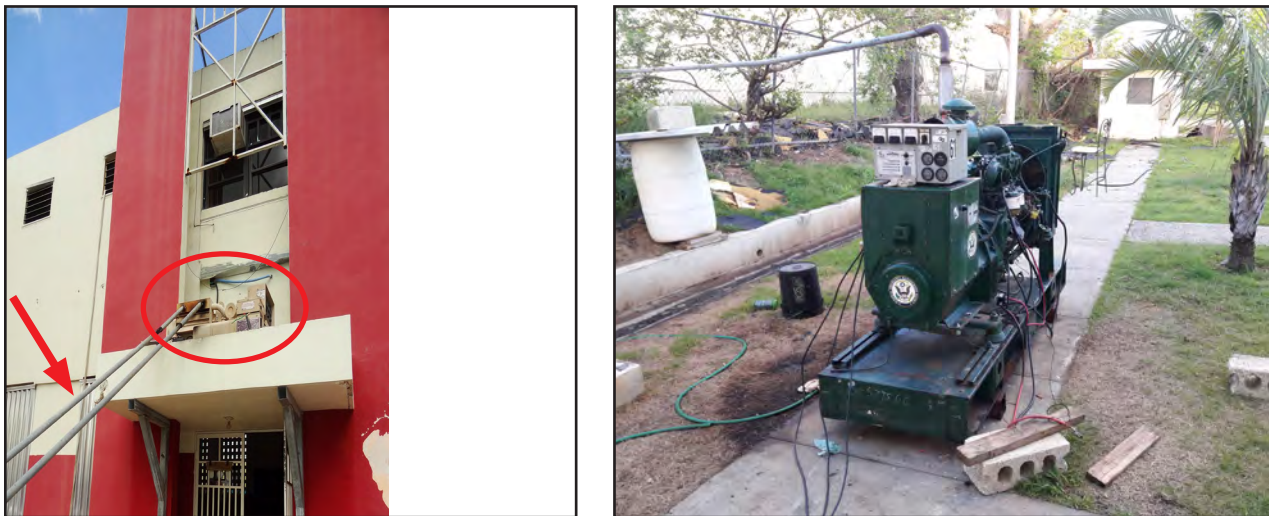
Figure 5-57: Toa Baja Fire Station. Left, generator (red circle) with temporary piping system (red arrow) installed to convey generator smoke away from the building. Right, portable generator supplied after Hurricane Maria.

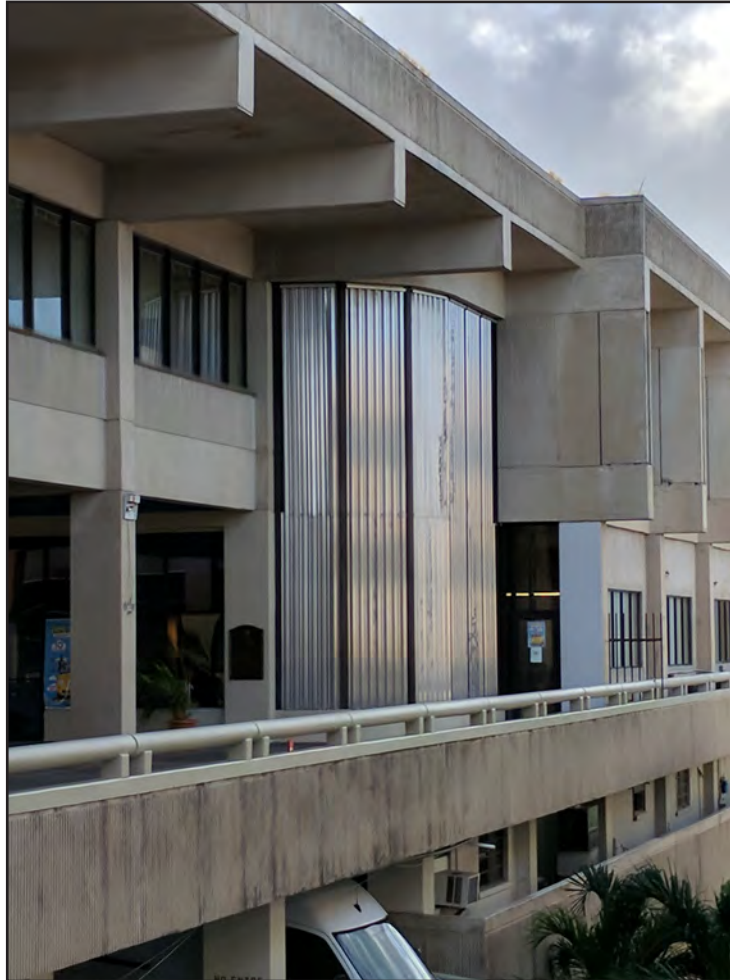
Figure 5-74: Broken window glazing (red arrows) at Bayamón Municipal Building.

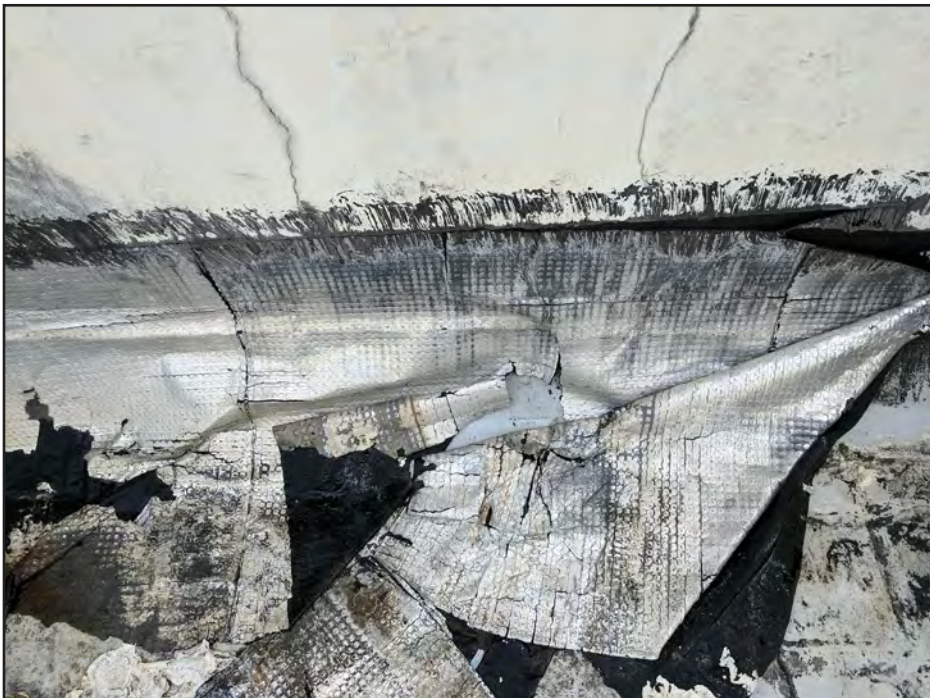
Figure 5-75: Vega Alta Municipal Building had roof leaks. Flashing can be seen displaced at the mechanical area of the roof. Water entered this location as well as others.

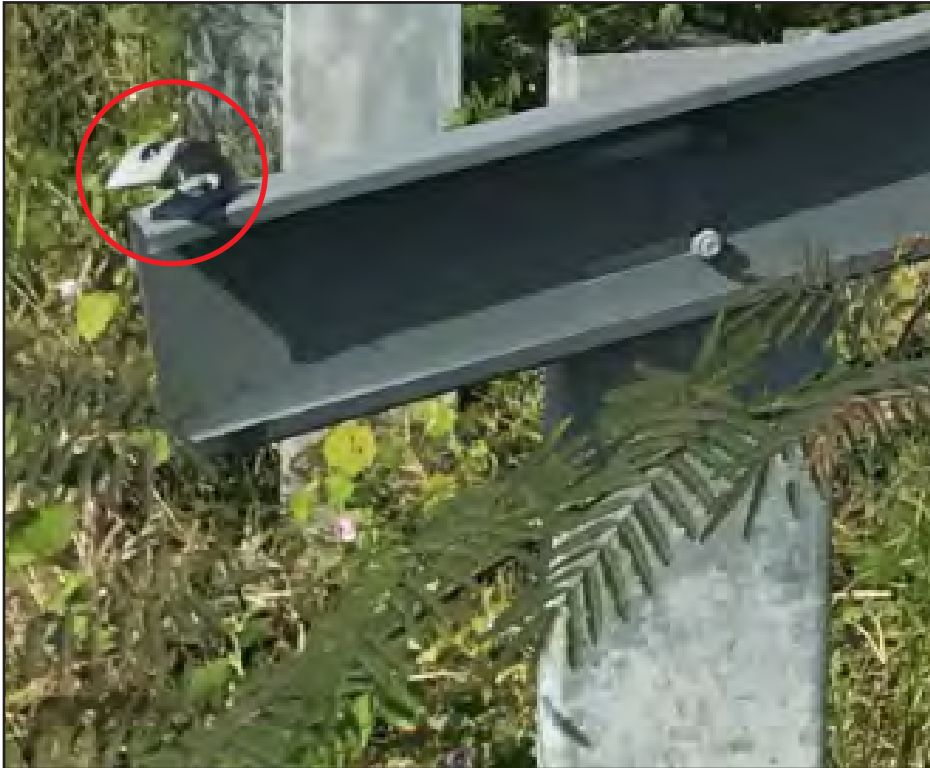
Figure 6-6: Reden solar array in Humacao: In this image, only the bent angle (red circle), remains after the steel lateral rail and bolted attachment were pried away in the hurricane.

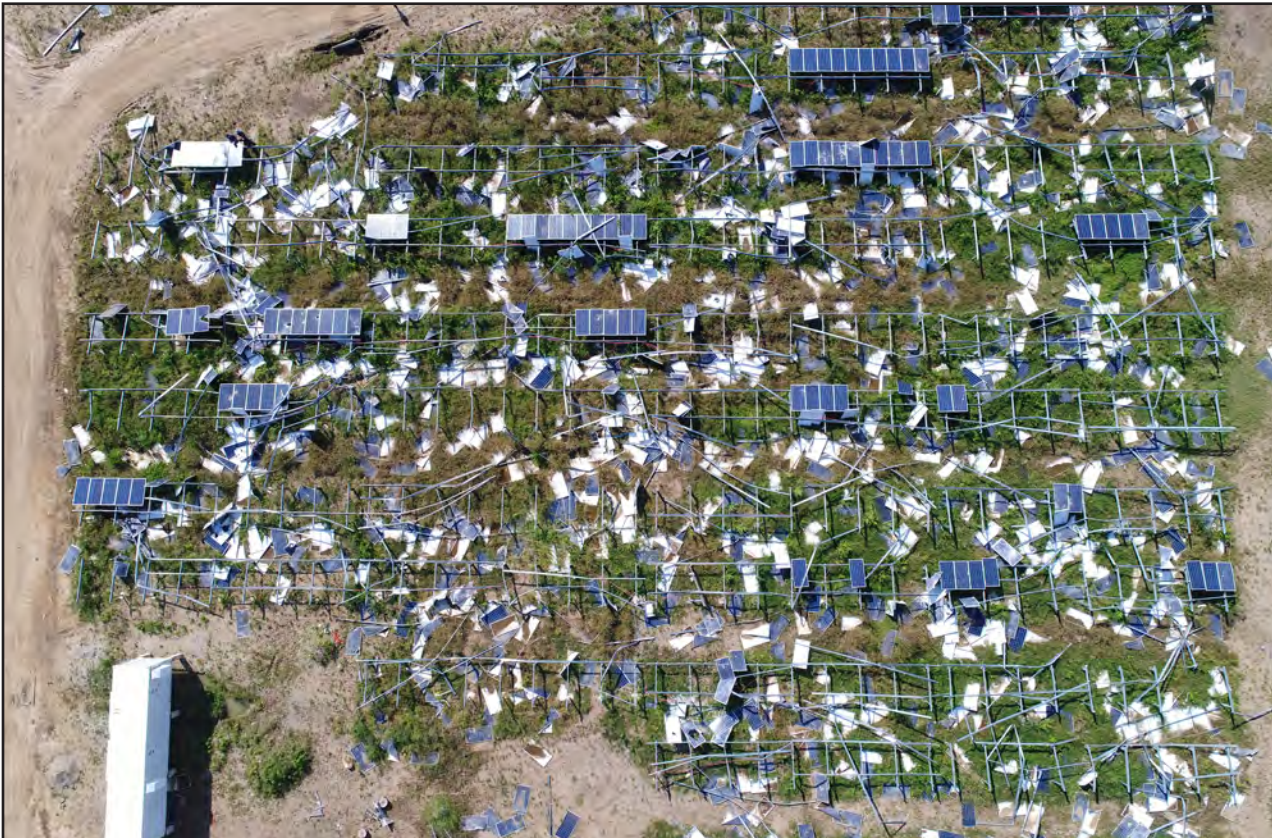
Figure 6-8: Reden solar array in Humacao: Aerial view of the Phase 2 Array with most PV panels removed from their ground-mount supports and many structural members damaged.

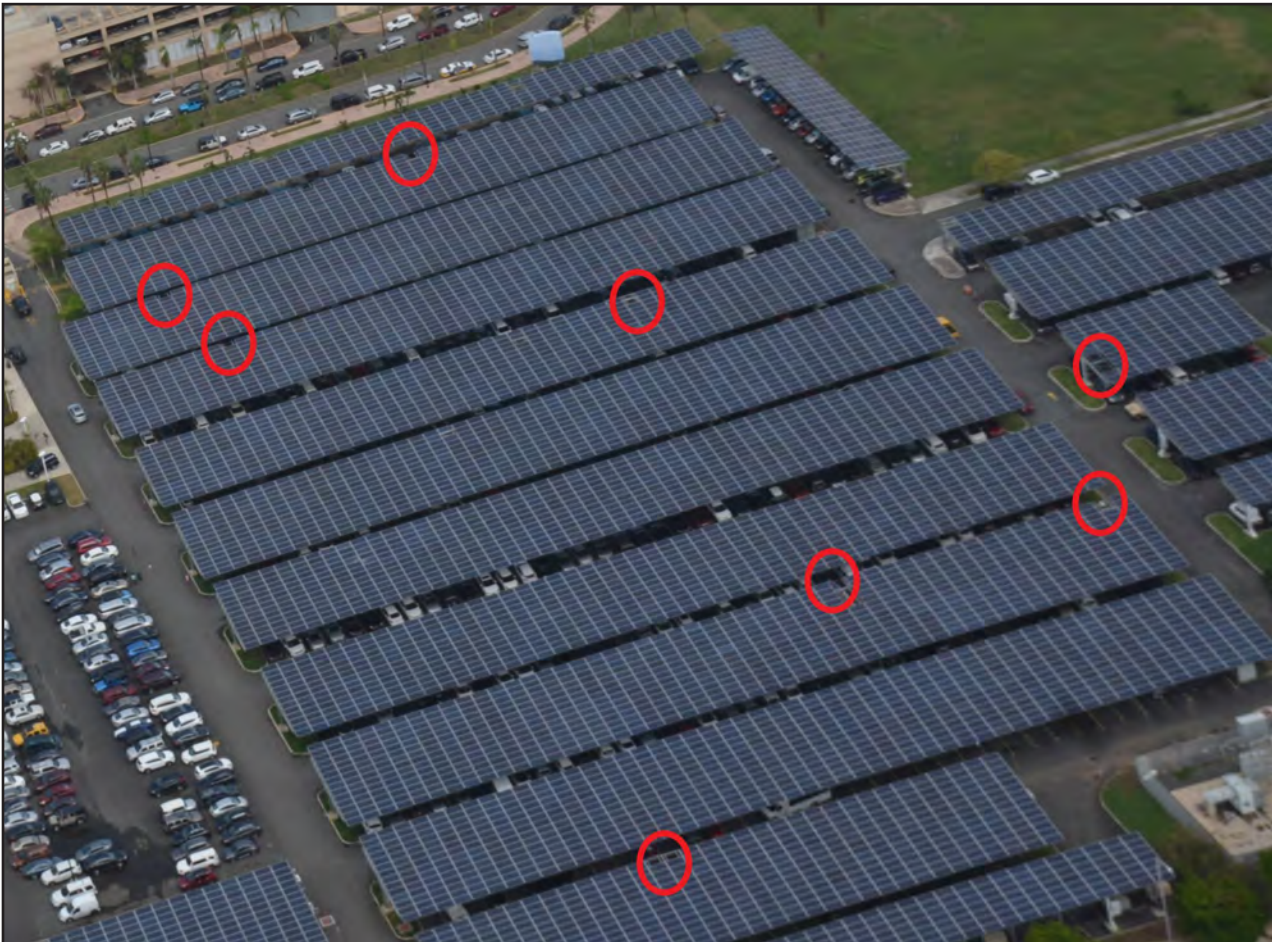
Figure 6-15: Puerto Rico Convention Center Solar Array: Some PV panels were lost (red circles) from these carpports. Based upon aerial imagery, it is estimated that fewer than 5 percent of the panels at this site were damaged or removed (Civil Air Patrol 2017).

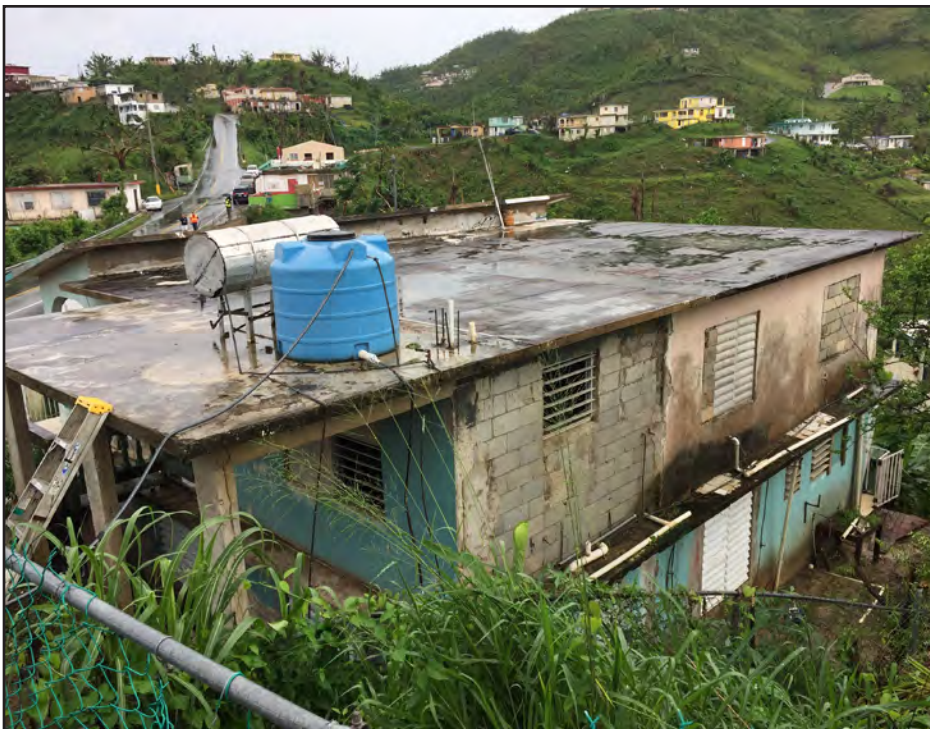
Figure 6-19: Solar water heater system missing solar collector panel on the flat slab concrete roof of a two-story concrete house in El Negro, Yabucoa.

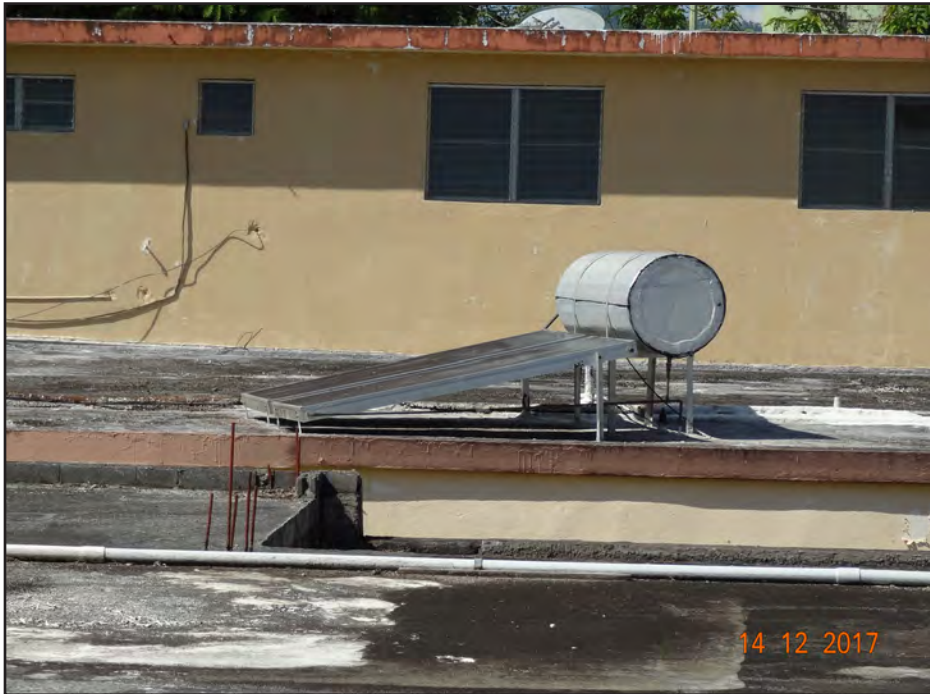
Figure 6-21: Solar water heater system with no evident wind damage on a concrete slab roof of a one-story concrete house in Caguas.

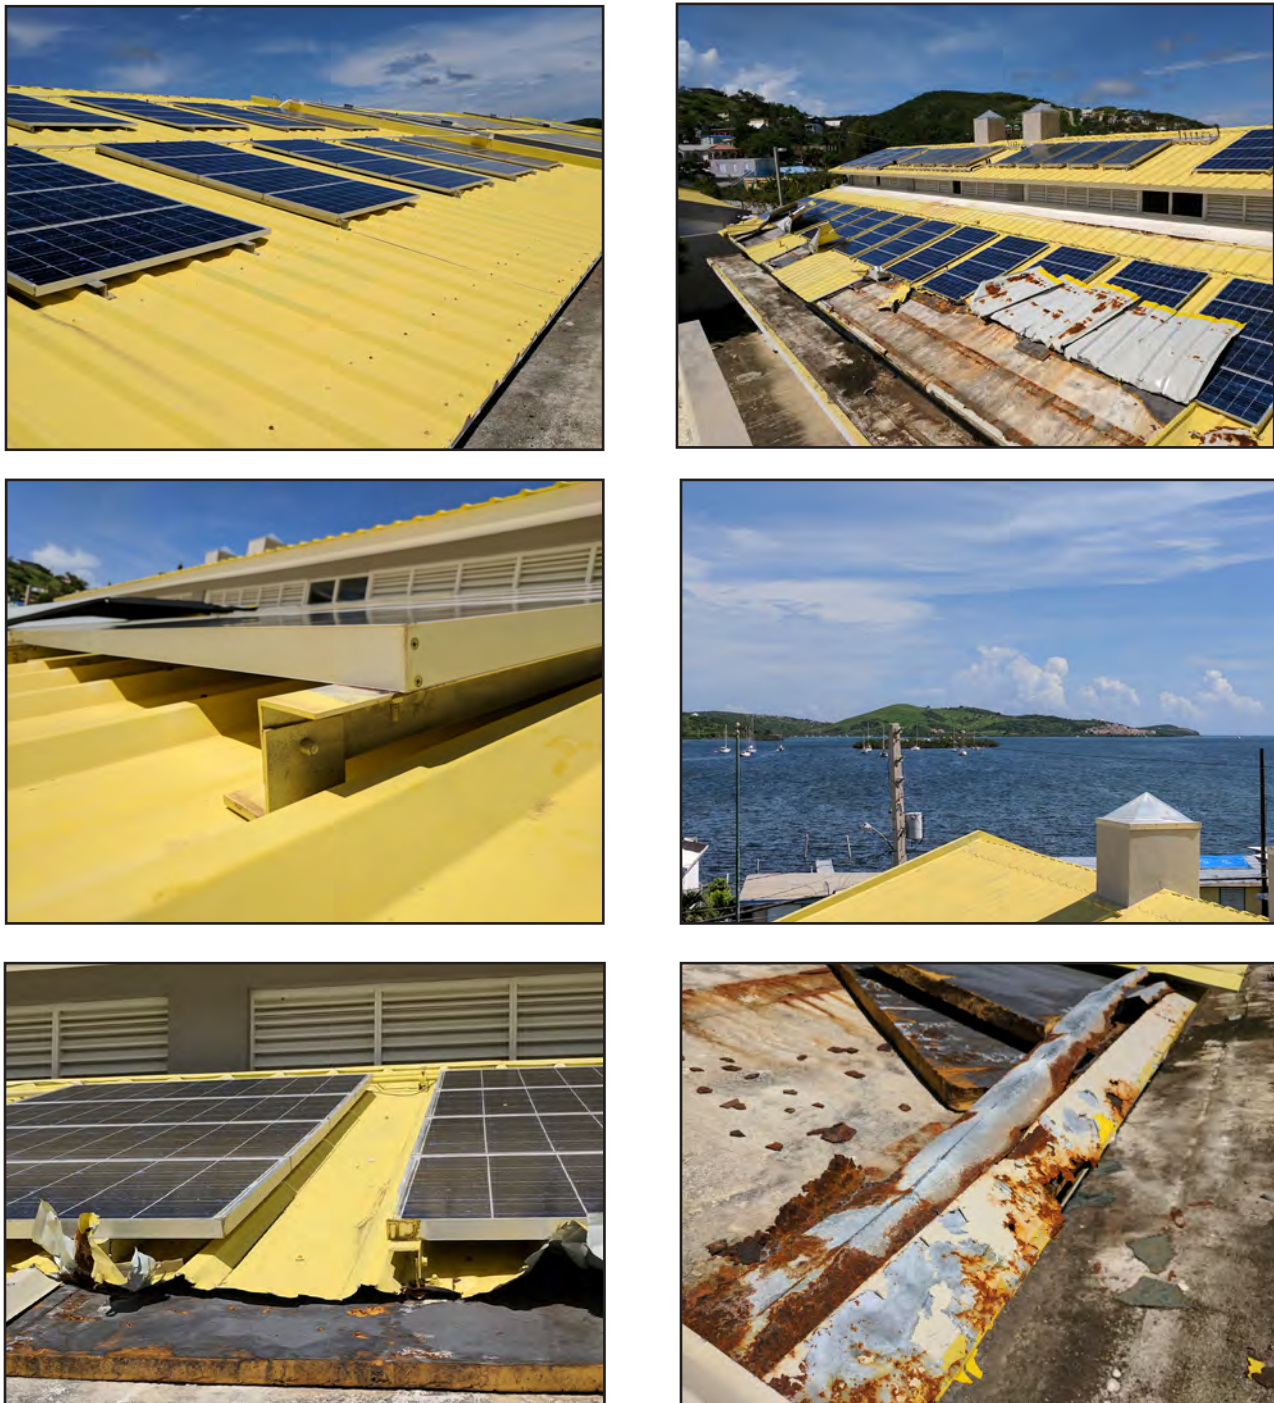
Figure 6-37: Views of the rooftop PV array at Culebra Ecological School, clockwise from top left: undamaged portion of the roof, roof covering failure, close-up of structural aluminum angle anchoring system attaching the PV panels to the concrete roof, open water exposure for the upwind fetch of the intense winds, close-up of failed roof covering section showing exposed rigid insulation foam, view of corrosion on metal roof edge flashing on portion of roof with roof covering failure.
