MULTIDISCIPLINARY ACCIDENT INVESTIGATION TEAM NARRATIVE/DIAGRAM

NL-020-18

MAIT SUPPLEMENTAL

- A mechanical inspection of the Forest River to determine if there were any pre-existing conditions that caused or contributed to the cause of the mechanical failure, which potentially caused the fire

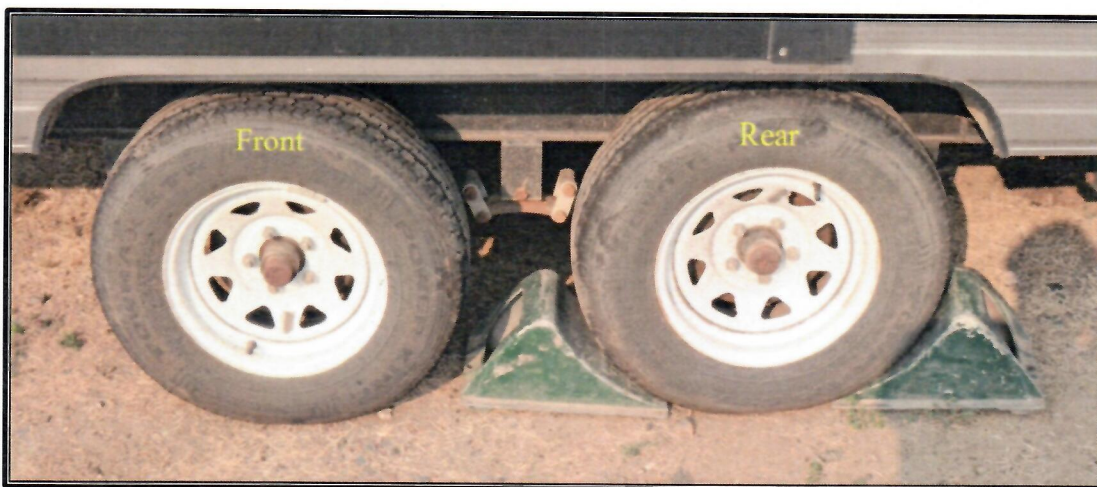
Left Side of the Axles

The vehicle had two, 3,500 pound capacity axles with drum style brakes. The outer ends of the axles had machined spindles that were welded to the axle tubes. The bearing assemblies, which were housed inside the brake hub, were seated on the machined spindles. The bearing assemblies and brake hubs are discussed later in this report. The axle tubes between the spindles were unremarkable.

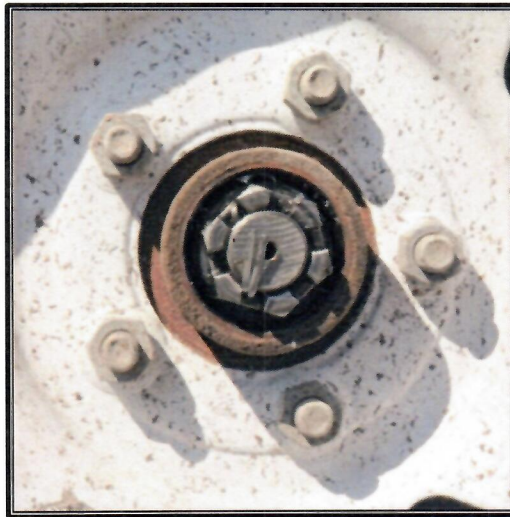
Left-Front Spindle with Dust Cap Removed

The ends of the spindles were threaded, allowing the brake hub to be held in place with a castle nut. There was a vertical, off center hole in the end of the spindles for a cotter pin. The cotter pins were intended to keep the castle nuts from loosening. The left-front and left-rear brake hubs rotated freely. The left-front and left-rear axle castle nuts were slightly over tight, and the brake hubs had no endplay.¹ The castle nuts should have been finger tight; pliers were needed to loosen the nuts.

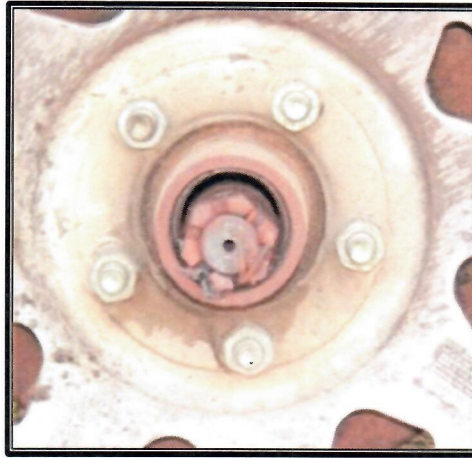
The right-front and right-rear axle, castle nuts, and cotter pins were damaged. The right-front castle nut was in contact with the brake hub, and the castle nut was fused to the spindle. An air impact wrench and socket were required to remove the castle nut.

Right-Front Spindle with Missing Dust Cap

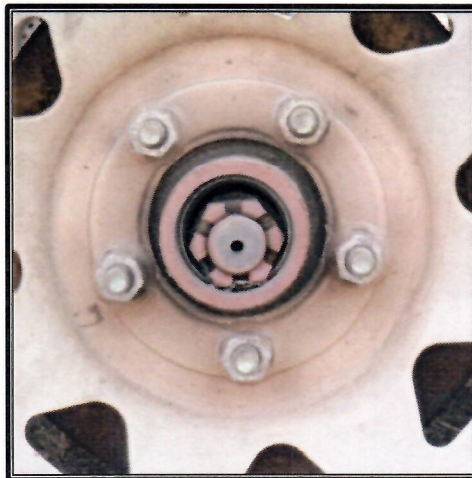
The right-rear castle nut was in contact with the brake hub, and the castle nut was fused to the spindle. The right-rear axle cotter pin was sheared off. The right-rear brake hub had less damage to the bearing race and seat than the right-front brake hub. A socket could not be used to remove the castle nut. An air chisel was used to rotate the castle nut. The castle nut became stripped and could not be removed. The air chisel deformed the castle nut to the point that the brake hub could be removed with the castle nut still attached to the spindle.

Right-Rear Spindle with Missing Dust Cap

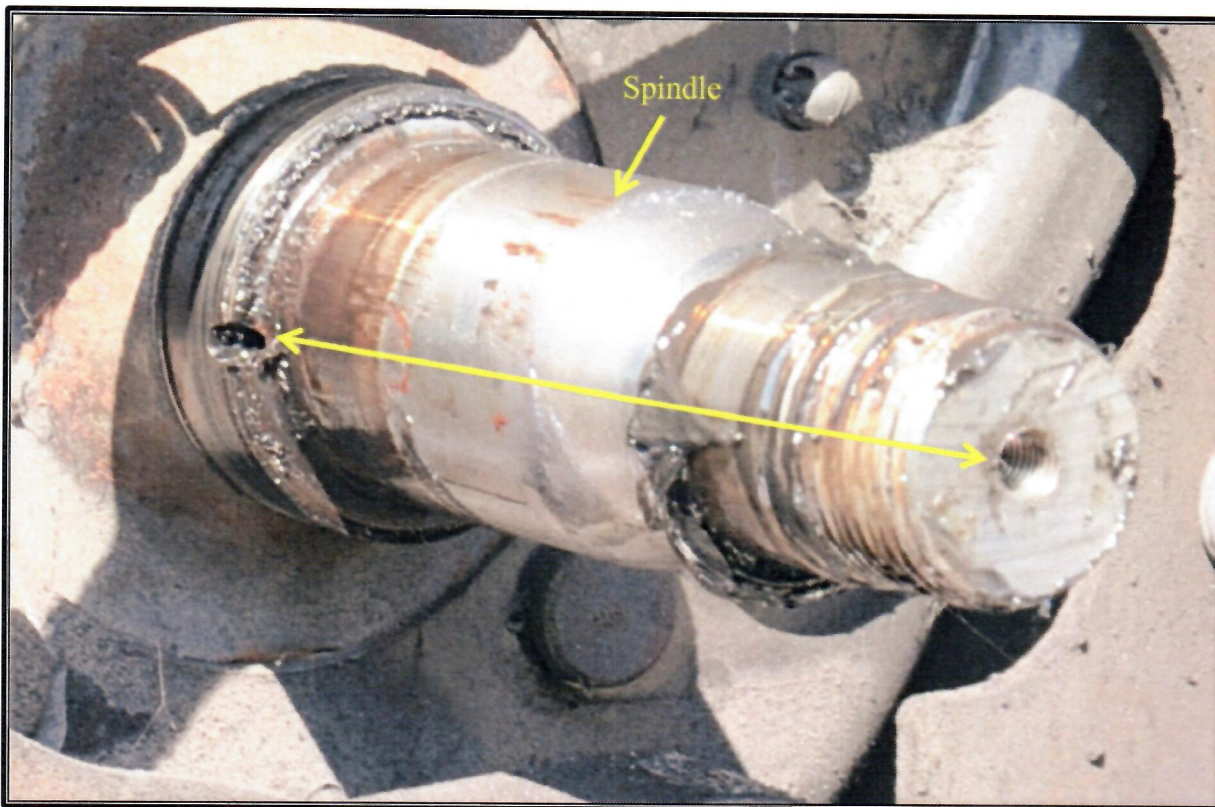
The outer faces of the spindles were threaded and had a horizontal channel that extended through the center of the spindles and exited where the rear bearing was seated. The threaded portion and horizontal channel were designed to have a grease fitting and allow new grease to be added to the bearings. All four spindles were missing the grease fittings. It was undetermined if the grease fittings were installed by the factory and were missing or if they were intentionally left out by the factory. The left-front and left-rear spindles were undamaged.

Undamaged Left-Front Spindle

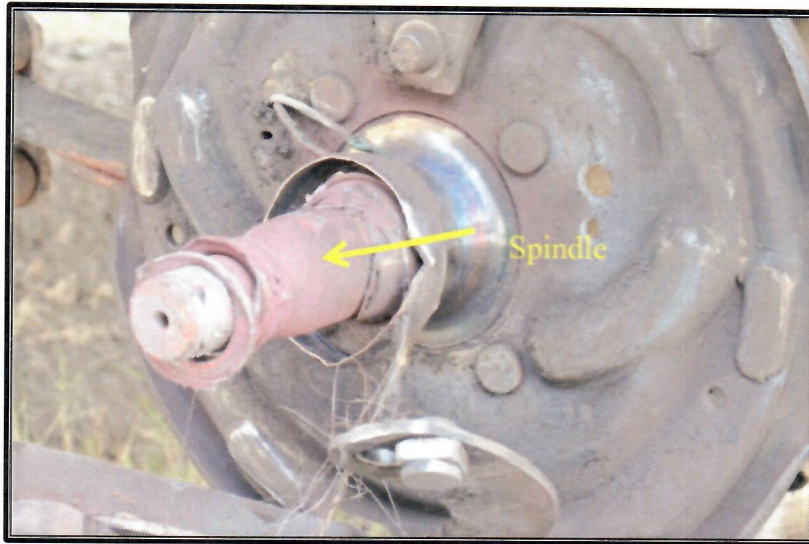
The right-front and right-rear spindles were discolored, pitted, and had damaged bearing components fused to them.

Damaged Right-Front Spindle

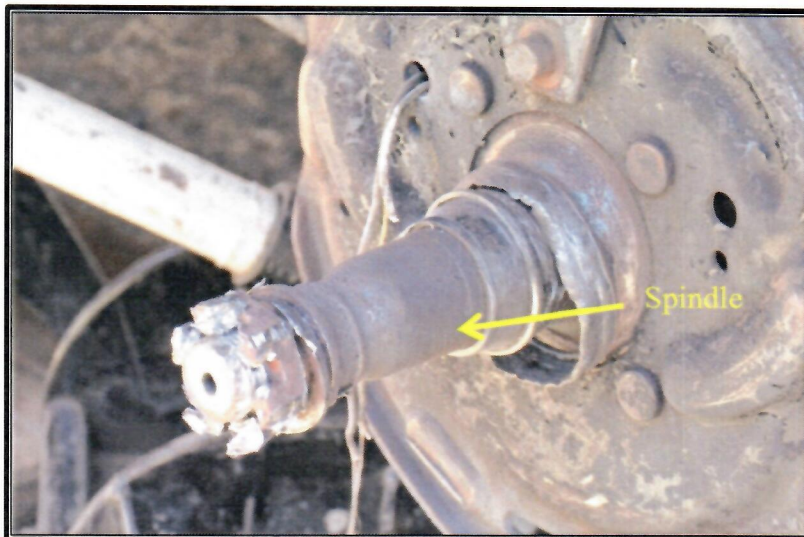
Damaged Right-Rear Spindle

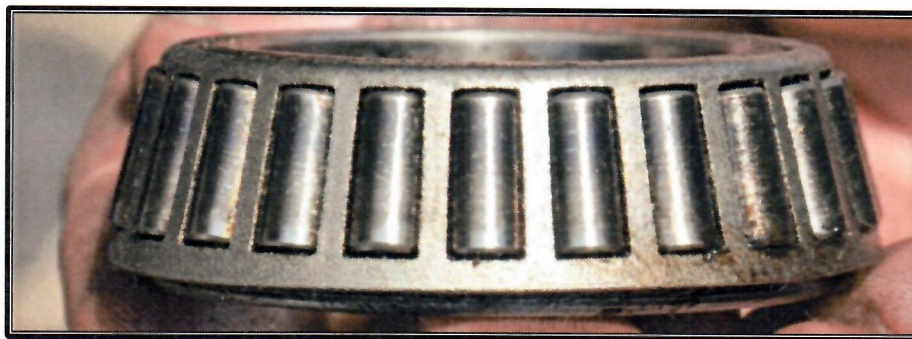
Left-Front-Inner Bearing

The bearing assemblies were housed in the brake hubs. Each brake hub had two bearing assemblies; an inner and outer. The bearing assemblies centered the brake hubs on the spindle and managed the radial and axial load of the vehicle. The left-front-inner bearing, rollers and race were discolored. The photographs below show the grease removed from the surface.

The left-front and left-rear-inner bearings were discolored from overheating due to an insufficient amount of grease and/or from having no end play. The missing roller from the left-rear-inner bearing was not found.

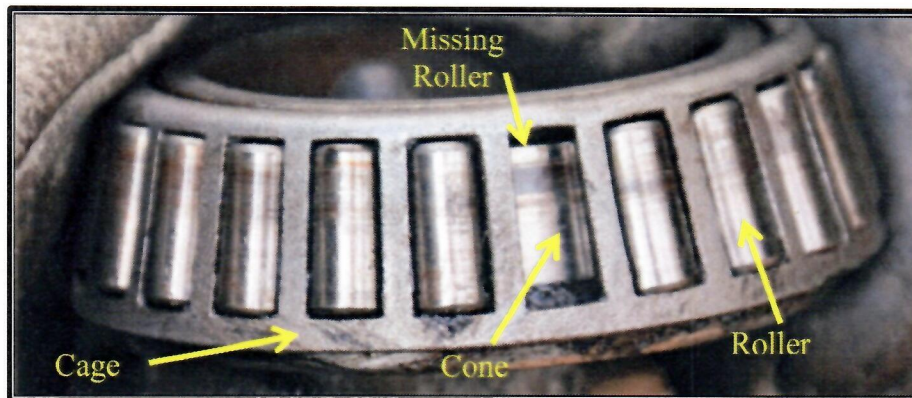
Left-Rear-Inner Bearing

The left-rear-inner bearing, rollers, cone, and race were discolored; and one roller was missing.

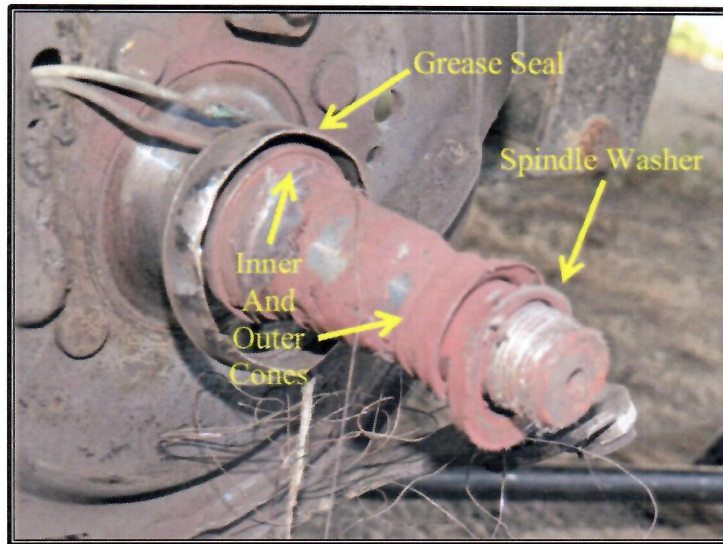
Right-Front Spindle

The right-front and right-rear inner and outer bearing assemblies were severely damaged and were missing all of the rollers and cages. The inner and outer cones remained on the spindles.

The right-front and right-rear wheels, brake assemblies, brake hubs, bearing assemblies, spindles, and castle nuts all had thermal damage. The right-front and right-rear bearing assemblies overheated and failed, most likely due to an insufficient amount of grease and/or no end play, as observed on the left-front and left-rear bearing assemblies.

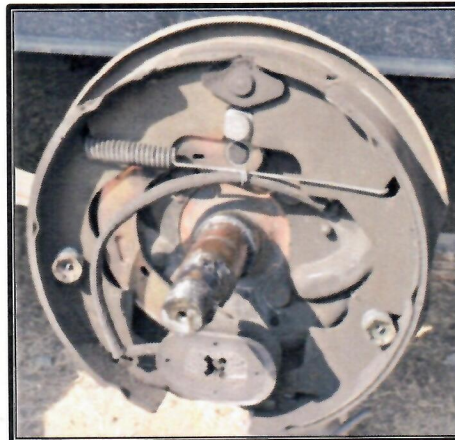
Left-Rear Brake Assembly

The vehicle was equipped with electric, drum style brakes. There were two brake assemblies per axle, for a total of four brake assemblies. The grease on the left-rear brake drum surface occurred when Investigator Patton removed the grease from the inner bearing race. The left-front and left-rear brake assemblies were unremarkable.

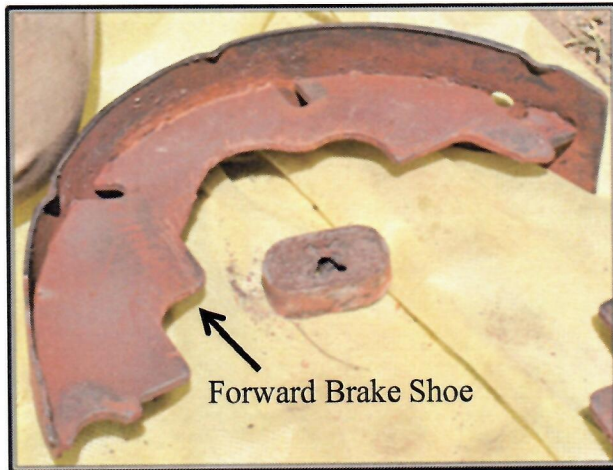
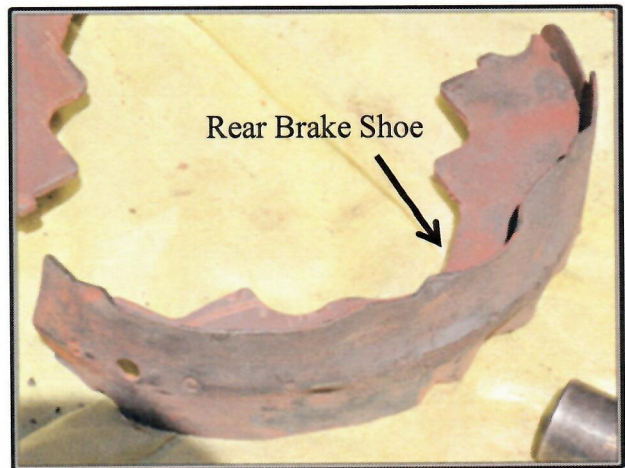
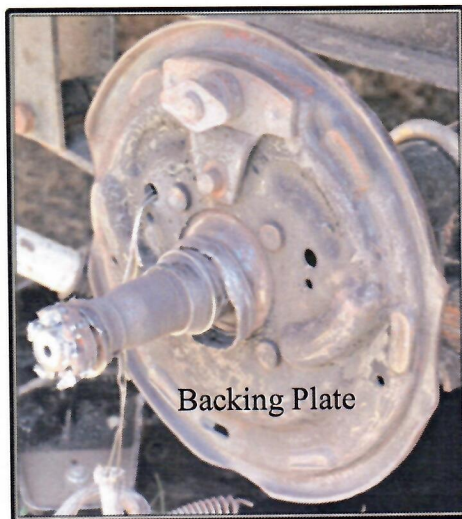
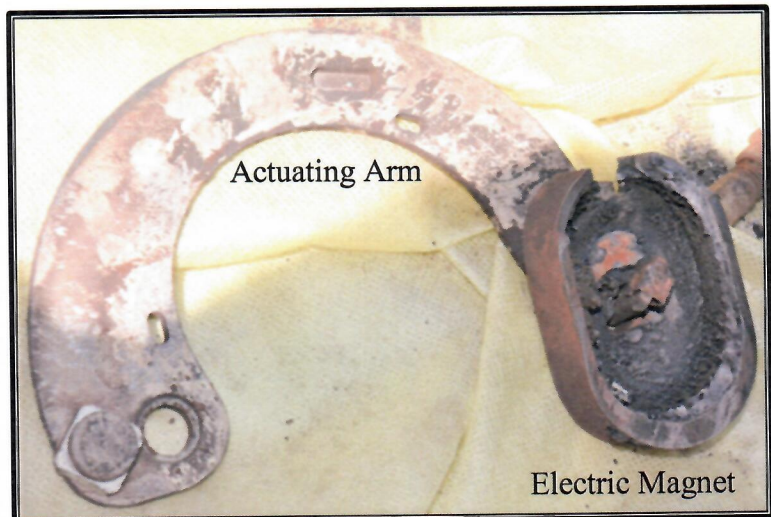
Right-Rear Brake Components

The right-front and right-rear brake components were detached from the backing plates and were found loose in the brake hubs. The brake shoes were designed to be secured to the backing plates with hold down springs, pins, and retainers. None of the aforementioned parts were found during the inspection. The right-front and right-rear brake assemblies were also missing the brake adjusting screw springs. The right-front and right-rear brake assemblies did have the brake return spring and the brake adjusting screw. All brake shoes on the right side were void of any friction material; they were discolored and deformed. The electric magnets attached to the actuating arms for each of the right side brake assemblies were melted, and the windings were displaced from the housing.

The failure of the bearings caused the right-front and right-rear brake hubs to contact the castle nuts that held the brake hubs on the spindles. The brake hubs were no longer centered on the spindles, which caused the brake components to detach from the backing plates. The right-front and right-rear spindle dust caps were missing. It was undetermined as to the length of time the spindle dust caps were missing. If the dust caps had been place, they most likely detached at the time of the bearing failures and/or when the brake hubs were no longer centered on the spindles.

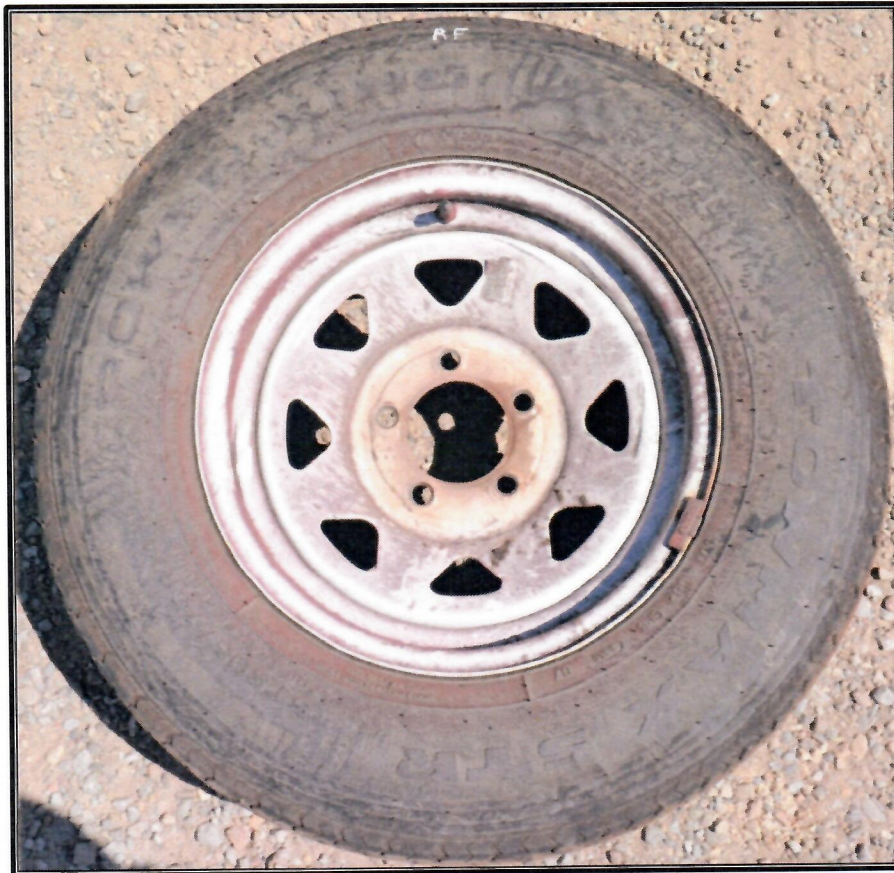
Right-Front Tire and Wheel

This tire was manufactured in the 23rd week of 2014. The tire was unremarkable. The wheel-mounting surface, around the bolt holes, was discolored.

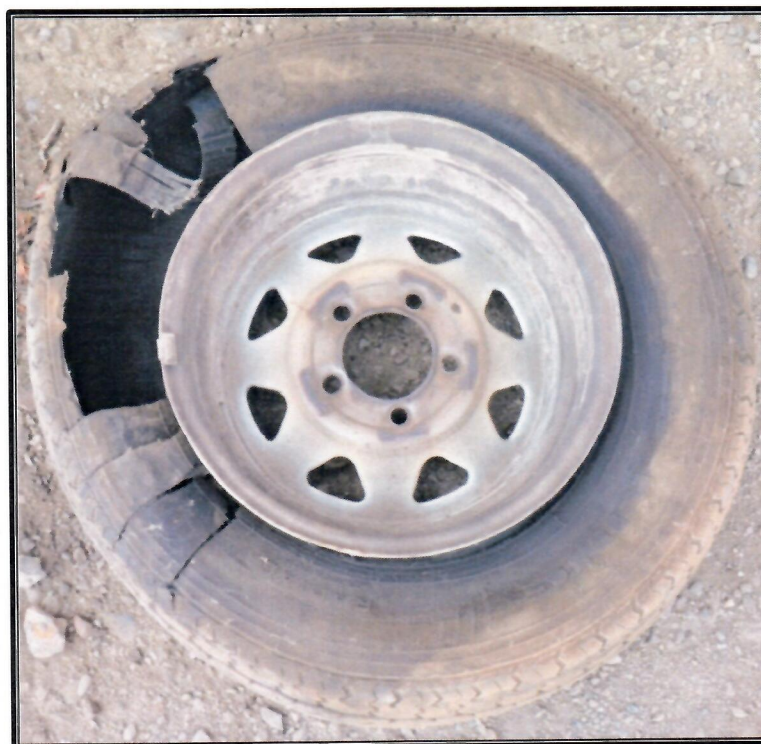
Right-Rear Inboard Tire and Wheel

The portion of the tire with the DOT number showing the week and year the tire was manufactured was missing. The outboard sidewall was unremarkable. The inboard sidewall bead seat was de-beaded around the circumference. The inboard sidewall had multiple tears and pieces missing from the 6:30 to the 10:30 positions, approximately 19 inches in chord length. The wheel-mounting surface, around the bolt holes, was discolored. There was no indication the tire had a prior flat repair.

The right-front and right-rear wheels were bolted to the brake hubs. With the brake hubs no longer centered on the spindles, the tires on the right-front and right-rear may have been tilted causing the top and bottom of the tire to be displaced inward or outward. Normally, the weight of vehicle and the heat generated from tires in contact with road would be spread over the entire tread surface. If the tires were tilted, the weight of the vehicle on the right side and the heat generated by the tires in contact with the road could be concentrated into a narrow section of the tread. The friction between the detached brake components, brake hubs, and the spindles caused these components to produce heat. The heat then spread to the wheels, which most likely caused the inflation pressure in the tires to increase. However, it was undetermined if the right-rear tire "blowout" was due to an inflation pressure increase and/or from the tires being tilted. The right-rear wheel did not show any signs of having had contact with the roadway, and the tire did not have any exposed metal cords from the tread.
