**National Park Service**

**Repair and Upgrade Washington Monument Elevator –  
Washington, DC**

**NAMA-224923**

**Pre-Design Report  
Final Submission**

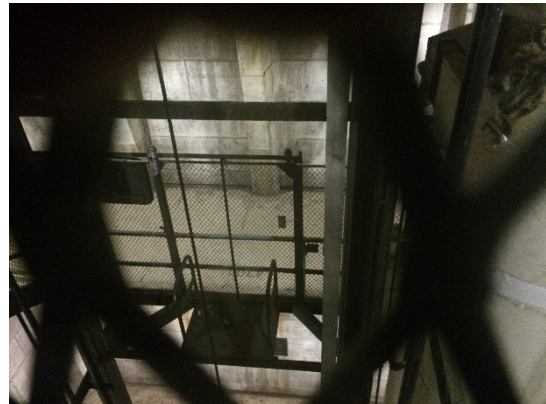
**Figure 2: Elevator Access Platform at an Intermediate Level**

At 35 locations throughout the elevator’s length of travel (17 locations on the west stair landings, 18 locations on the east stair landings), a landing extending into the elevator shaft is provided for access/emergency egress from the elevator cab (**Figure 2**). The platform and railing provided at these locations do not meet current building code requirements for live load (100 pounds per square foot) or the requirements for a guard system along an opening (a minimum height of 42 inches and no openings that can pass a sphere greater than 4 inches in diameter).

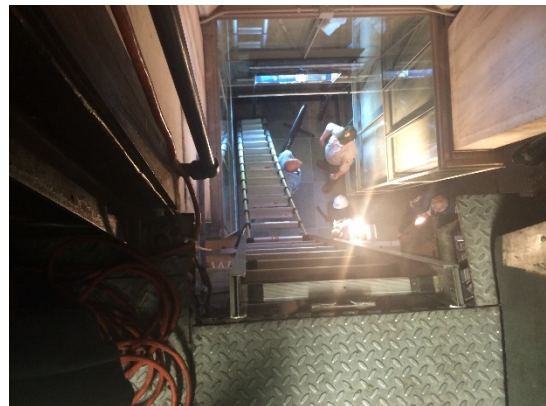
**Figure 3: Observation Level Access to Machine Room Via Portable and Fixed Ladder**

The elevator machine room is approximately 8 feet 10 inches by 8 feet 10 inches in size and is supported by steel framing with an aluminum diamond plate flooring surface. No permanent access to the elevator machine room is provided from the observation level; access is gained using a modified aluminum ladder extension permanently attached to the elevator machine room support framing and a second portable extension ladder (**Figure 3**). The limited access is a concern for NPS staff and the elevator maintenance contractor.

- Permanent access to the elevator machine room should be provided from the 500-foot level to the 519-foot level. This would be accomplished by providing a fixed ladder and a hung platform at the entrance to the elevator machine room on the south side of the elevator shaft. The new permanent access would meet current Occupational Safety and Health Administration (OSHA) requirements for a fixed ladder and access platform; a section and partial plan layout of a proposed method for the platform and ladder to access the elevator machine room at the 519-foot level are provided on **Figures 4 and 5**. Alternate layouts will be considered during the Schematic Design phase.

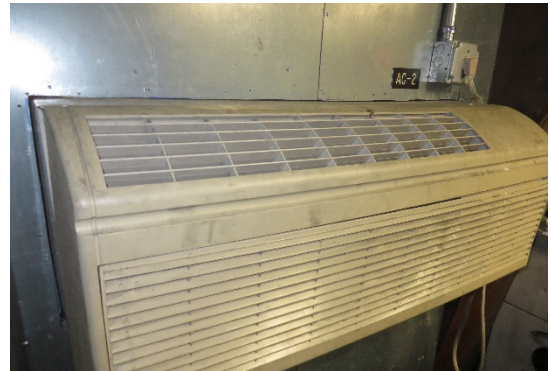
- The only recommended repair to the mechanical systems serving the elevator machine room is to replace the Trane PTAC unit. The unit is in poor-to-fair condition (**Figure 6**) and will need to be replaced within the next 2 to 5 years.

**Figure 6: Interior Trane PTAC Unit (AC-2) in Poor to Fair Condition**

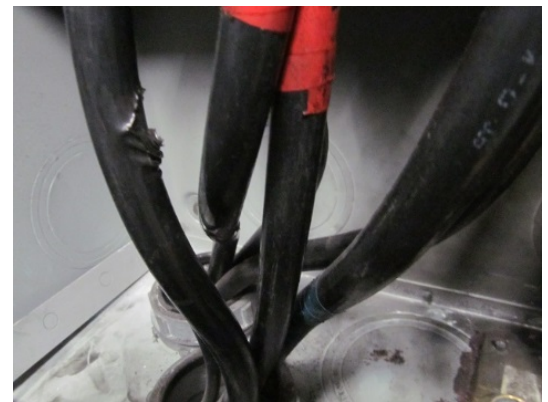
- The outer skin of one of the cables on the load side of the Siemens breaker in the circuit breaker panel is peeling (**Figure 7**) and may need maintenance if it is more than just a cosmetic issue. This may or may not be affecting the integrity of the cable. The electrical testing shall evaluate the integrity of the cable.

**Figure 7: Peeling Skin on Cable (Left Conductor) in Siemens Circuit Breaker Panel**

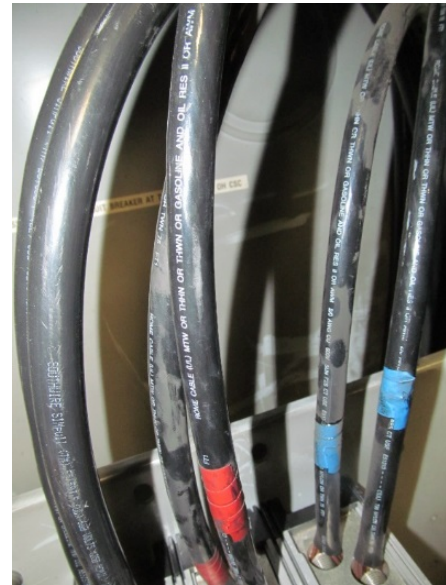
In addition, inside the main circuit breaker panel in the elevator machine room, the MI cables (coming from the 480-foot level) are spliced to copper conductors. After the splice, the copper conductors consist of mismatched sizes (see Section 3.04.1, *Recommended Repairs*).

- Inside the main circuit breaker panel in the elevator machine room, the MI conductors (coming from the 480-foot level) transition to copper conductors via splices. After the splices, the copper conductors consist of mismatched sizes (**Figure 8**): 1 set of 2-250 thousands of circular mils (MCM) cables, and 2 sets of 2-2/O cables. However, per NEC 2011 code, para. 310.10.1.2, parallel conductors should be the same size (2/O and 250 MCM are mismatched). Replacing the cables with all 250 MCM will require re-splicing the MI cable within the panel. While not critical to the performance of the elevator, it is recommended the wiring be upgraded to meet the NEC code. Specifically, the mismatched copper conductors between the MI cable splice and the 400-amp Siemens breaker in the elevator machine room main circuit breaker panel should be the same size and should be sized appropriately.

**Figure 8: Mismatched Conductor Sizes (250 MCM vs 2/O) in Siemens Circuit Breaker Panel**

- Another item to address is the electrical cables associated with the Bunker and the main breakers. The best practice is to size the cables to carry at least 400 amperes. Some of the existing conductors are rated to carry less than 400 amperes (2-2/O cables have a capacity of 350 amperes). However, this is not an NEC code violation and is permissible per NEC para. 240.4.B and 240.6.A, which allow the next highest available breaker size above 350 amperes to be used (400 amperes).

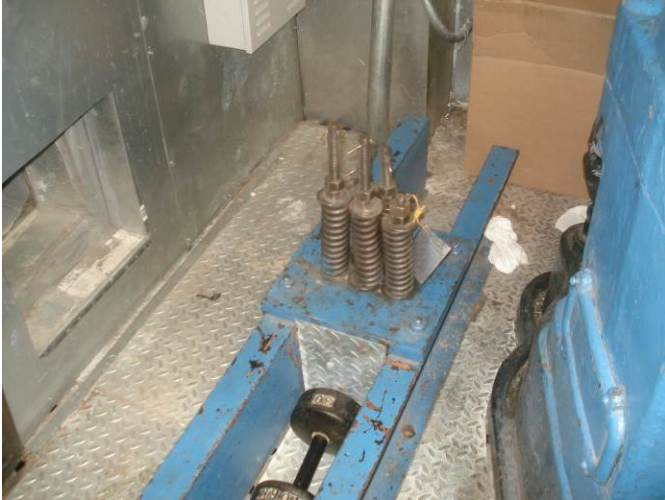
1. Clean Machine Room

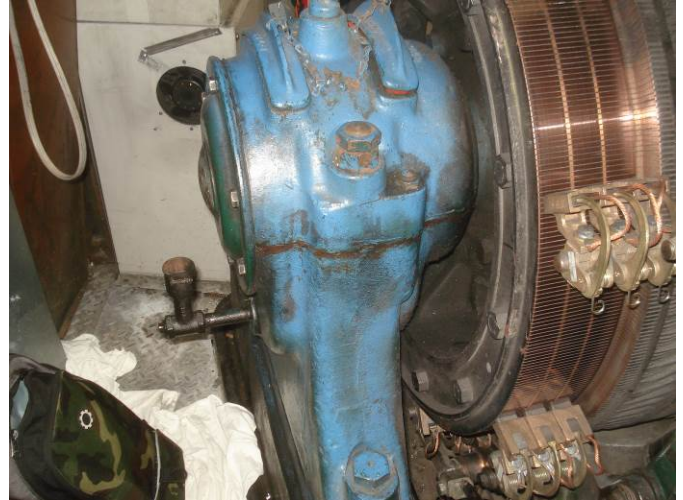
2. Clean hoist machine of accumulation of dirt

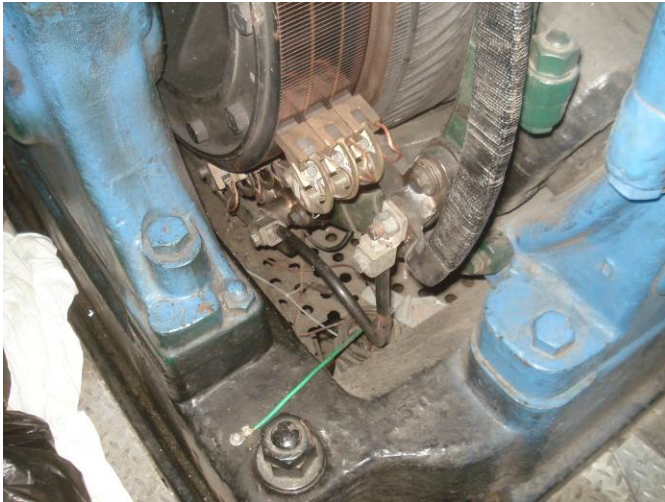
3. Clean hoist machine of accumulation of dirt

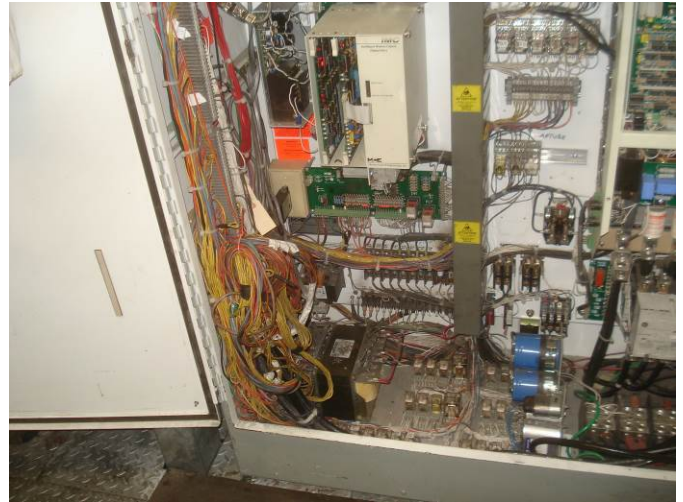
4. Clean out controller

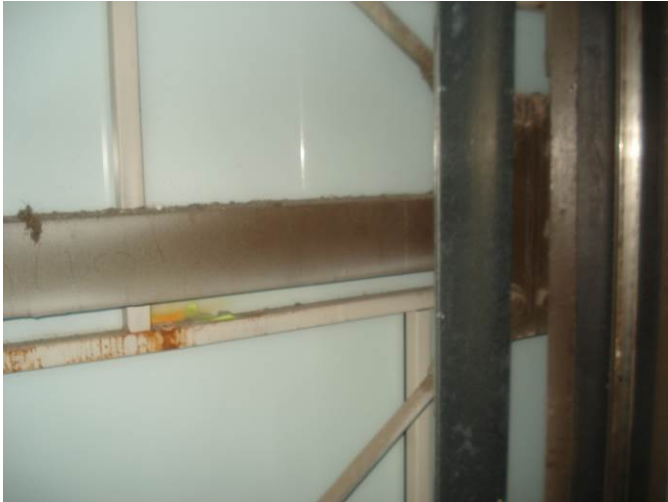
5. Clean down hoistway

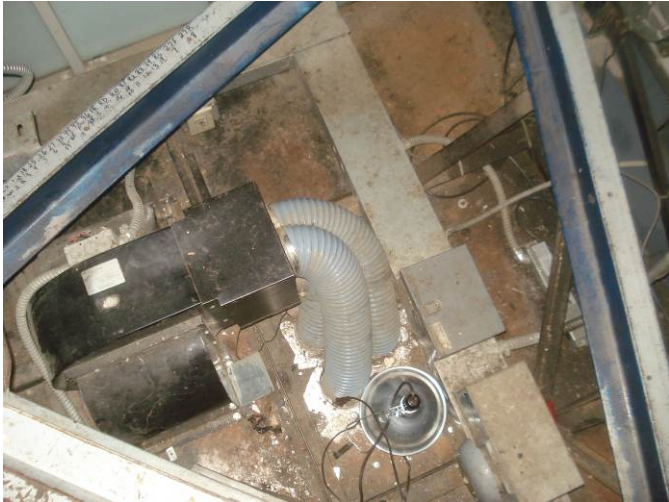
6. Clean cartop

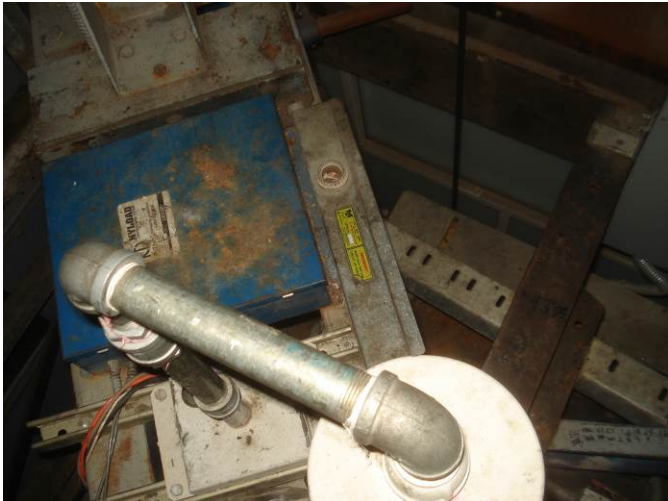
7. Cartop light needs to be operational

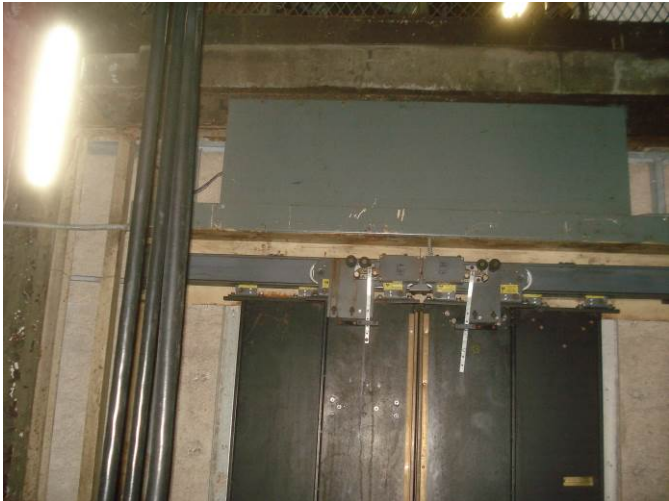
8. Replace missing dust covers

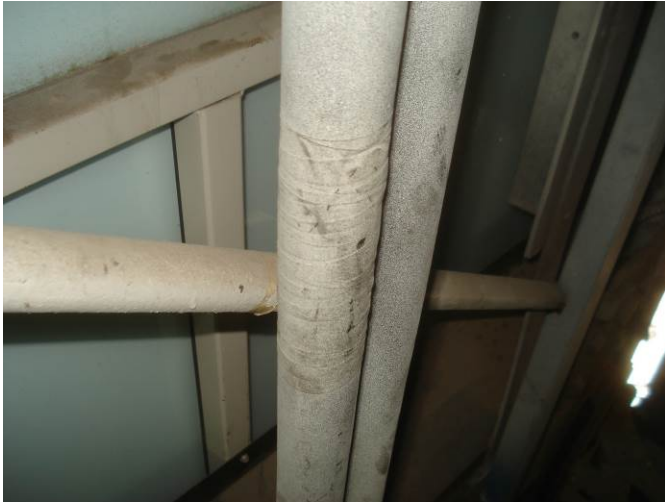
9. Confirm the traveling cables do not have shorts in the wires as there is tape on the traveling cable at the top and bottom of the hoistway

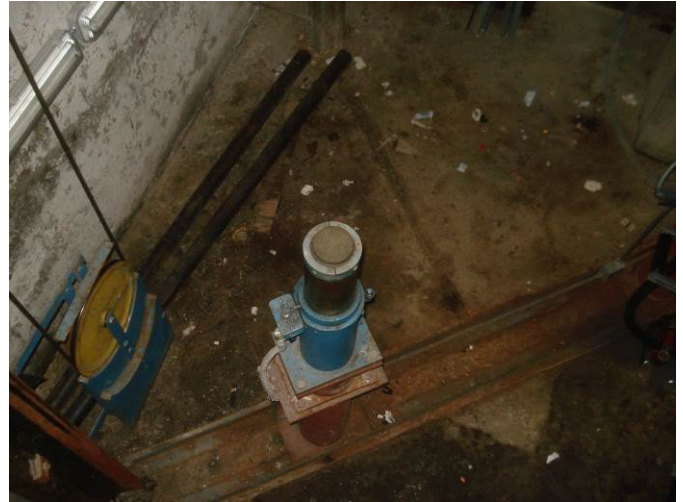
10. Clean pit

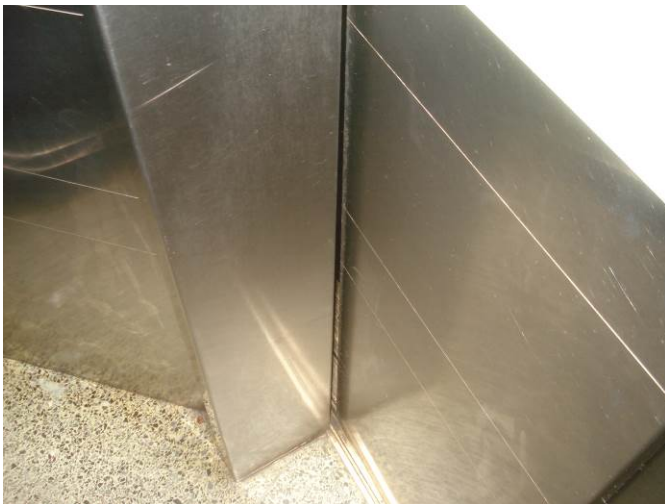
11. Reduce gap between rear door and return panel

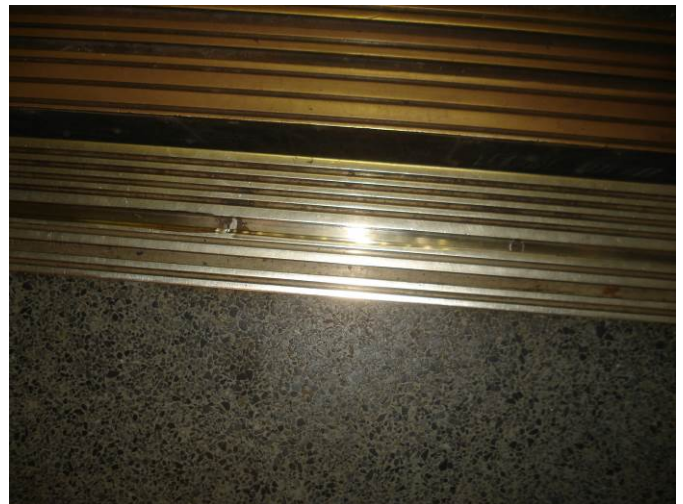
12. Car sill is worn and requires replacement

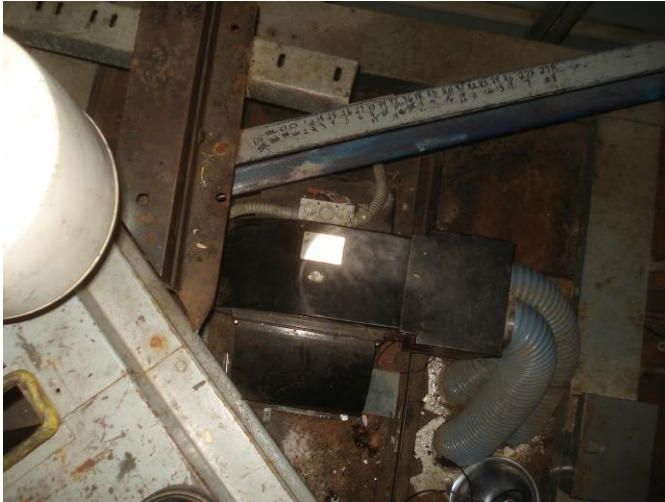
13. Replace electrical cover on cartop fan and clean cartop

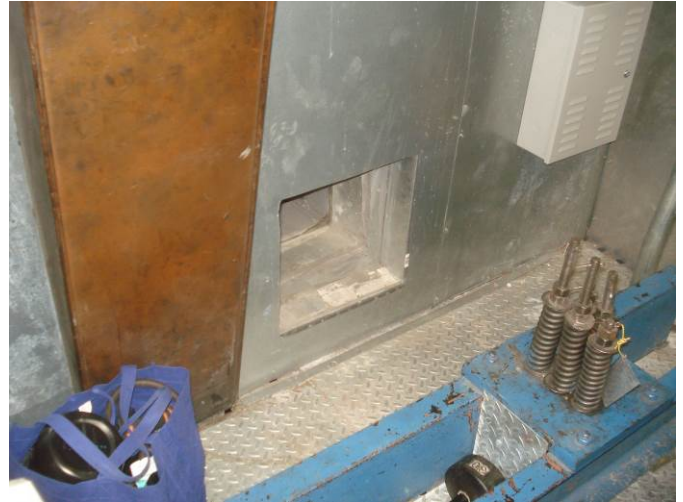
14. Provide covers on A/C vent

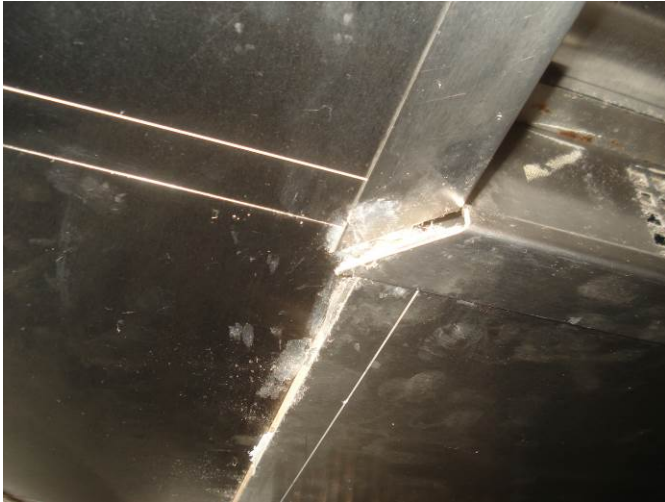
17. Repair ceiling where a portion appears to be coming loose

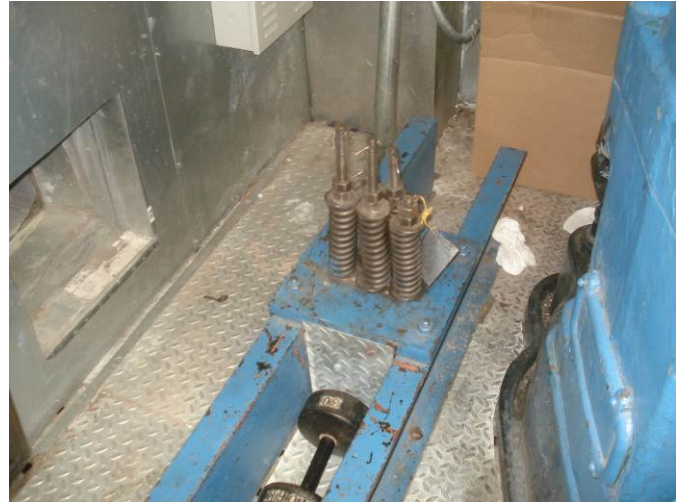
18. Remove dumbbells from machine room. By code, only elevator equipment is allowed in machine room.

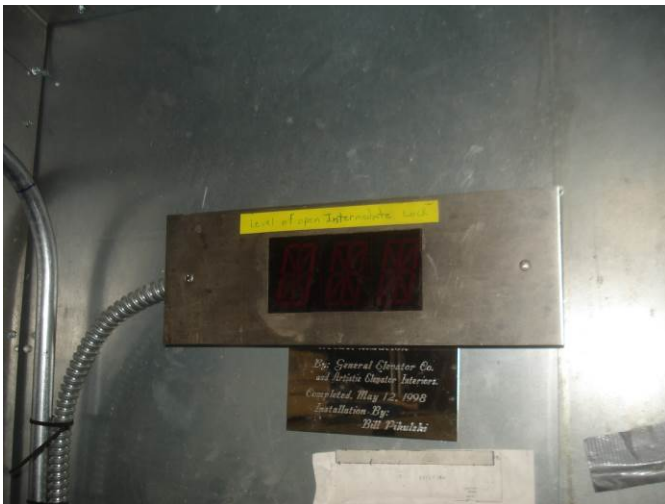
19. Repair position indicator in machine room

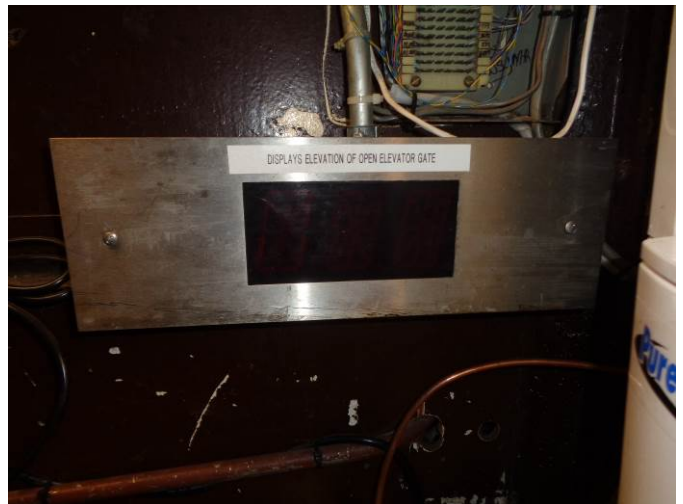
20. Repair position indicator in fire control room at ground floor

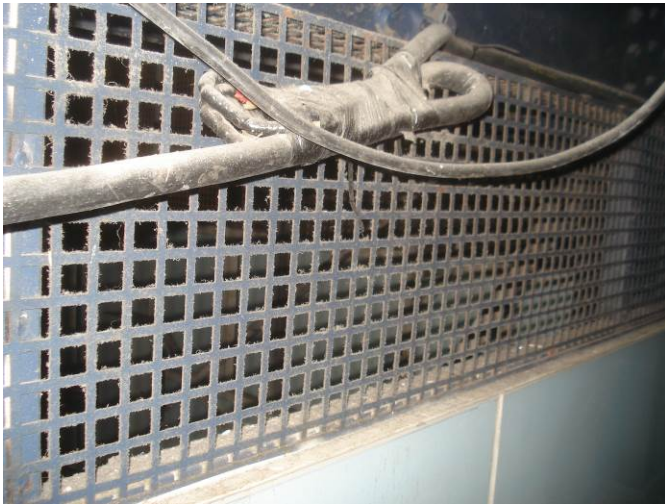
21. Clean hoistway outside of dust, dirt and debris

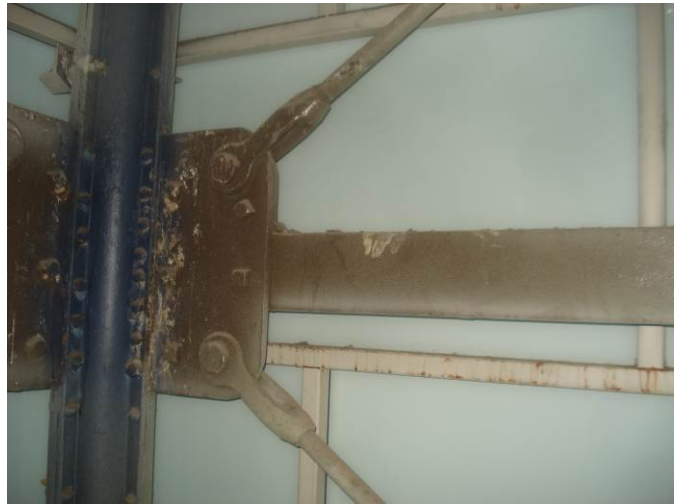
22. Clean inside hoistway of dust, dirt and debris

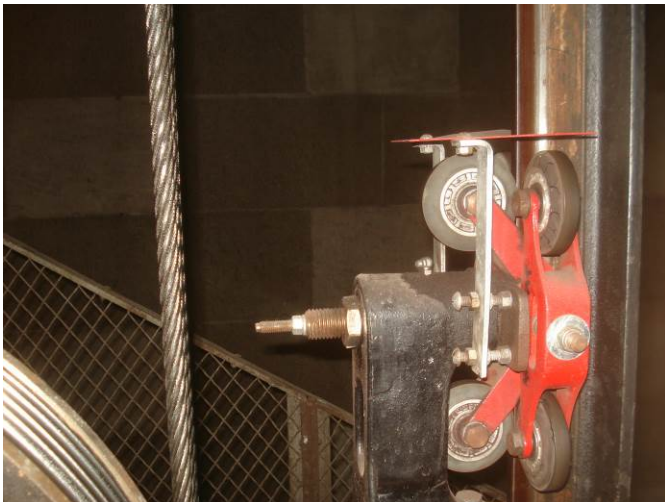
23. Chain link fence around hoistway is not safe or code compliant

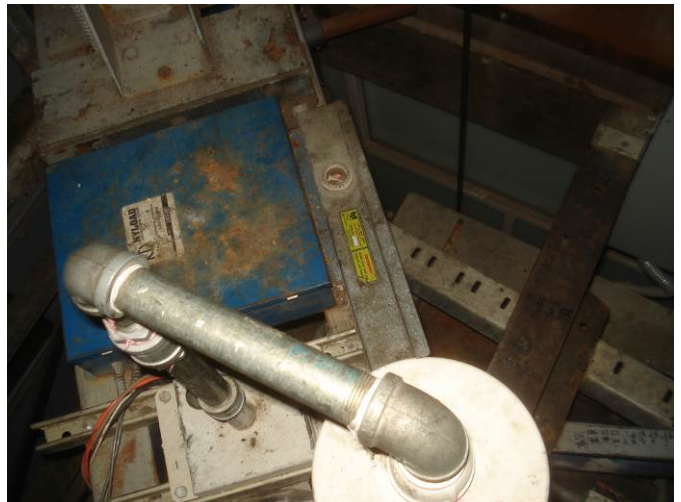
24. All wiring on car top should be protected

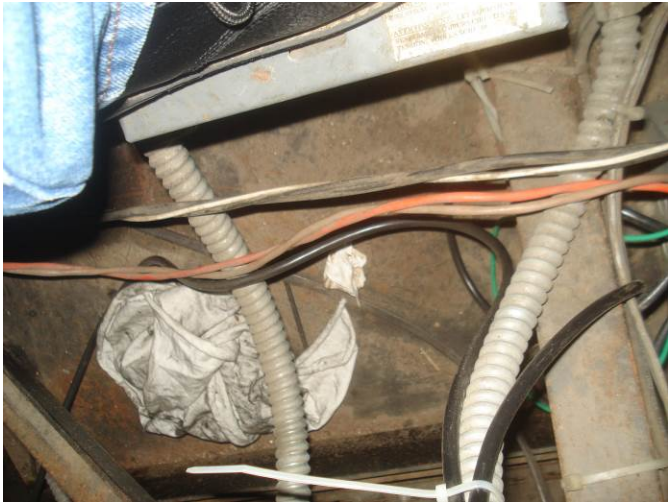
25. All wiring on car top should be protected.

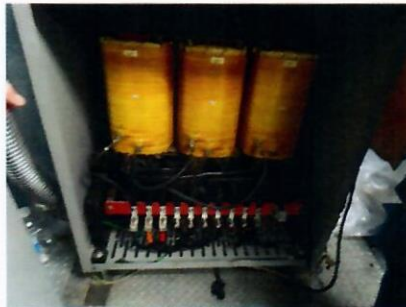
Testing was also done on the isolation transformer. The primary and secondary of the transformer are in excellent condition with balanced values in both windings.(See picture)

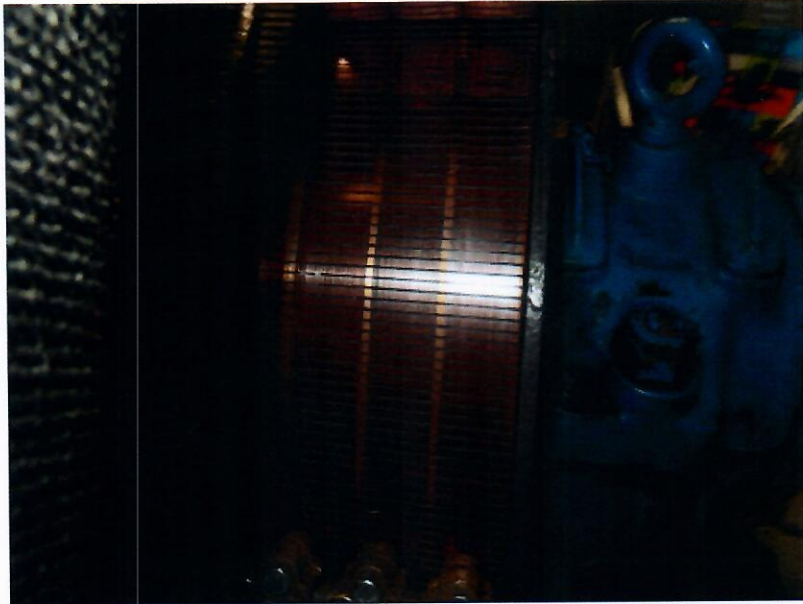
Close up of commutator which  
needs to be cleaned between  
bars.

The armature should be blown out, vacuumed and sprayed with black air-dry varnish. The brush holders/insulators should be sand blasted or cleaned thoroughly to clear the insulation material of static electricity. There is capacitance between the bars caused by carbon deposits. This carbon should be removed by undercutting the commutator bars. (See Pictures).

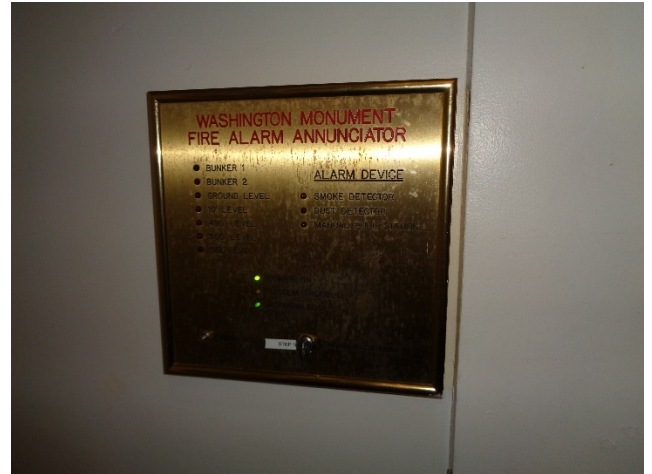
2. A new fire alarm panel should be provided.

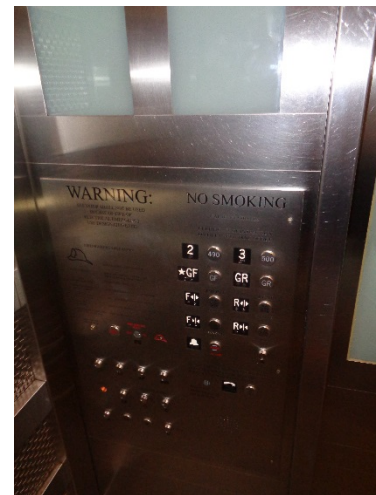
4. Existing car station is to be replaced.

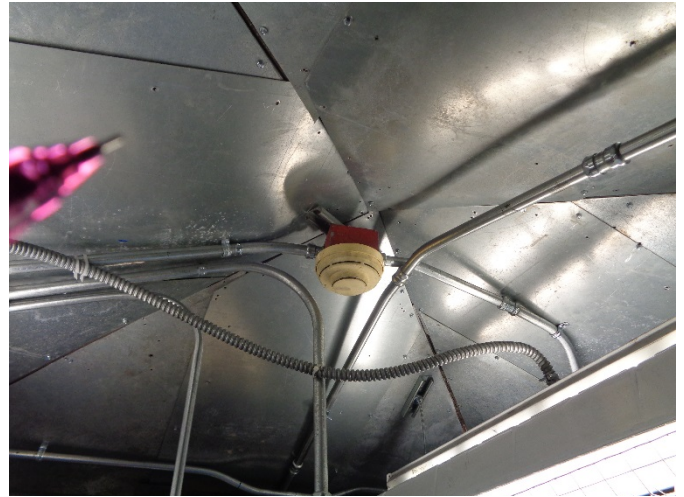
6. Existing machine room does not appear to be fire rated.

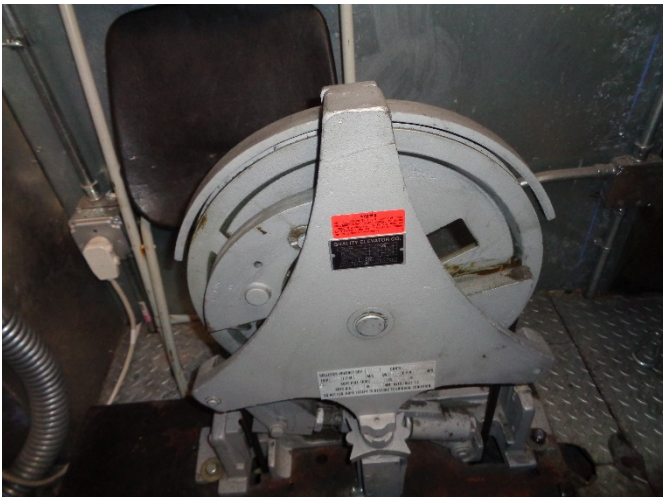
7. Dover Governor should be replaced.

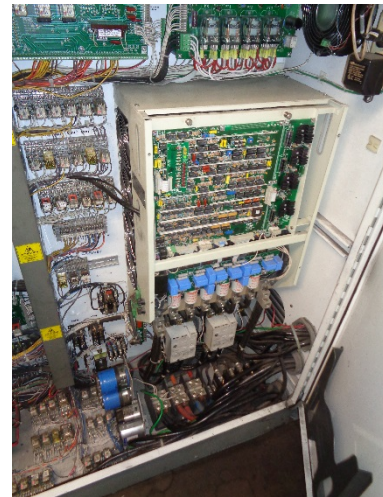
8. MCE controls need to be replaced.

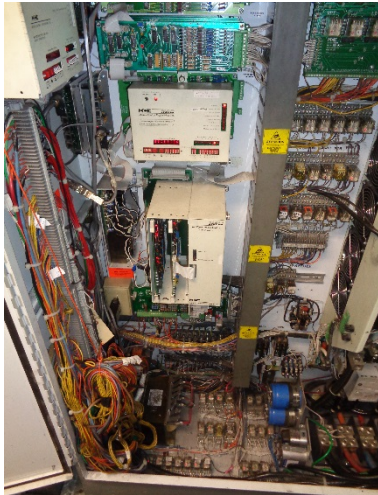
9. Existing MCE controls need to be replaced

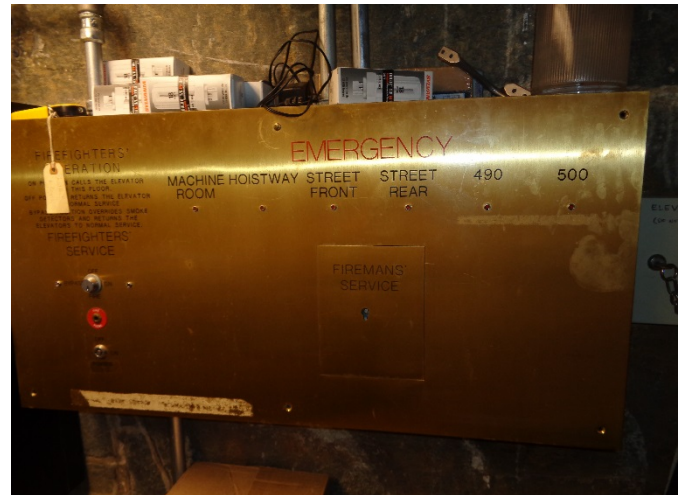
12. Existing fire control panel to be replaced.
