# **CBP Needs to Improve Its Video and Audio Coverage at Land Ports of Entry**

**September 25, 2023**

**OIG-23-54**

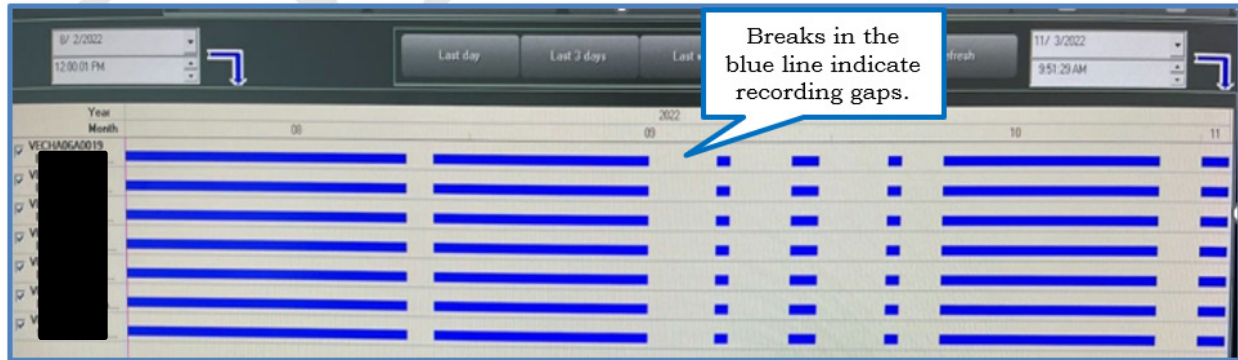
**Figure 1. Video Recording Software Illustrating Intermittent Recording Gaps from August 2 through November 3, 2022**

We observed CAVSS video recording gaps at all 10 LPOEs we visited, with some gaps ranging from multiple days to a few months. While onsite, we confirmed the video could not be played back during the time of these recording gaps. At one LPOE, we observed seven cameras only recording intermittently for 15 days over 3 months, as shown in Figure 1. In this instance, personnel assigned to the LPOE could not tell us why the cameras were not recording video. Additionally, LPOE personnel reported this recording issue to the BSDP PMO help desk contractors responsible for maintaining and troubleshooting issues with CAVSS; the contractors did not provide the cause but confirmed no video recordings were available.

Recording gaps were a widespread issue primarily caused by equipment not always rebooting after the Office of Information and Technology applied required network patches and conducted required scans.<sup>18</sup> Additionally, BSDP PMO did not assess the impact of the patches and scans on live video feeds and recording capabilities. Finally, outdated equipment makes it harder to apply patches and conduct scans because the current video management system has surpassed its life cycle.

**CBP Response to Recommendation 1:** Concur. BSDP PMO will coordinate with the Office of Information and Technology's Cyber Security Directorate to seek a less invasive scanning and patching approach, to include identifying tools available to minimize impacts to scanning and patching and develop a plan to mitigate any identified impacts. Additionally, BSDP PMO is researching other video management solutions with a visualization dashboard of system performance that alert video surveillance system operators when equipment is offline. Estimated Completion Date: January 31, 2024.

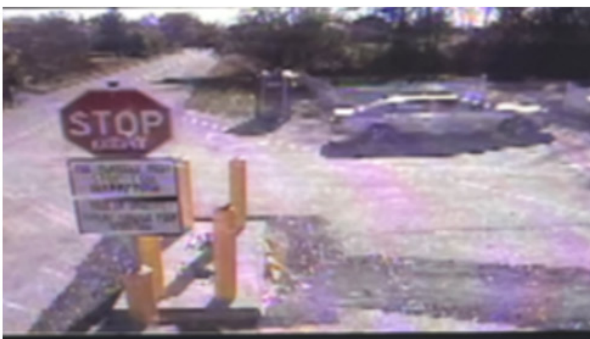
**Older Analog Camera**

We observed 101 instances of poor image quality for CAVSS footage at 18 LPOEs. Overall, the IP cameras produced much clearer images than analog cameras, as shown in Figure 3.

**Figure 3. Comparison of the Image Quality for an Older Analog Camera vs. a Newer Digital Camera at Two LPOEs**

As of May 2023, LPOEs had approximately 12,274 video surveillance cameras of which 57 percent (7,007) were analog cameras and 43 percent (5,267) were IP cameras. ISC and CBP physical security standards note that analog cameras should be replaced with IP cameras when possible. Further, BSDP PMO considers analog cameras to be outdated technology and officials said they will replace all analog cameras with IP cameras as funding and network infrastructure are available. Network infrastructure that supports CAVSS equipment is inadequate at some LPOEs, contributing to poor image quality.

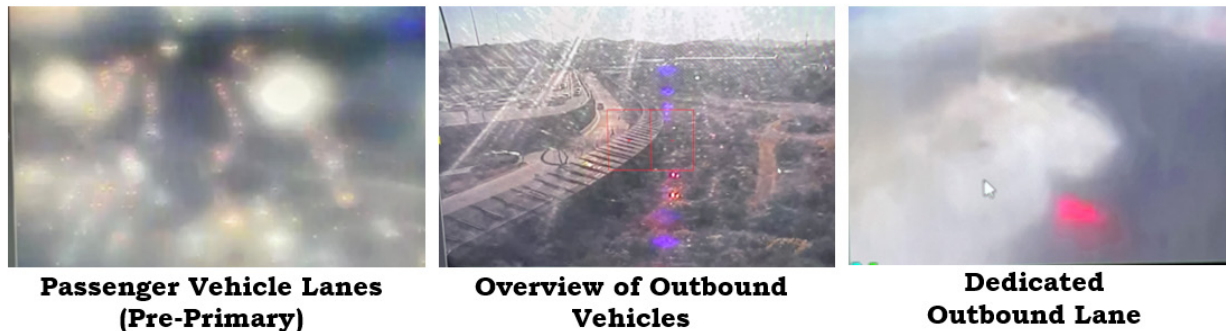
**Figure 5. Examples of Poor Image Quality for IP Cameras at Two LPOEs**

We also observed some instances of poor image quality from IP cameras resulting from needed maintenance, including the cleaning of camera lenses. Figure 5 shows examples of poor image quality for an area where passenger

vehicles line up to approach the LPOE primary inspection area, as well as areas that vehicles travel to exit the United States.

Although BSDP PMO currently requires preventative maintenance at each LPOE twice per year, we observed some cameras that had not received such maintenance. In some cases of cameras with poor image quality, a help desk ticket had been submitted for the camera to be cleaned or replaced. BSDP PMO officials said they had explored providing additional preventative maintenance but found it to be cost prohibitive. As an alternative, BSDP PMO pursued a health dashboard for more proactive monitoring, but due to the age of the existing video management system, determined it would be too costly.

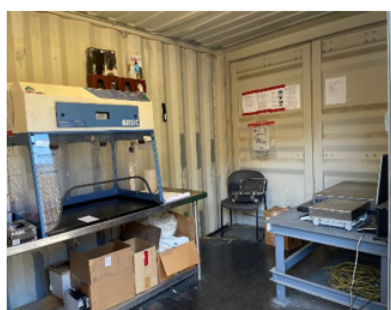
**Seizure Processing Area**

Figure 7 shows three LPOE areas without required video coverage where seized drugs are processed and weighed, seized property and contraband are temporarily stored, and weapons are stored.

**Figure 7. Three Examples of LPOE Areas With No Video Coverage**

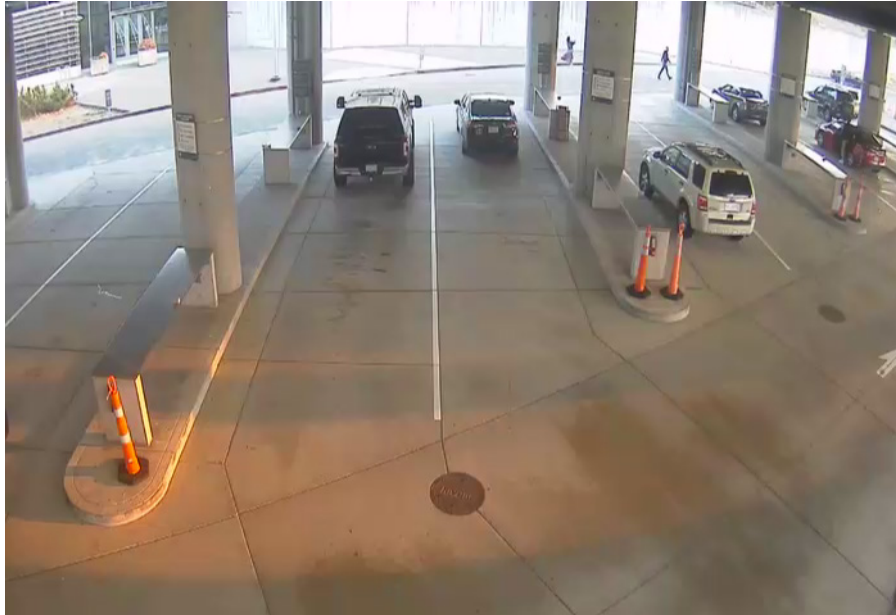
**Figure 8. Example of an Image from Cameras Covering Secondary Vehicle Inspections at One LPOE**

BSDP PMO requires all CAVSS equipment to comply with the approved device list and be accessible for viewing at the CASC. We observed an LPOE with approximately 18 video cameras that were not on the approved device list and did not feed into the CASC. This occurred because the Office of Facilities and Asset Management did not coordinate with BSDP PMO before purchasing and installing the equipment at the LPOE. According to LPOE personnel, these cameras were intended to address gaps in video coverage for the secondary vehicle inspection process (see Figure 8) and capture outbound operations and were purchased and installed for about \$140,000.

Personnel at one LPOE justified the use of video equipment not connected to CAVSS by referring to the limitations of OFO's current video management system and equipment. Specifically, personnel stated that the current system and equipment have a very limited field of view, often produce poor image quality, and have limited capabilities to accurately capture images of vehicles and plates in outbound lanes at all LPOEs within their field office. According to LPOE personnel, when encountering port runners or confused motorists, they were often unable to obtain details needed to identify the vehicle, such as license plate or even the make/model.

**Recommendation 5:** We recommend the CBP Office of Information and Technology Assistant Commissioner implement a process to ensure video and audio surveillance equipment installed complies with applicable security and privacy controls required by DHS network standards, CBP information security policies, and Centralized Area Video Surveillance System Design Standards for design and operation, as applicable.

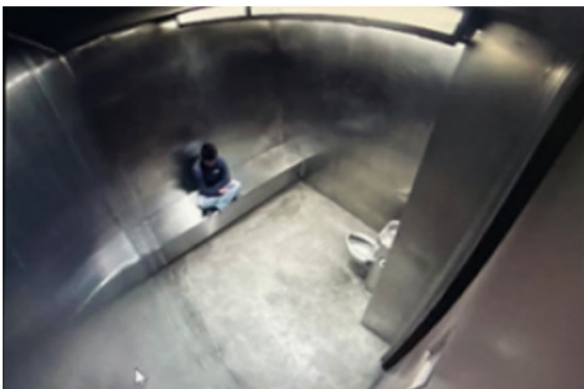
**No Privacy Panel or Video Masking**

LPOEs did not always have the required protection for the detainee’s privacy when using the toilet. At two LPOEs, we observed four hold rooms with toilets that did not have any privacy protections — in these instances, there was no blurred video or physical structure (privacy panel). We also identified two hold rooms at one LPOE with physical structures that did not provide sufficient privacy. Figure 12 shows examples of these hold rooms with toilets.

**Figure 12. Examples of Inadequate Privacy Protections for Hold Rooms with Toilets at Two LPOEs**

**Recommendation 6:** We recommend CBP's Border Security Deployment Program Project Management Office, in collaboration with CBP's OFO Directors of Field Operations, take immediate action to ensure all land ports of entry have the required privacy protections for hold rooms with lavatory facilities.

**CBP Response to Recommendation 6:** Concur. BSDP PMO will task the OFO field offices with ensuring that LPOEs have the required privacy protections in place in the video management system. If they are not in place, field offices will be required to provide the camera names to BSDP PMO for action. Estimated Completion Date: November 30, 2023.
