**SUBJECT: UNITED STATES V. SHELL CHEMICAL LP
CIVIL ACTION NUMBER 2:18-CV-1404-EEF-JVM
FENCELINE MONITORING – CORRECTIVE ACTION PLAN
LDEQ AGENCY INTEREST NUMBER 26336**

SHELL NORCO MANUFACTURING COMPLEX

CORRECTIVE ACTION PLAN

Benzene Fenceline Monitoring

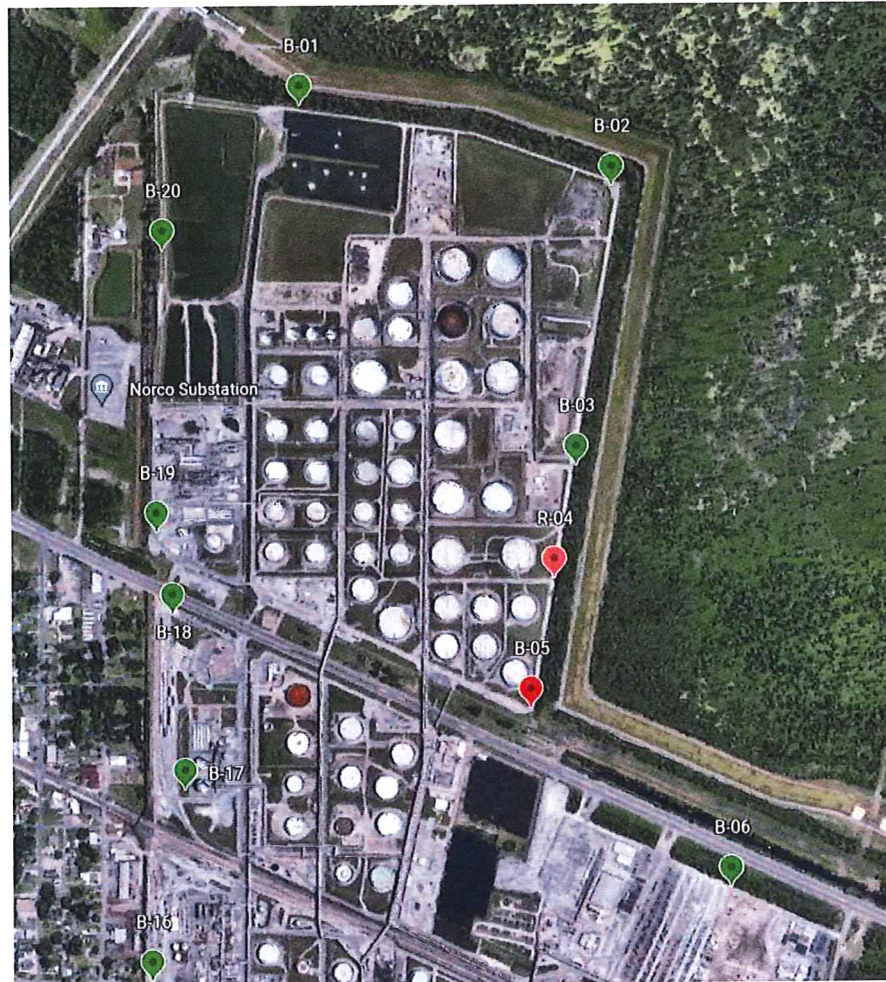
Figure IV-1: Monitors Above Action Level

Sample Period	Sample Point Above Action Level	Benzene Result ($\mu\text{g}/\text{m}^3$)
8/17 - 8/31	R-04 (Refinery Only)	15.0
	B-05	17.0
8/31 - 9/14	R-04 (Refinery Only)	14.0
	B-05	19.0
9/14 - 9/28	B-05	10.0
9/28 - 10/12	B-05	9.5
10/12 - 10/26	None	-

The Root Cause Analyses for the monitoring periods identified above, 8/17/22 – 10/12/22, were combined due to the proximity of the affected monitors and timing of the affected periods. A wind rose for each of the monitoring points and map of the monitoring locations is provided below wherein the red points show the monitors above the action level.

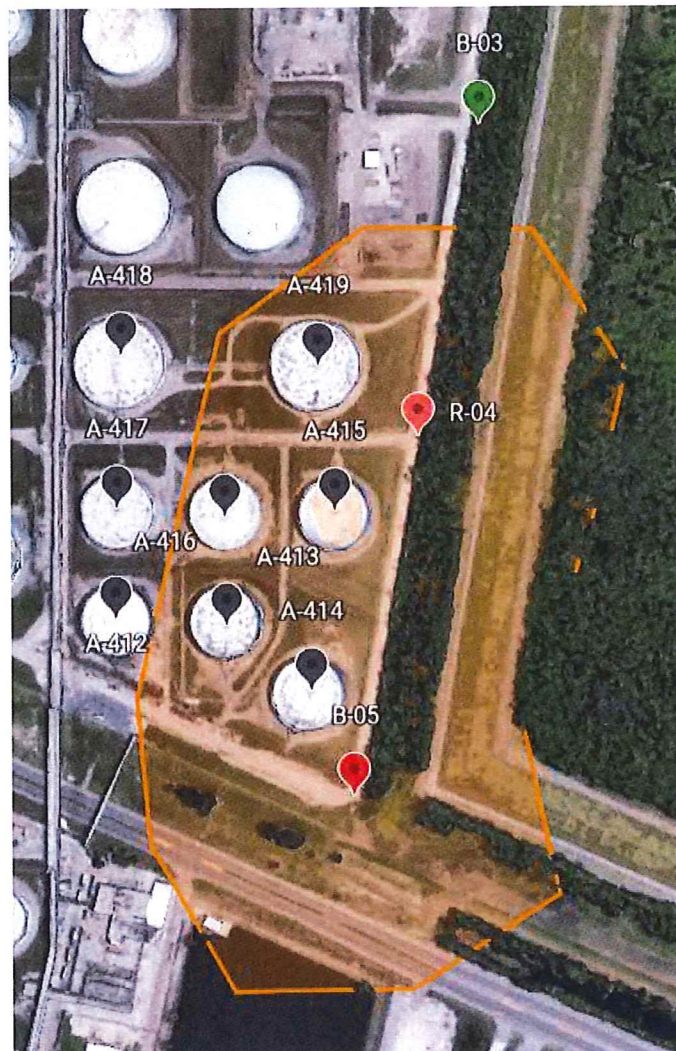
Figure IV-6: Emissions Sources within 500 feet of Affected Monitors

For the purposes of the root cause analysis for the aforementioned periods, emissions sources within 500 feet of the affected monitors were investigated. Figure IV-6 shows the area within a 500-foot radius around Monitors R-04 and B-05. Note that Monitor B-03 averaged a result of $1.3 \mu\text{g}/\text{m}^3$ during these periods with a maximum result of $2.3 \mu\text{g}/\text{m}^3$.

The nearest emissions sources to R-04 and B-05 are the North Property Crude Tanks, A-414, A-413, A-415, A-416, and A-419, as shown in Figure IV-6. These external floating roof tanks receive crude oil from the supply pipeline and provide crude oil feed to the distilling unit. Tank A-414 can also receive material from the off-spec header during unit upset conditions. Currently Tank A-415 is out of service for tank cleaning and inspection.

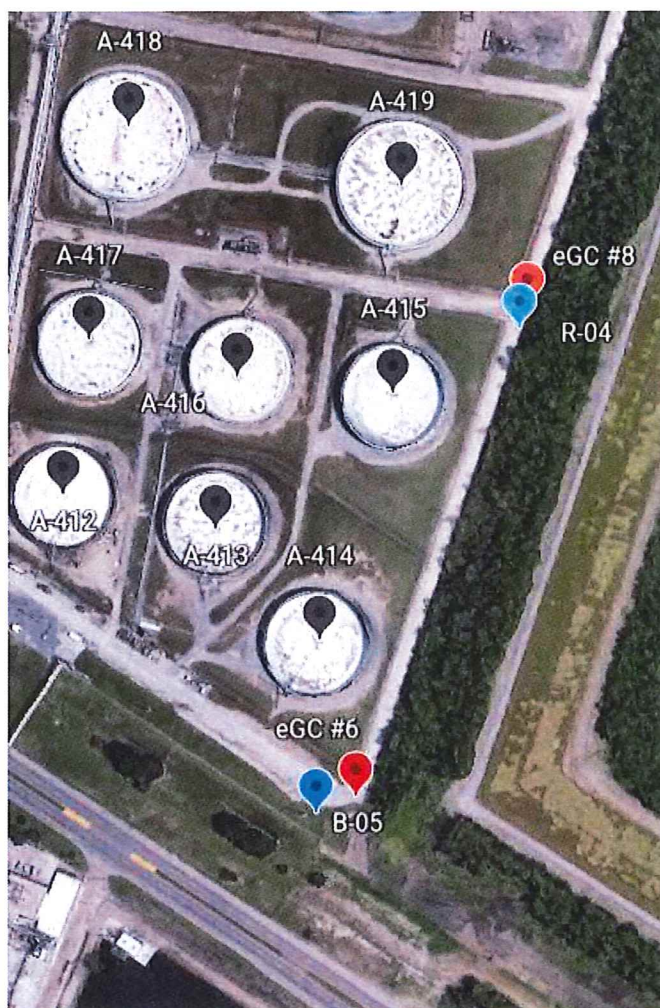
Figure IV-7: eGC Trailers

Two eGCs trailer-mounted benzene monitors are currently deployed in the North Property Tank Farm near the crude tanks. eGC #8 was deployed in early August in preparation of the tank turnaround activities. eGC #6 was moved to the southeast corner of North Property on October 12 due to elevated results from the passive monitor B-05. Figure IV-7 shows the locations of the eGC monitors.

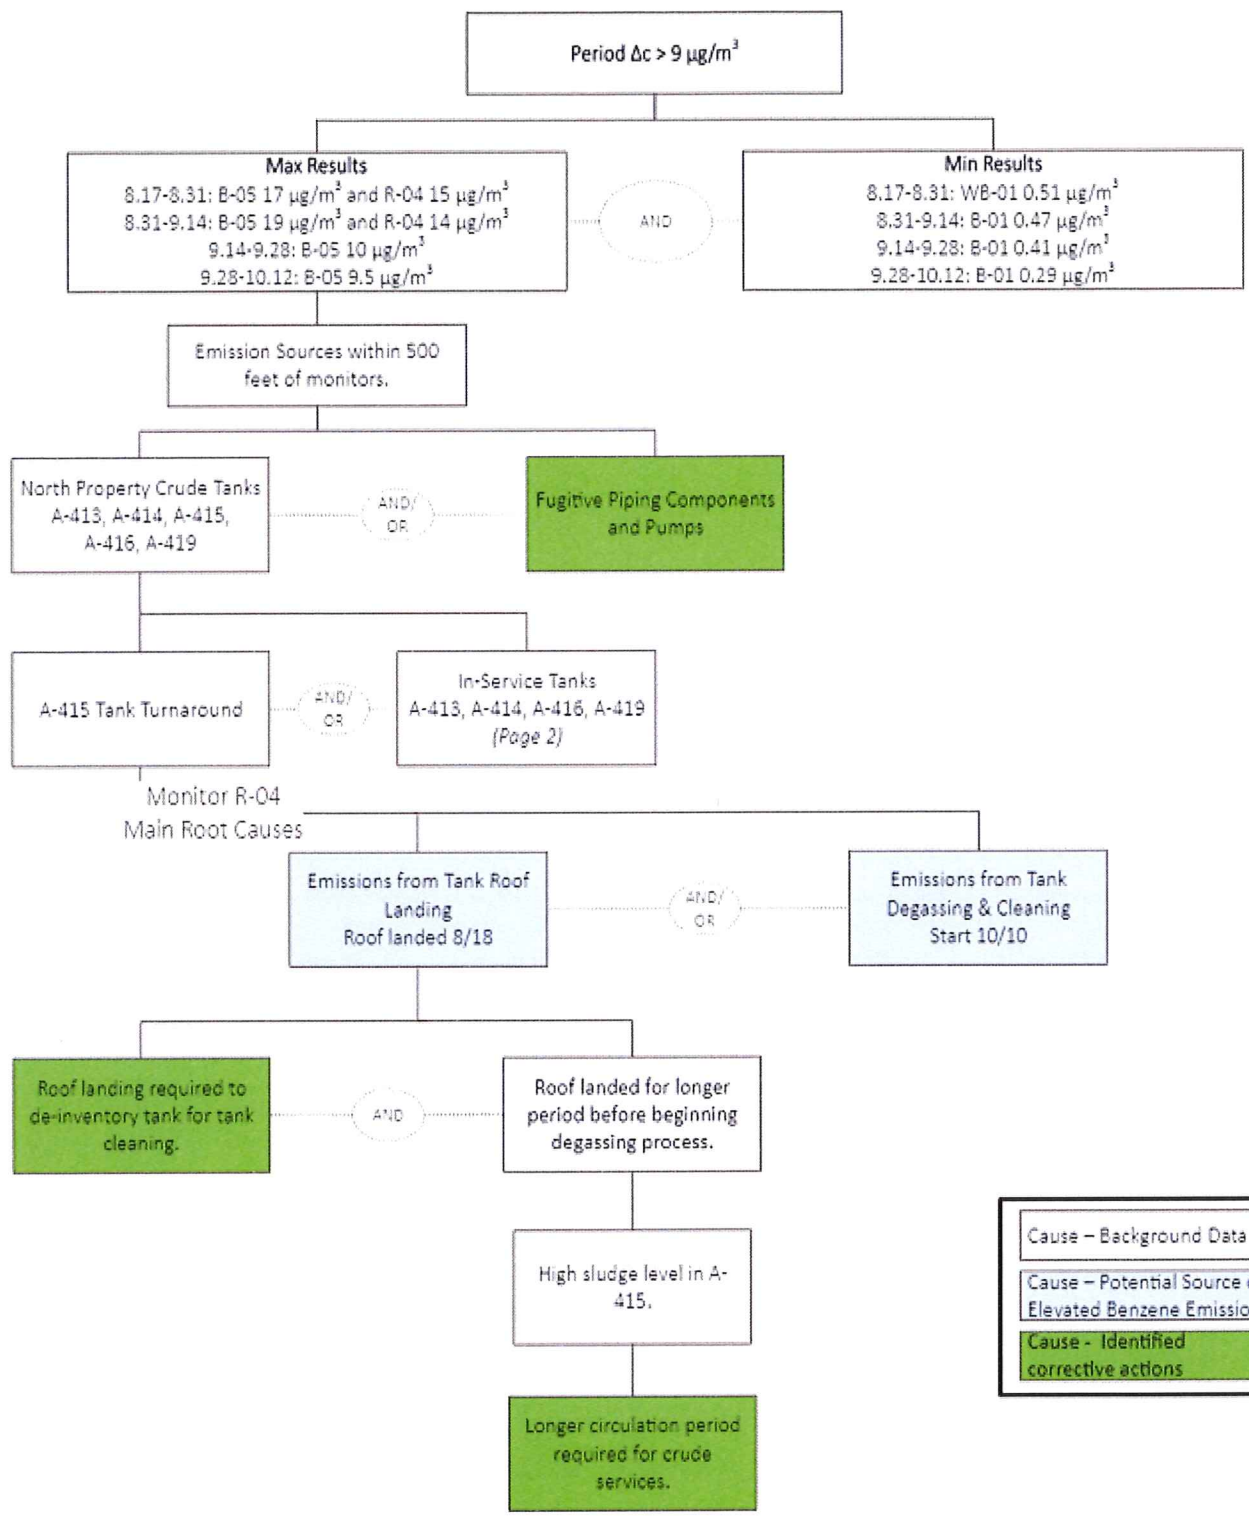
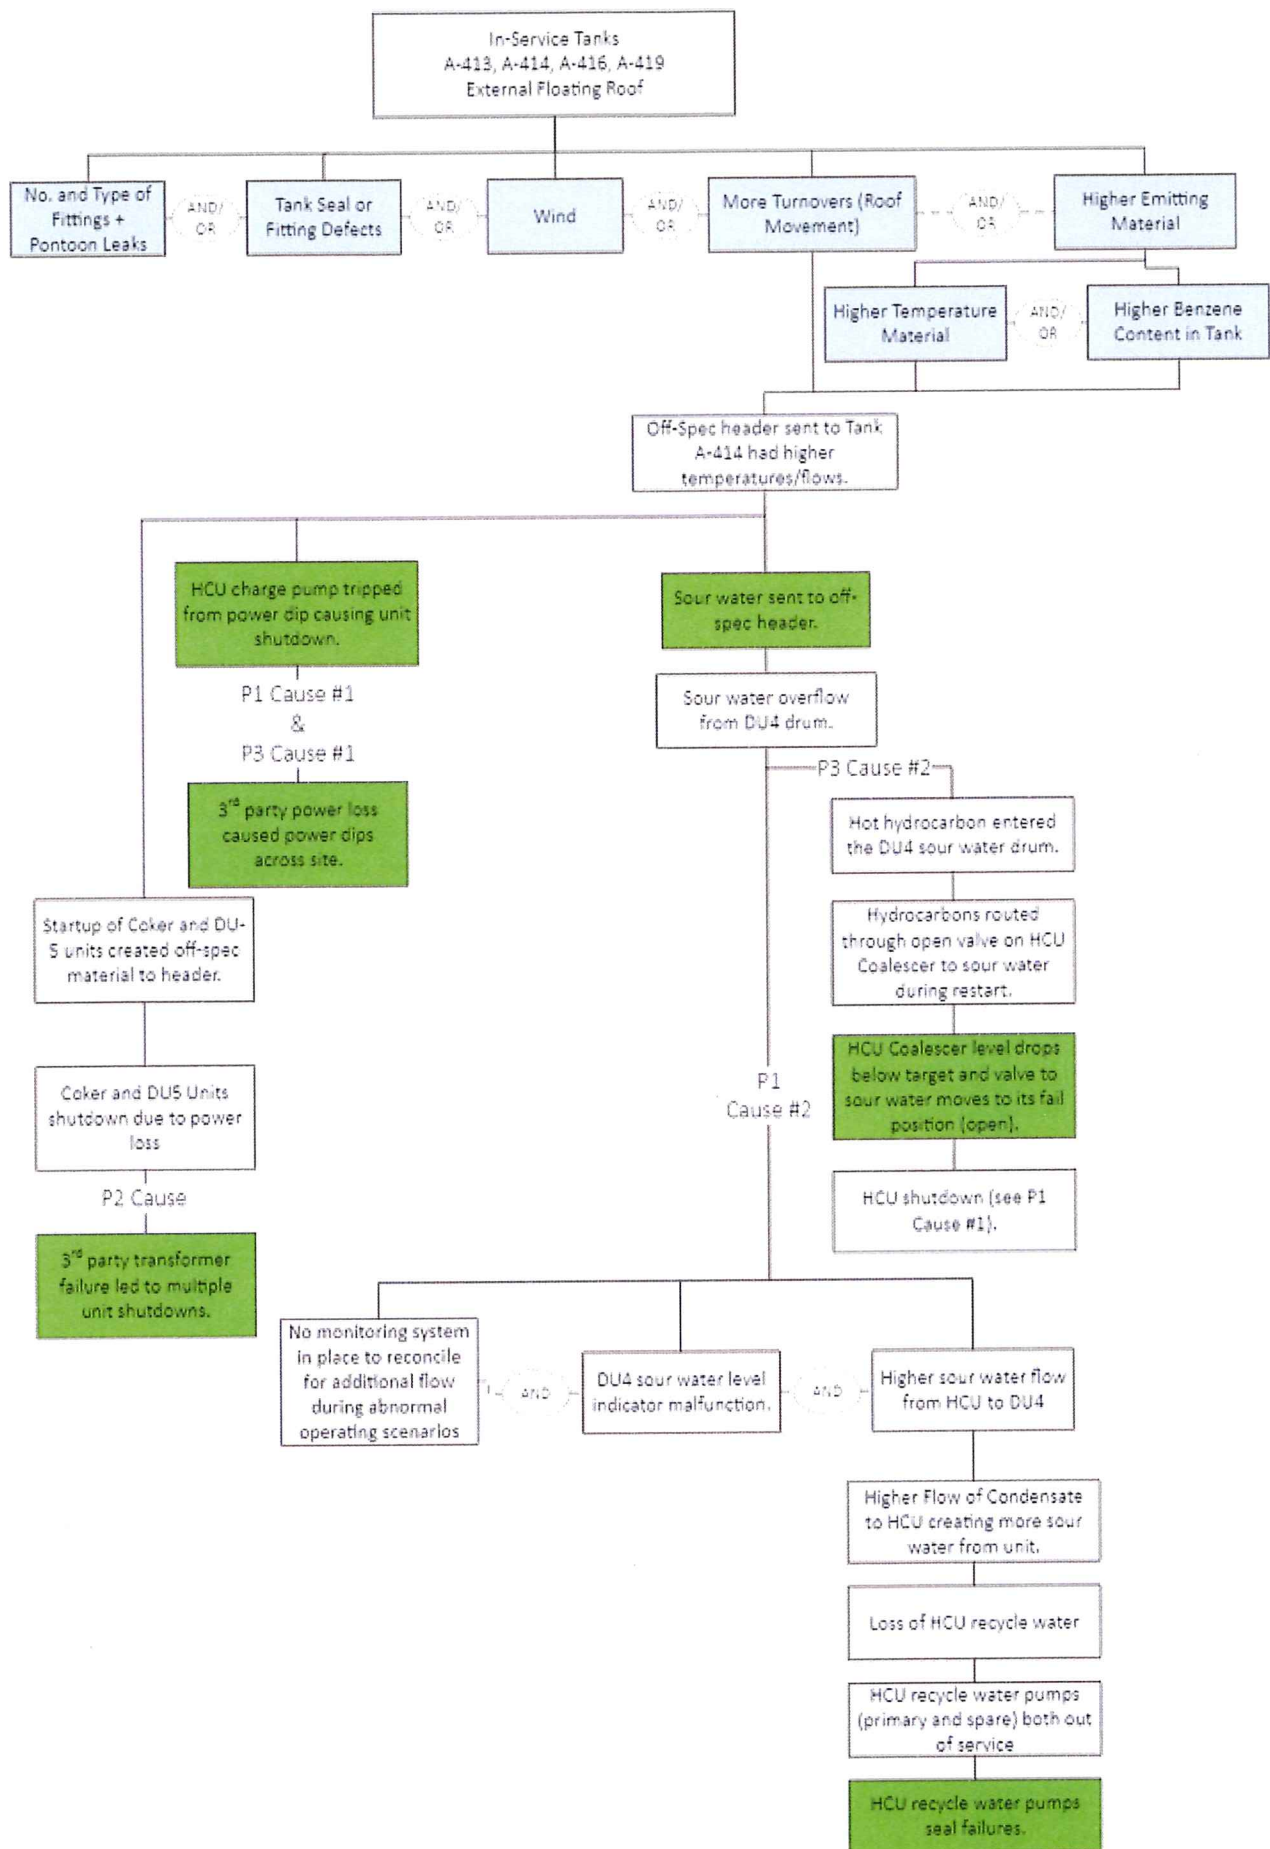
Figure IV-8: Cause Tree Analysis

The Cause Tree below in Figure IV-8 depicts the root cause(s) identified for this period. The green boxes represent a root cause that was directly addressed with a corrective action identified in Table IV-2. Note that not every cause must be addressed to break the tree and prevent recurrence. Specific causes were chosen to address with actions as marked in the green boxes on the tree.

Table IV-2: Corrective Actions		
Corrective Actions	Completion Date	Comments
Sample Period: 8/17/22- 8/31/22		
Identify any and all activities which took place in the affected area during this time.	9/14/22	Tank A-415 turnaround activities occurred during this period.
Identify any process abnormalities as potential contributing factors to the elevated readings on the #8 eGC and the fenceline monitors (B-05 and R-04).	9/20/22	HCU shutdown unexpectedly on 8/20 due to a power dip from a 3 rd party provider resulting in routing of material into Tank A-414
HCU 2 nd Stage was restarted following power dip	8/22/22	The routing of off spec material to tank A-414 ceased
Return the HCU recycle water pumps to service	8/25/22	The Sour water was routed back into the slop system away from tank A-414
Sample Period: 8/31/22 – 9/14/22		
Identify any and all activities which took place in the affected area during this time.	9/14/22	Tank A-415 turnaround activities occurred during this period. Work activities in this area include contractor vehicles, hoses, and a fuel storage vessel used for tank cleaning.

Identify any process abnormalities as potential contributing factors to the elevated readings on the #8 eGC and the fenceline monitors (B-05 and R-04).	9/3/22	Unplanned shutdown of DU5 and Coker Units due to a loss of energy from 3 rd Party Supplier on 9/3/22
Make repairs to the damaged cable and perform equipment testing on the transformer prior to startup	9/5/22	3 rd Party and Shell personnel responded immediately to the incident; repairs were made to the damaged equipment and the units were able to restart shortly thereafter.
Remove all equipment near the substation fencing that could provide access to the substation by wildlife.	9/5/22	The 3 rd party removed all equipment in that area and is in the process of adding more signage to make onsite personnel aware that parking of vehicles or storing of equipment in those areas are not allowed
DU5 Unit was restarted following loss of energy	9/6/22	The routing of off spec material to tank A-414 ceased

Corrective Actions	Completion Date	Comments
Identify any process abnormalities as potential contributing factors to the elevated readings on the #8 eGC and the fenceline monitor (B-05).	10/11/22	Site experienced loss of power from 3 rd party supplier on 9/28 resulting in the HCU to shut down
3rd party utility supplier inspected their equipment trips, made repairs, cleared the failed shield wire and restored normal electrical power to the site	9/29/22	
HCU was restarted following power dip	9/29/22	The routing of off spec material to tank A-414 ceased
Review tank integrity inspection reports for deficiencies	10/11/22	No deficiencies were noted, no changes in fittings, no pontoon leaks detected. Field walks with FLIR, LSAR probes and TIGER confirmed results
Deploy additional eGC monitor near Fenceline monitor B-05	10/12/22	
Utilize monitoring devices for VOC and Benzene detection	10/18/22 - 10/21/22	LDAR monitoring data did not note any leaks on or around the vicinity of the monitor. Drone flyovers did not note any leaks near the monitor
