# Independent Engineering Report Costa Sur Steam Plant

**Puerto Rico Electric Power Authority**

**Report SL-015976.CS**

**October 8, 2021**

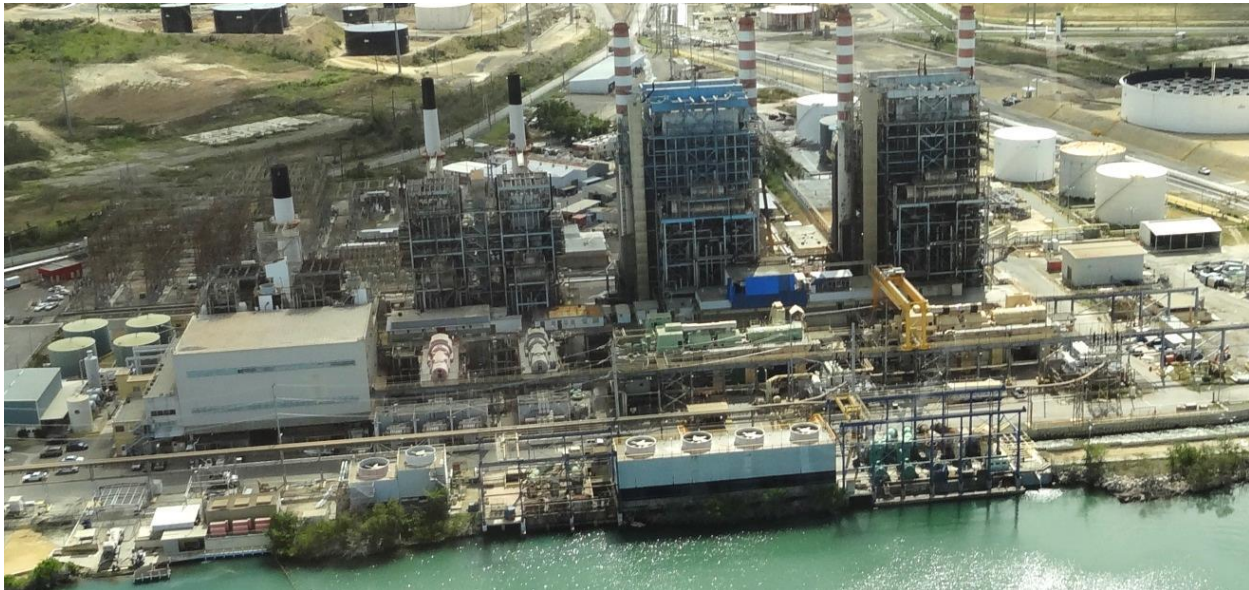
**Figure 1-3 — Costa Sur Steam Plant**

Looking east. Units 1, 2, 3 and 4 are left of center and non-operational.  
Units 5 and 6 are right of center, each with two stacks.

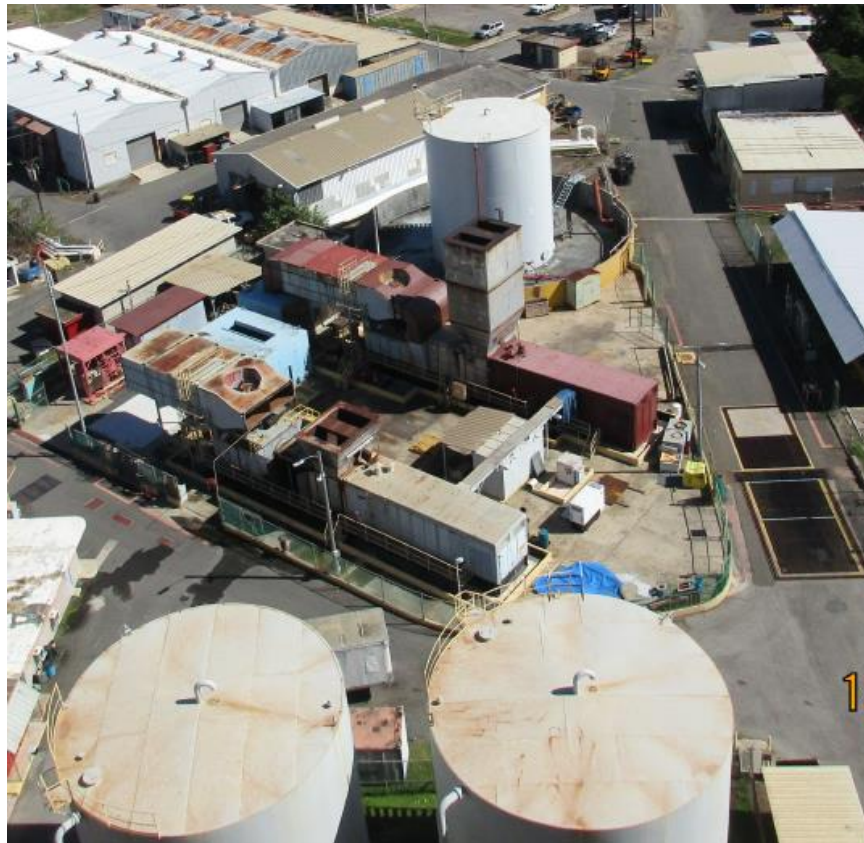
**Figure 3-1 — Black Start Gas Turbines**

Both GTs are #2 diesel-fueled and both are currently out of service but being repaired.

PREPA is considering the replacement of these GTs with two new approximately 30 MW black start GT generators. Each GT would be able to operate on natural gas or No. 2 fuel oil and would be designed for peaking operation or black start of the Costa Sur facility.

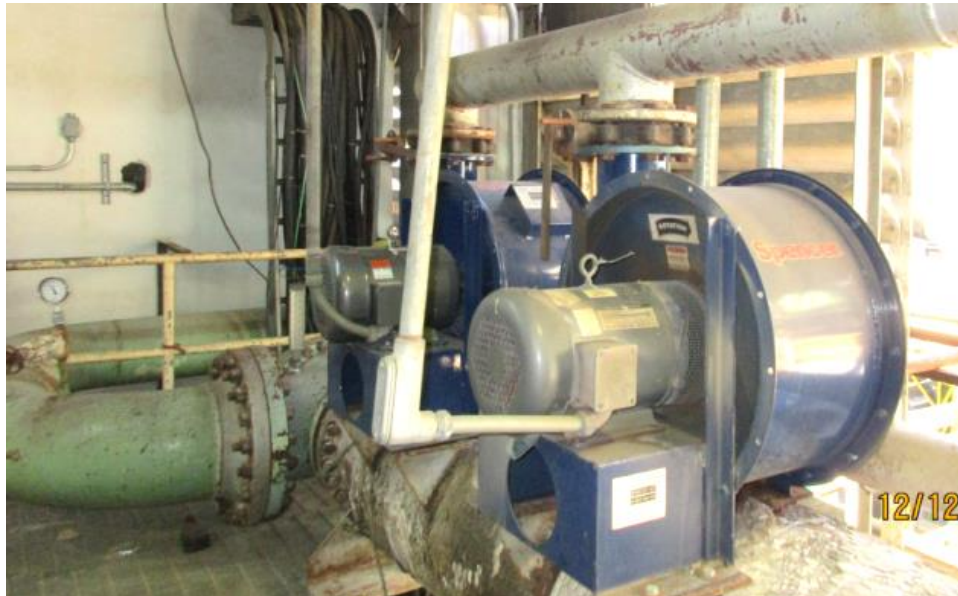
**Figure 3-2 — Gland Steam Exhauster Blowers**

Components are repaired or replaced on Units 5 and 6 and in the facility as needed. For example, Figure 3-2 shows a pair of recently installed blowers for the Unit 5 Gland steam exhausters. Pipe supports are a common system requiring attention.

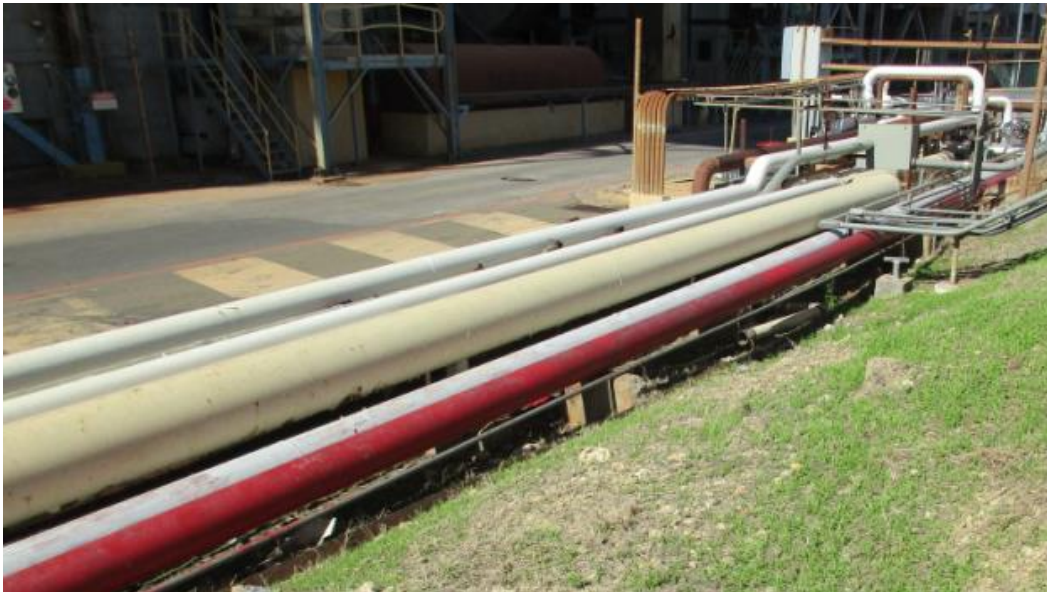
**Figure 3-3 — Vegetation Management Example**

Vegetation is trimmed and sprayed monthly by an outside contractor and is under control.

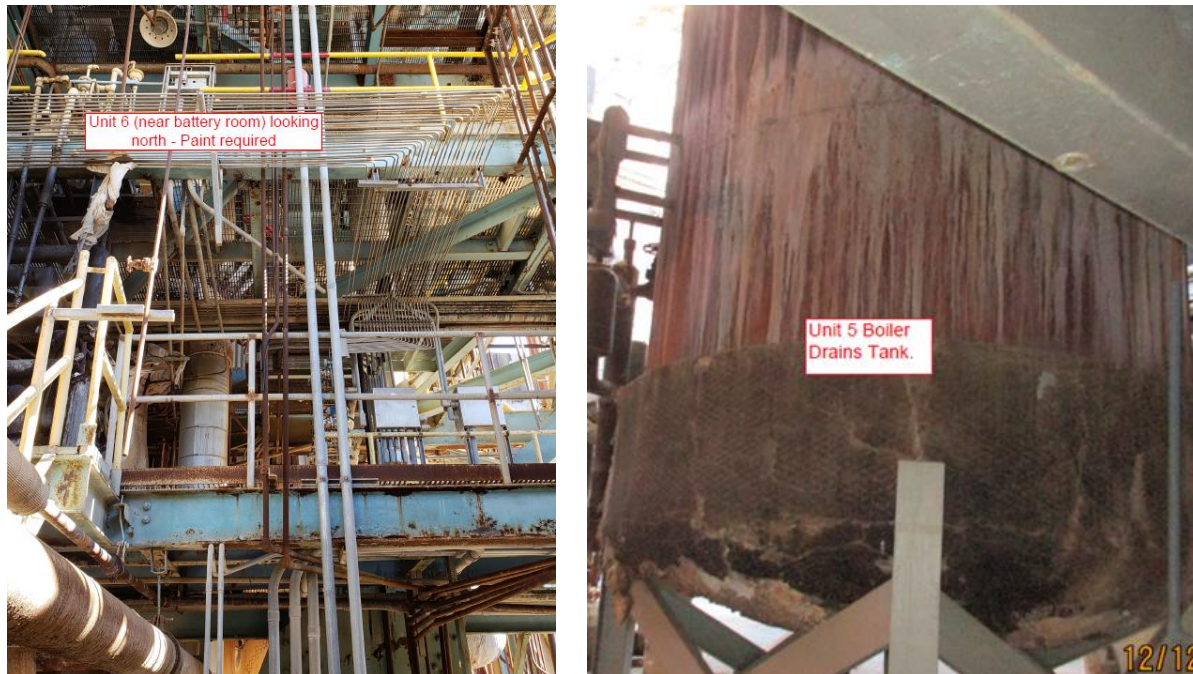
**Figure 3-4 — Corrosion Examples, Units 5 and 6**

The structural steel on Units 5 and 6 is only partially painted. The Unit 6 boiler was scheduled to be painted along with its stack but it's unclear if and when this would occur. New stack insulation was also planned to be installed. The stack ladders on Units 5 and 6 were replaced in the summer of 2018.

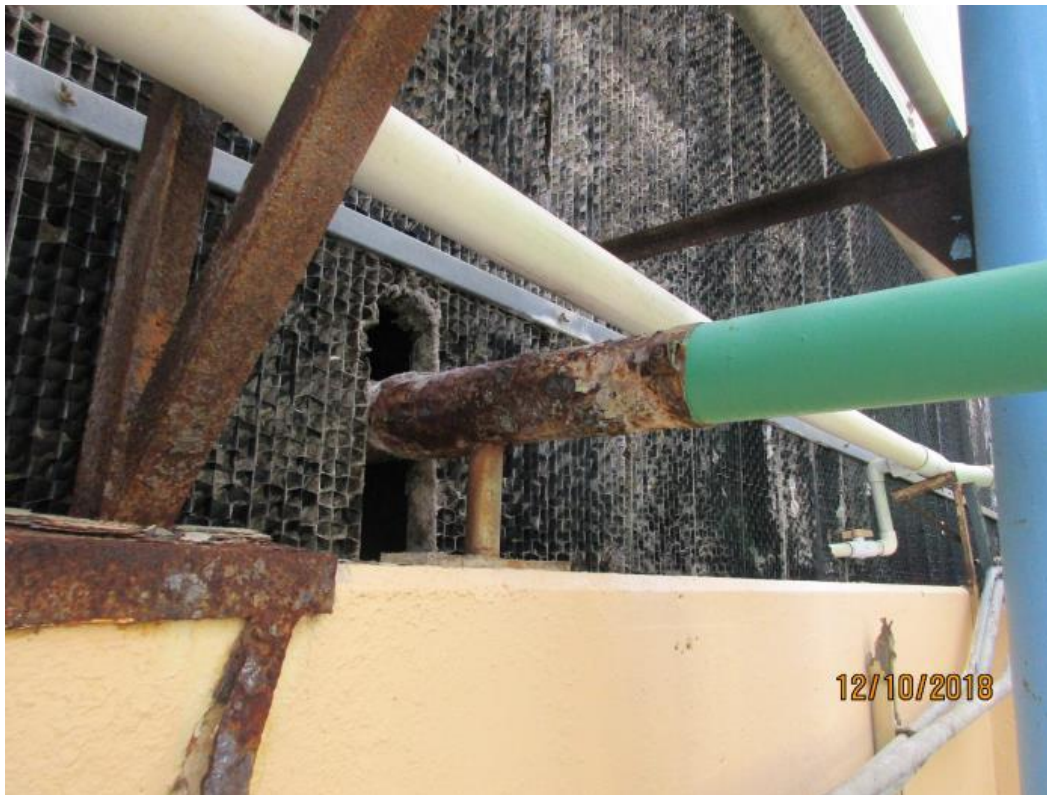
**Figure 3-5 — Cooling Tower Corrosion, Units 5 and 6**

The closed cooling water system is in good operating condition but has some corrosion and scaling. The system had some earlier chemistry issues since phosphate and some other chemicals were banned from use in the 1990s, and it had some recent issues after the water chemistry contractor went out of business. The chemical feed supply and implementation is now administered by GE-SUEZ, a private contractor.

The Plant will backwash the fill to remove the scaling.

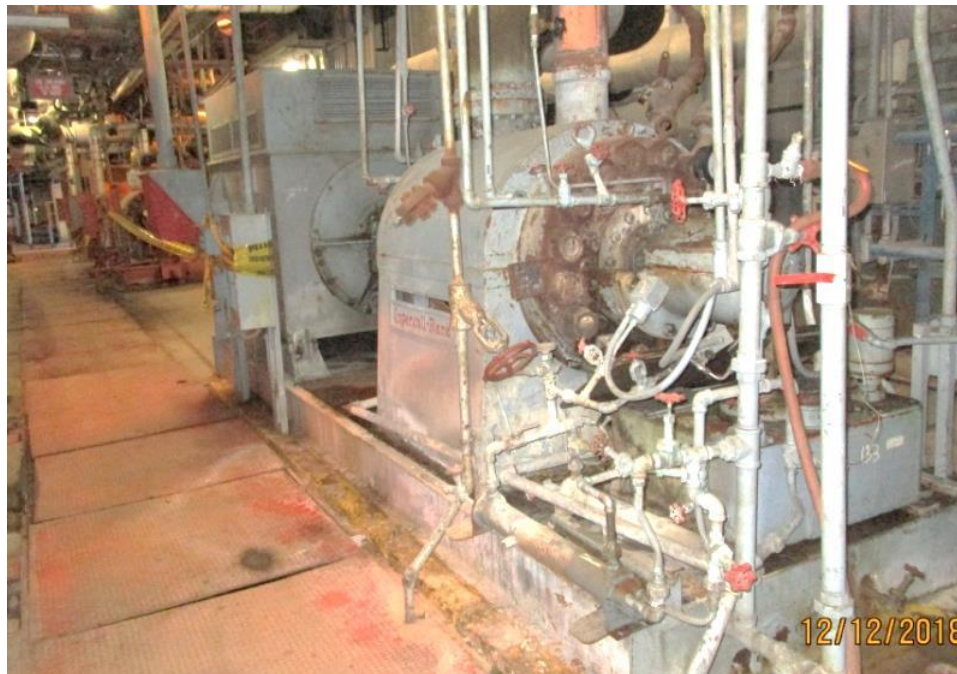
**Figure 3-6 — Unit 4 BFP 4-1**

An important consideration in deciding a path forward for Units 3 and 4 is that the Plant uses Unit 4 BFP 4-1 when starting Units 5 and 6. The motor-driven BFPs on Units 5 and 6 can be used for startup, but the Unit 4 BFP has a reduced pressure surge when starting, lessening the negative impact on the feedwater heaters and the feedwater control valves. BFP 4-2 is out of service with a two-year lead time on its electrically isolated bearings. It is not practical to use the Unit 3 BFPs for starting Units 5 and 6. The Unit 3 BFPs, shown in the background of Figure 3-6, are not identical to Unit 4's BFPs and therefore are not practical to swap out because of different balancing drum piping configurations and water sources. However, the Plant is installing piping to allow demineralized water from Units 3 and 4 to become a backup source for Units 5 and 6.
