SEISMIC ASSESSMENT REPORT

School Seismic Safety Assessments Project

June 2019

SEISMIC ASSESSMENT REPORT VOLUME 1 of 4

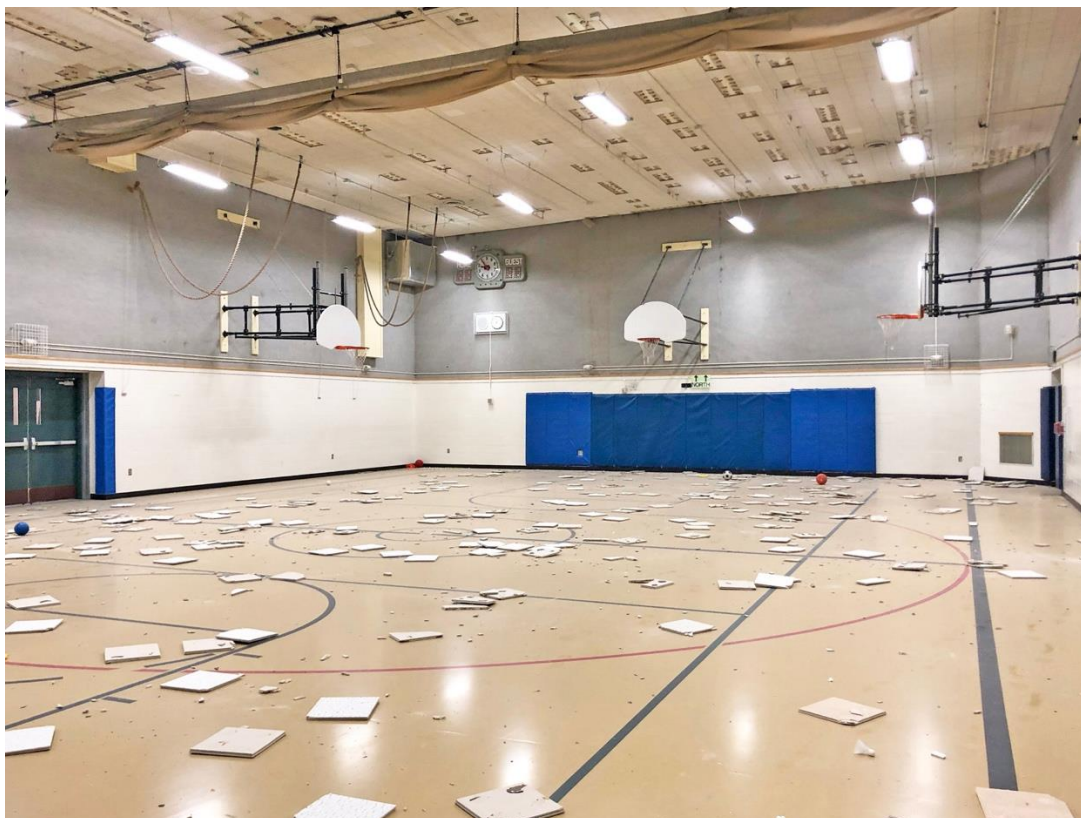
Figure 2.2-1. Nonstructural Ceiling Tile Earthquake Damage to an Elementary School in Eagle River, Alaska, from the 2018 M7.0 Anchorage Earthquake (Photo by Reid Middleton, Inc.).

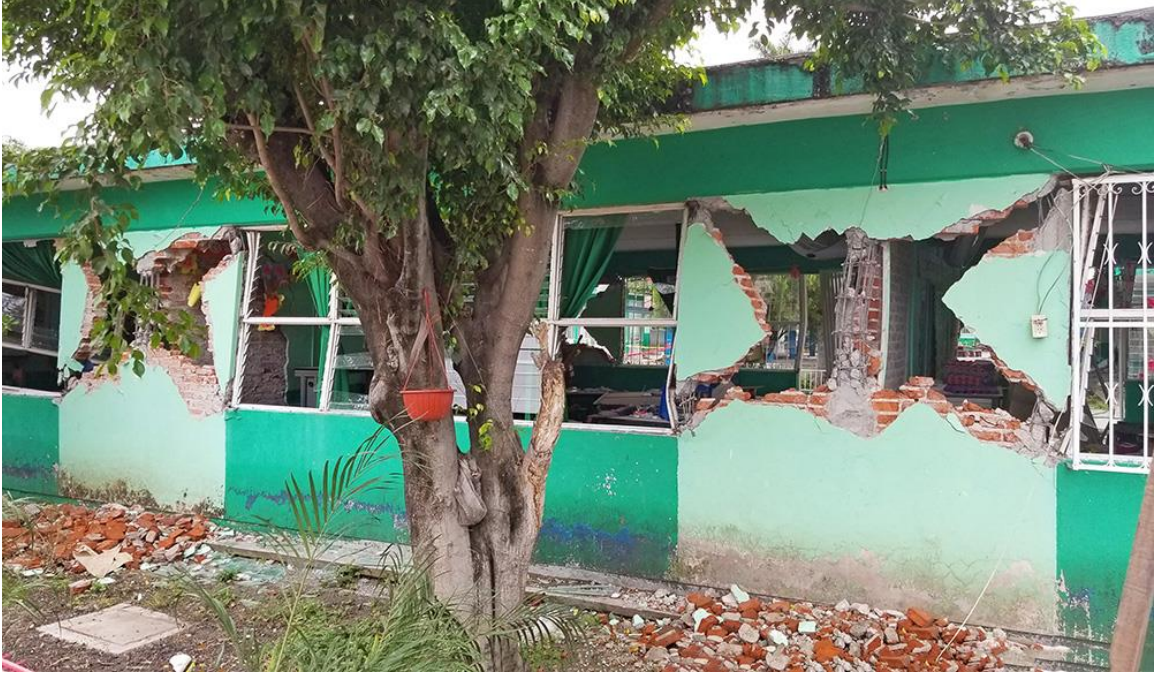
Figure 3.1.3-1. Structural Earthquake Damage to a Primary School in Central Mexico from the 2017 M7.1 Central Mexico Earthquake (Photo by Reid Middleton).

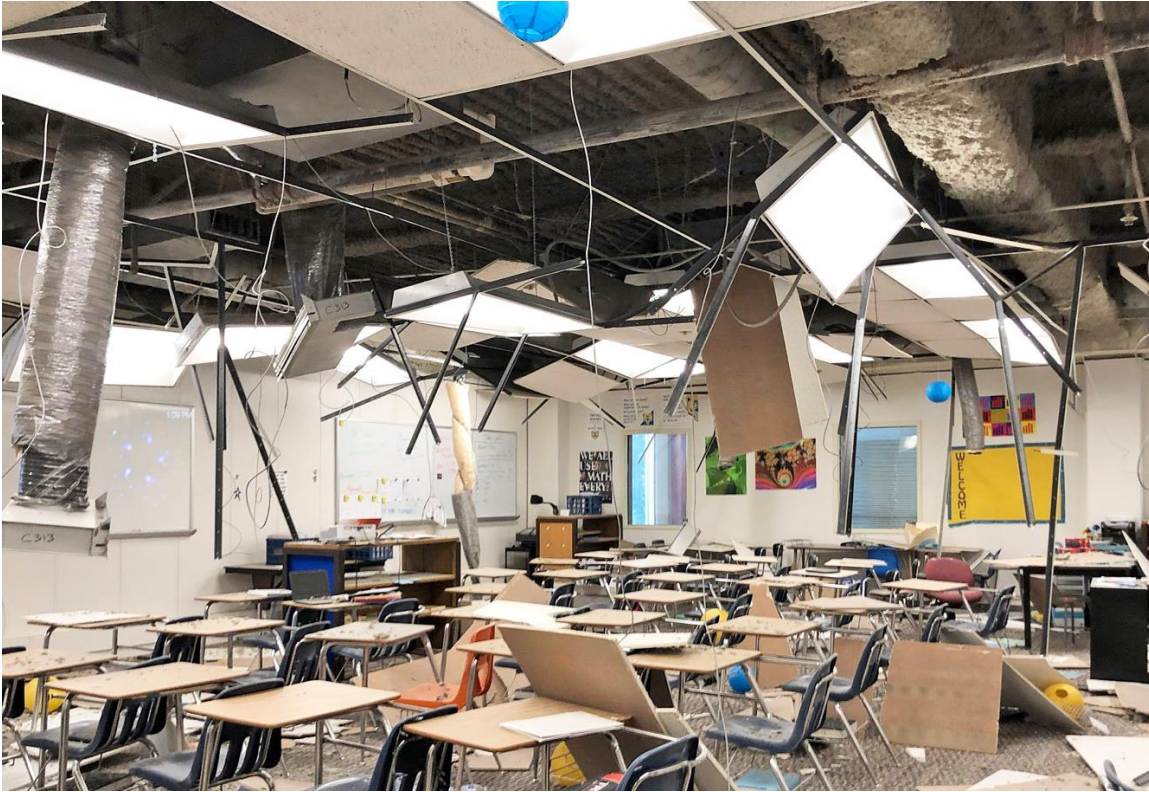
Figure 3.1.5-1. Nonstructural Earthquake Damage to a High School in Anchorage, Alaska, from the 2018 M7.0 Anchorage Earthquake (Photo by Reid Middleton, Inc.).

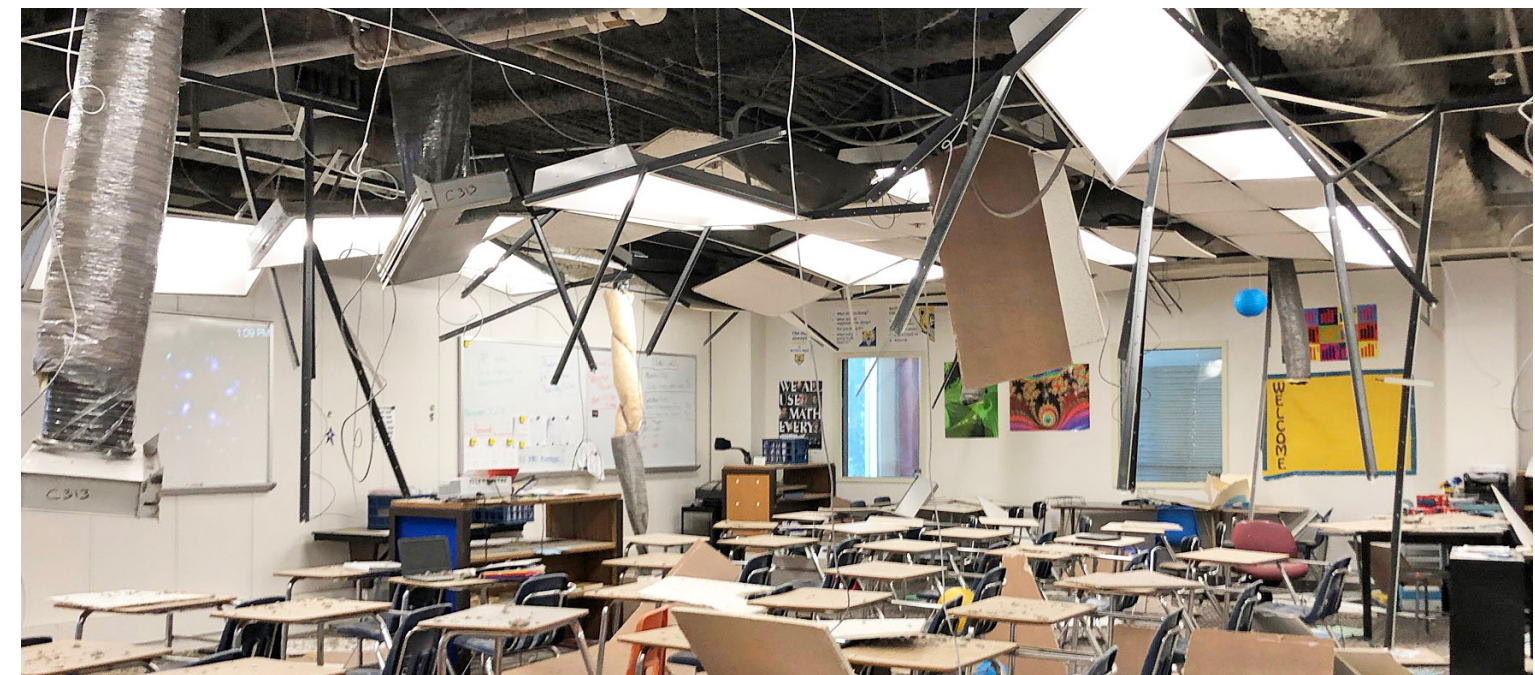
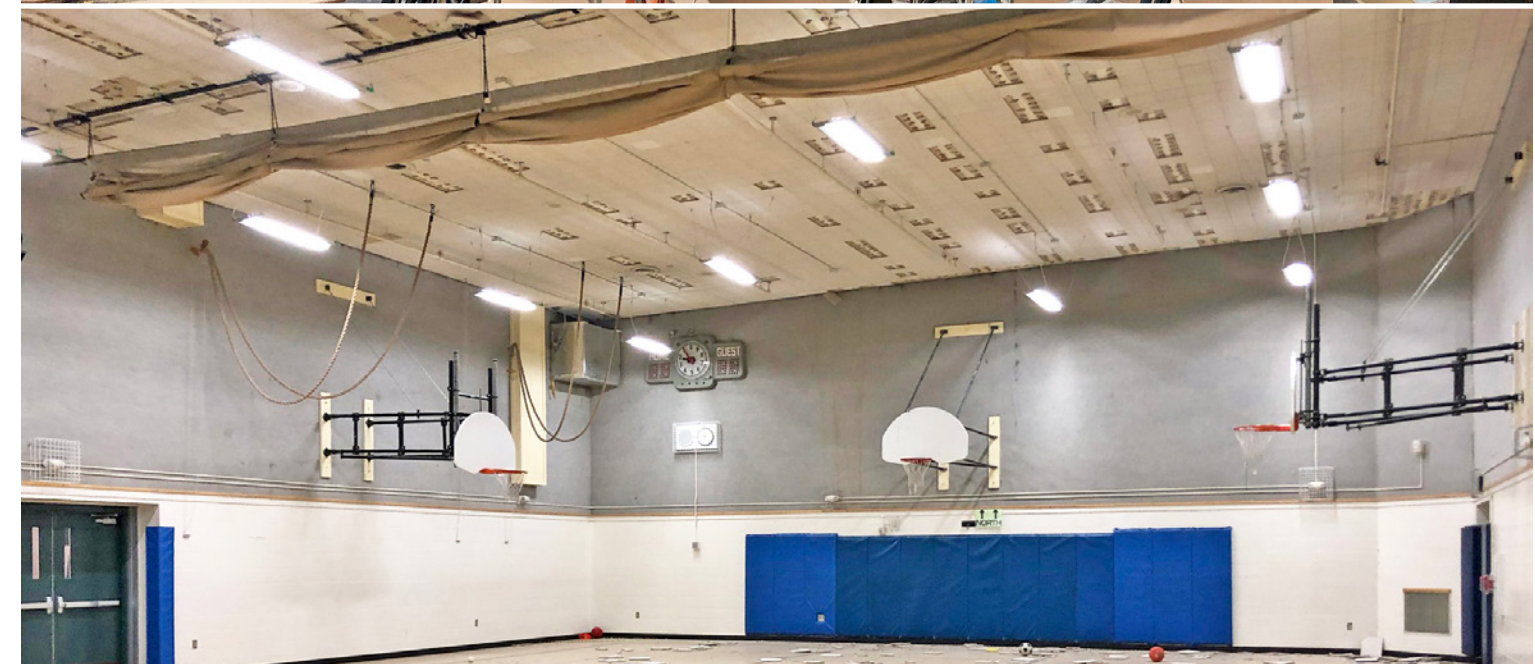
Extensive ceiling system damage in many schools caused falling hazards during and after the earthquake. Credit: David Stierwalt, Reid Middleton, Inc.

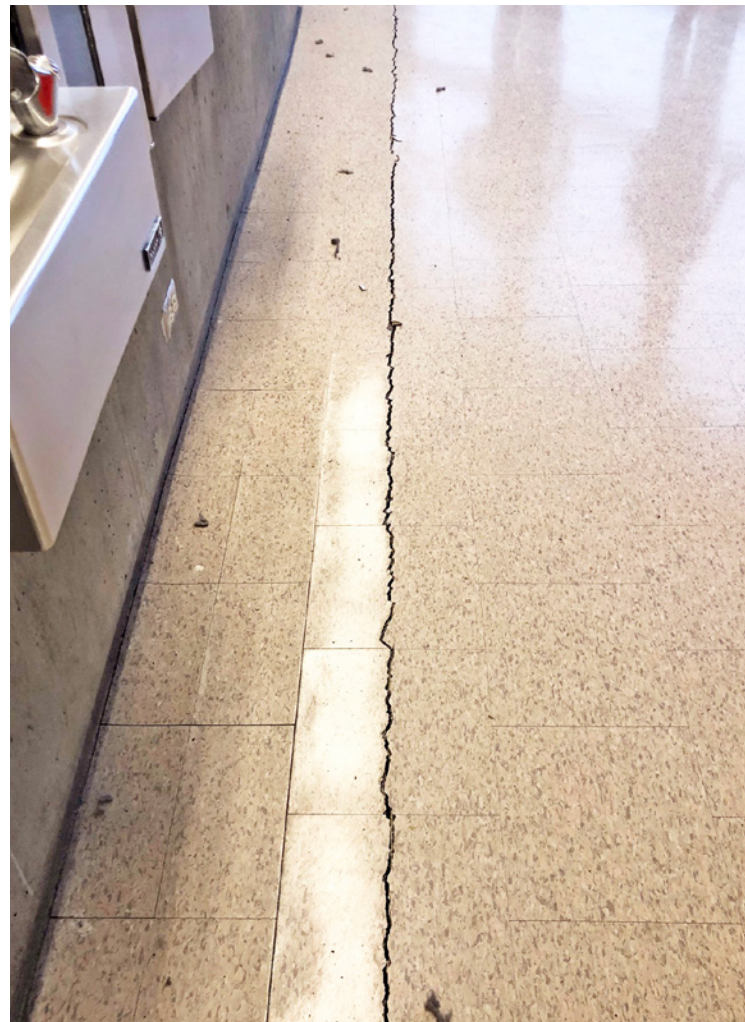
Floor and floor finish cracking. – High School Flooring Crack. Credit: David Stierwalt, Reid Middleton, Inc.

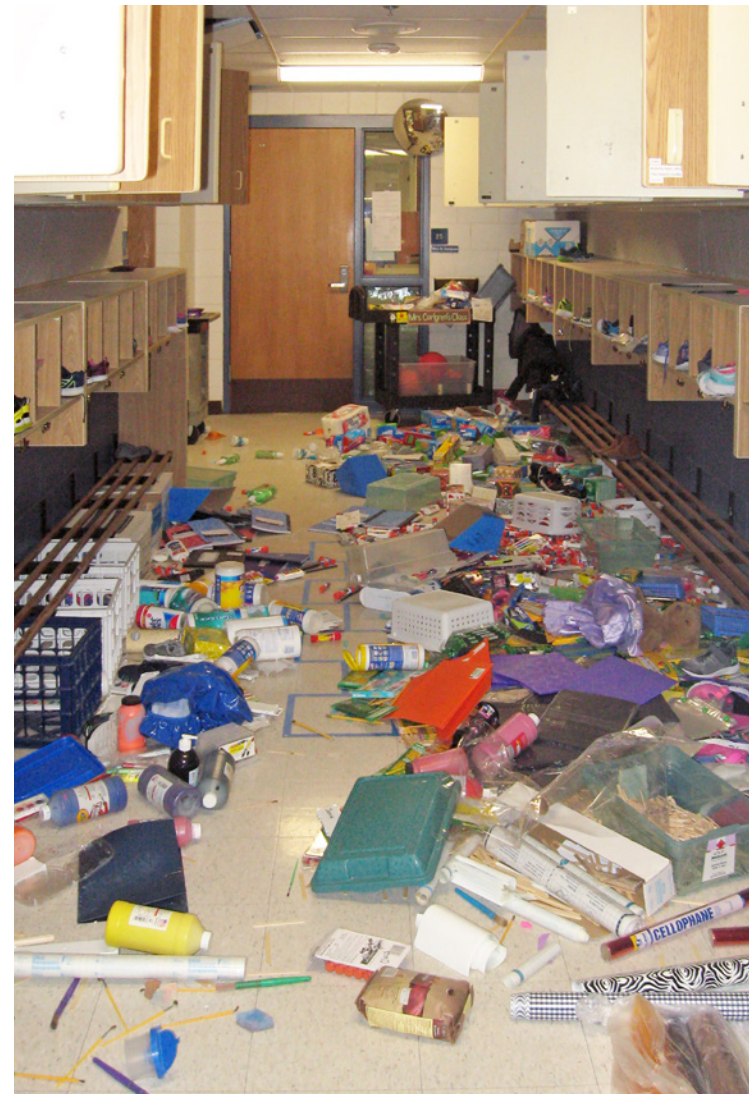
Elementary School Fallen Contents. Credit: David Stierwalt, Reid Middleton, Inc.

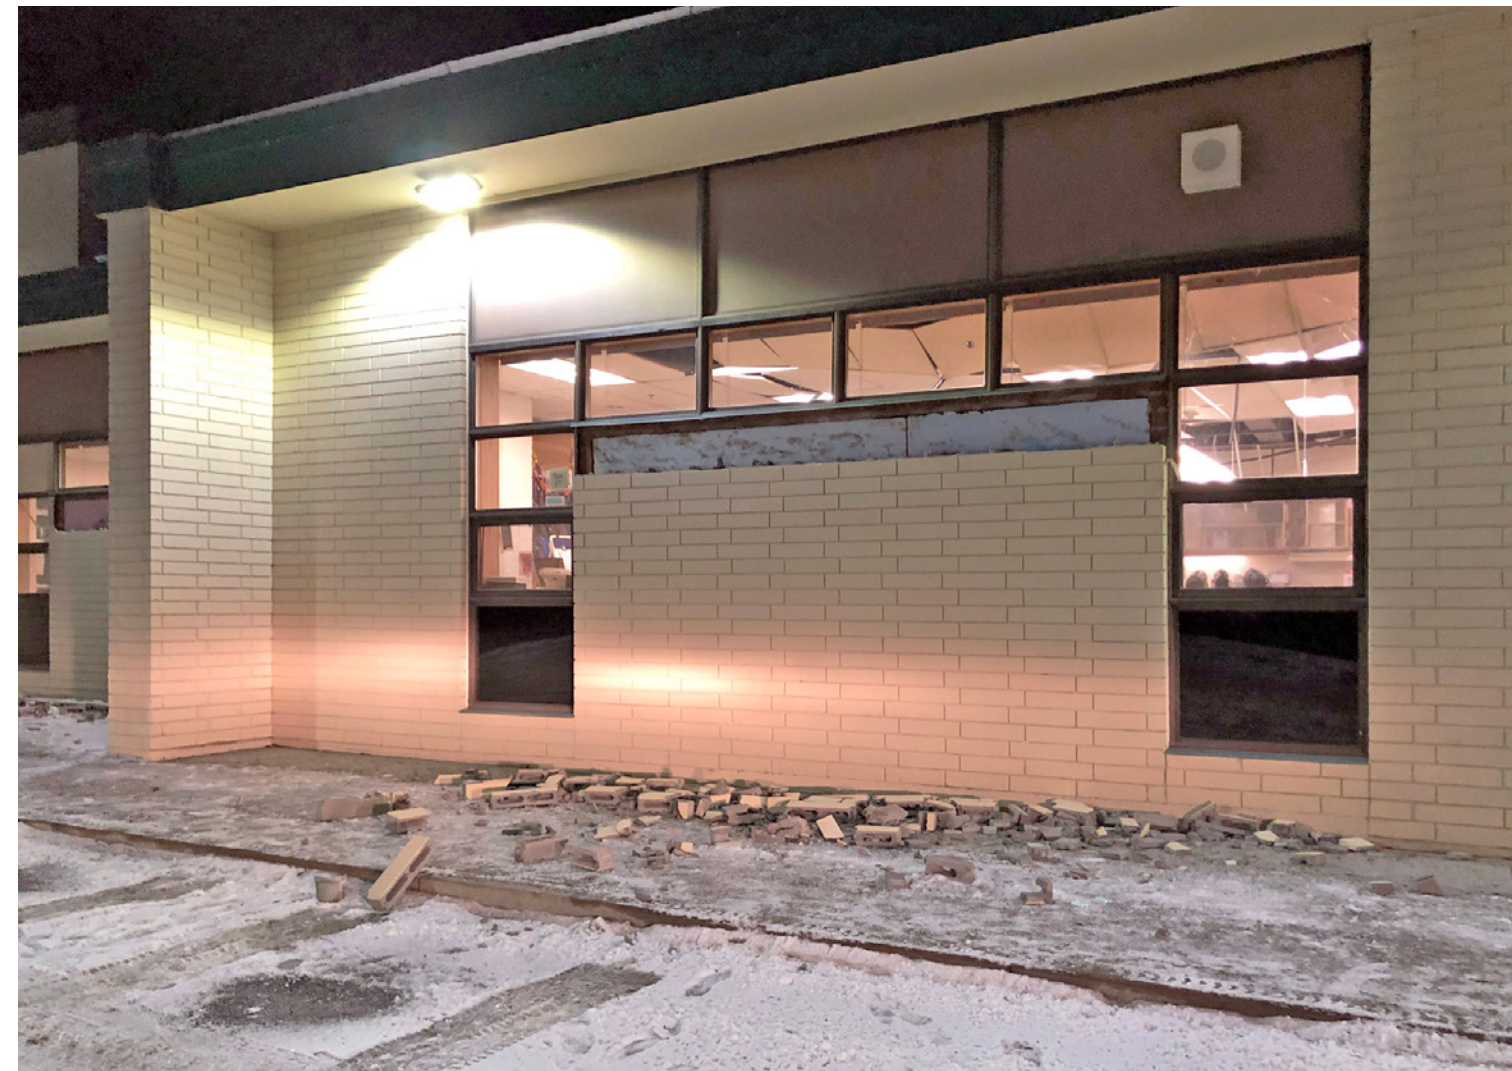
Significant wallboard cracking, brick and masonry veneer damage, window damage, and cladding damage caused falling hazards. – Elementary School Fallen Brick Veneer. Credit: David Stierwalt, Reid Middleton, Inc.

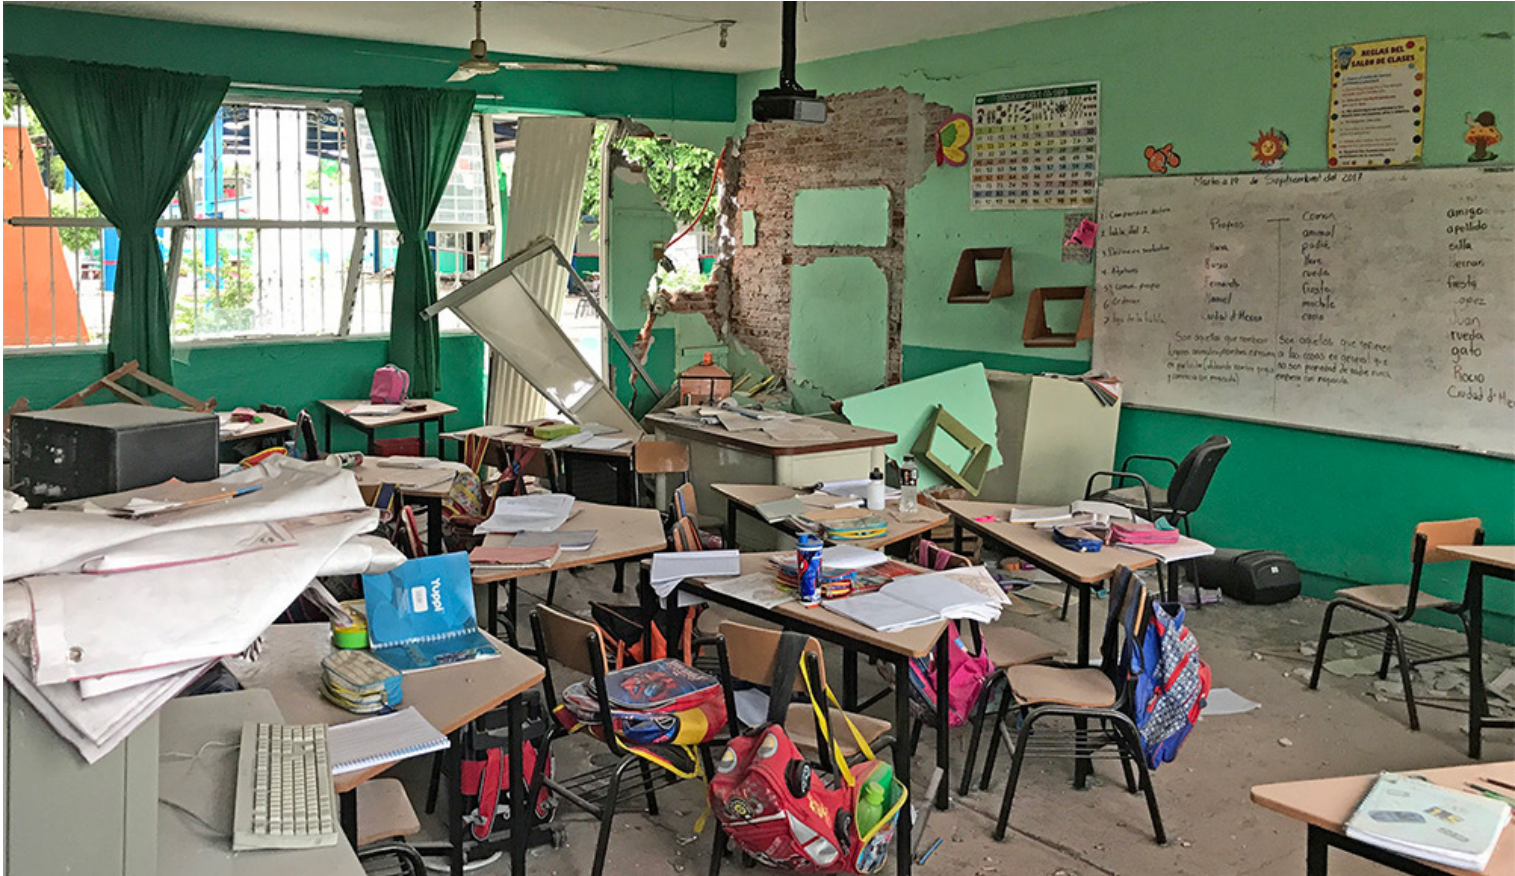
Damaged Primary School in Jojutla. The unreinforced masonry infill walls were damaged. Many Washington state schools are constructed similarly. Credit: Erik Bishop, Reid Middleton, Inc.

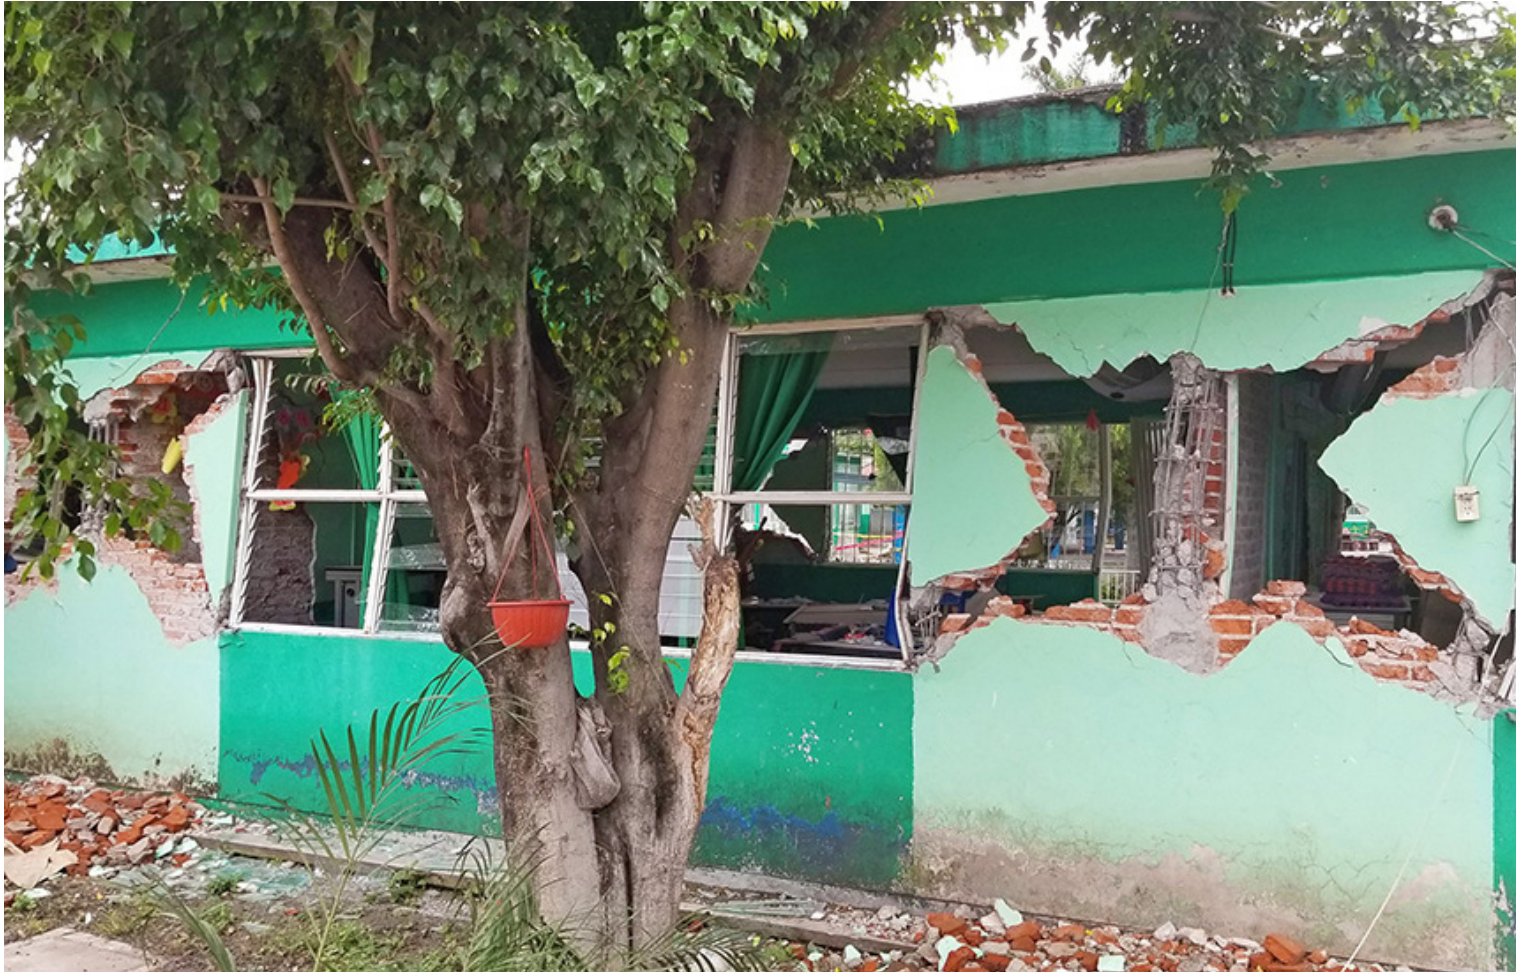
Damaged Primary School in Jojutla. Total failure due to diagonal tension in unreinforced masonry wall. Many Washington state schools are constructed similarly. Credit: Erik Bishop, Reid Middleton, Inc.
