Washington State School Seismic Safety Assessments Project

# SEISMIC UPGRADES CONCEPT DESIGN REPORT

Carbonado Historical School 19  
Carbonado School District 19

## SEISMIC UPGRADES CONCEPT DESIGN REPORT Carbonado Historical School 19 – Community Gym (Bldg B) Carbonado School District 19

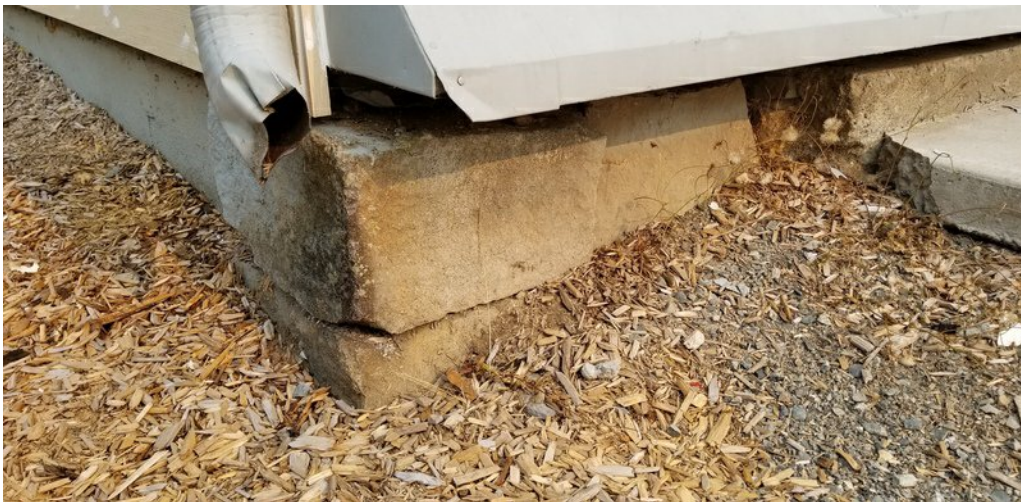
**Figure 1-2. Example of foundation condition (SE corner of building)**

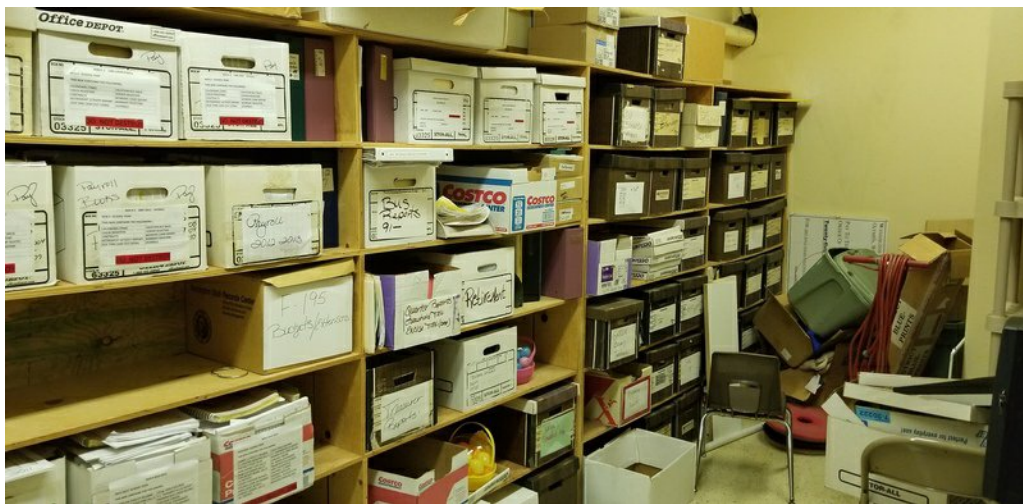
Figure 1-7. Fall prone content and shelving that is not adequately braced

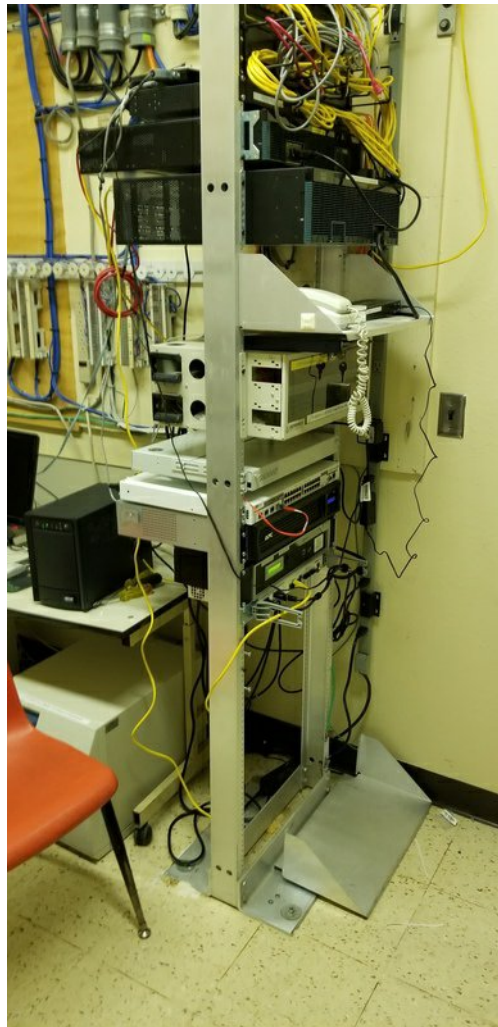
**Figure 1-8. Fall prone content and shelving that is not adequately braced**

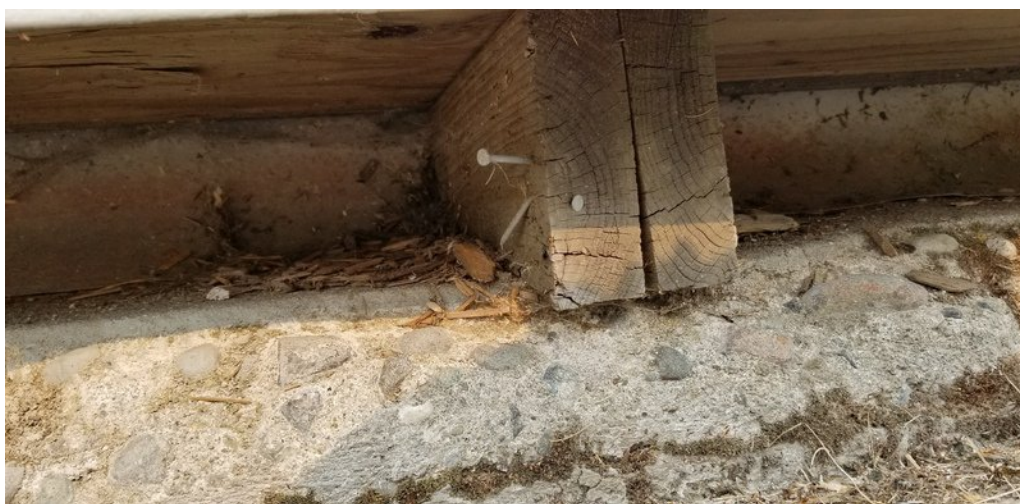
**Figure 1-9. Example of foundations and minor deterioration of concrete**

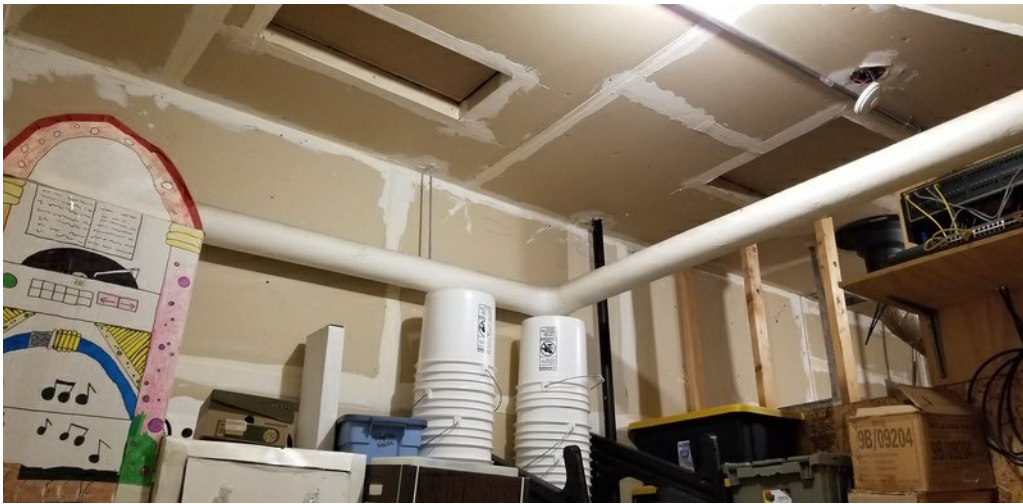
**Figure 1-10. Fall prone items in second floor storage area**
