Washington State School Seismic Safety Assessments Project

SEISMIC UPGRADES CONCEPT DESIGN REPORT

Naches Valley High School
– Main Building
Naches Valley School District 3

June 2019

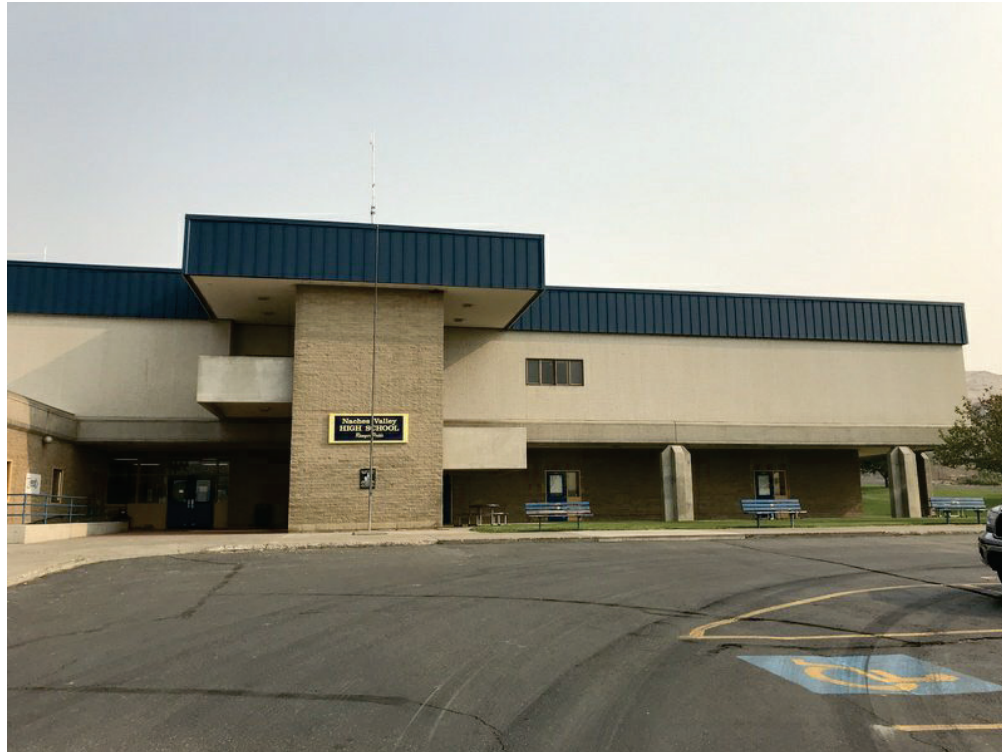
Figure 1-1. Naches Valley HS Classroom Bldg Main Entry

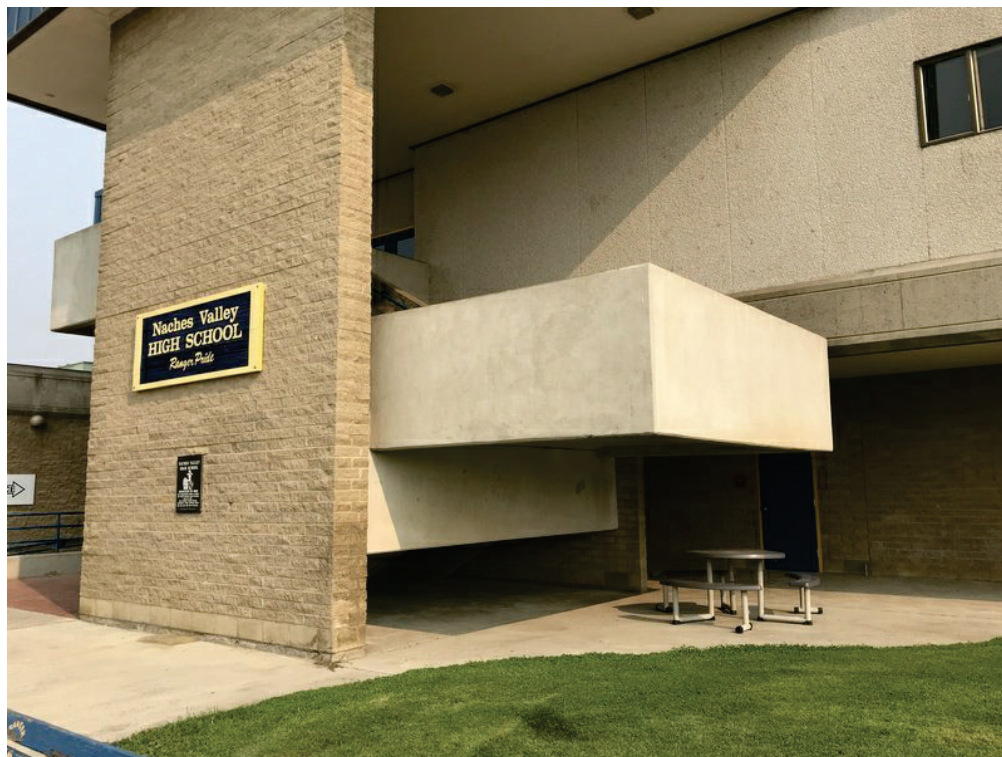
Figure 1-2. Naches Valley HS Classroom Bldg exterior entry stair

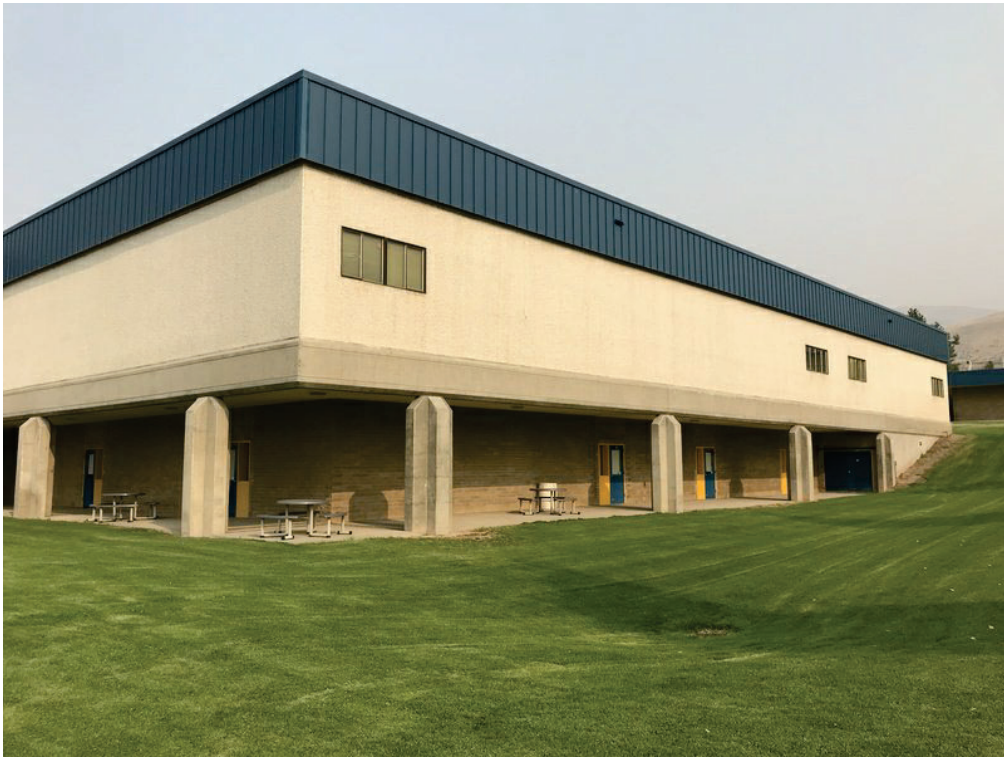
Figure 1-3. Naches Valley HS Classroom Bldg SE corner

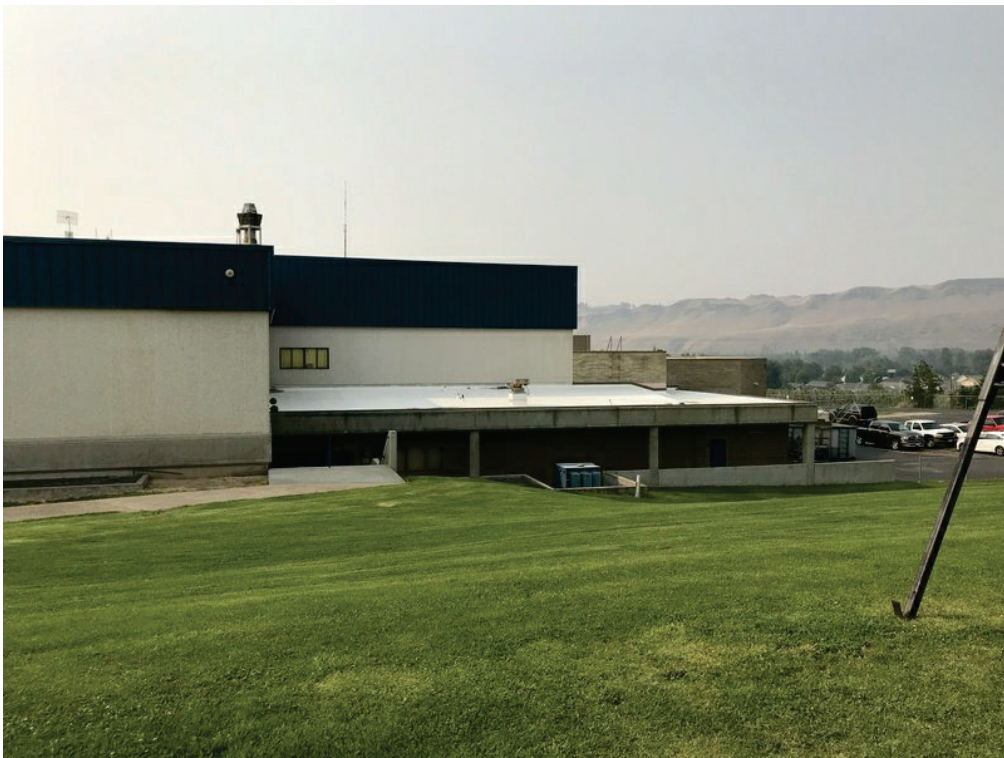
Figure 1-4. Naches Valley HS Classroom Bldg North wall

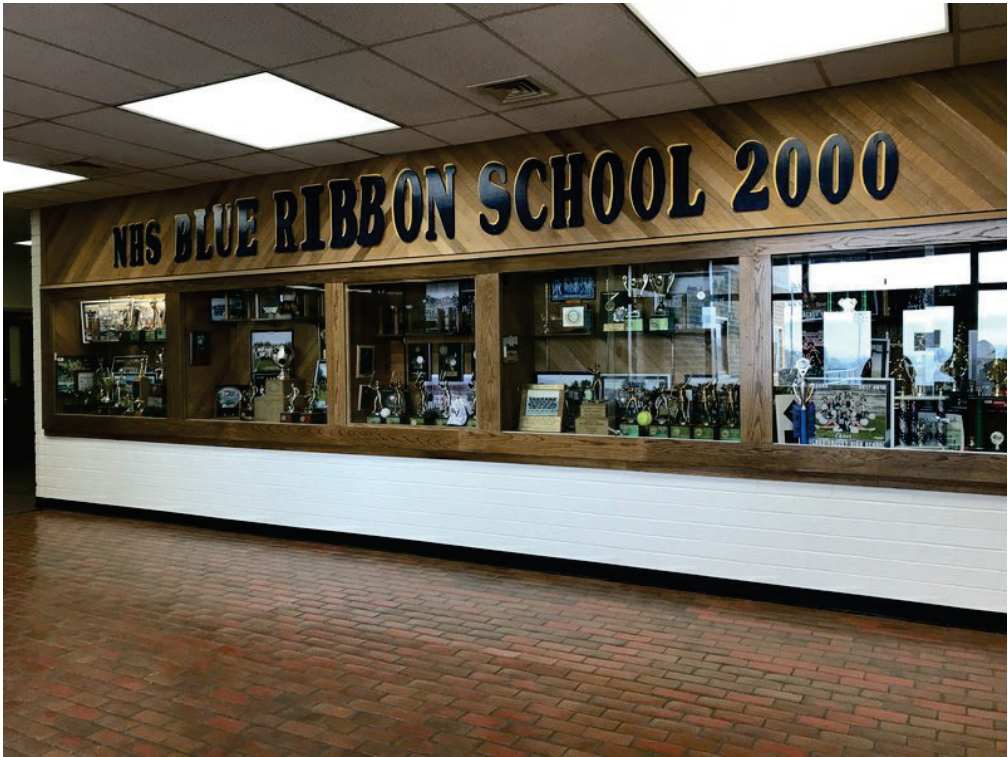
Figure 1-5. Naches Valley HS Classroom Bldg Entry

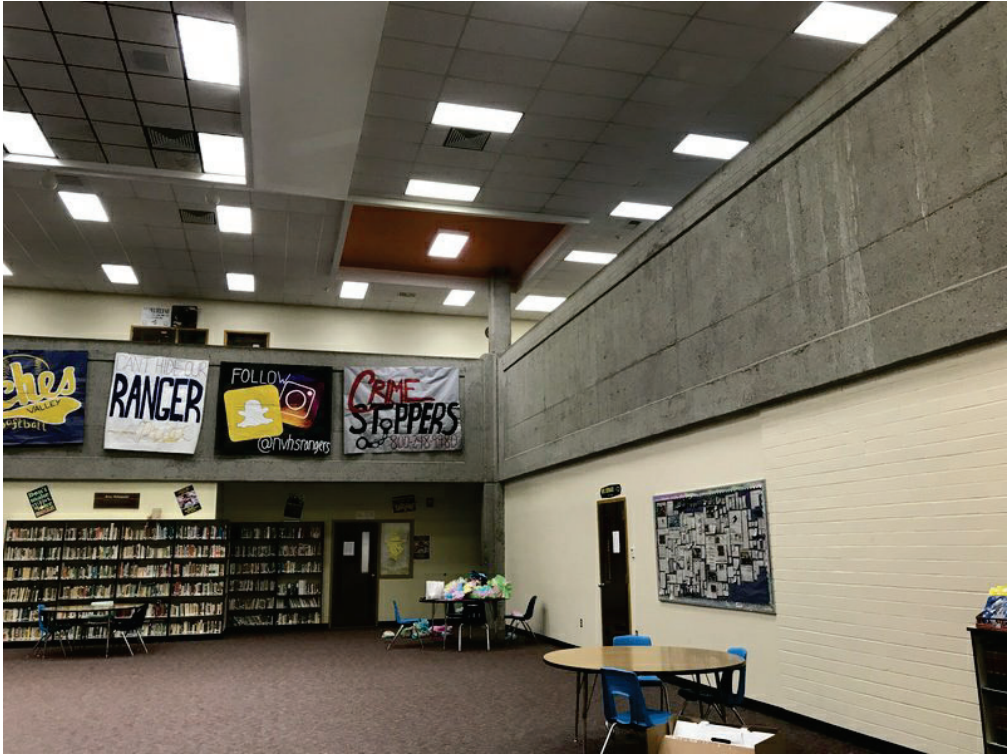
Figure 1-6. Naches Valley HS Classroom Bldg two-story library space

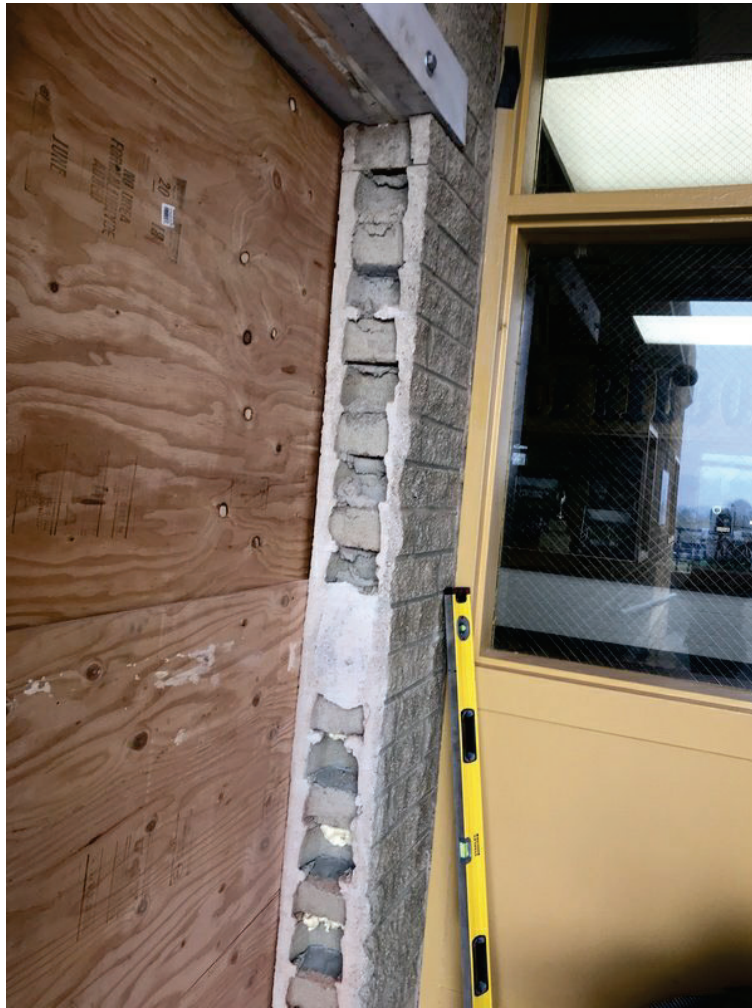
Figure 1-7. Naches Valley HS Classroom Bldg - new door opening exposes wall construction

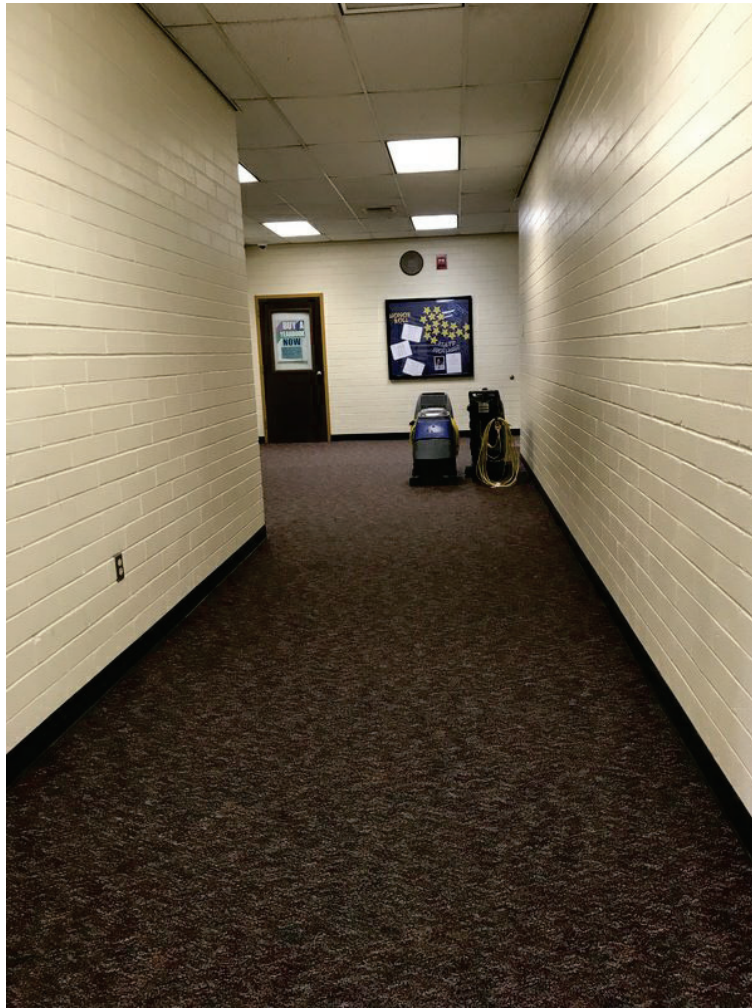
Figure 1-8. Naches Valley HS Classroom Bldg hallway (cmu construction)

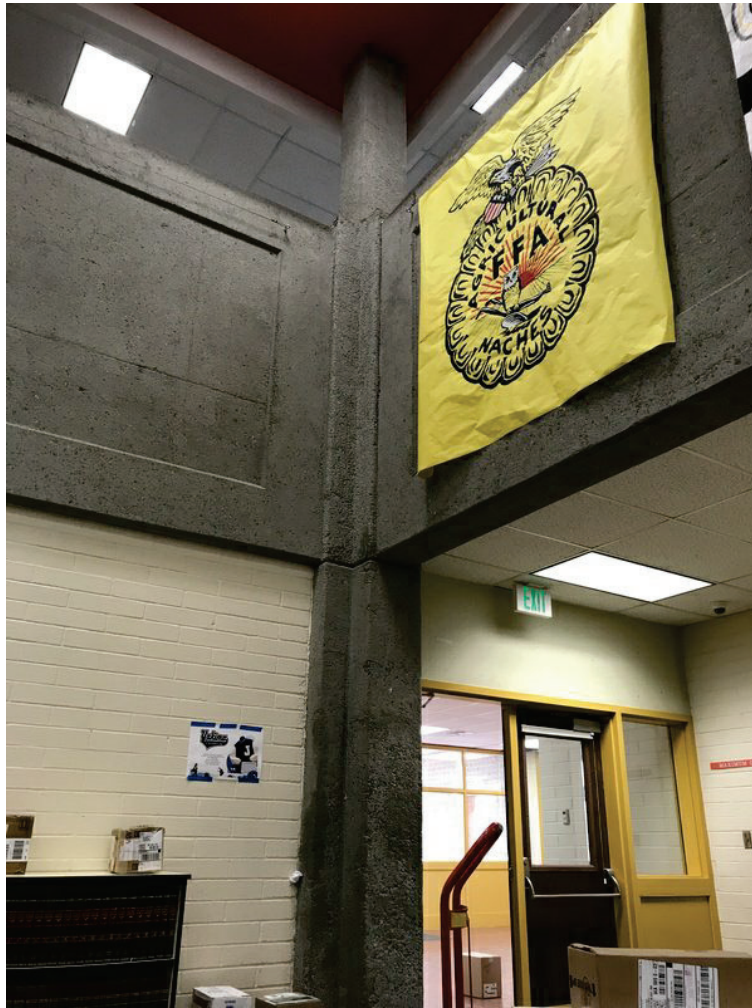
Figure 1-9. Two story construction - concrete beam supported on concrete column

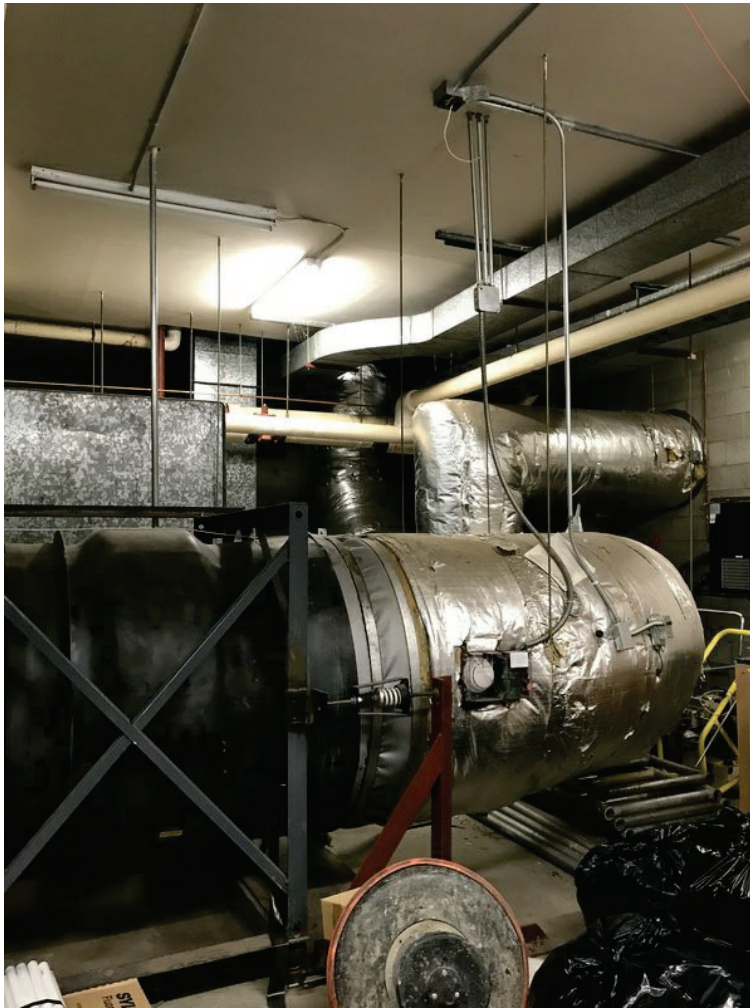
Figure 1-10. Classroom building mechanical space
