SEISMIC UPGRADES CONCEPT DESIGN REPORT

Adams Elementary School
– Main Building
Spokane Public Schools

June 2019

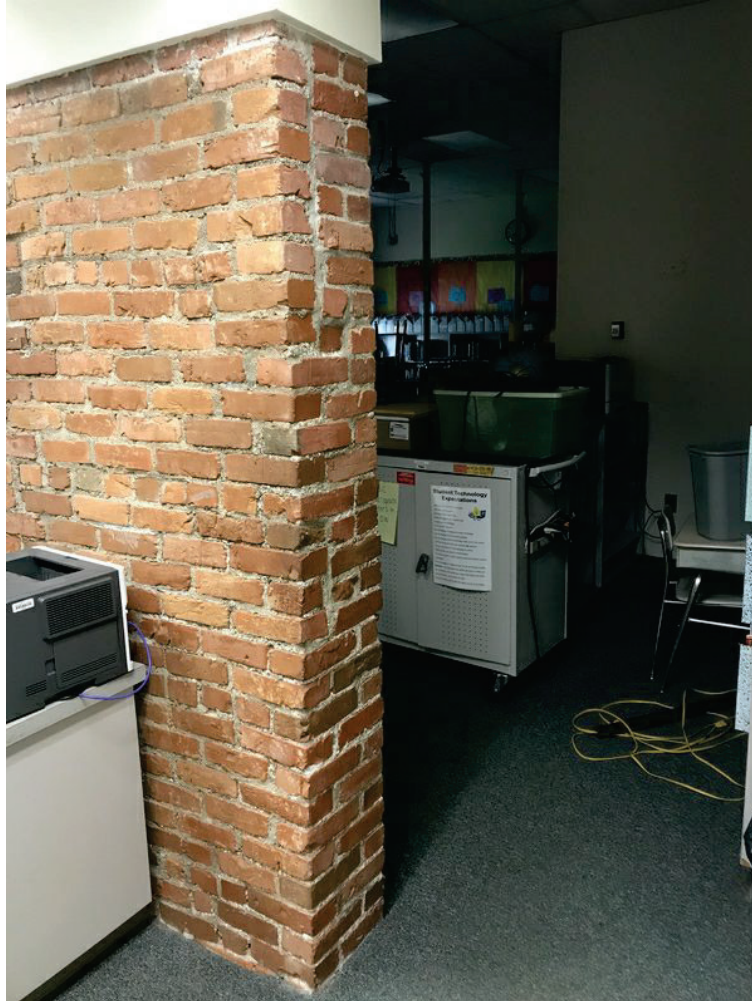
Figure 1-1. Interior exposed URM wall.

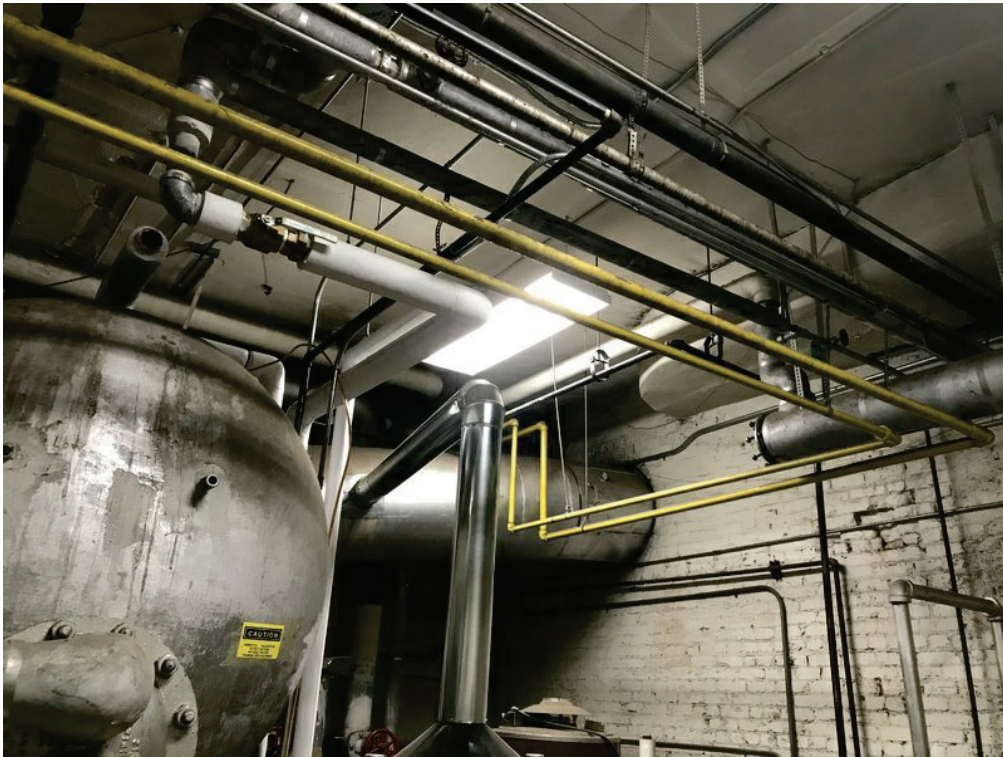
Figure 1-2. Mech Room - gas piping is painted yellow

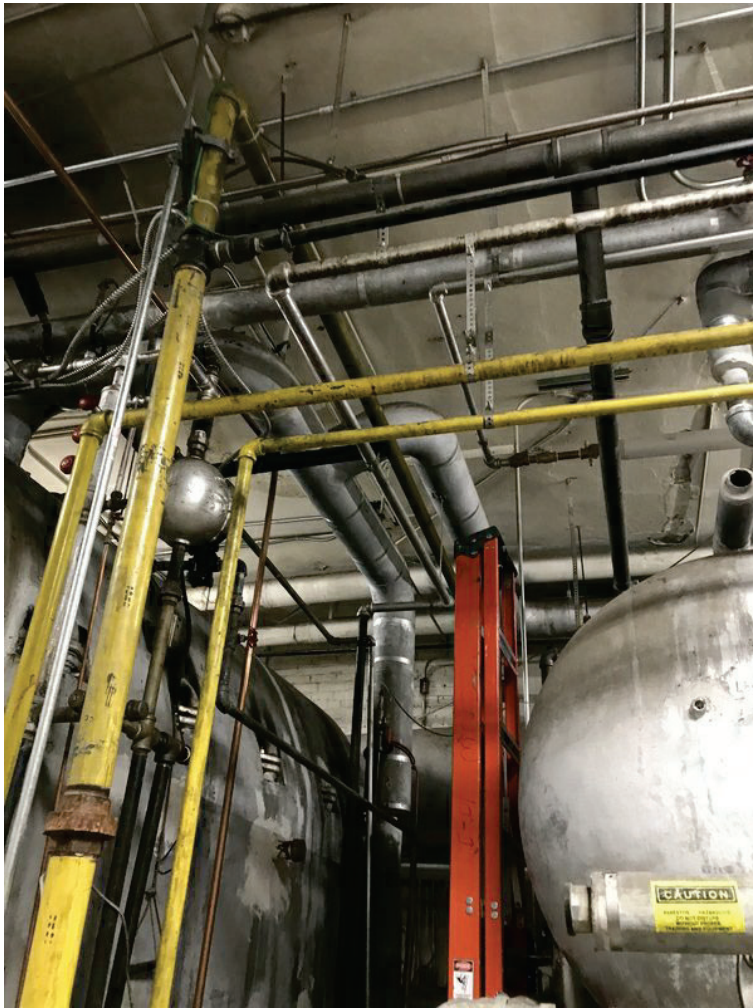
Figure 1-3. Mech Room - gas piping is painted yellow

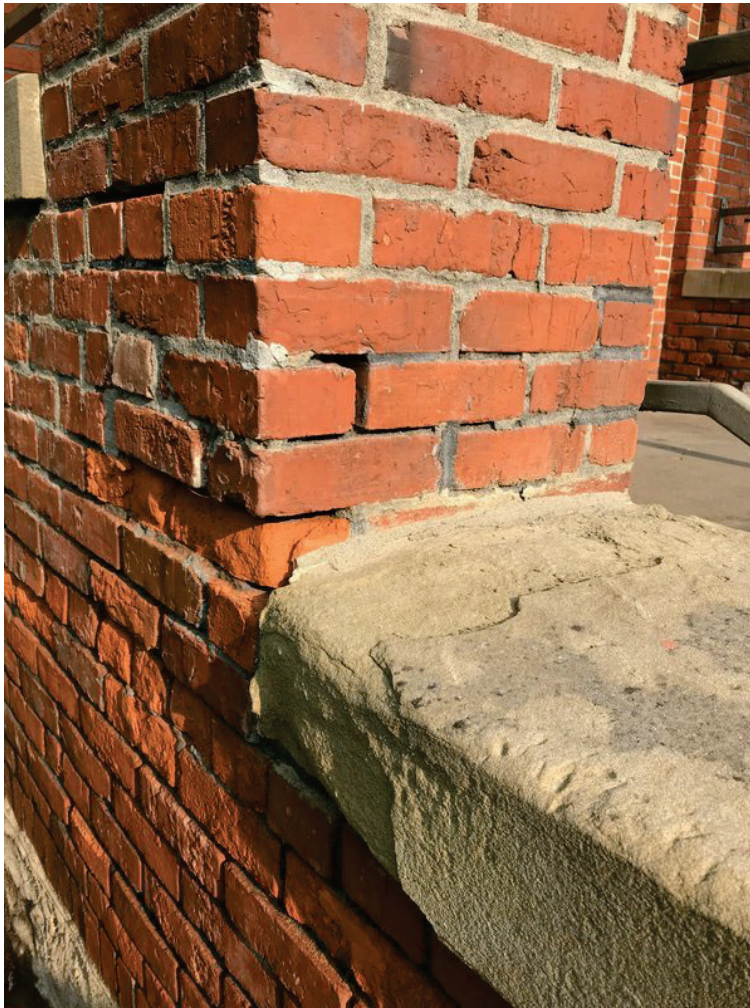
Structural System	Description
Gravity System	Generally good, although there were a few isolated areas of the URM walls where the mortar was deteriorating. There is also a substantial amount of ivy growing on the east wall of the building. The condition of the wall could not be assessed, but ivy has been known to cause damage to URM walls by infiltrating and widening cracks.
Lateral System	Generally good, although there were a few isolated areas of the URM walls where the mortar was deteriorating. There is also a substantial amount of ivy growing on the east wall of the building. The condition of the wall could not be assessed, but ivy has been known to cause damage to URM walls by infiltrating and widening cracks.

Figure 1-4. Deteriorated mortar in masonry column at east entry

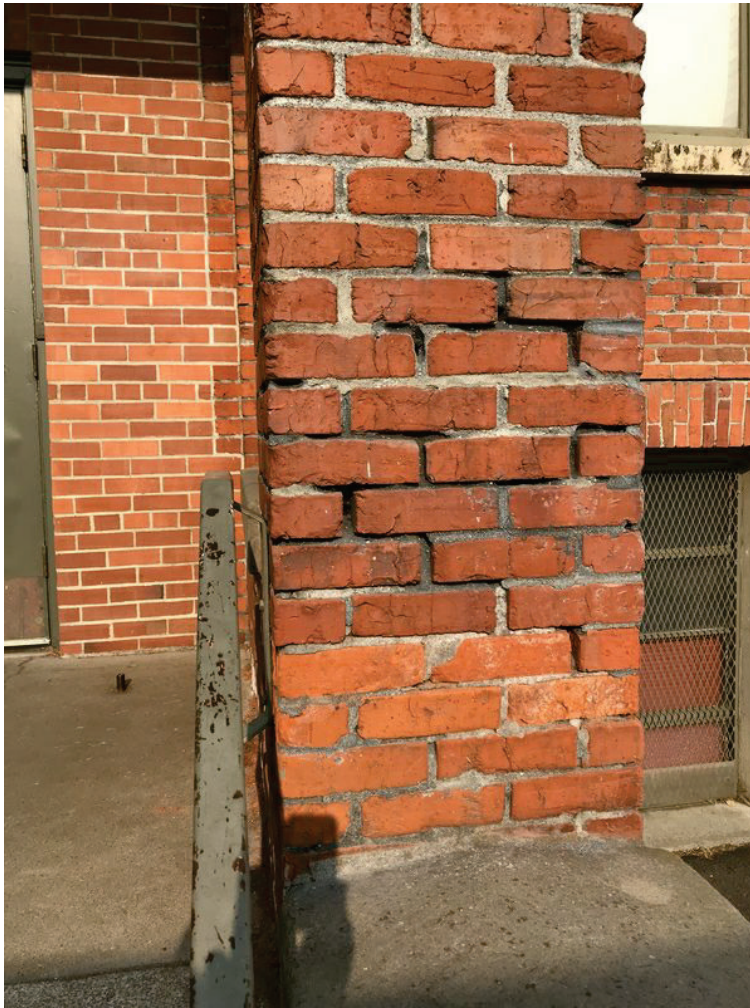
Figure 1-5. Deteriorated mortar in masonry column at east entry

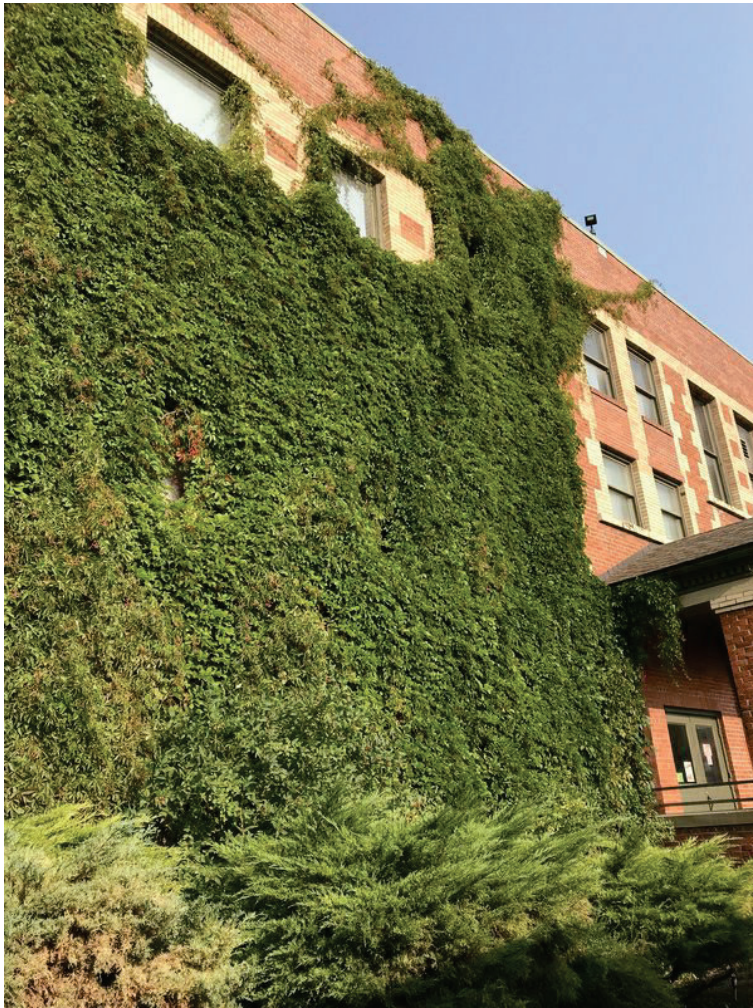
Figure 1-6. Ivy growth on east wall of building

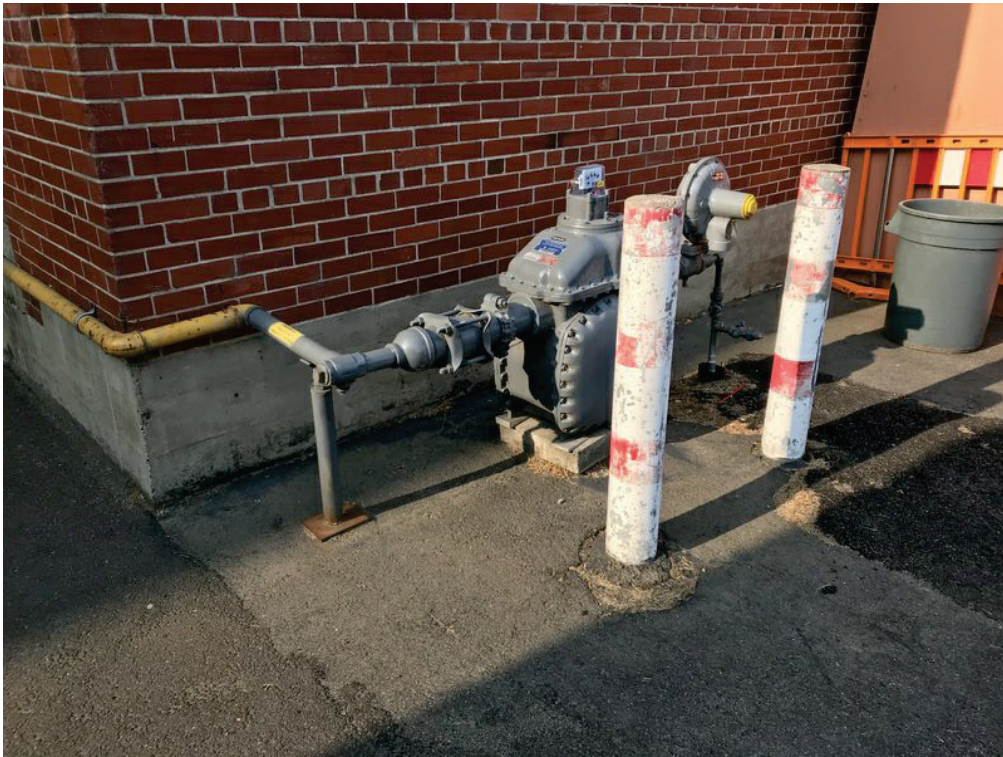
Figure 1-7. Gas meter at northwest corner of building

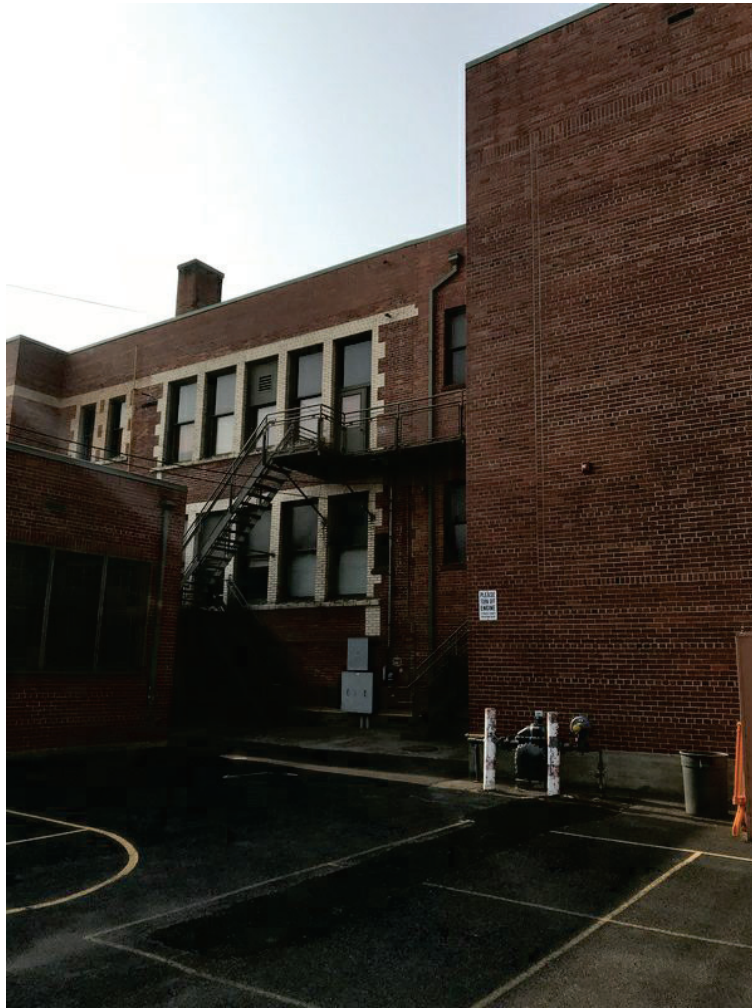
Figure 1-8. View from northwest corner of building, URM chimney can be seen

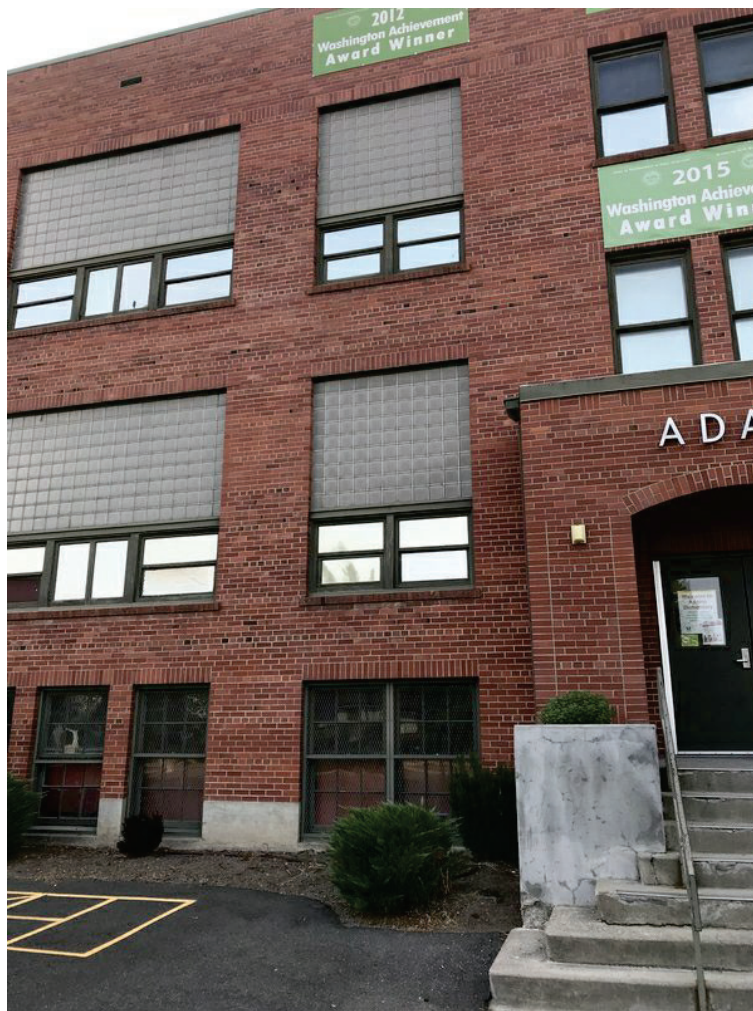
Figure 1-9. West elevation/entry showing infill glass block above windows

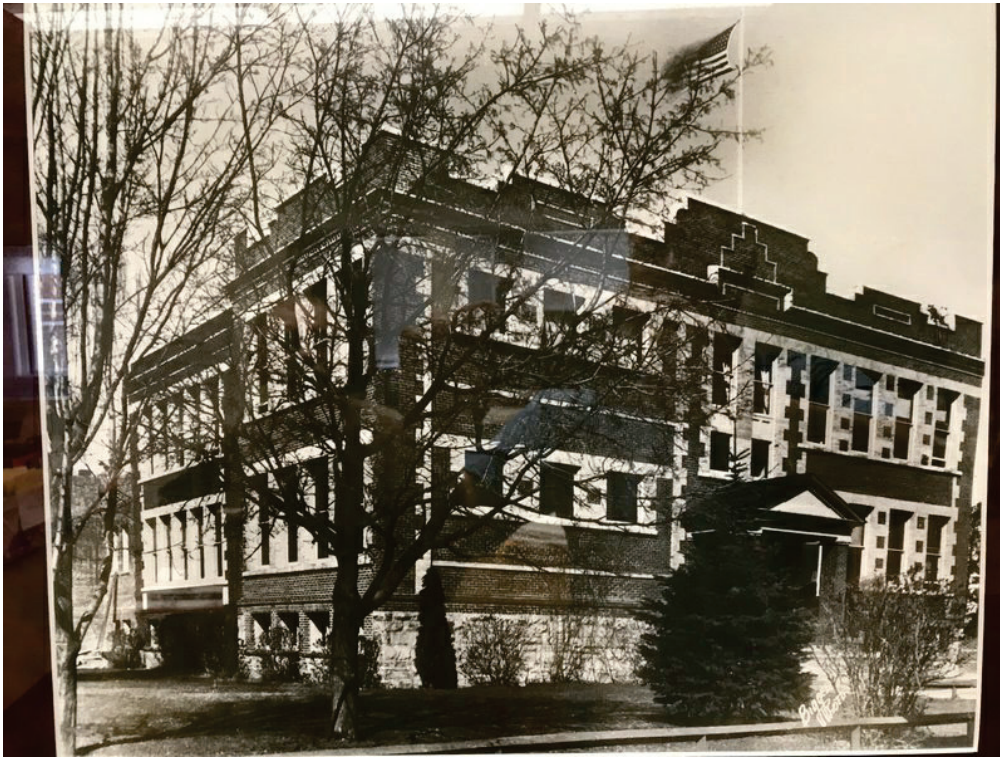
Figure 1-10. Original photo from SE corner of building showing original taller parapet configuration.
