Washington State School Seismic Safety Assessments Project

SEISMIC UPGRADES CONCEPT DESIGN REPORT

Lake Roosevelt Jr/Sr High, Lake Roosevelt
Elementary – CTE/Gym Building
Grand Coulee Dam School District

June 2019

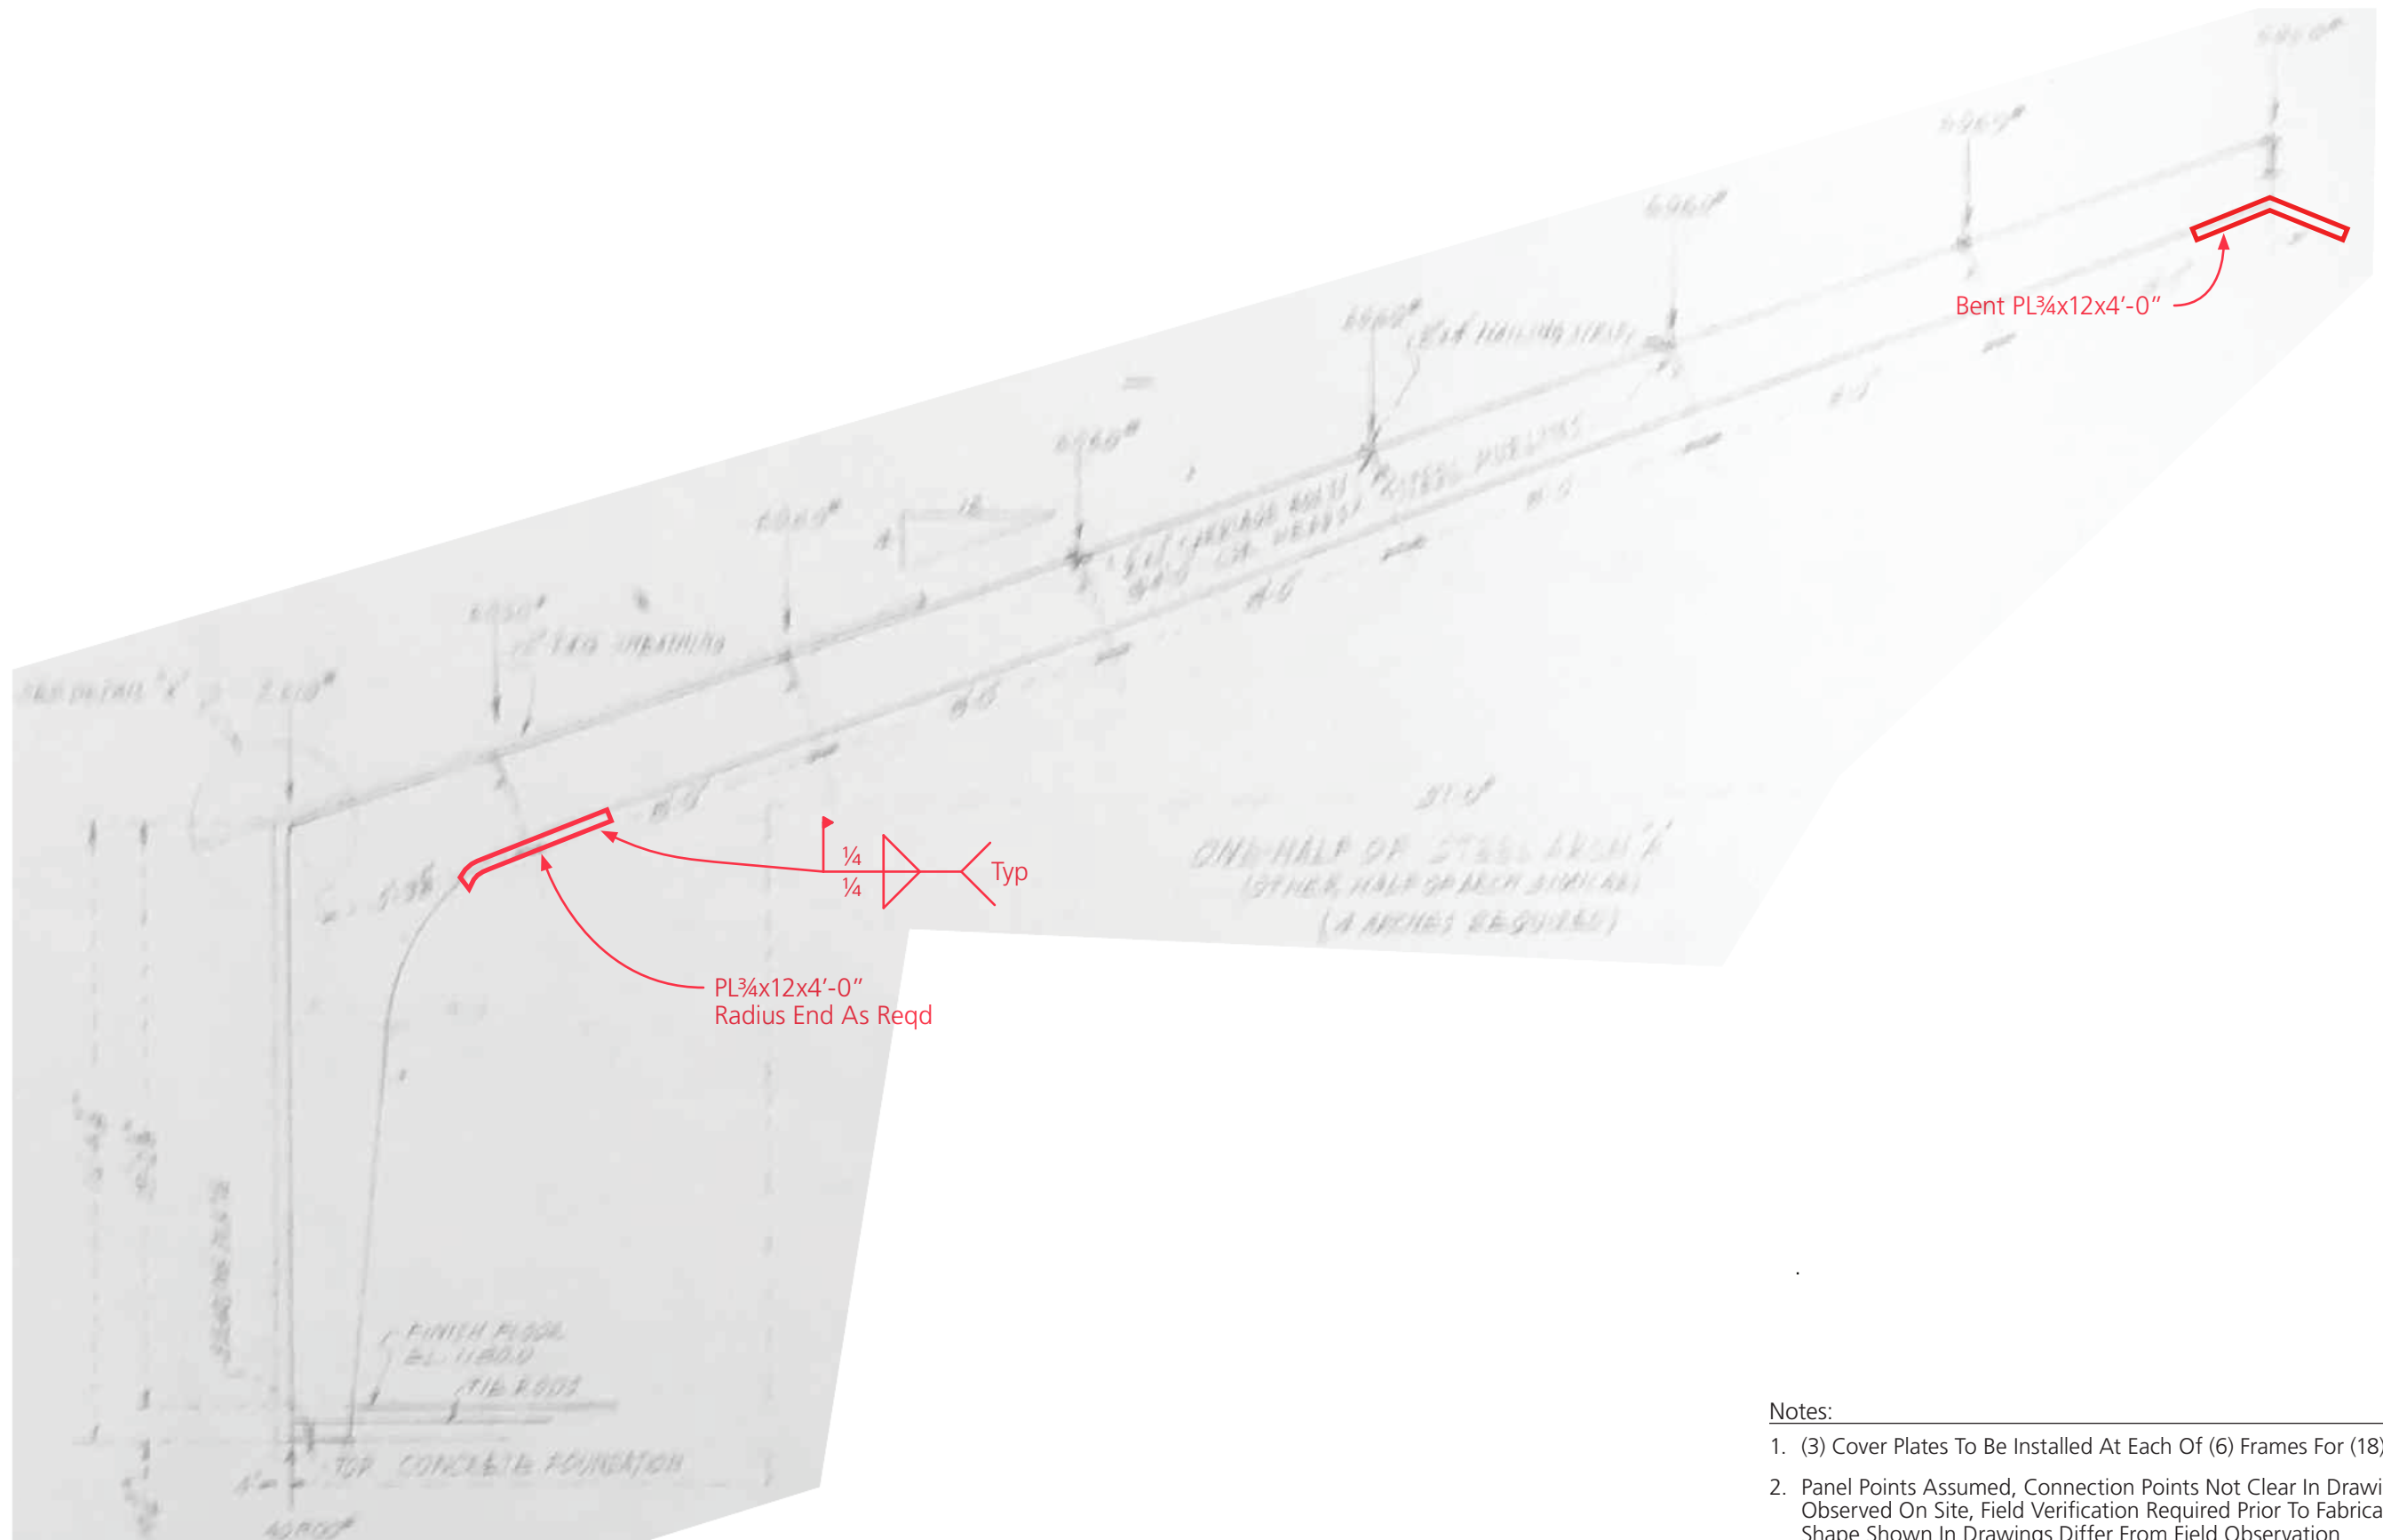
Figure 1 - Moment Resisting Connections

Deficiency	Description
Moment-Resisting Connections	The frame member connection could not be determined from the drawings provided; however, the connections were observed to be noncompliant, full penetration welds.

- Notes:
1. (3) Cover Plates To Be Installed At Each Of (6) Frames For (18) Total Plates
 2. Panel Points Assumed, Connection Points Not Clear In Drawings & Not Observed On Site, Field Verification Required Prior To Fabrication - Tframe Shape Shown In Drawings Differ From Field Observation
