1. Raymond Fire Department, Fire Station

1.1 Building Description

1.2 Seismic Evaluation Findings

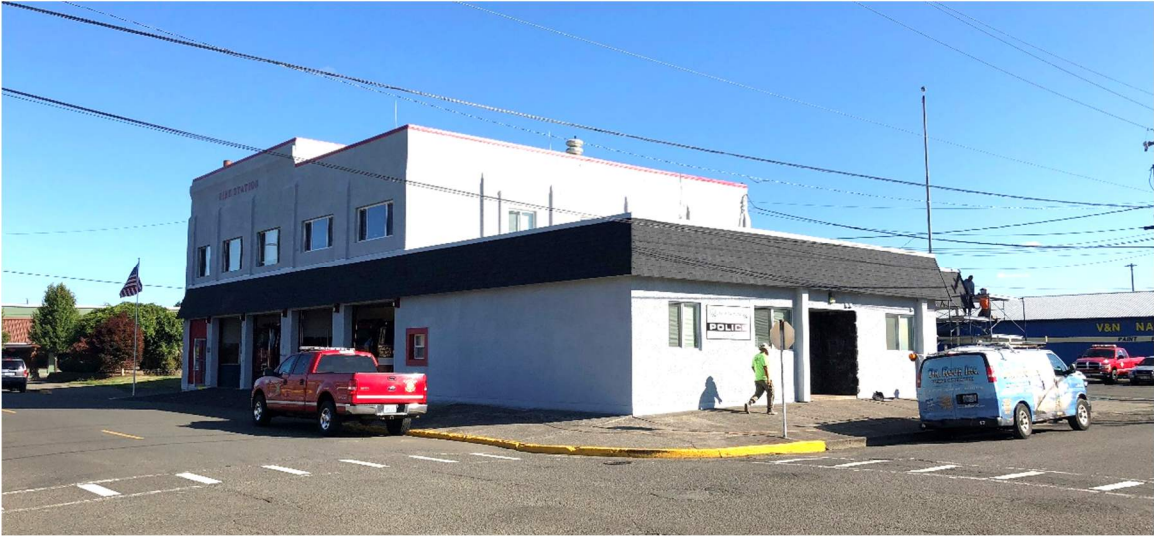
Figure 1-1. North West Exterior

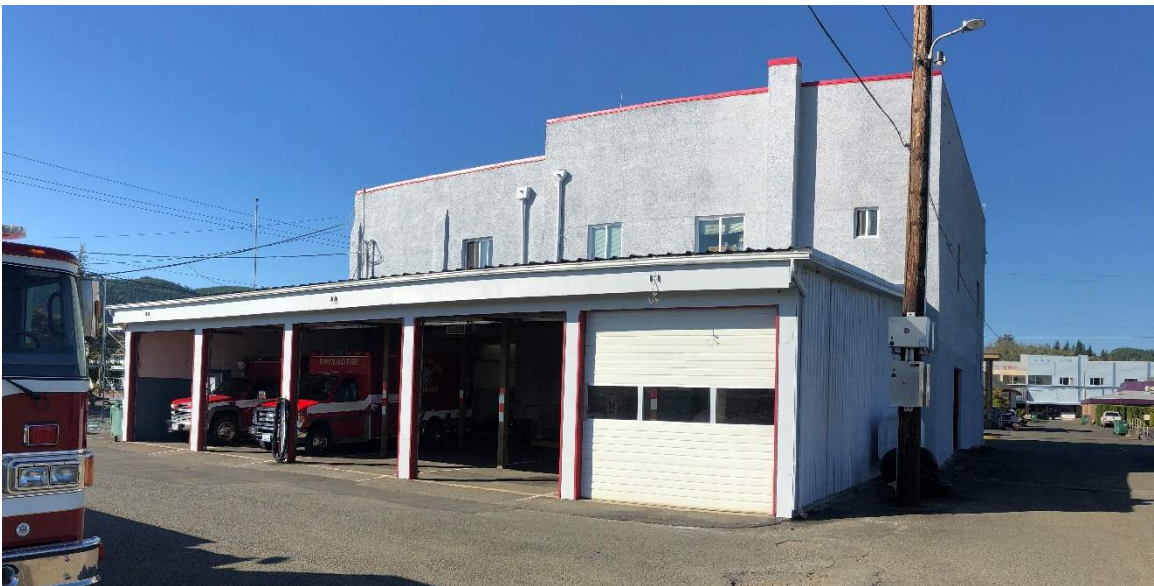
Figure 1-2. South Exterior

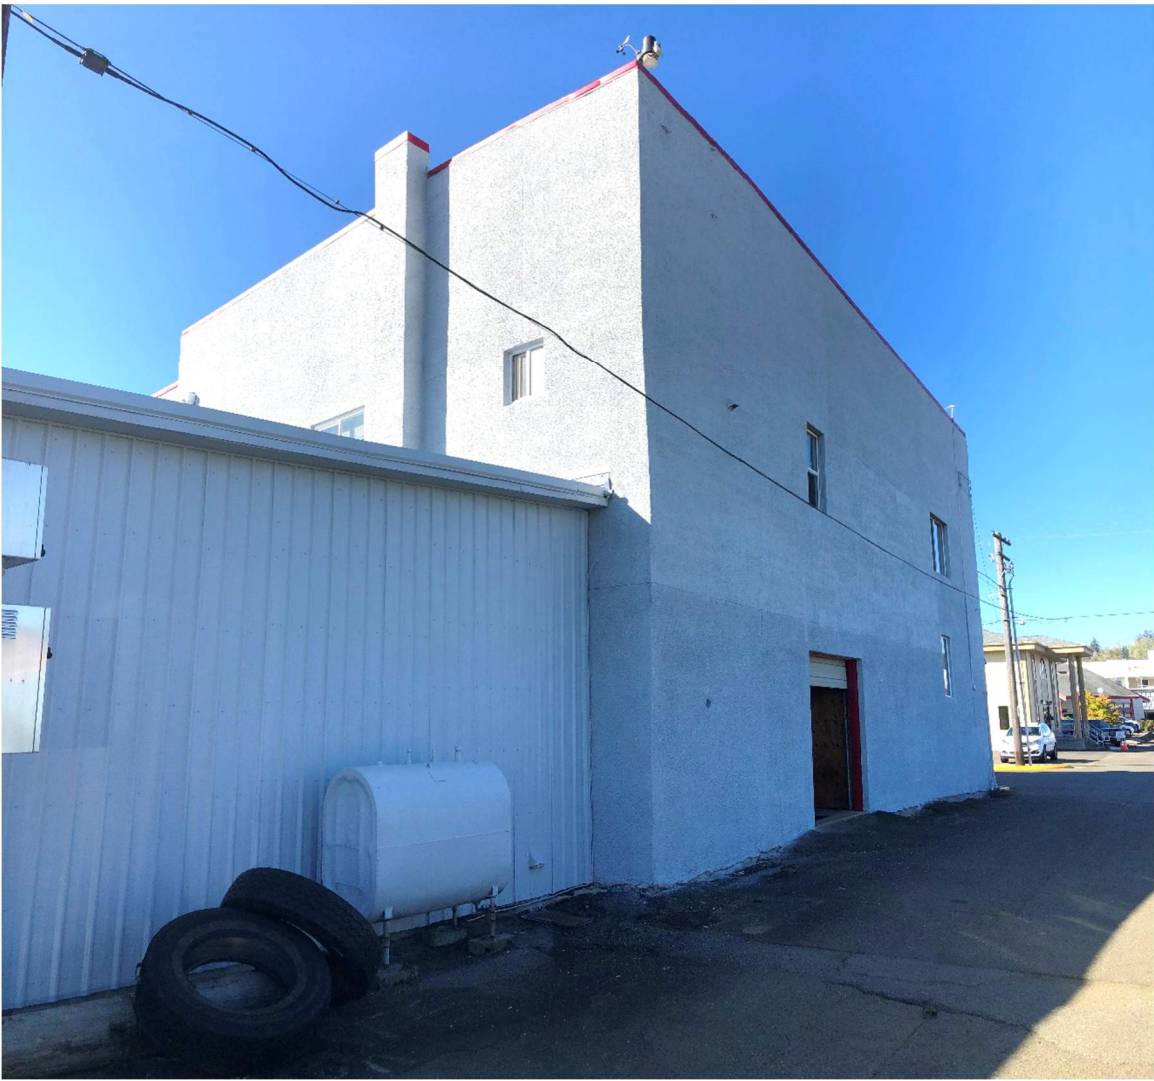
Figure 1-3. East Exterior

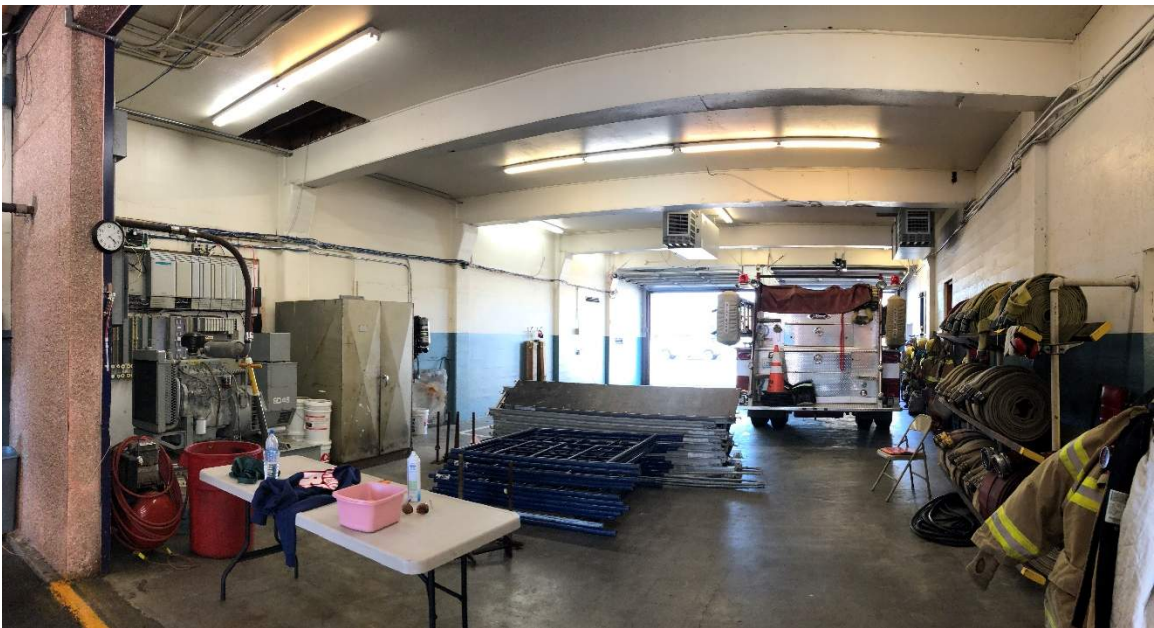
Figure 1-4. Typical Garage Bay

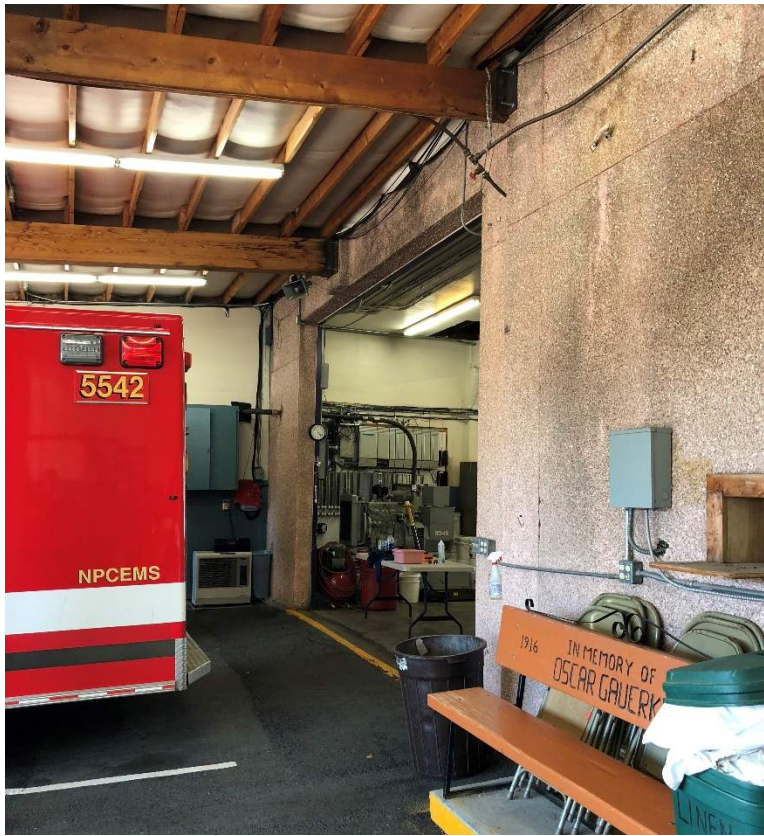
Figure 1-5. Original South Exterior Wall at Wood-Framed Garage Bay Addition

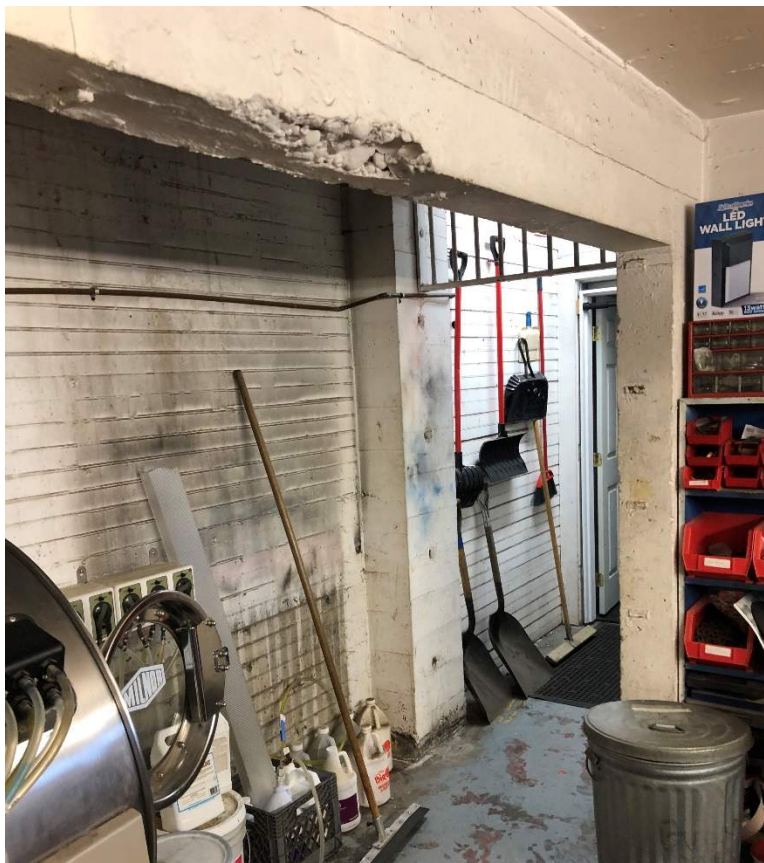
Structural System	Description
Structural Roof	No visible signs of corrosion, damage, or deterioration.
Structural Floor(s)	No visible signs of corrosion, damage, or deterioration.
Foundations	Unknown.
Gravity System	Spalling and cracks observed in interior concrete walls. Minor cracking in observed in wood beams and posts.
Lateral System	No visible signs of corrosion, damage, or deterioration.

Figure 1-6. Interior Showing Spalling Concrete

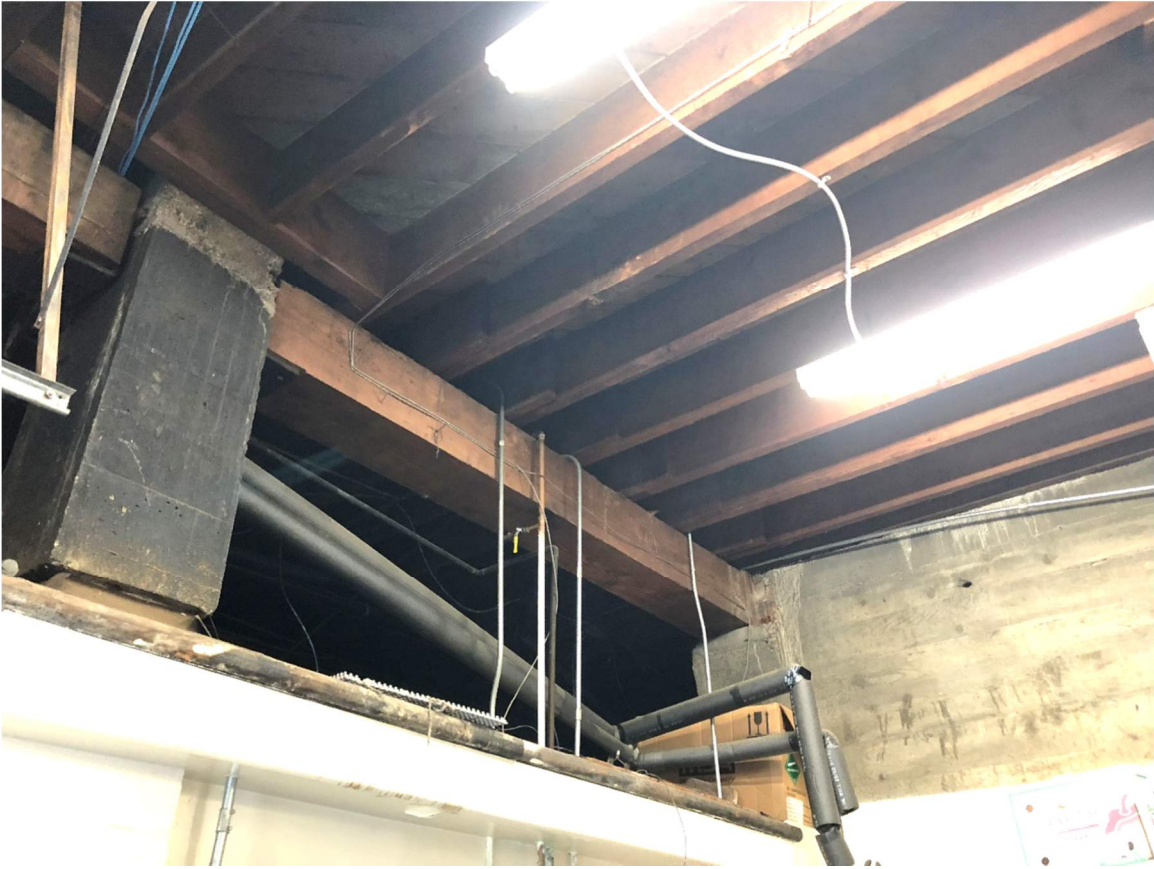
Cross Ties	There are no continuous cross ties between diaphragm chords. Diaphragm strengthening may be appropriate to mitigate seismic risk.
Uplift at Pile Caps	Foundation conditions are unknown. Further evaluation is recommended if determination is desired.

Figure 1-7. Flexible Floor Diaphragm with Diagonal Sheathing and Wood Framing

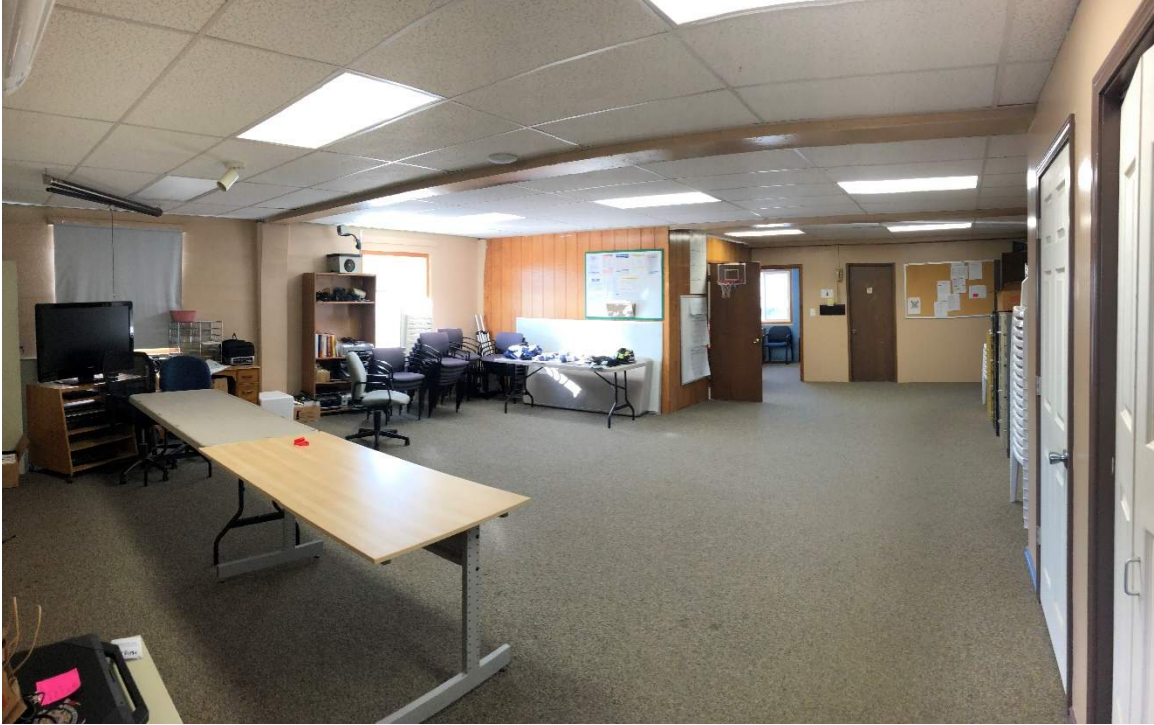
Figure 1-8. Second Level Interior

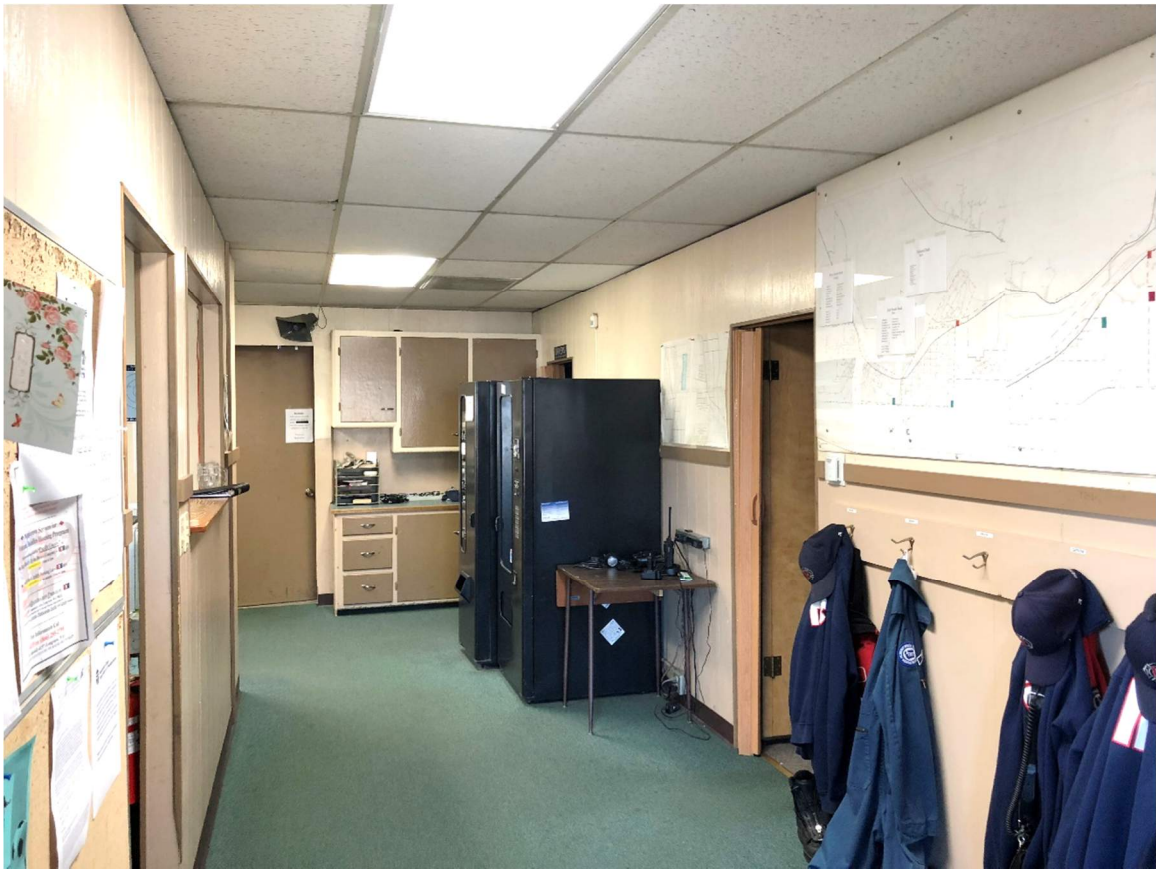
Deficiency	Description
LSS-1 Fire Suppression Piping	No fire sprinklers.
CG-8 Overhead Glazing	Further investigation is required to verify detailing of glazing panes.
MC-1 URM Chimneys	Concrete chimney.
CF-2 Tall Narrow Contents	Anchorage is required for tall narrow contents more than six feet high to provide overturning restraint.

Figure 1-9. Upstairs Hallway with Unbraced Tall, Narrow Contents – Typical Throughout
