# 1. Tumwater Fire Department, Department Headquarters

## 1.1 Building Description

## 1.2 Seismic Evaluation Findings

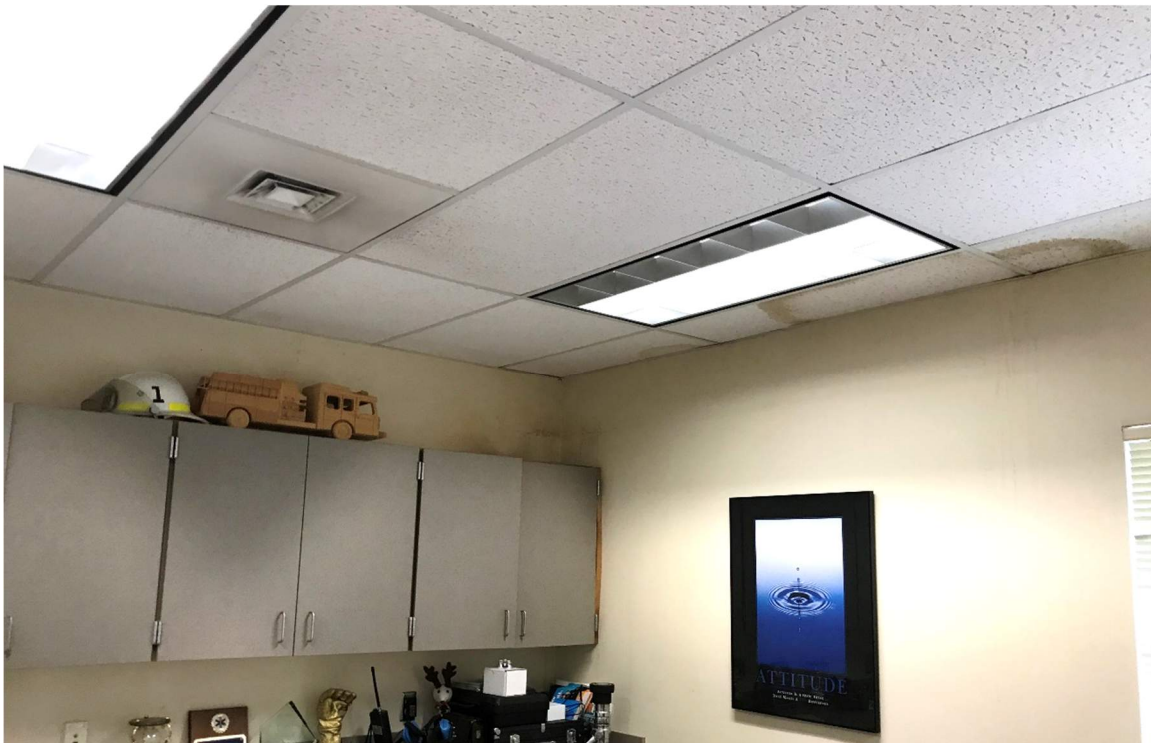
Structural System	Description
Roof	No visible signs of damage, recent construction.
Floor	No apparent damage in select locations, but architectural finishes prevent an inspection of entire structure.
Foundations	Slab in vehicle bay shows no apparent damage. Isolated slabs for HVAC units outside appear undamaged. Unable to verify for rest of structure.
Gravity System	No apparent damage, unable to verify condition of walls under architectural finishes. High bay shows no apparent damage
Lateral System	In high bay, no apparent damage to steel members. In rest of building, structure that was visible in select spots, (storage, mechanical rooms) appeared in good condition. Unable to verify in some location of known water damage from roof leak.

Figure 1-1. Apparent Water Damage from Roof Leak

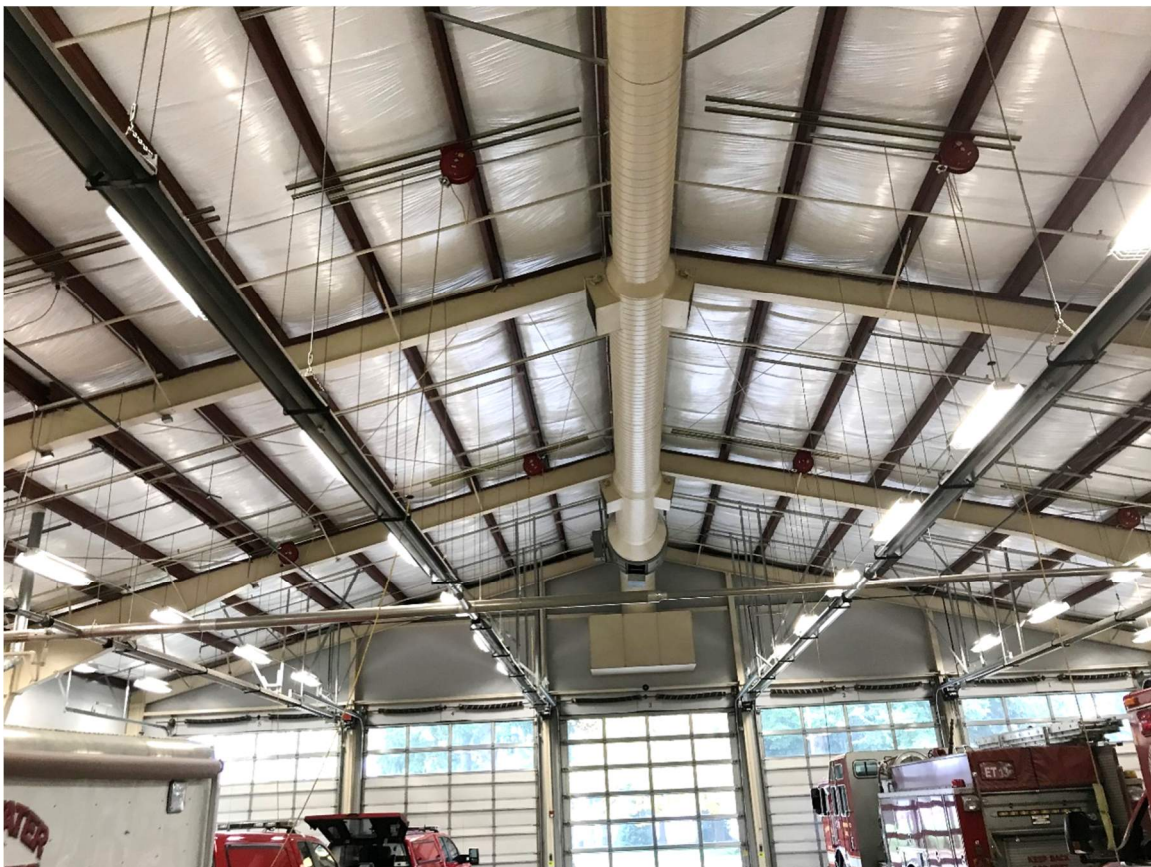
Figure 1-2. Structure of Vehicle Bay

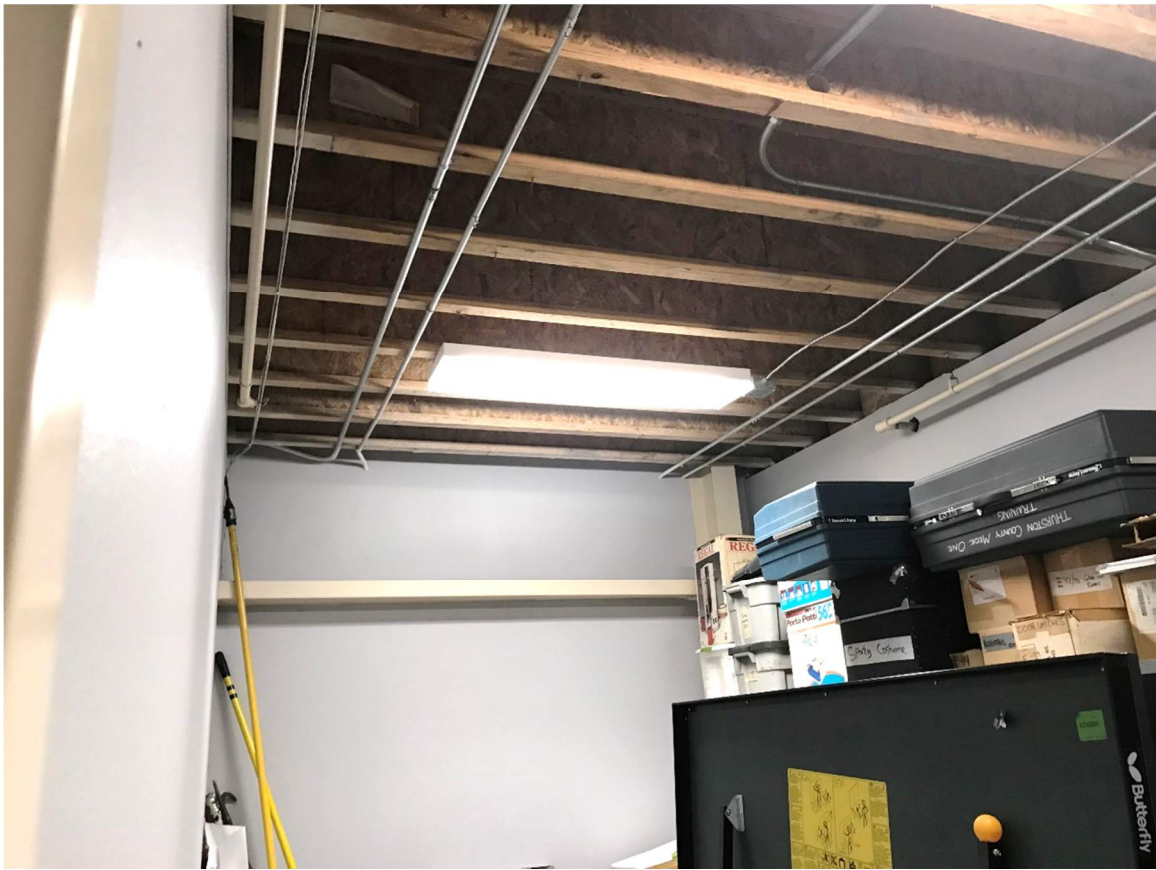
Figure 1-3. Structure of Second Floor

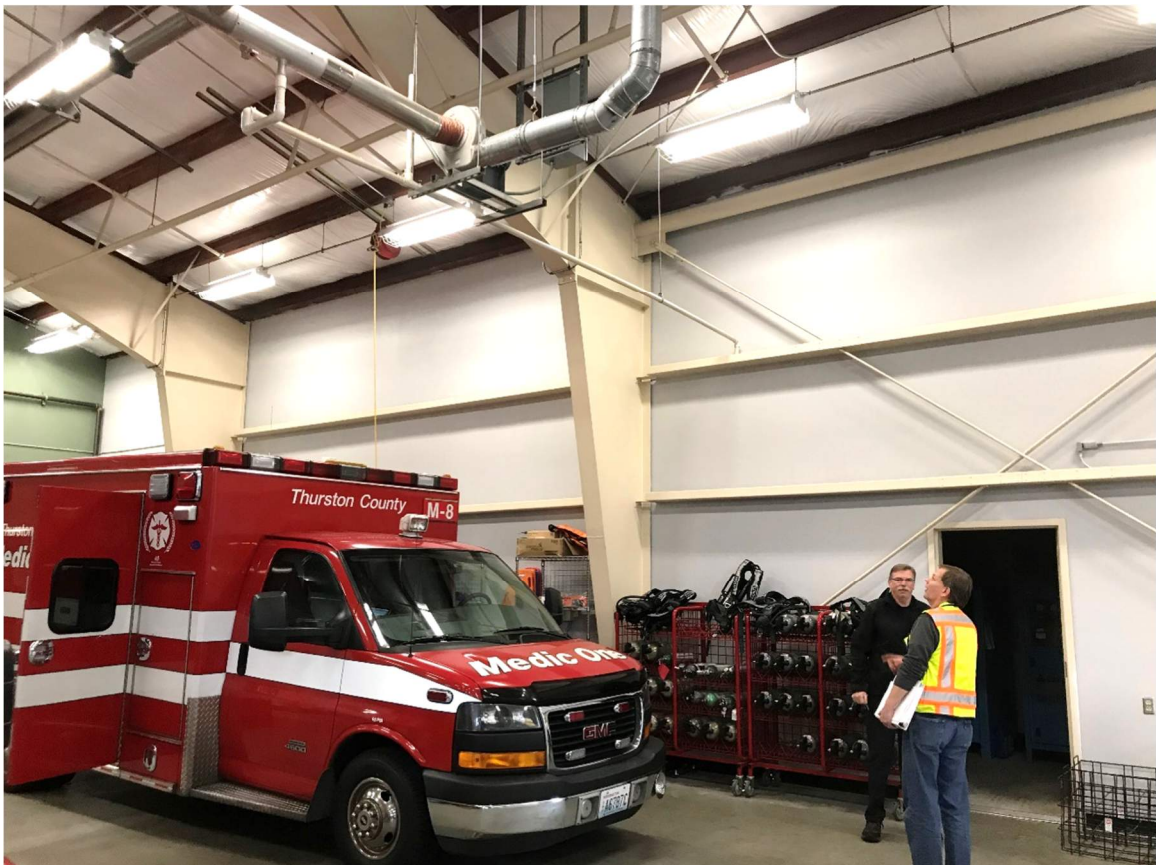
Figure 1-4. Vehicle Bay Bracing

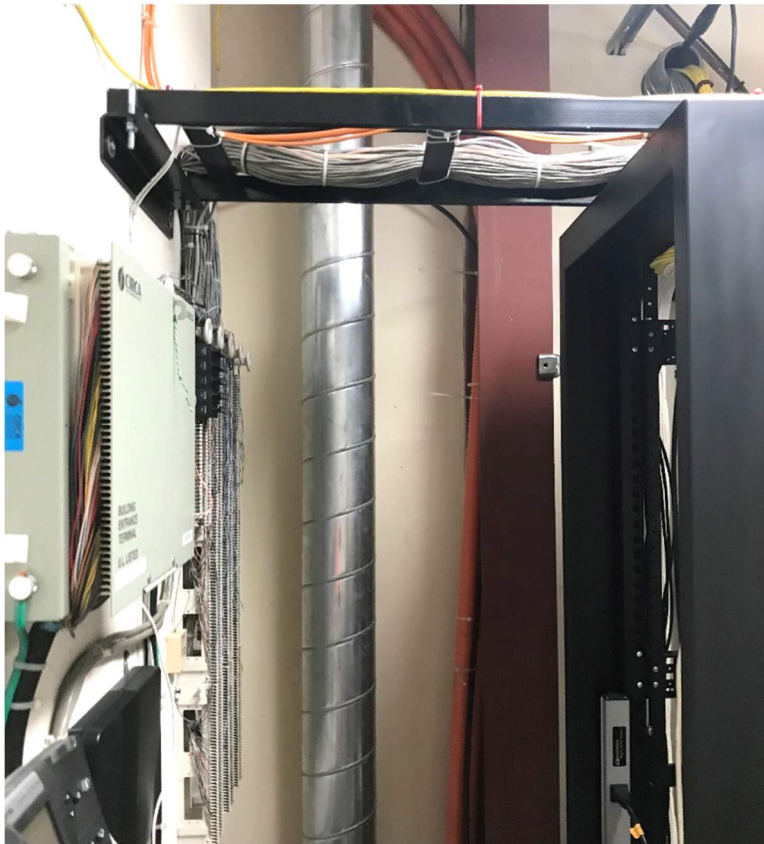
**Figure 1-5. IT Equipment Secured**

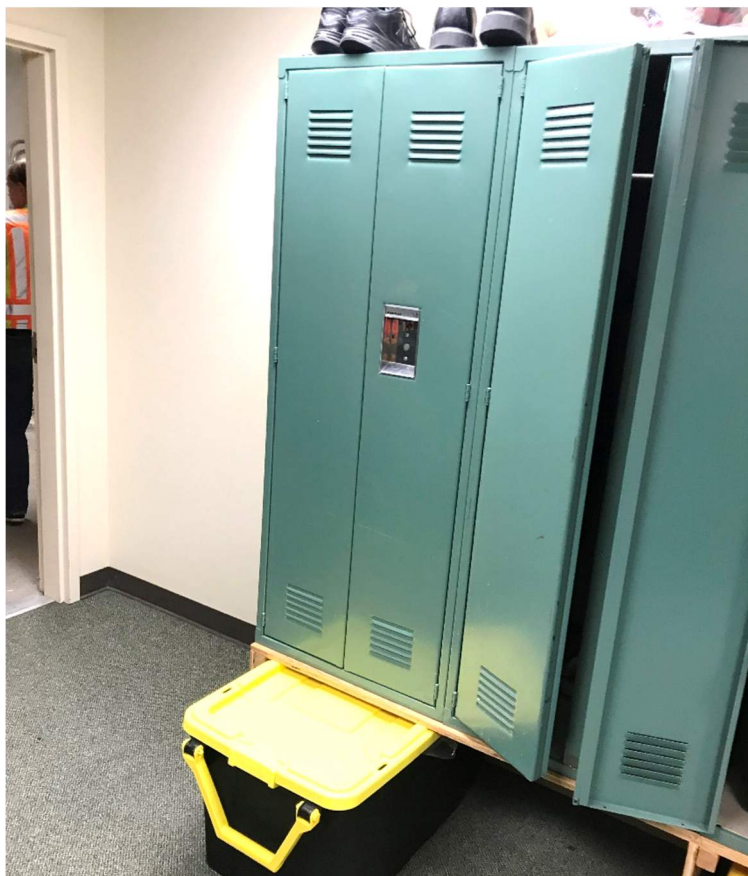
**Figure 1-6. Interior Contents Unattached**

EVALUATION ITEM	EVALUATION STATEMENT	C	NC	N/A	U	COMMENT
CF-1 Industrial Storage Racks. HR-LMH; LS-MH; PR-MH.	Industrial storage racks or pallet racks more than 12 ft high meet the requirements of ANSI/RMI MH 16.1 as modified by ASCE 7, Chapter 15. (Tier 2: Sec. 13.8.1; Commentary: Sec. A.7.11.1)			X		No racks observed
CF-2 Tall Narrow Contents. HR-not required; LS-H; PR-MH.	Contents more than 6 ft (1.8 m) high with a height-to-depth or height-to-width ratio greater than 3-to-1 are anchored to the structure or to each other. (Tier 2: Sec. 13.8.2; Commentary: Sec. A.7.11.2)		X			Several lockers on second floor and closets in personal rooms are unattached
CF-3 Fall-Prone Contents. HR-not required; LS-H; PR-H.	Equipment, stored items, or other contents weighing more than 20 lb (9.1 kg) whose center of mass is more than 4 ft (1.2 m) above the adjacent floor level are braced or otherwise restrained. (Tier 2: Sec. 13.8.2; Commentary: Sec. A.7.11.3)		X			See CF-2. Additionally equipment racks in high bay are unmounted and on rollers.

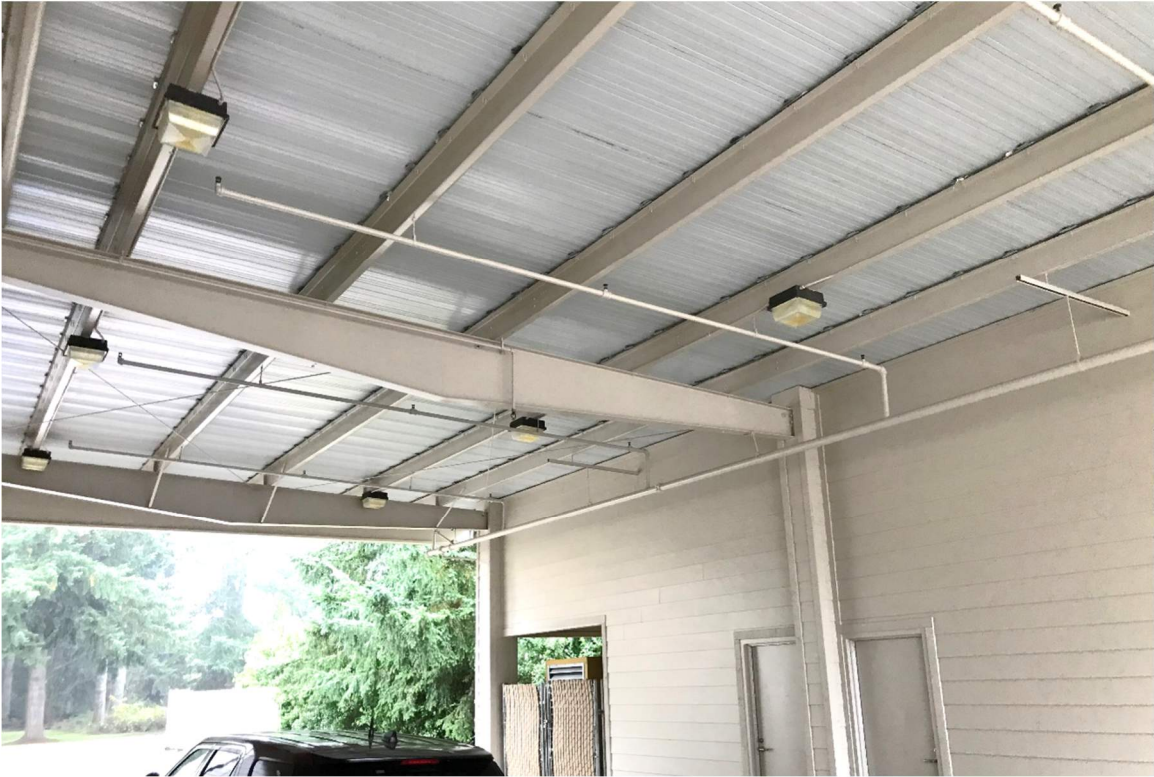
**Figure 1-7. Truck Washing Bay Structure**

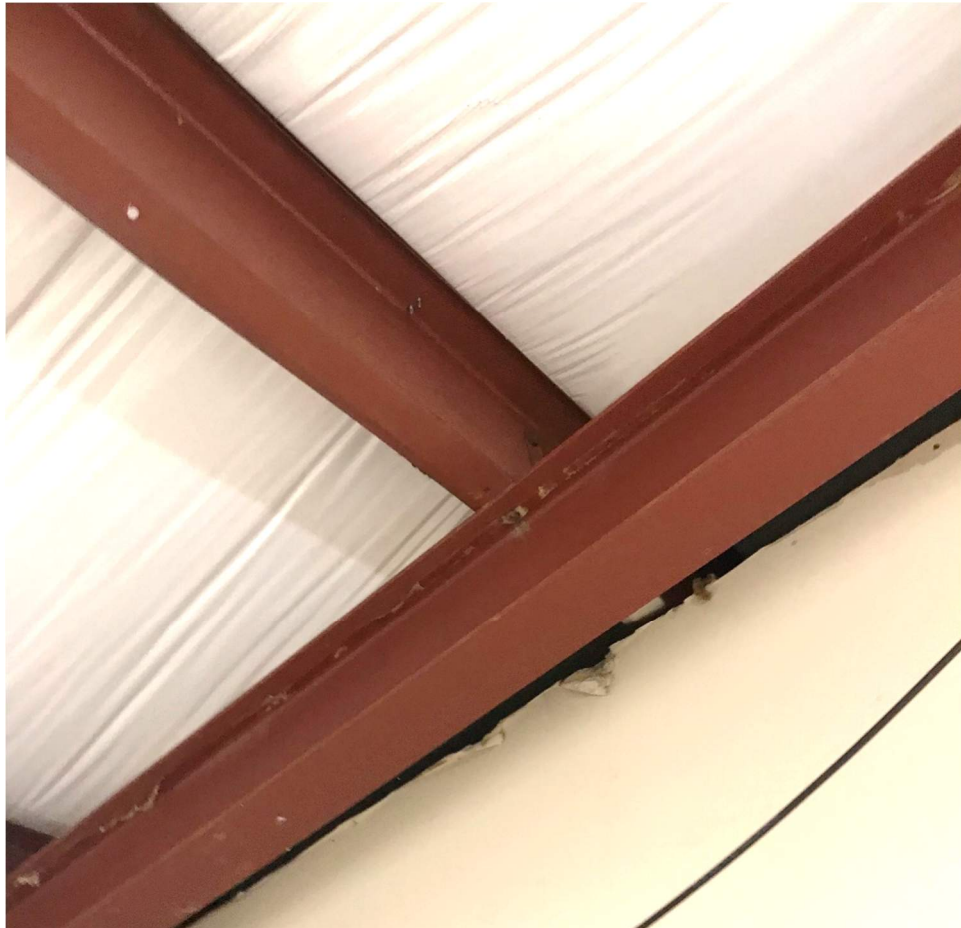
**Figure 1-8. New Roof Structure**

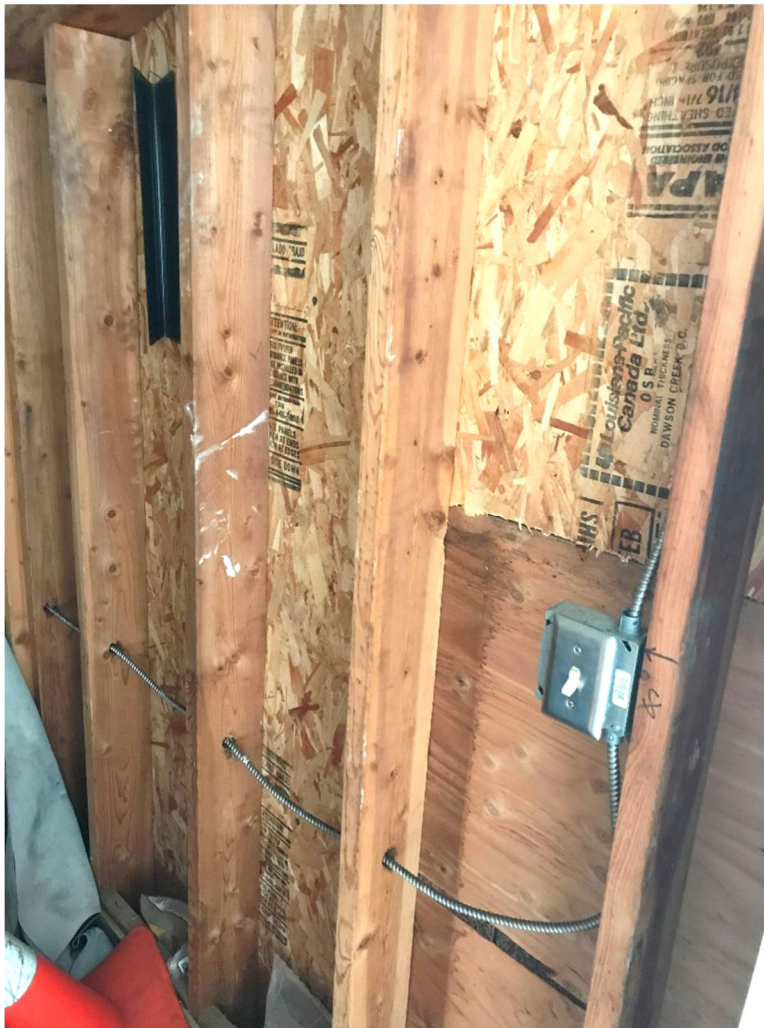
Figure 1-9. Visible Wooden Shear Walls in Storage Closet

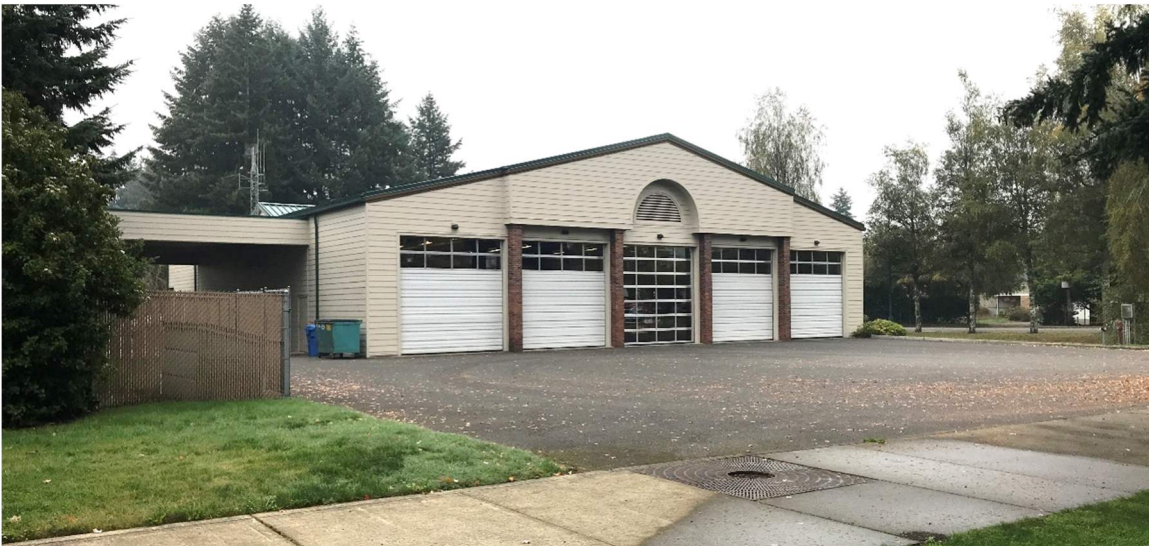
Figure 1-10. Vehicle Bay Exterior
