1. Walla Walla Fire District 4, Station 41

1.1 Building Description

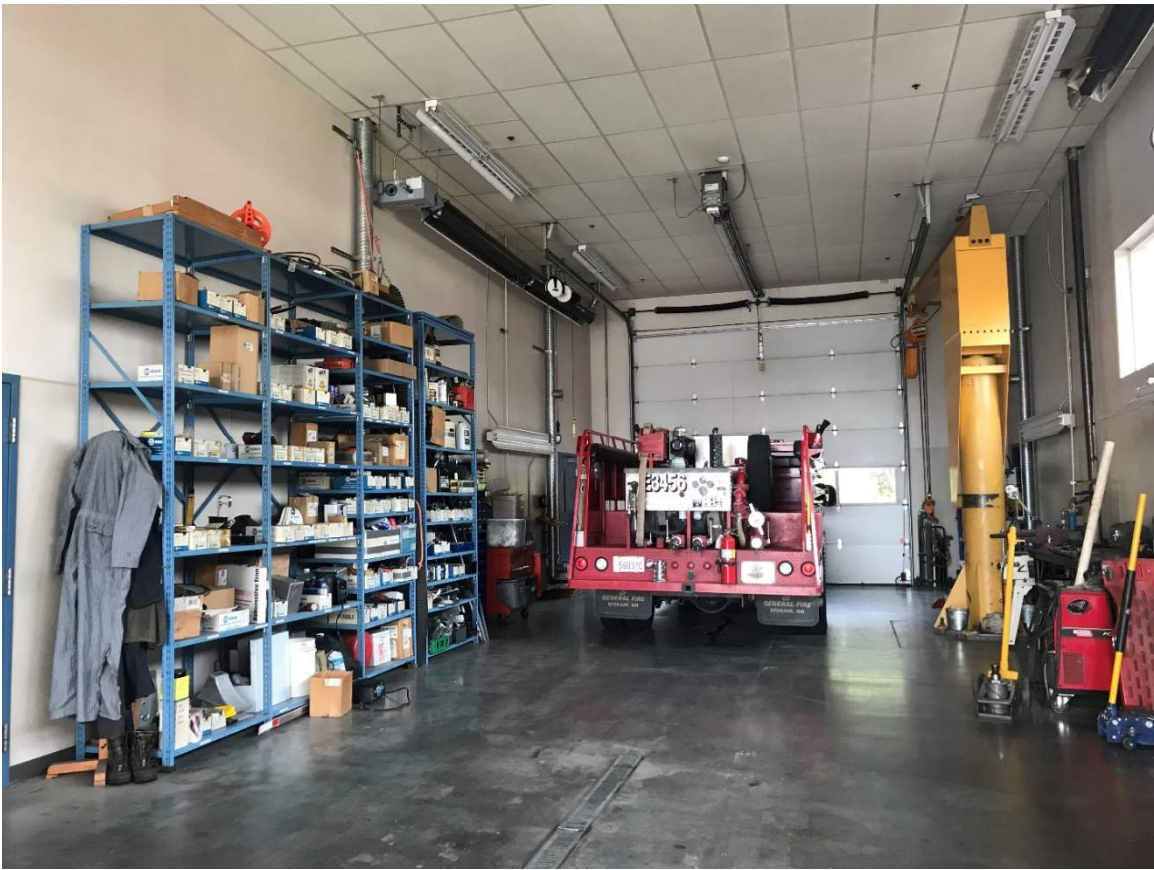
Figure 1-5. Walla Walla Station 41, Apparatus Bay

Deficiency	Description
Narrow Wood Shear Walls	The wood shear walls along Apparatus Bay overhead door openings have aspect ratio greater than 2-to-1. Further investigation should be performed. Lateral system strengthening by providing seismic straps along the openings at the shear walls may be appropriate to mitigate seismic risk.
Narrow Wood Shear Walls	The wood shear walls along south and east facades have aspect ratio greater than 1.5-to-1. Further investigation should be performed. Lateral system strengthening by providing seismic straps along the openings or additional shear walls may be appropriate to mitigate seismic risk.

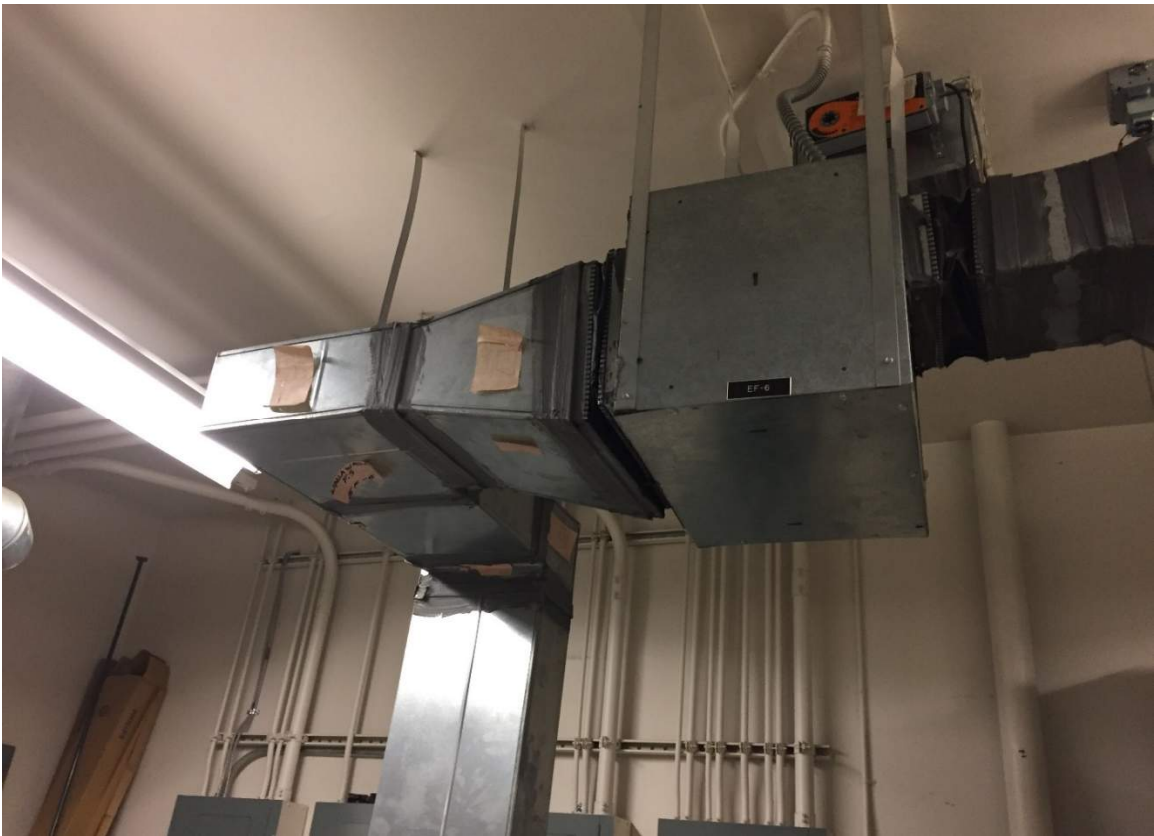
Figure 1-7. Walla Walla Station 41, Overhead Ductwork

P-1 Flexible Couplings	Flexible couplings do not appear to be provided natural gas piping bends. Flexible coupling for fire suppression piping may be appropriate to mitigate seismic risk.
P-2 Fluid and Gas Piping	No bracing was observed on natural gas pipeline during the site investigation. Bracing natural gas piping may be appropriate to mitigate seismic risk.
D-1 Duct Bracing	No bracing provided on the ductwork. Bracing to ductwork may be appropriate to mitigate seismic risk.

D-2 Duct Support	The duct supports are unobservable. Further investigation should be performed.

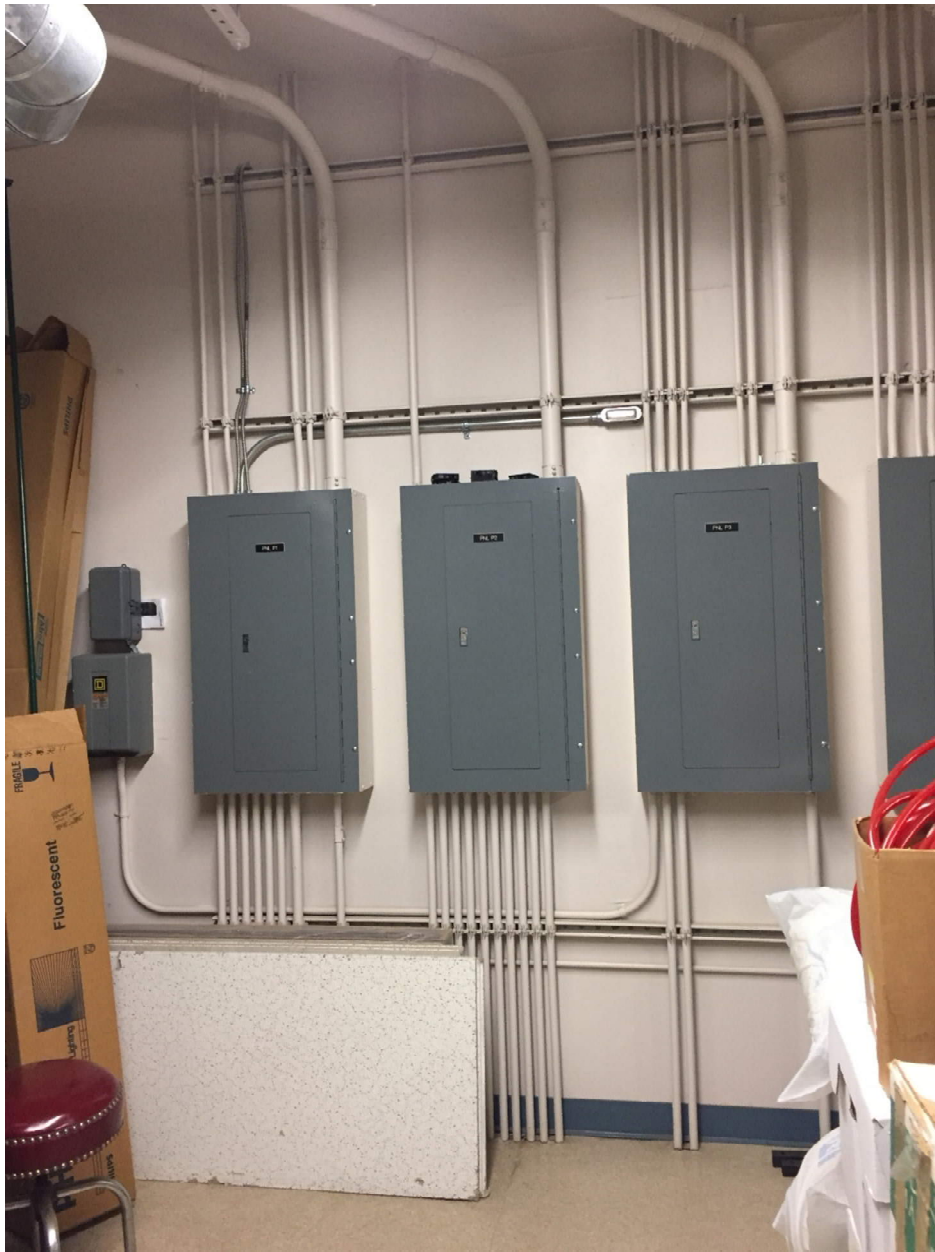
Figure 1-9. Walla Walla Station 41, Electrical Room

X				HR—not required; LS—not required; PR—H. ELECTRICAL EQUIPMENT: Electrical equipment is laterally braced to the structure. (Tier 2: Sec. 13.7.7; Commentary: Sec. A.7.12.11)	Electrical equipment appears to be mounted on wall or floor.
	X			HR—not required; LS—not required; PR—H. CONDUIT COUPLINGS: Conduit greater than 2.5 in. (64 mm) trade size that is attached to panels, cabinets, or other equipment and is subject to relative seismic displacement has flexible couplings or connections. (Tier 2: Sec. 13.7.8; Commentary: Sec. A.7.12.12)	Conduits do not appear to have flexible couplings.
