Washington State
School Seismic Safety Assessments Project

MARY M. KNIGHT SCHOOL ELEMENTARY SCHOOL BUILDING Mary M. Knight School District 311

SEISMIC UPGRADES CONCEPT DESIGN REPORT

June 2021

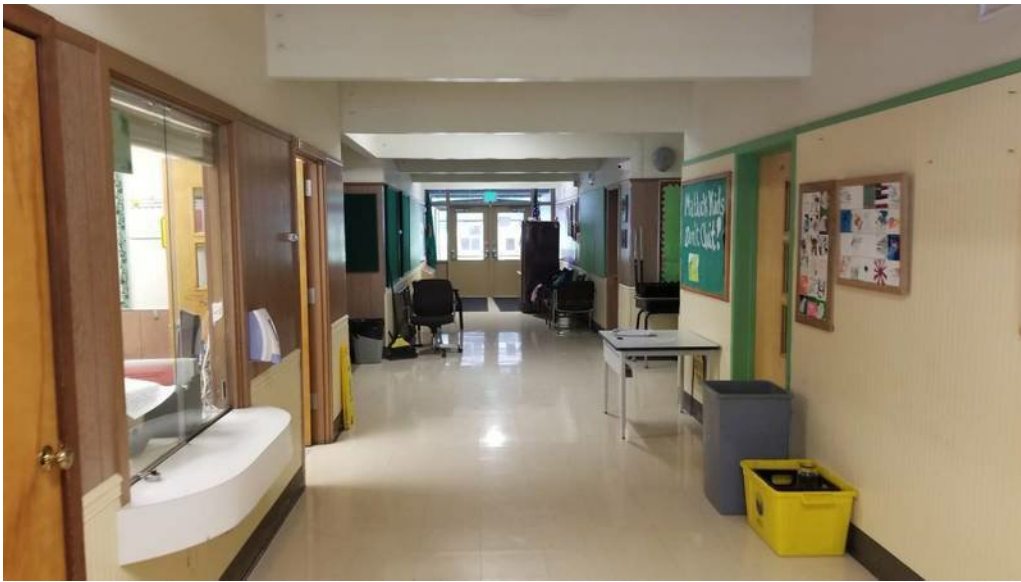
Figure 1-1. Main corridor at front rear entrance.

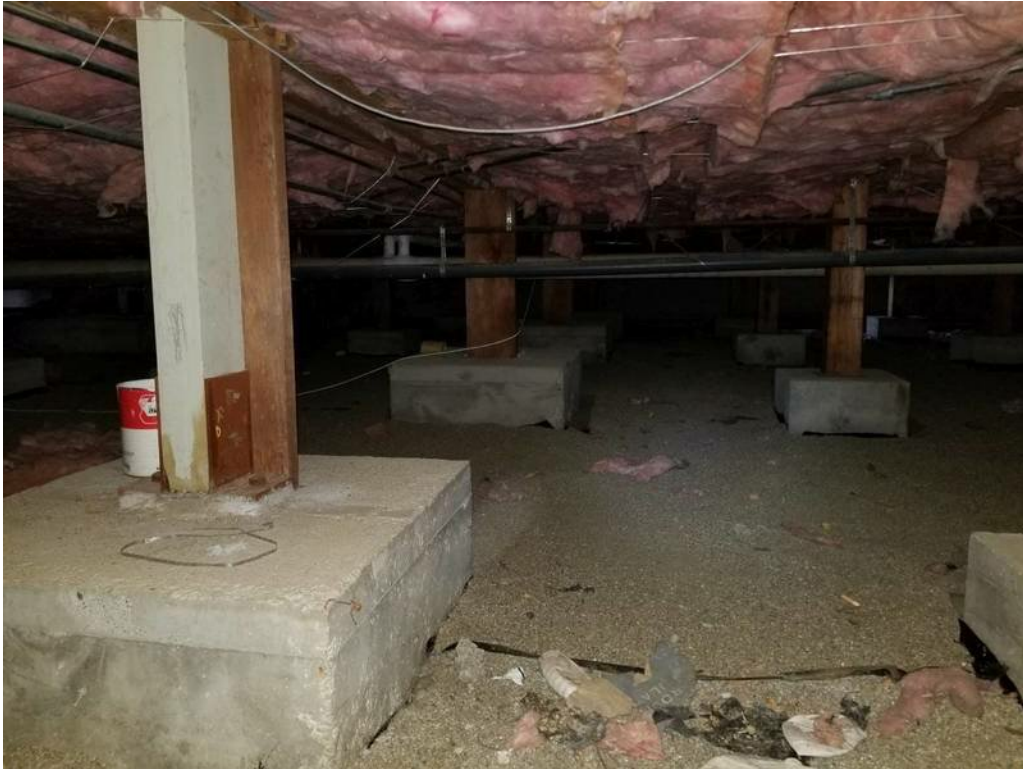
WSP USA, Inc., performed a Tier 1 screening in accordance with the ASCE 41-17 standard *Seismic Evaluation and Retrofit of Existing Buildings*. The evaluation included field observations and review of record drawings to verify the existing construction. The structural seismic evaluation indicated that the building has multiple seismic deficiencies; the most susceptible ones relate to three principal areas: first, shear walls, and second, diaphragm size and aspect ratio. Specifically, redundancy of shear walls, overstressing of existing shear walls, insufficiently braced wall lines with openings 80% of the length or more, and aspect ratio and spans of straight-sheathed diaphragms. Finally, many of the interior footings are neither tied together nor braced by surrounding soil, and there are no positive connections between the posts and the footings.

Figure 1-7. Crawl space below school.

Conceptual seismic upgrade recommendations for the structural systems are provided to improve the performance of the building to meet the Life Safety structural performance objective criteria of ASCE 41-17. Sketches for the concept-level seismic upgrades are provided in Appendix B. The structural upgrades include adding shear walls to the exterior of the building, strengthening interior walls as shear walls along the corridor, plywood sheathing overlay on top of the existing tongue-and-groove decking, new concrete foundation stem walls in the crawlspace below the added interior shear walls, and positive clip connections of the crawlspace posts to the existing footings.
