Washington State
School Seismic Safety Assessments Project

NAPAVINE JR/SR HIGH SCHOOL ANNEX BUILDING Napavine School District

SEISMIC UPGRADES CONCEPT DESIGN REPORT

June 2021

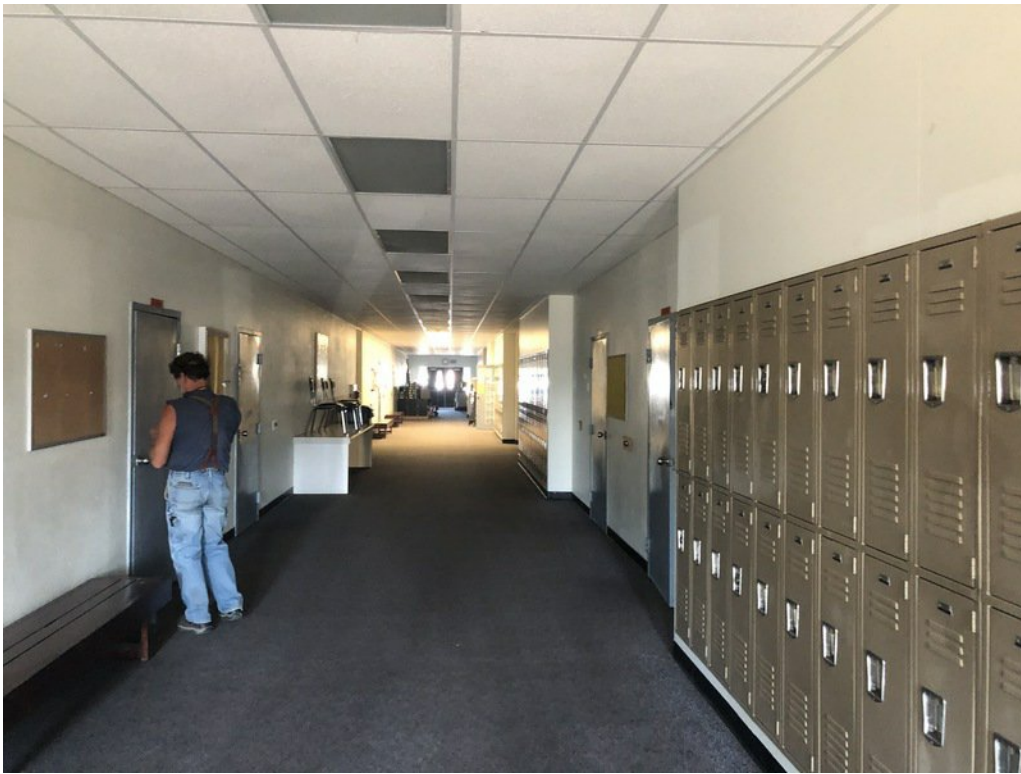
Figure 1-1. Central Hallway of the Building

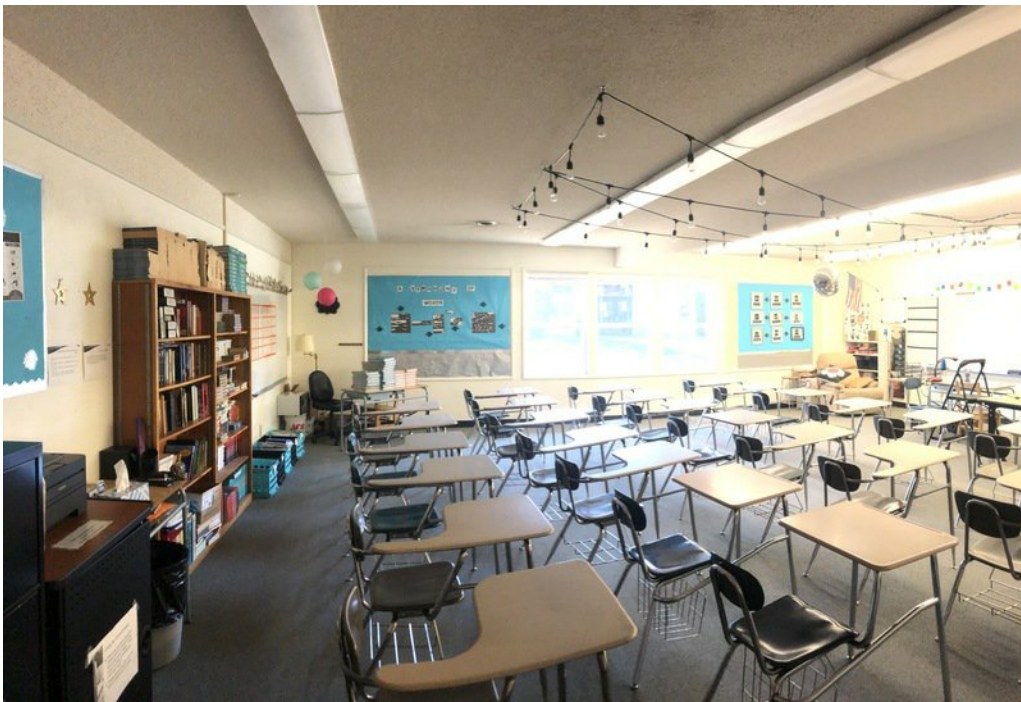
Deficiency	Description
CF-2 Tall Narrow Contents. HR-not required; LS-H; PRMH.	It did not appear that contents taller than 6 feet were adequately restrained. Restraining contents by bracing top of contents to nearest backing wall or providing overturning base restraint may be appropriate to mitigate seismic risk.
CF-3 Fall-Prone Contents. HR-not required; LS-H; PR-H.	A number of bookshelves appear to support heavy items that do not appear well secured. Heavy items on upper shelves should be restrained by netting or cabling to mitigate seismic risk.

Figure 1-2. Unbraced Shelves and Storage Units to the Left

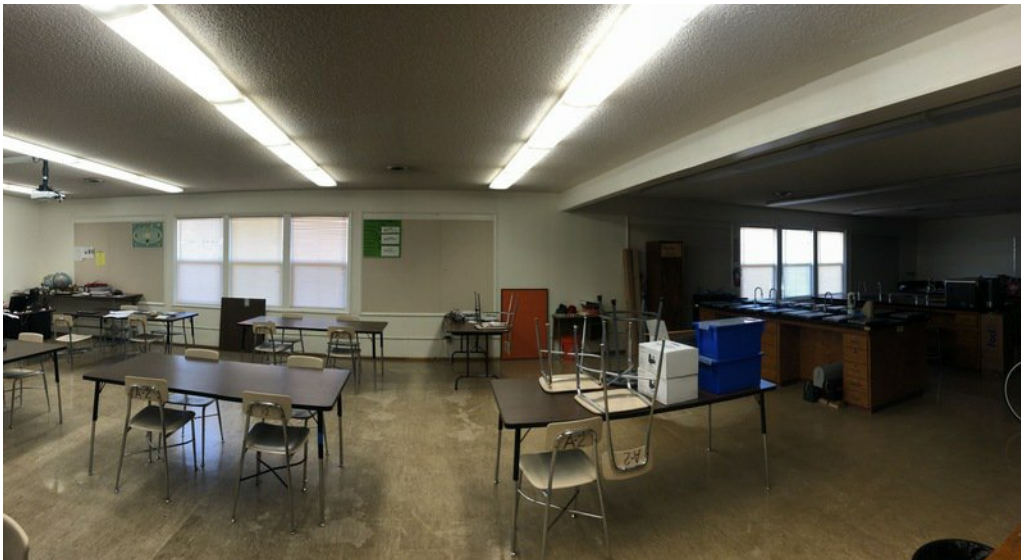
Figure 1-3. Movable Partition Wall to the Right

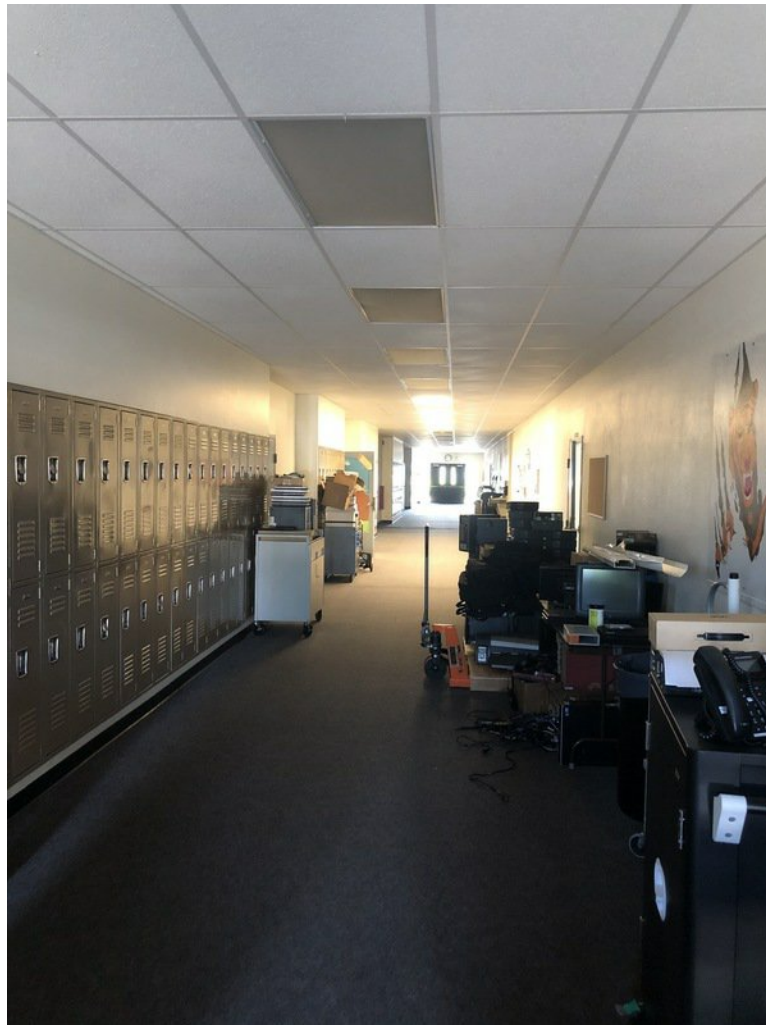
Figure 1-4. Suspended Ceiling in the Hallway

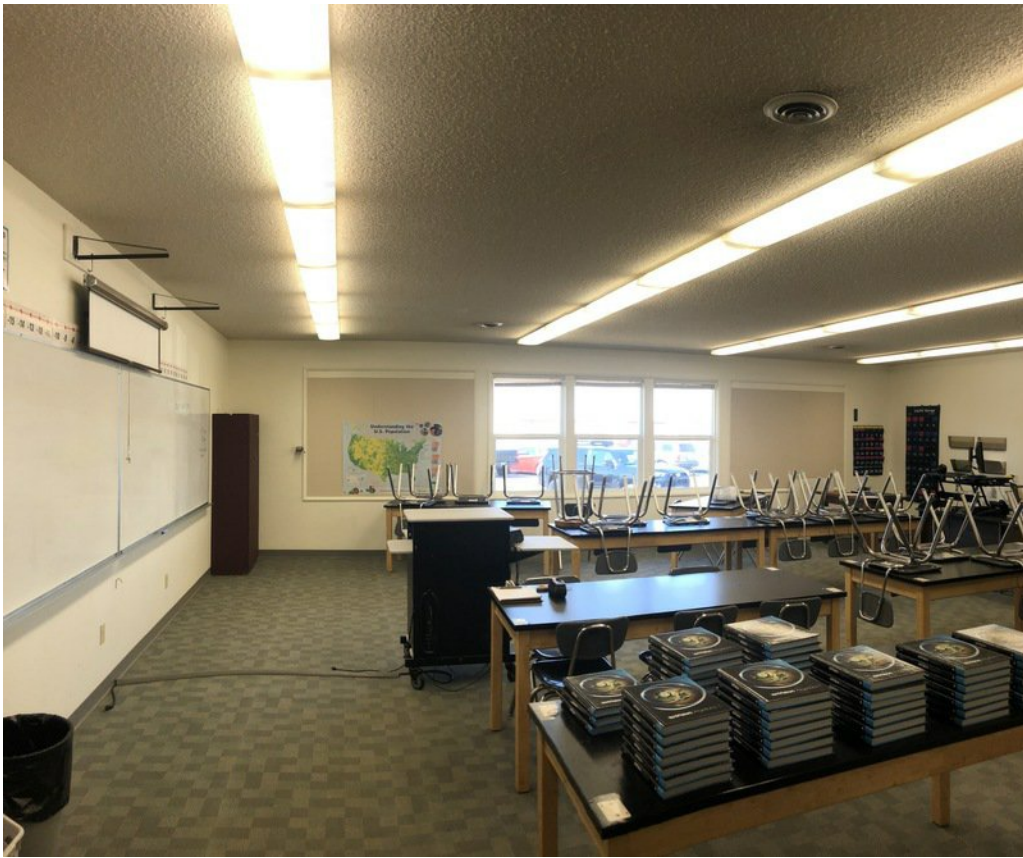
Figure 1-5. Gypsum Board Ceiling in a Typical Classroom
