Washington State  
School Seismic Safety Assessments Project

# QUILCENE HIGH SCHOOL MAIN BUILDING Quilcene School District #48

SEISMIC UPGRADES CONCEPT DESIGN REPORT

June 2021

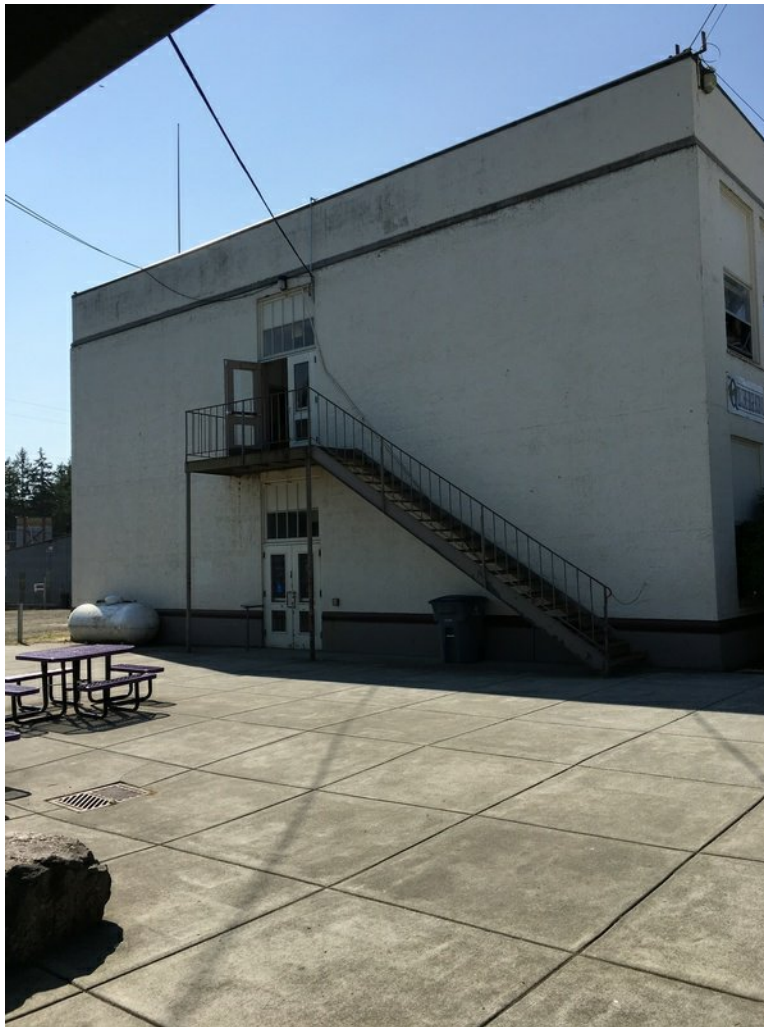
**Figure 1-2. High School, North Elevation with Decommissioned Steel Stair**

Conceptual seismic upgrade recommendations for the structural systems are provided to improve the performance of the building to meet the Life Safety structural performance objective criteria of ASCE 41-17. Sketches for the concept-level seismic upgrades are provided in Appendix B. The structural upgrades include overlaying the existing diagonal shiplap diaphragms at the second floor and roof with wood structural sheathing, providing positive out-of-plane wall anchorage to the exterior walls, and providing additional shear strength in the north-south direction with thickened concrete shear walls at the ends of the east and west exterior walls. The recommendations for nonstructural seismic improvements are to laminate or replace the large overhead glazing that can shatter during an earthquake and become sharp and dangerous overhead hazards and to remove and replace the decommissioned stair at the north end of the building.

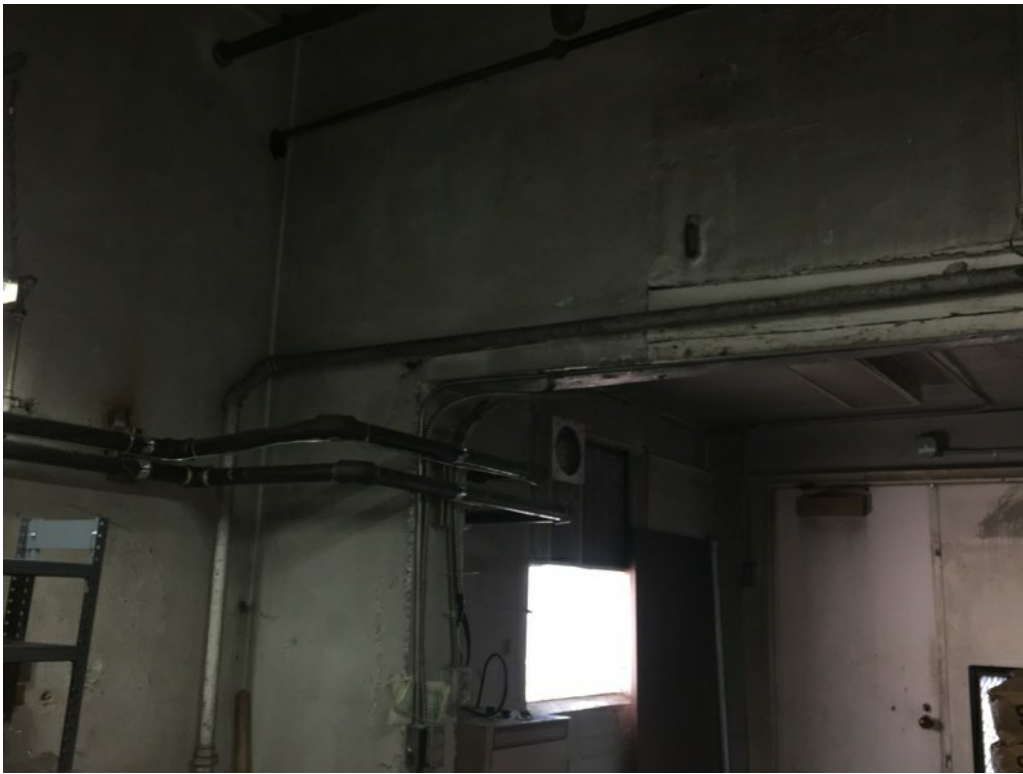
**Figure 1-6. High School, Typical Concrete Framing**

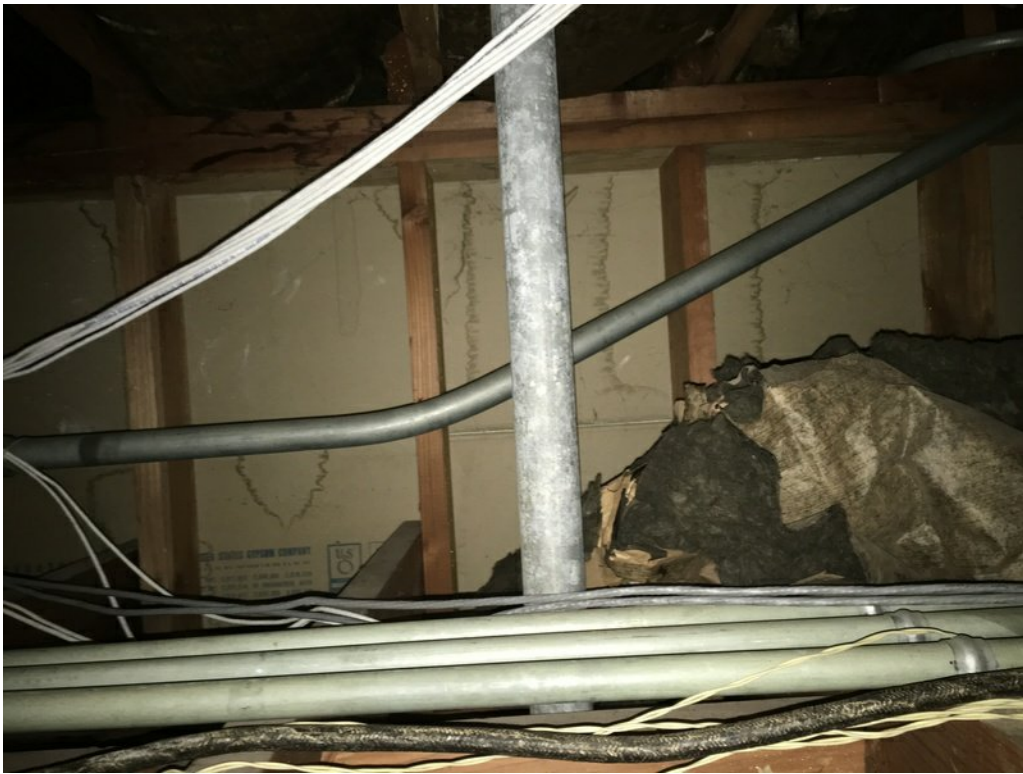
**Figure 1-8. High School, Typical Framing Above Ceiling**
