Washington State
School Seismic Safety Assessments Project

TACOMA SCHOOL OF THE ARTS PACIFIC AVENUE BUILDING Tacoma Public Schools

SEISMIC UPGRADES CONCEPT DESIGN REPORT

June 2021

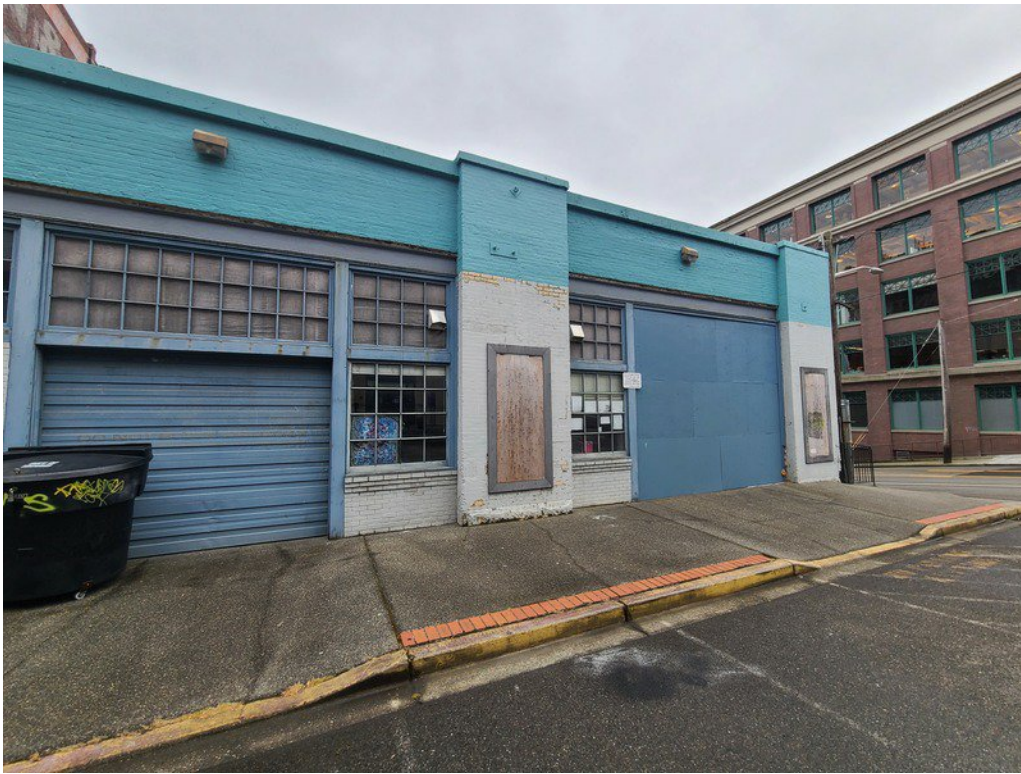
Figure 1-1. The west side of the building. Some minor deterioration is present at the URM walls.

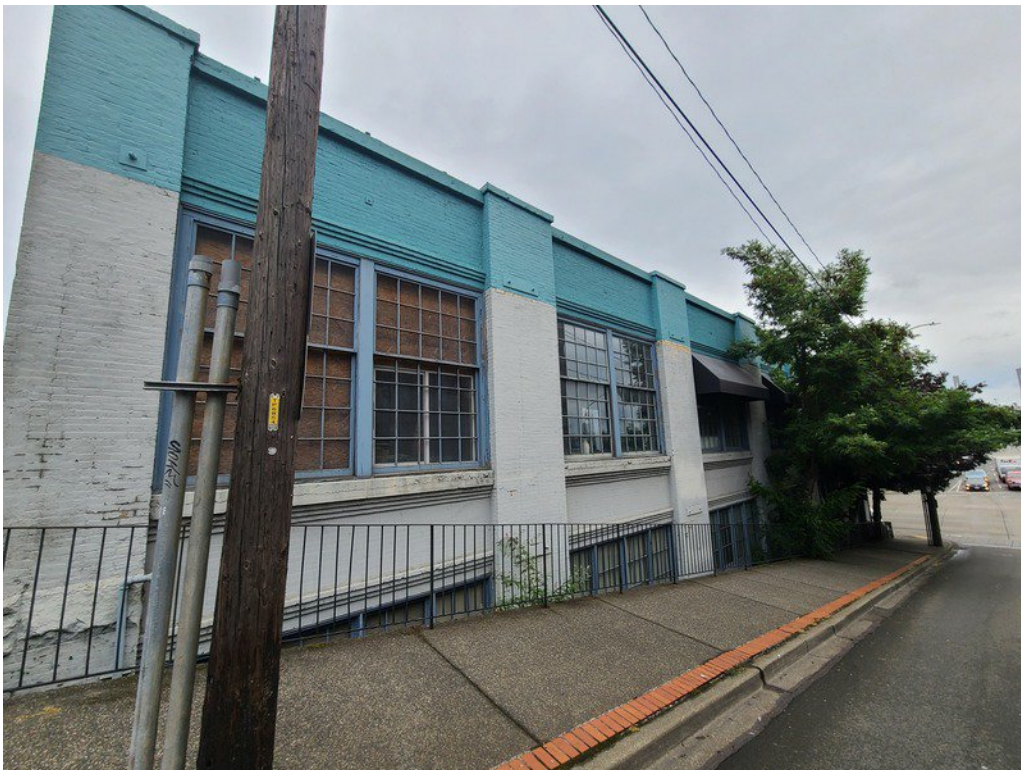
Figure 1-2. The south side of the building. Some minor deterioration is present at the URM walls

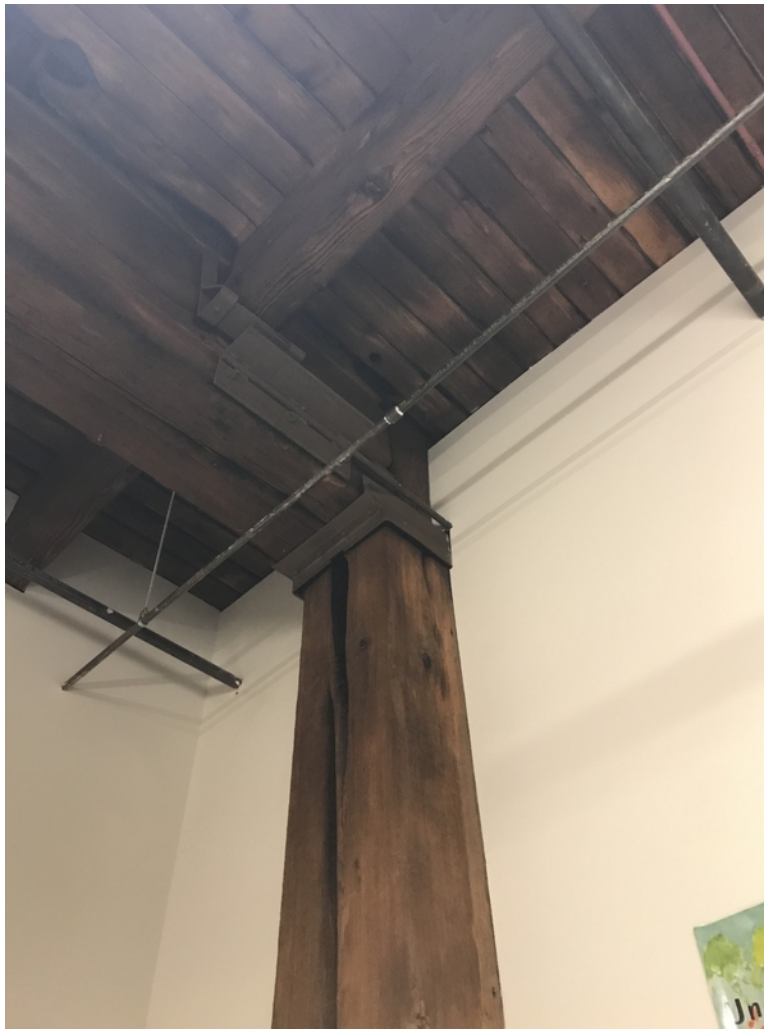
Figure 1-3. Wood post supporting a girder at a partition wall. Post has major split, and girder has minor split where it bears on the post.

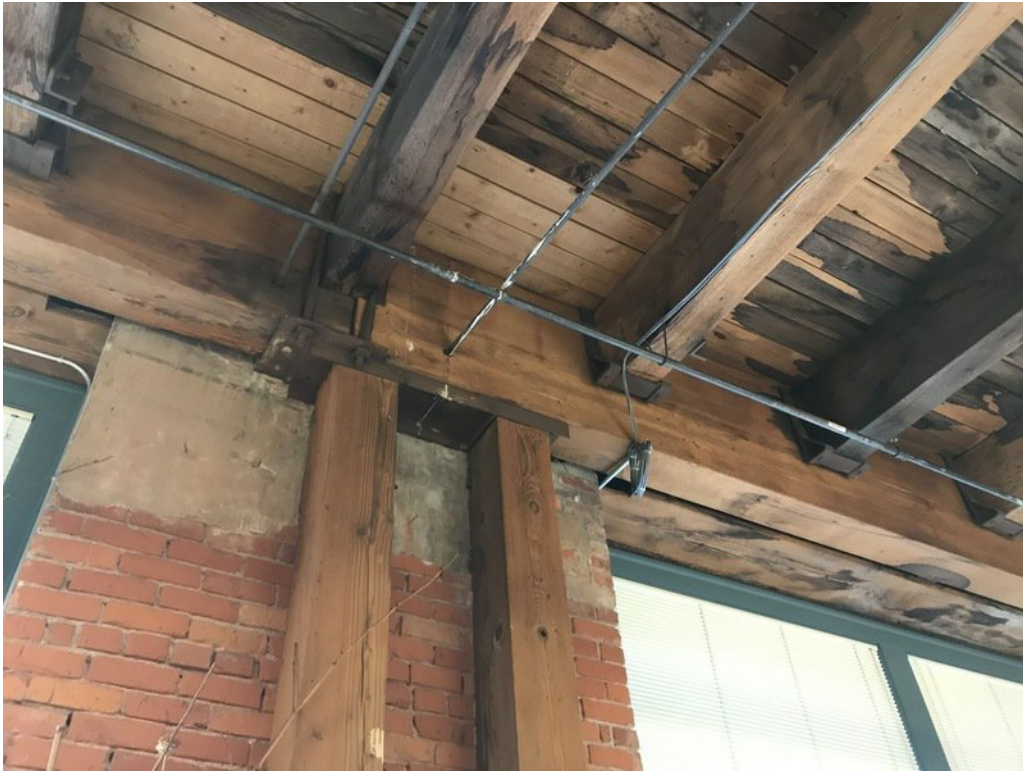
Figure 1-4. Connection of floor joists and girder at URM exterior wall.

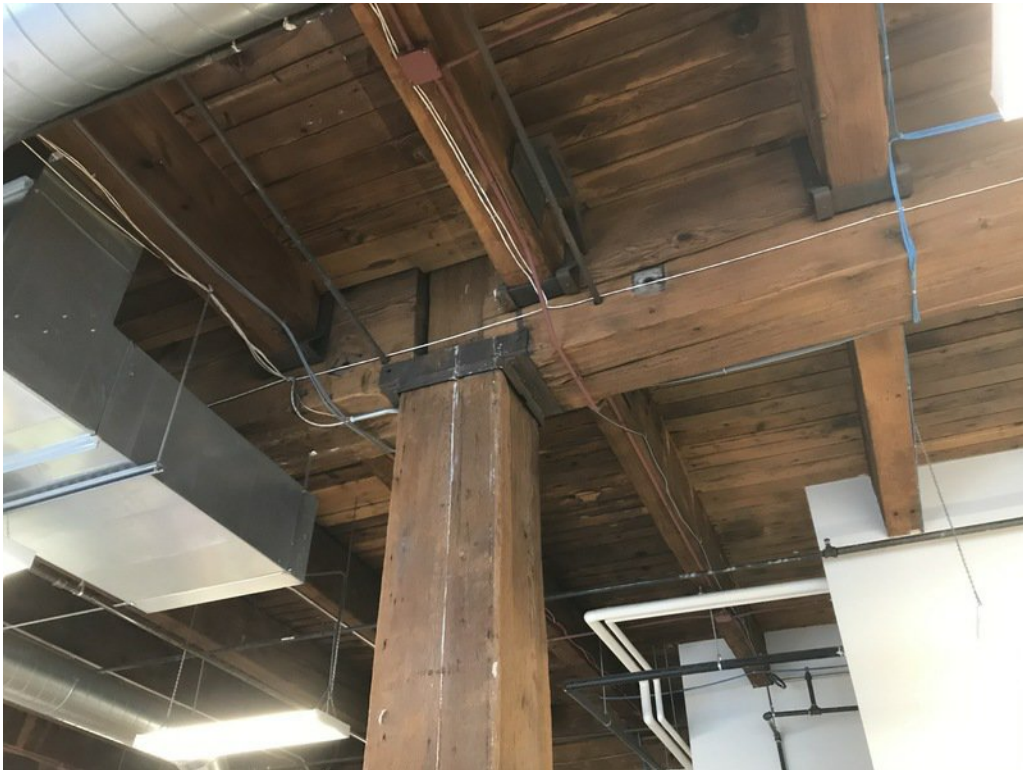
Figure 1-5. Wood post to girder connection. Some minor splitting is present in the girder.

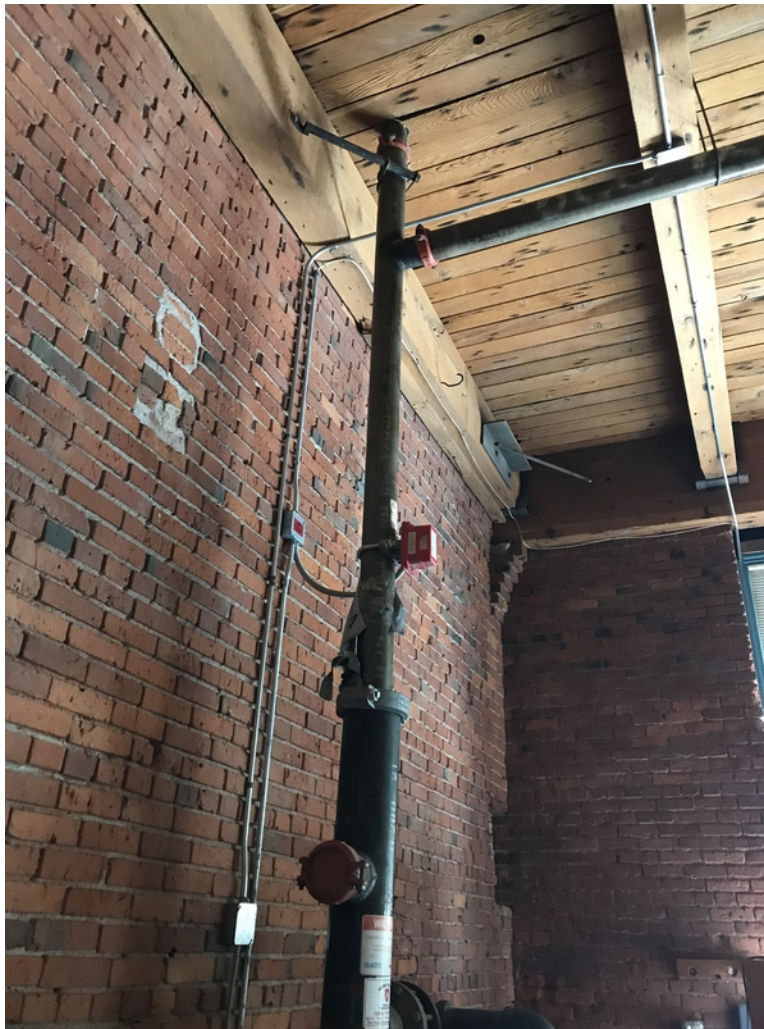
Figure 1-6. Northeast corner of the building on the first floor. Appears to be minor damage to the URM, as is common in various locations throughout the building.

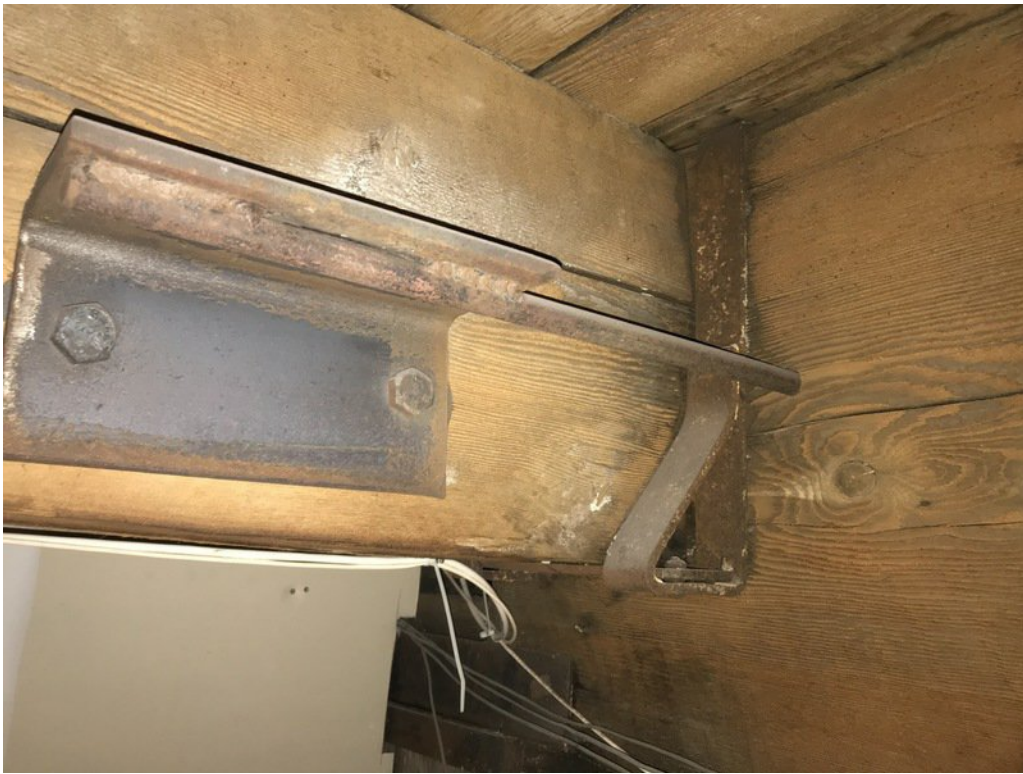
Figure 1-7. Joist to girder connection at the interior mechanical space.
