Canyon Fire Shelter Deployment and Entrapment Incident Review

CA-AFV-003151
Vandenberg Air Force Base, California
September 19, 2016

1. Executive Summary

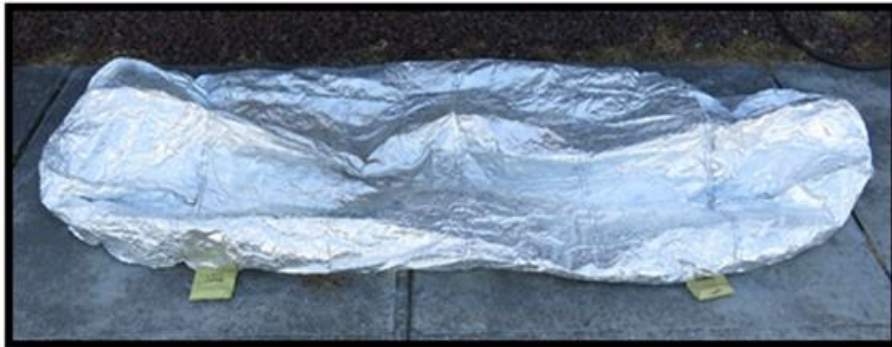
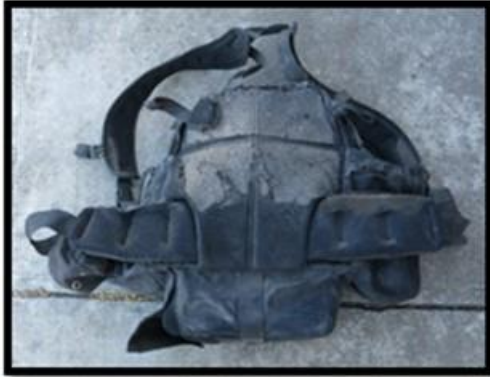
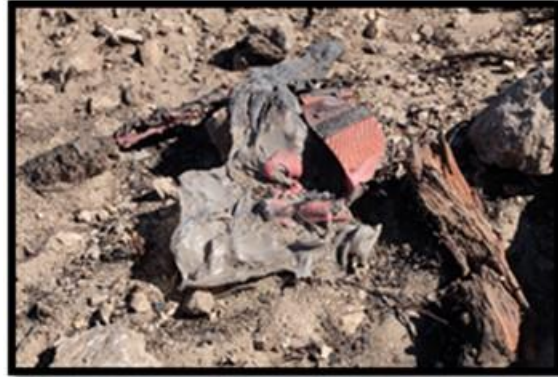
Engine Captain 253

- **Fire Shelter:** Manufacture Date – February 2014.
 - After the shelter was left at the deployment site, it was reported that the shelter was being tossed around by the wind. Dozer 2 was able to hold the shelter in place with its blade.
 - Structural Condition: A few spots of extreme heat are present. The spots were likely caused by hot embers.
- **PVC Bag:** The bag was found at the shelter deployment site, it was mostly melted.
- **Fireline Pack:** Padding cover melted.

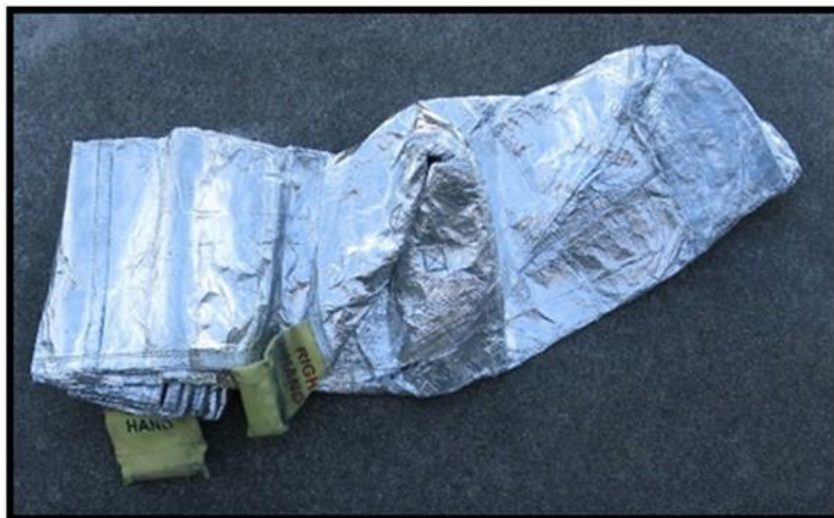
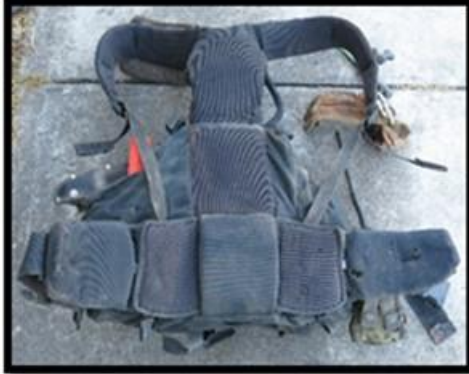
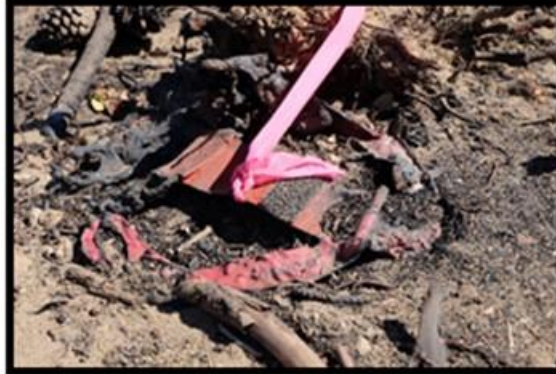
Helitack Crewmember

- **Fire Shelter:** The fire shelter was carried by the firefighter to the safety zone. It was mostly accordion folded.

- **PVC Bag:** The bag was found at the pack drop site, it was mostly melted.
- **Fireline Pack:** Numerous melt spots were present on the pack, most likely caused by hot ember contact during the entrapment.

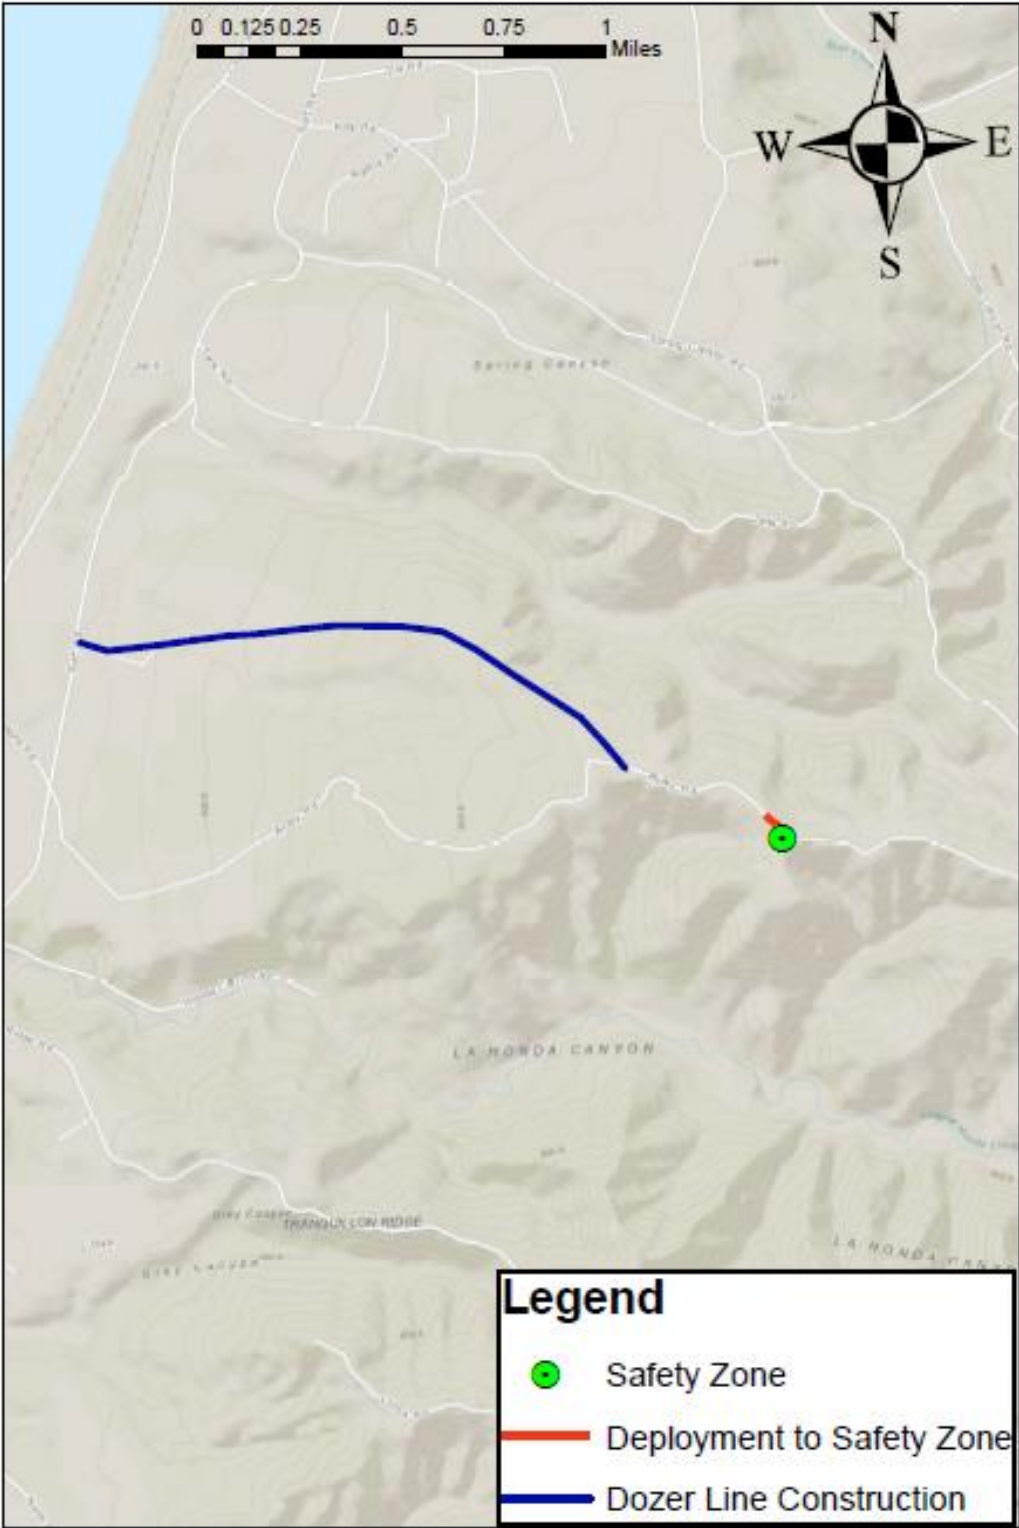
Map of Safety Zone, Dozer Line Construction, and Deployment Sites

- **Latitude x Longitude:** 34°36'42.81"N x 120°35'55.66"W
- **Elevation:** 1,025 feet.
- **Description:** The deployment sites were directly adjacent to Avery Road, 388 and 524 feet from the safety zone. The dozer widened the road to use it as control line. The majority of the south side of the road was black from the earlier burning operation. The north side of the road was considered green with 2 to 10-foot tall brush and small trees. Because the fire spread direction was to the north, the site received mostly radiant heat. Locations of all equipment was marked by flagging.
