NCHRP Report 350 Test 3-71
Of the Multi-Barrier Model MB-42x72 JSS LCB
Longitudinal Channelizing Barricade System
TRC Inc. Test Number: 061221

Prepared by:
Transportation Research Center Inc.
10820 State Route 347
East Liberty, OH 43319

Final Report
December 2006 - January 2007

Prepared for:
Off the Wall Products, LLC
180 South 300 West, Suite 314
Salt Lake City, UT 84101

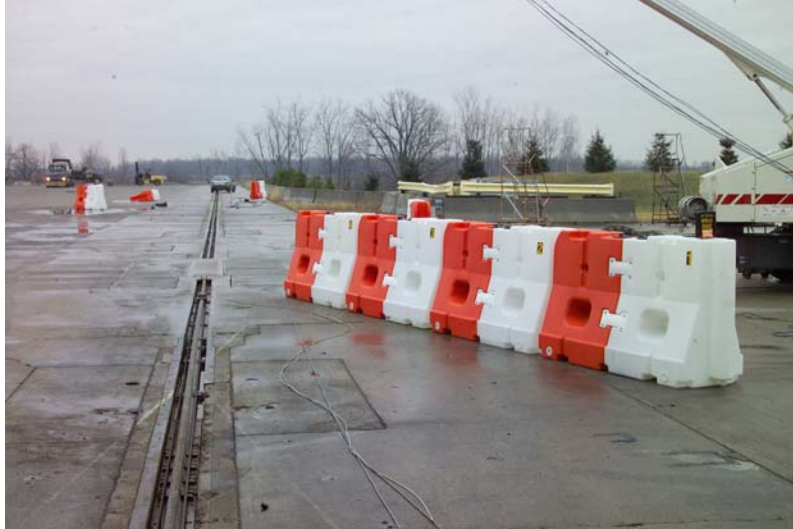
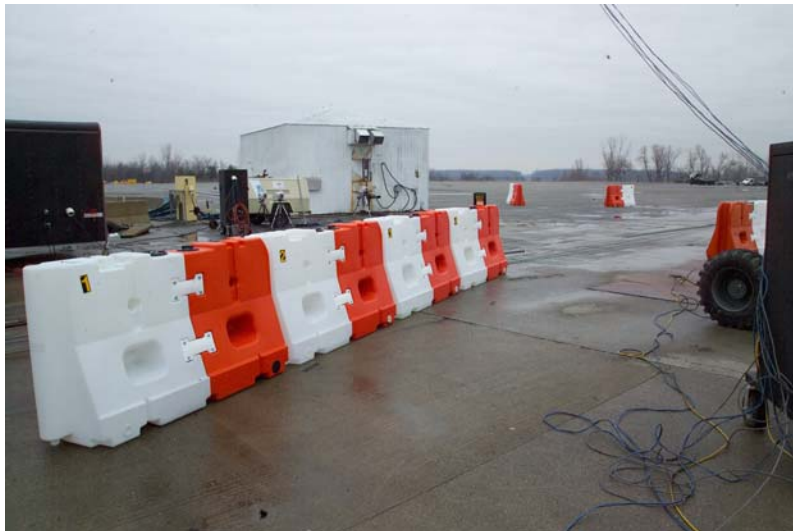
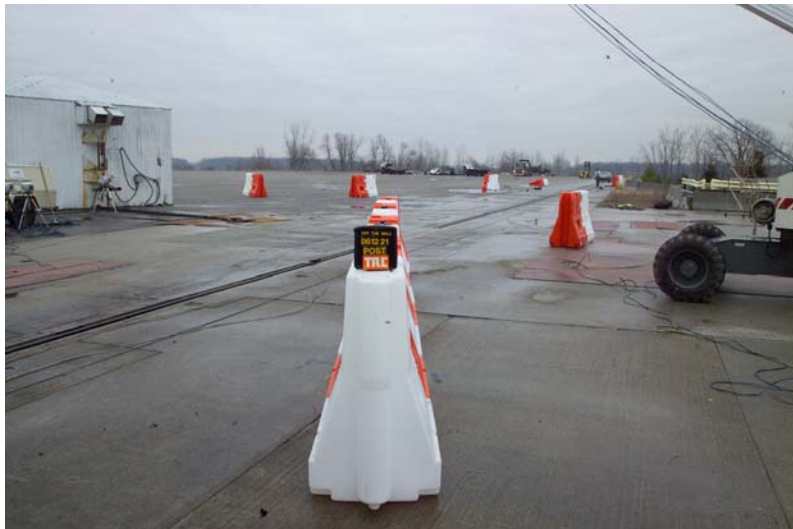
Figure 7. MB-42x72 JSS LCB channelizing barricade system after test 061221

Five of the ten individual barricade sections that made up the Multi-Barrier Model MB-42x72 JSS LCB channelizing barricade system, barricades 6, 7, 8, 9 and 10, were displaced outside of the immediate impact zone as shown in Appendix A, A-37, A-39, A-41, A-43, A-45, A-47, A-50, A-56, A-57, A-58, A-59, A-60, A-67, A-68, A-69, A-70 and A-71.

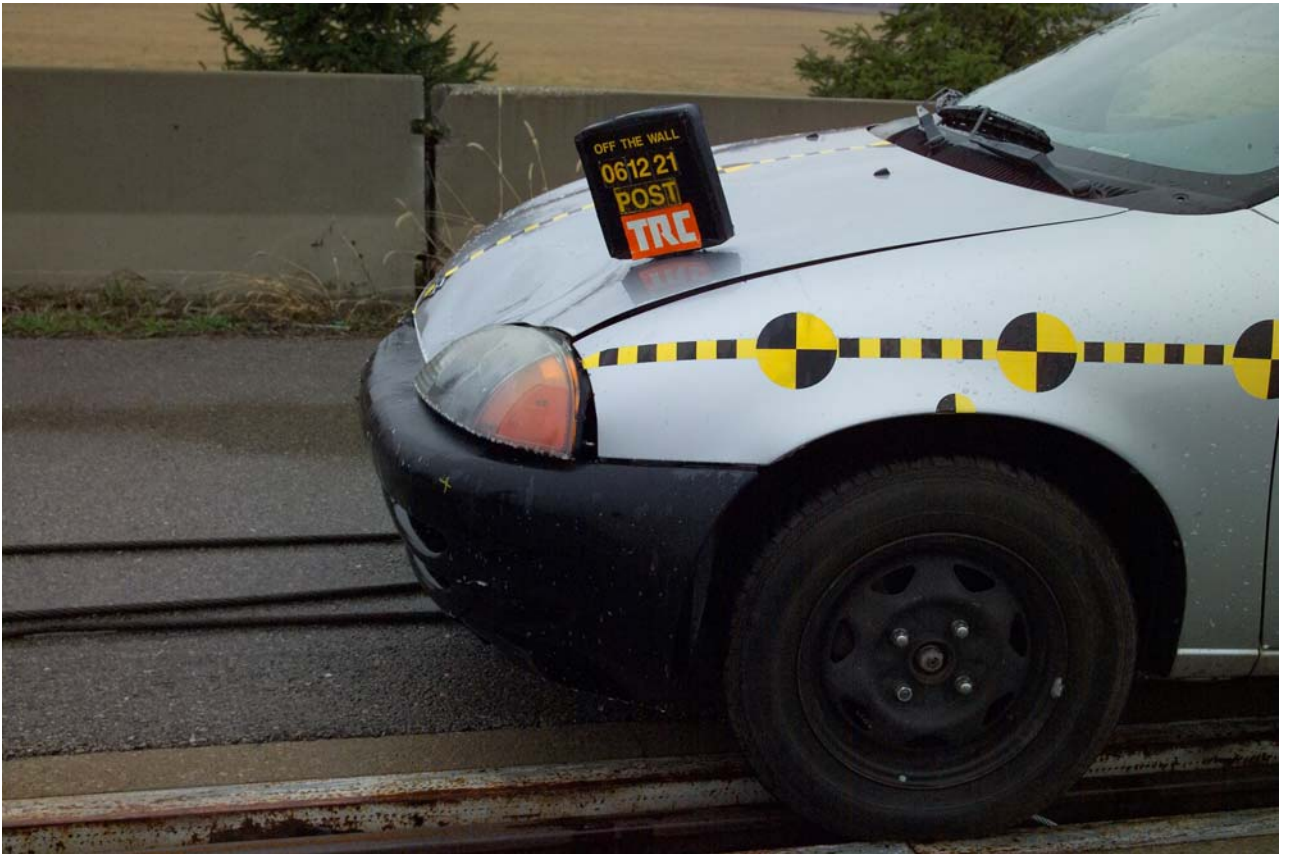
Figure A-17 Post-Test Vehicle Damage - View 1

Most of the damage to the vehicle was to the front and right front sides as shown in Appendix A, Figures A-2, A-14, A-16, A-17 and A-18. The bumper, hood and right fender were moderately damaged. Maximum crush to the exterior of the vehicle was 280 mm. No measurable crush was evident to the occupant compartment of the vehicle.

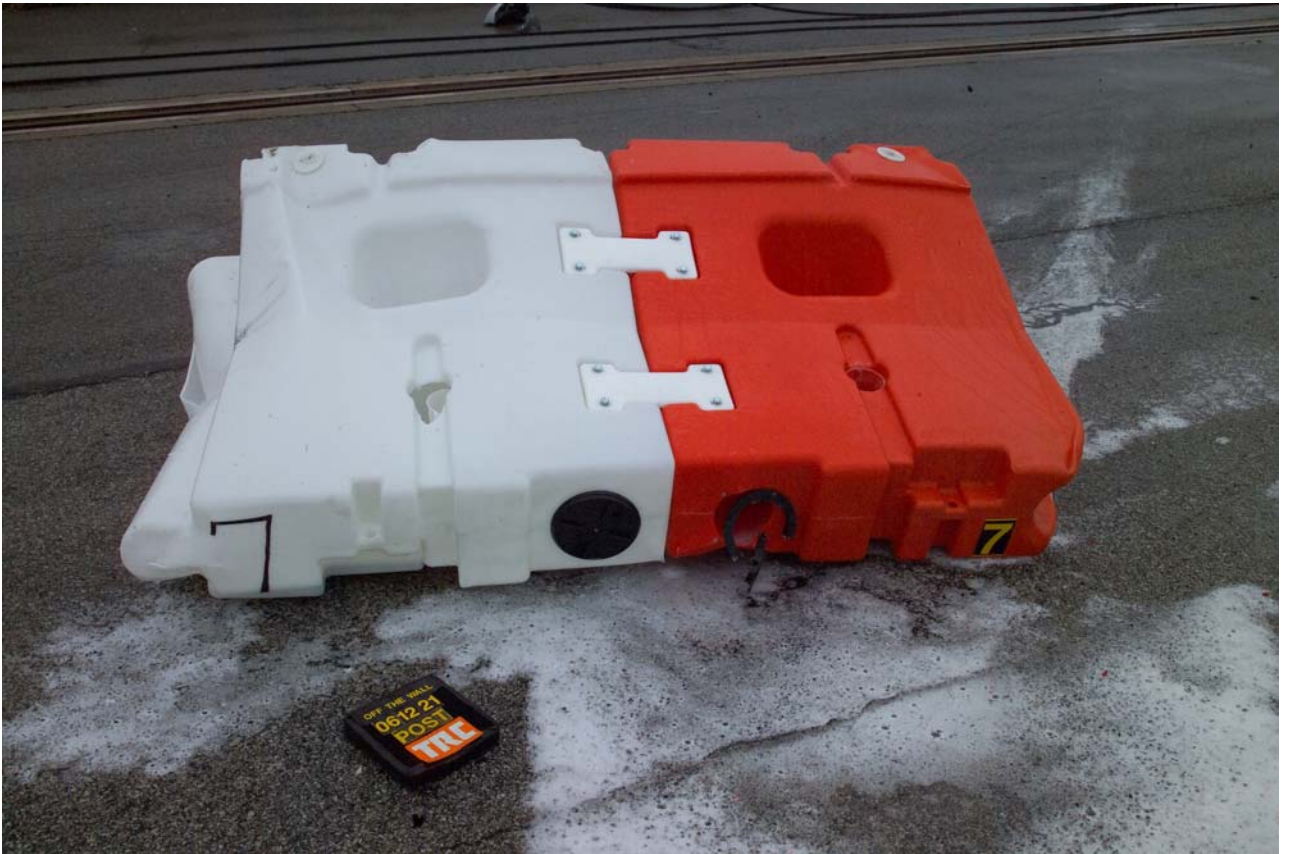
Figure A-57 Post-Test Barricade 7 View

Individual barricade sections 5, 6, 7, and 8 incurred damage to their overall outer shell sidewalls, being scored or ruptured, as shown in Appendix A, Figures A-57, A-58, A-61, A-62, A-63, A-64, and A-65.
