Macondo

T H E G U L F O I L D I S A S T E R

Chief Counsel's Report | 2011

National Commission on the BP Deepwater Horizon Oil Spill and Offshore Drilling

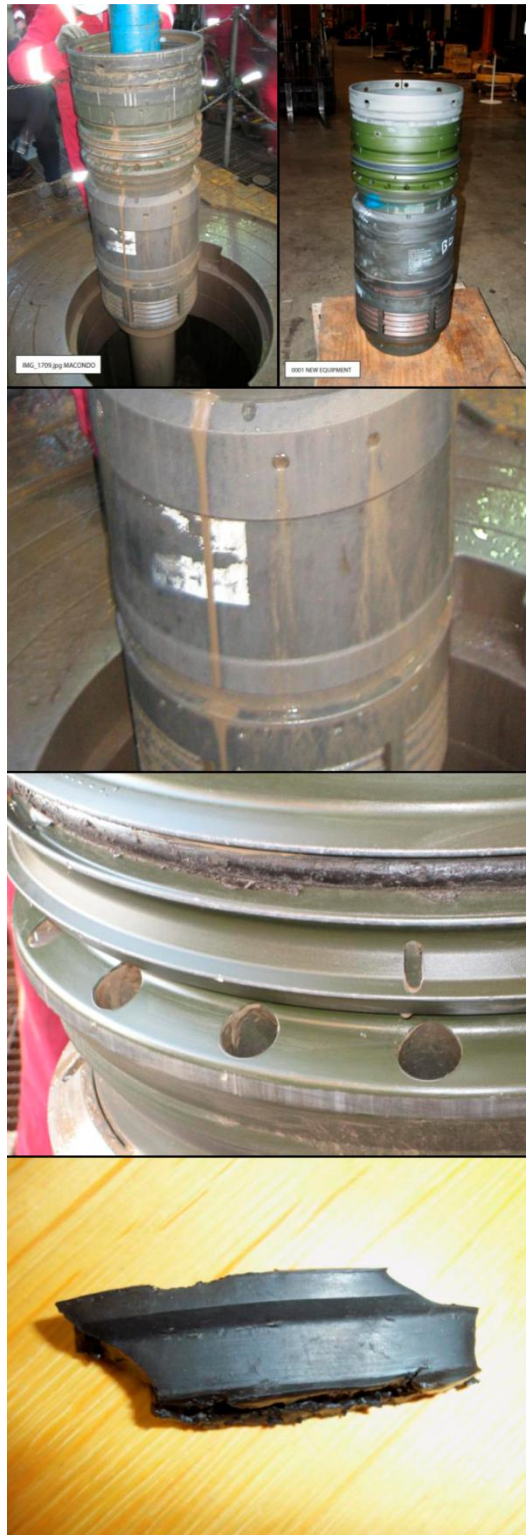
- Figure 4.1.4. Exterior of the Macondo production casing hanger and seal assembly. The outside surfaces of the Macondo casing hanger and seal assembly show no damage (left). They have no erosion-induced channels. Instead, they resemble the condition of brand-new equipment (right).

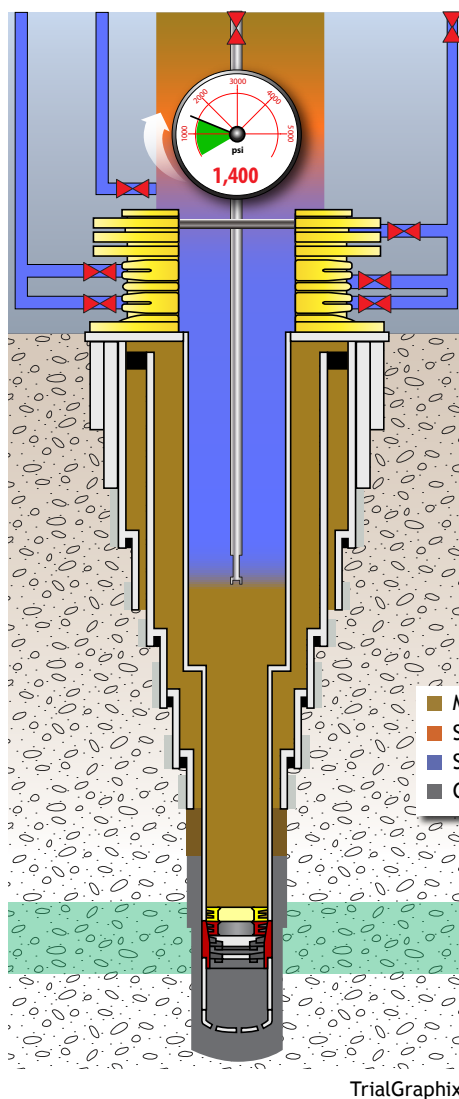
Figure 4.6.7. First test failure.

During the first negative pressure test, the crew repeatedly bled the drill pipe pressure down to 0 psi. However, more fluids bled than expected, and the drill pipe pressure repeatedly increased. After the last bleed, the drill pipe pressure rose from 0 to 1,400 psi, a clear failure.

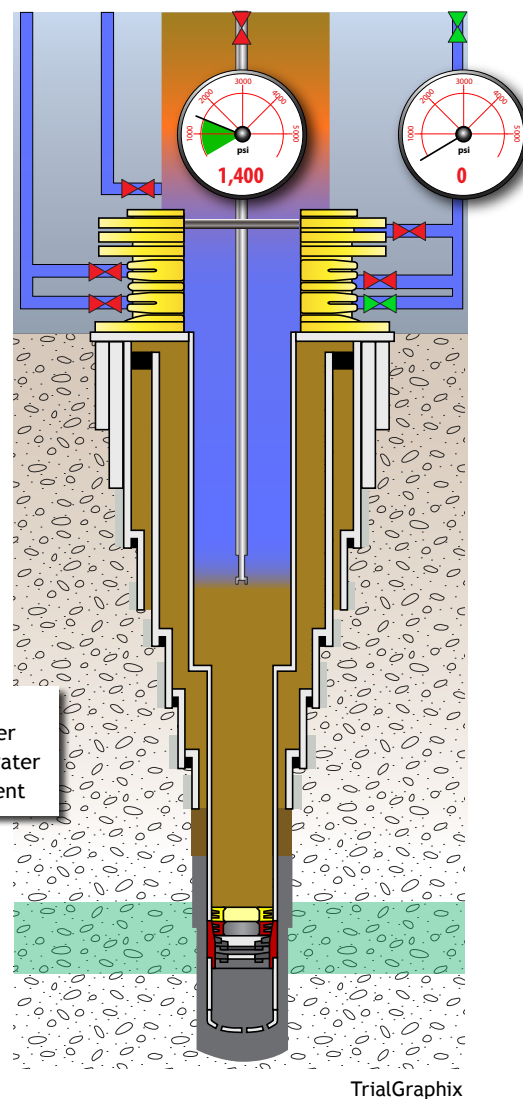
Figure 4.6.8. Second test failure.

During the second negative pressure test, the crew bled off the pressure in the kill line, rather than the drill pipe. The crew observed no excessive flow or pressure buildup on the kill line. The well site leaders and rig crew decided this was a successful test. But they had never accounted for the pressure on the drill pipe, which remained at 1,400 psi throughout the second test.

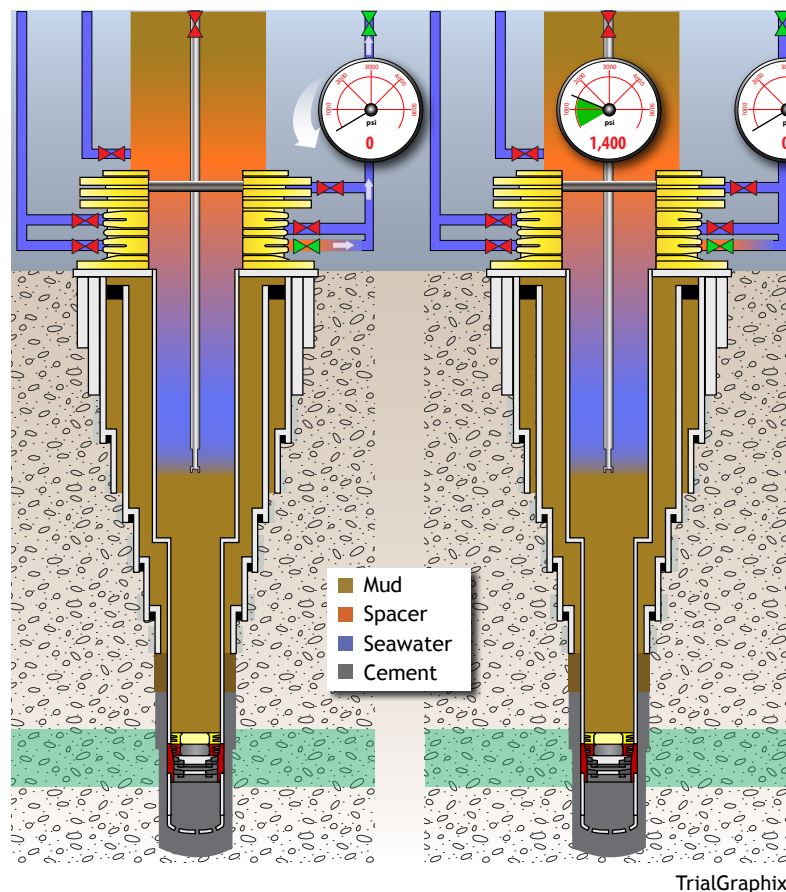
Figure 4.6.18. 6:40 p.m.

The rig crew conducted a negative pressure test on the kill line. The rig crew reduced the pressure on the kill line to 0 psi, bleeding an insignificant amount of water (left). No flow or pressure buildup was observed on the kill line, which on its own would have been a successful negative pressure test. However, the 1,400 psi on the drill pipe remained and was never properly accounted for (right).
