Kauffman Stadium Assessment

JCSCA + Burns & McDonnell

This document contains information pertaining to the condition of Kauffman Stadium as documented by the Jackson County Sports Complex Authority (JCSCA), including descriptions, conditions, and exhibits which have been reviewed by Burns & McDonnell and documented in this report.

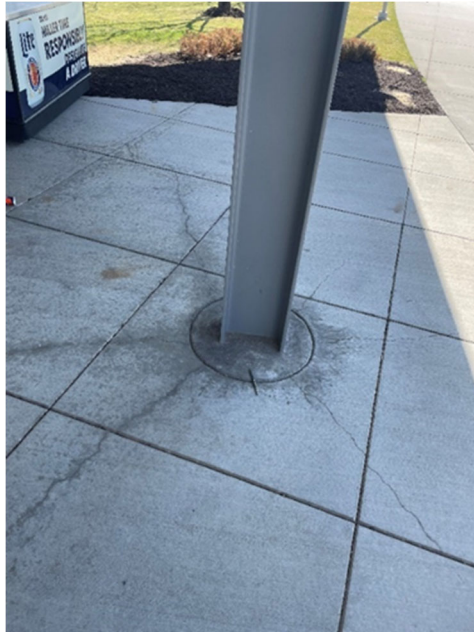
Kauffman Stadium is comprised of a significant amount of paved area within the concourse. These paved areas serve mostly as access walkways for pedestrians to traverse the stadium grounds, both inside and outside the security fencing. In addition to the walkways, stairs, curbing, and retaining walls make up the site flatwork. Overall, the site flatwork at Kauffman Stadium was observed to be in satisfactory condition, apart from a few mild site defects. **Figure C-1.1** and **Figure C-1.2** shows an example of site pavement cracking.

Figure C-1.1: Star Cracking at Column Foundation
Location: Outfield Plaza

- Pavement cracking throughout the stadium concourse should be monitored closely or repaired. Cracks exceeding ¼" in width should be replaced or sealed to avoid pavement damage during freeze-thaw conditions. Significant displaced of pavement can create a tripping hazard for pedestrians and are aesthetically unpleasant. Refer to **Figure C-1.1**, **Figure C-1.2**, **C-7**, and **Figure C-8** for examples.
- Broken or damaged site appurtenances and rust discoloration. An example shown in **Figure C-6** don't pose as a hazard for stadium visitors but will improve the stadium's overall aesthetic quality.
- Keep open areas near dugouts clear and tidy. See **Figure C-11** for an example of an area that could be tidied.

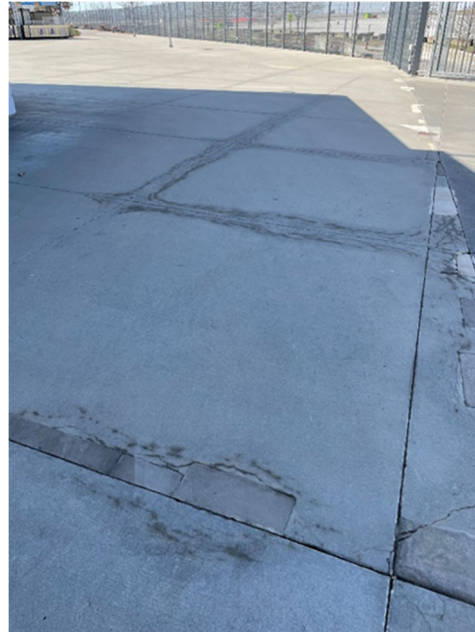
Figure C-1.2: Concrete Cracking
Location: Unknown

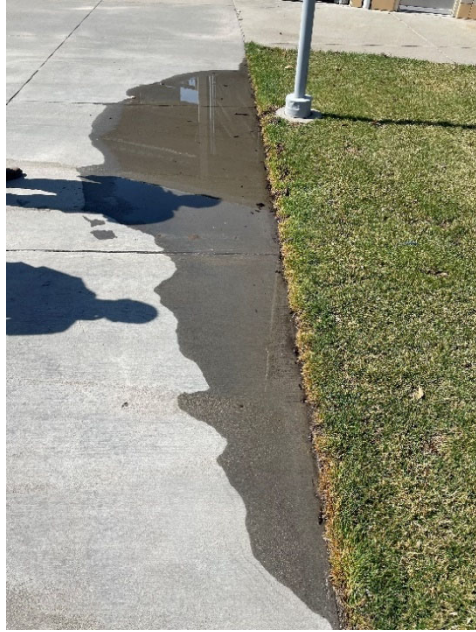
Standing water (in relative low points) was a common site defect observed. **Figure C-2** displays an area of concrete adjacent to a grassed area that is not draining effectively.

Figure C-2: Water Ponding
Location: Near Gate A

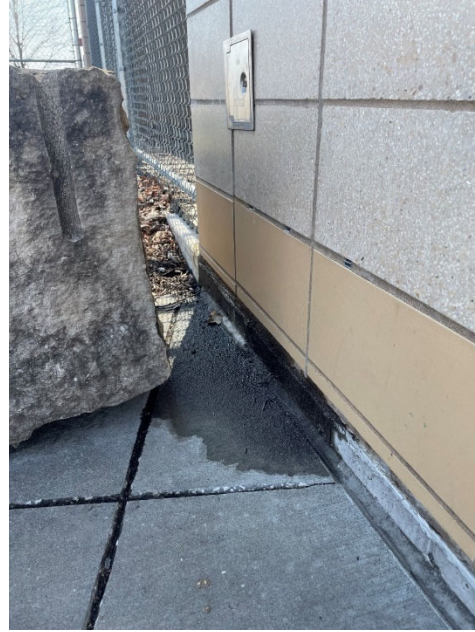
Figure C-3.1: Water Seepage
Location: Janitor's Closet (J251)

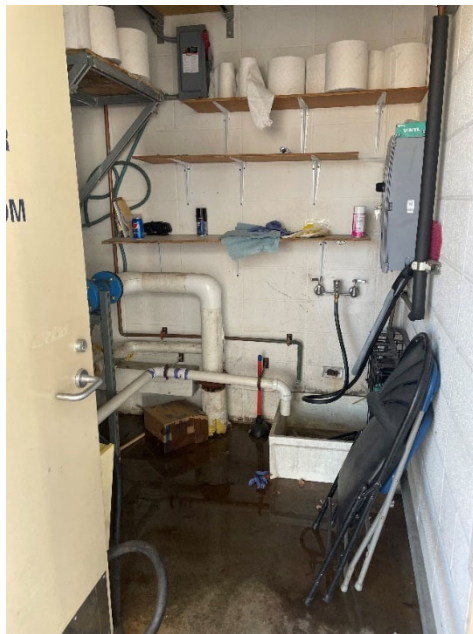
Figure C-3.2: Water Ponding in Janitor's Closet
Location: Janitor's Closet (J251)

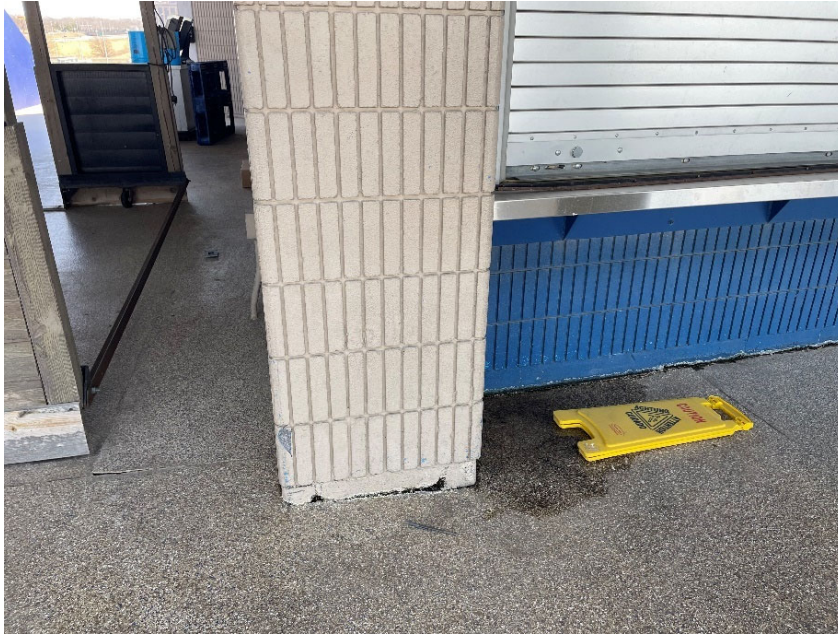
Figure C-4.1, **Figure C-4.2**, and **Figure C-5** portray other examples of walking surfaces that are trapping water. A puddle in a doorway can be a slipping risk. Additionally, sitting water at the base of a wall can infiltrate the material and over time, wear on the wall, especially as freeze/thaw conditions arise. This concern is valid also in **Figure C-3.1**, **Figure C-3.2**, and **Figure C-3.3**. Ponding inside of the Janitor's Closet has led to a seepage from the interior of the room to the exterior façade. This door was open at the time of the assessment.

Figure C-4.1: Concession Stand, Holding Water
Location: Upper Concourse Concessions Stand

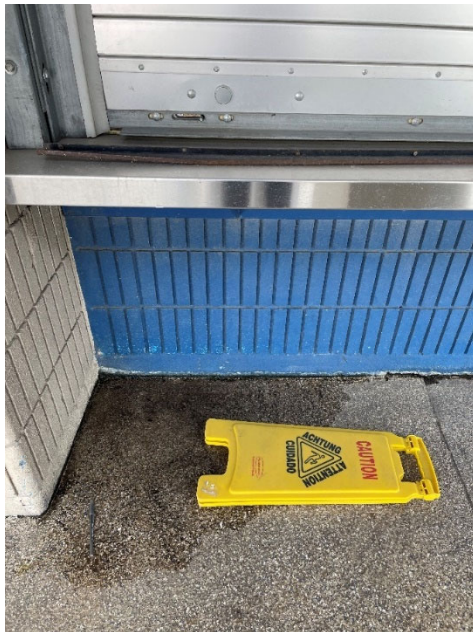
Figure C-4.2: Concession Stand, Holding Water
Location: Upper Concourse Concessions Stand

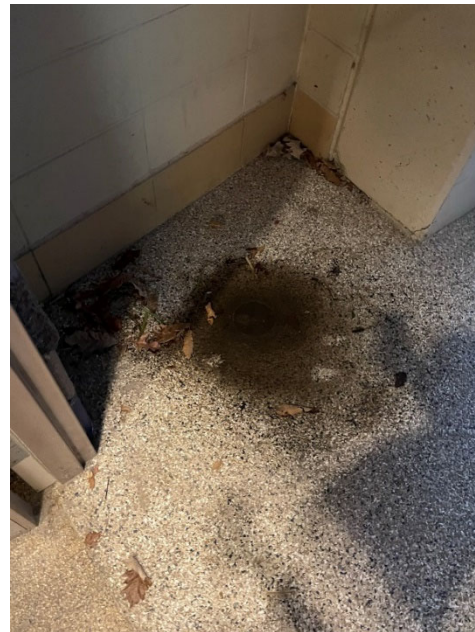
Figure C-5: Water Ponding
Location: Women's Restroom, Around Section 216

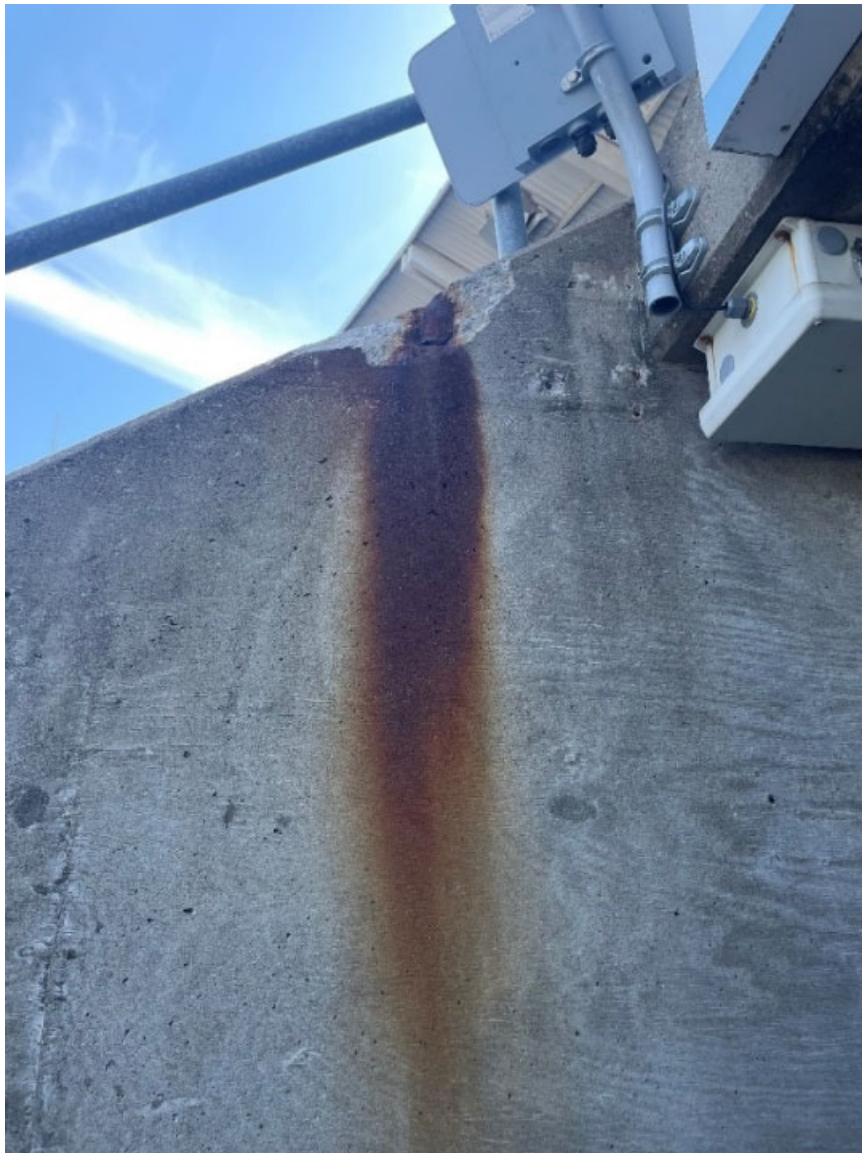
Location: Outfield, Upper Concourse

Other items of aesthetic concerns are shown in **Figure C-6**, as rusted metal discoloration has traveled down the face of the concrete wall.

Figure C-6: Concrete Discoloration Due to Eroded Metal

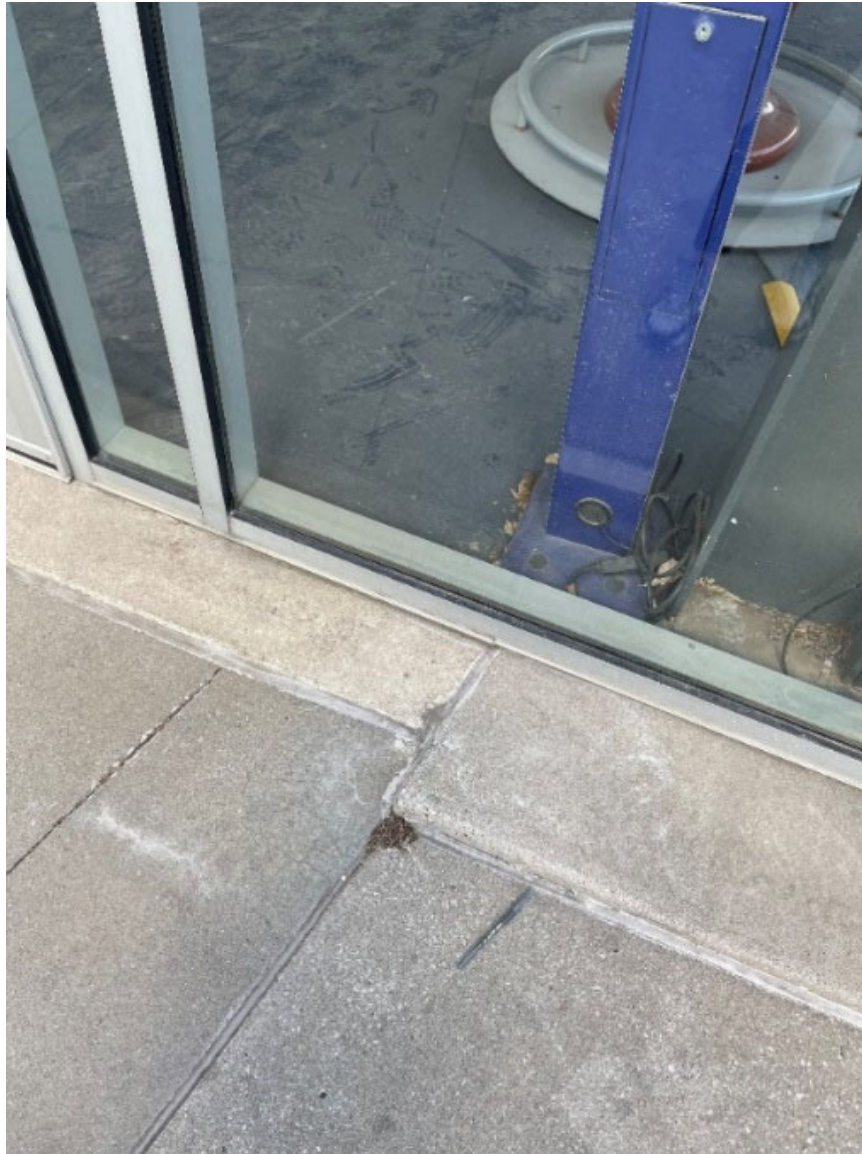
A minor item that was raised as a concern during the assessment walk was the existence of tripping hazards. **Figure C-7** shows a particular intersection of concrete that could be a tripping hazard. Additionally, **Figure C-8** shows an eroded step edge in the H&R Block Private Suite which could also pose a tripping hazard.

Figure C-7: Tripping Hazard, Uneven Pavement Intersection
Location: Adjacent to Miller Lite Fountain Bar

- Any major pavement faulting (1" or greater) observed or warned of in this report will need to be addressed. Displaced pavement from freeze-thaw conditions can be a tripping hazard and is a threat to pedestrian safety.

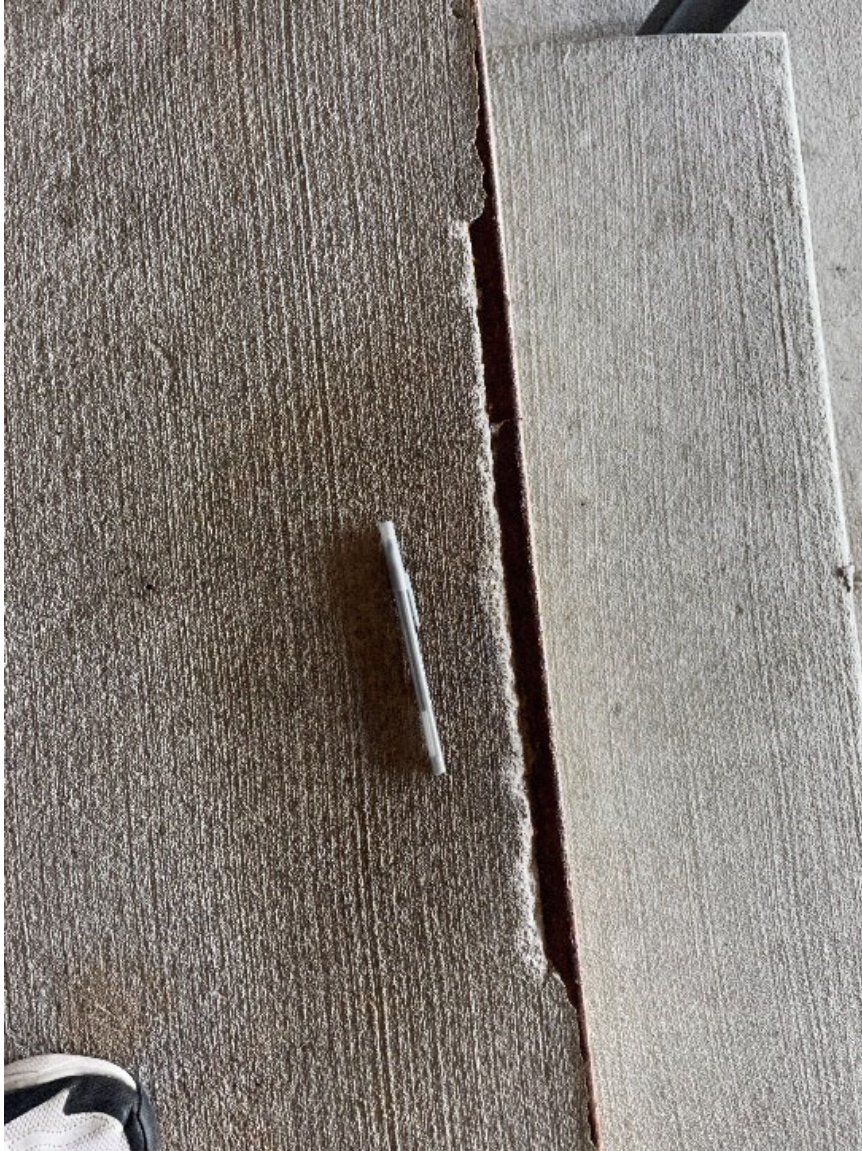
Figure C-8: Eroded Step Edge
Location: H&R Block Private Suite Stairs

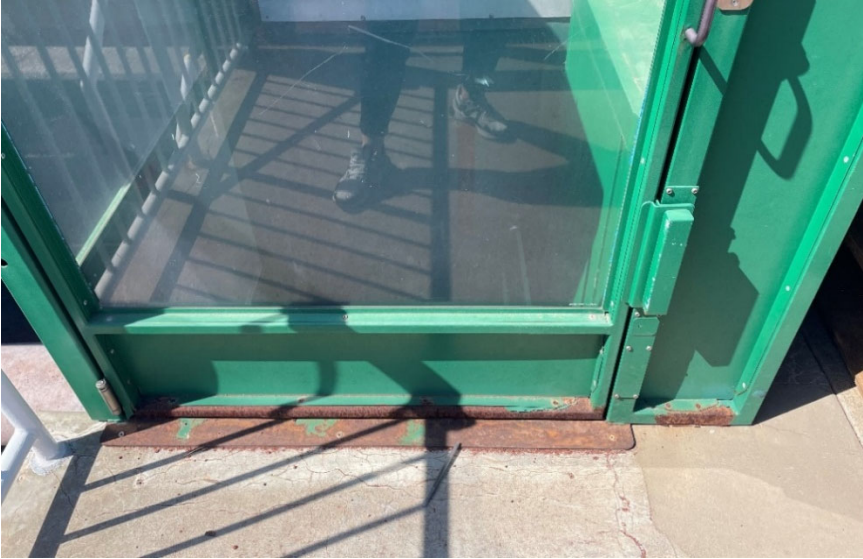
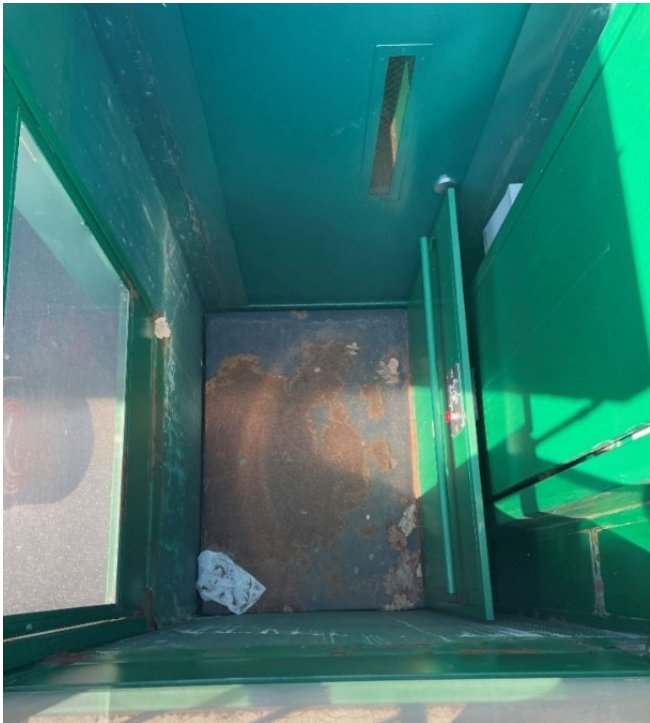
Site features that allow access to areas of the stadium were in mostly acceptable condition. A few site defects include the rust on the elevator from the underground to the ground level/ field level, as shown in **Figure C-9.1** and **Figure C-9.2**.

Figure C-9.1: ADA Elevator
Location: Adjacent to Dugout

Figure C-9.2: ADA Elevator
Location: Adjacent to Dugout

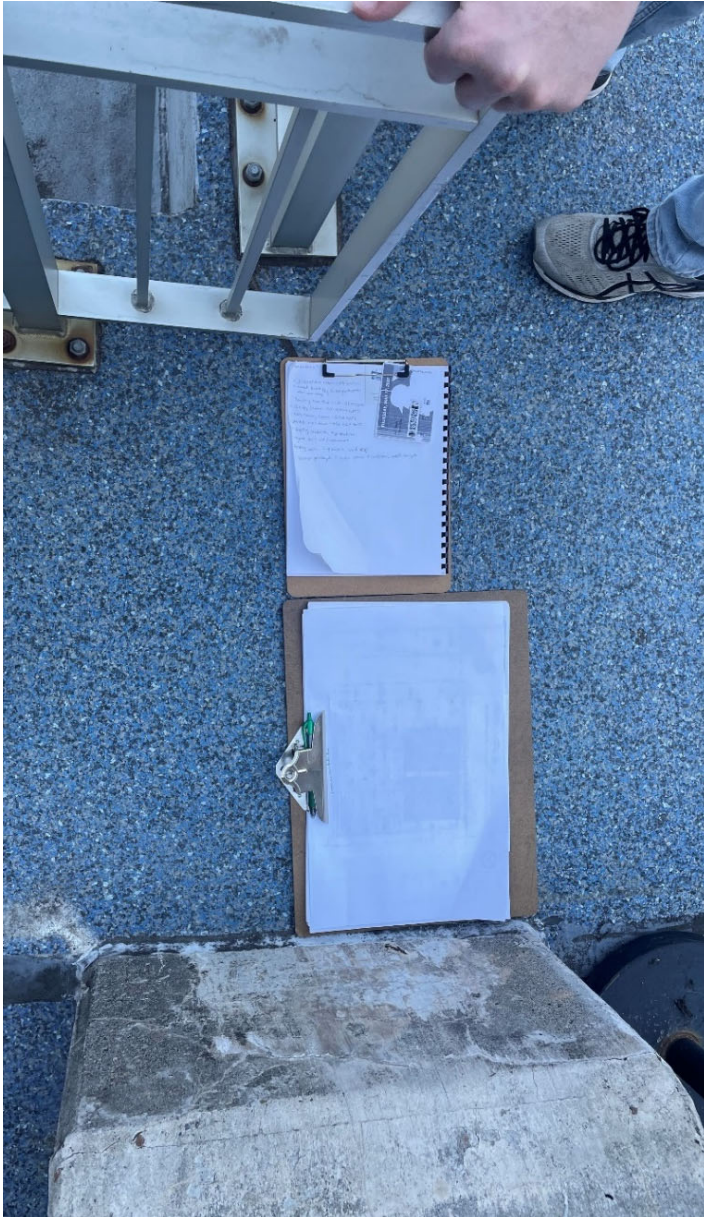
In the upper concourse, on the first base-side, there was an ADA watching platform that was surrounded by metal gates. These gates and the protruding column provide a tight window for a wheelchair, as seen in **Figure C-10**. This access point to the ADA watching platform should be reviewed for wheelchair accessibility.

Figure C-10: ADA Seating Area Fence
Location: Upper Concourse

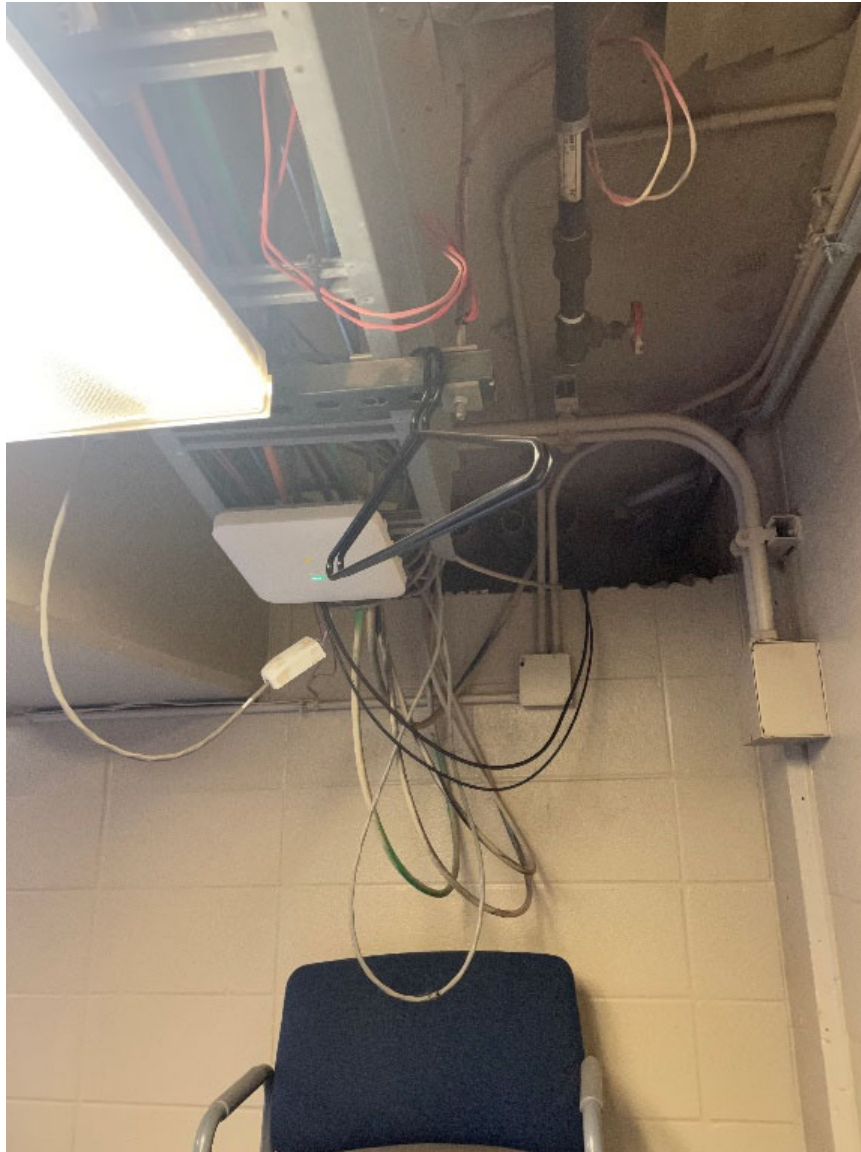
In the underground passageway near the dugout, some cable management is needed. No items should be hanging off the cable tray, as shown in **Figure C-11**.

Figure C-11: Cable Management Needed
Location: Tunnel by Dugout

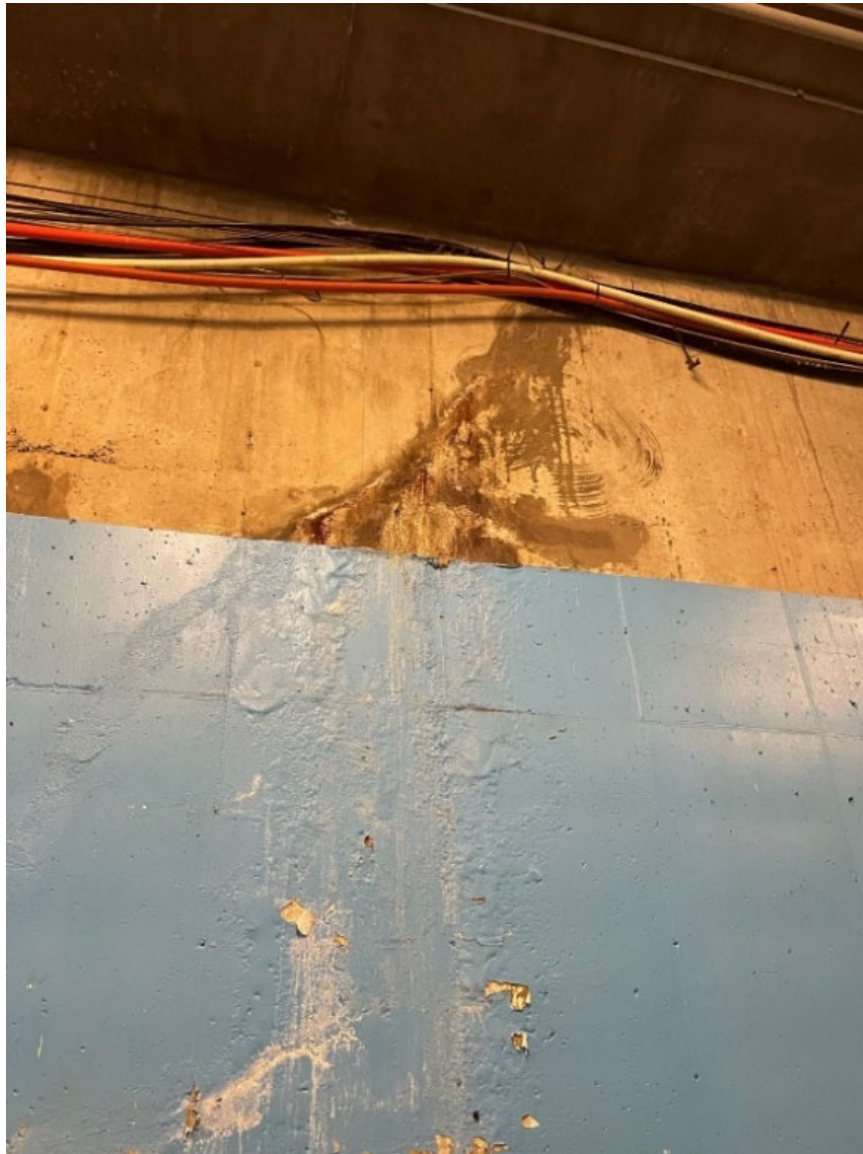
Location: Underground tunnel connecting Kauffman & Arrowhead

No significant settlement of the structure was observed. The slab-on-grade is primarily in satisfactory condition. No major cracks or spalling of the concrete slab-on-grade was observed. There was some water damage observed in the underground tunnel which connects Kauffman to Arrowhead Stadium, as show in **Figure S-1**.

Figure S-1: Water Damage

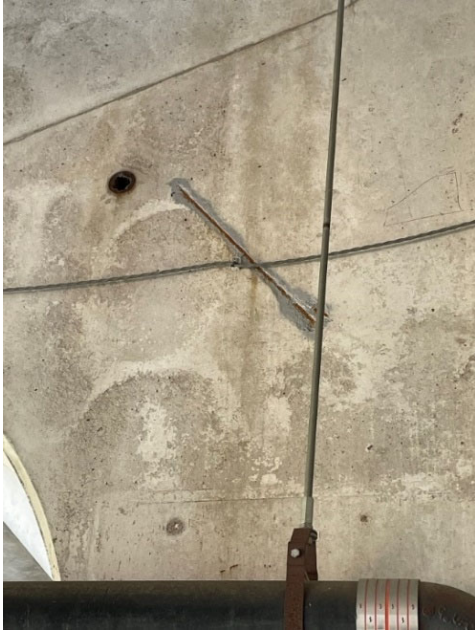
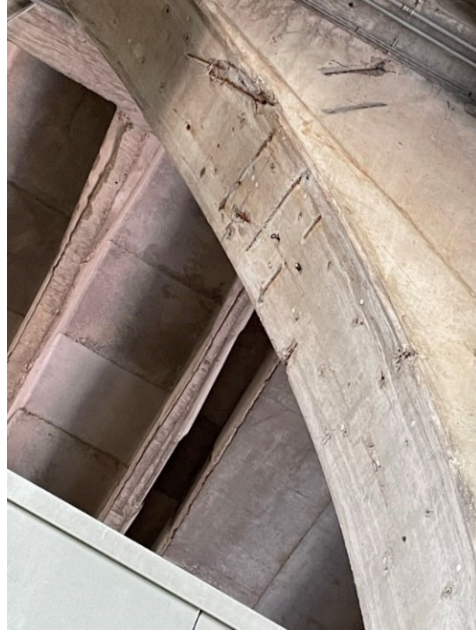
Figure S-2: Exposed Reinforcement
Location: Typical Outdoor Seating

- Concrete cracking and spalling should be routinely monitored and patched to ensure rebar corrosion does not worsen.
- Continued, routine monitoring of these areas is recommended. Concrete patchwork is recommended within the next 1 to 2 years.
- Locations where handrails were missing, it is recommended to replace immediately.

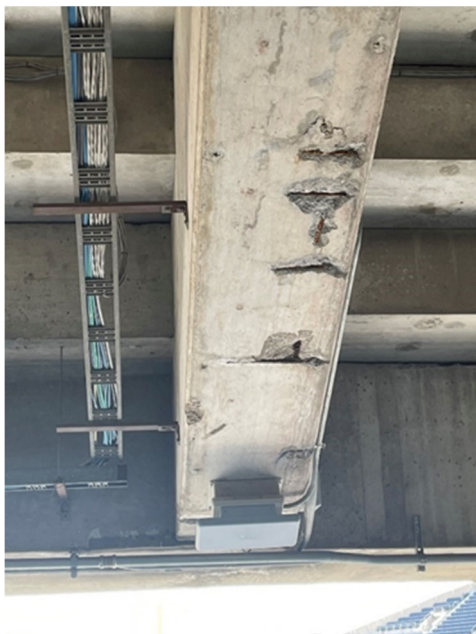
While some cracking and spalling was observed, the original reinforced concrete columns and walls are in satisfactory condition. However, there were multiple cases where the steel reinforcing was exposed, as show in [Figure S-2](#), [Figure S-3.1](#), and [Figure S-3.2](#). In [Figure S-2](#) the vertical column and wall surfaces are flat and smooth. Concrete patchwork of the original structure was observed to be flat and smooth and is in satisfactory condition as well. The expansion joints at the original superstructure to the renovation superstructure are in satisfactory condition. No deterioration was observed. Conversely, further review of structures in [Figure S-3.1](#) and [Figure S-3.2](#) is needed.

Figure S-3.1: Support Frame Deterioration
Location: Looking Out From H&R Block Private Suite

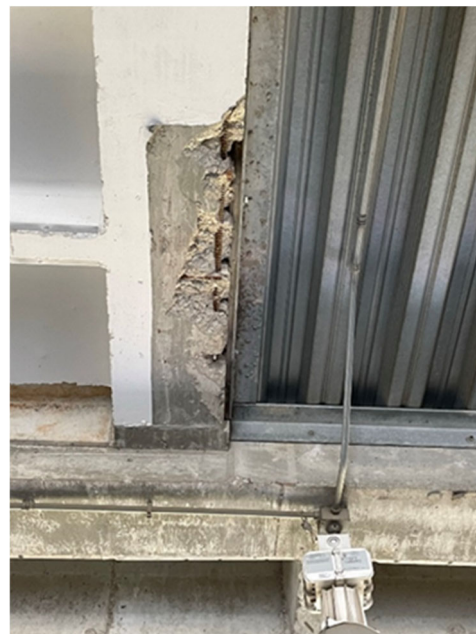
Figure S-3.2: Support Frame Deterioration
Location: Middle Concourse

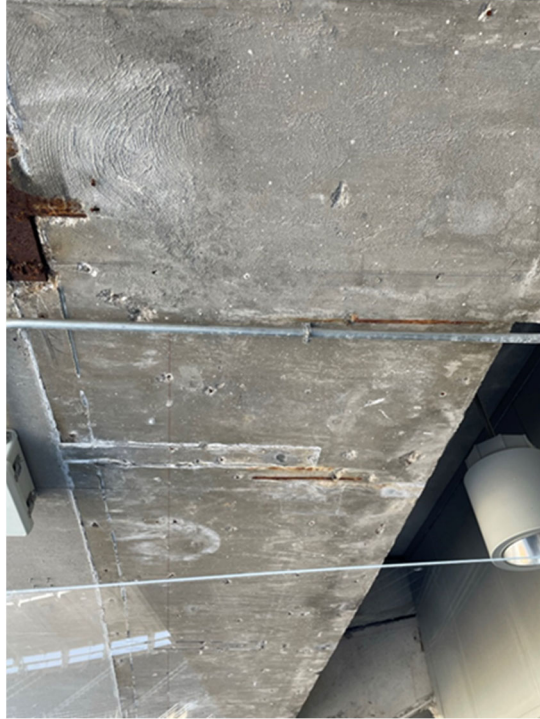
Figure S-4: Rusted Metal in Support Frame
Location: Middle Concourse

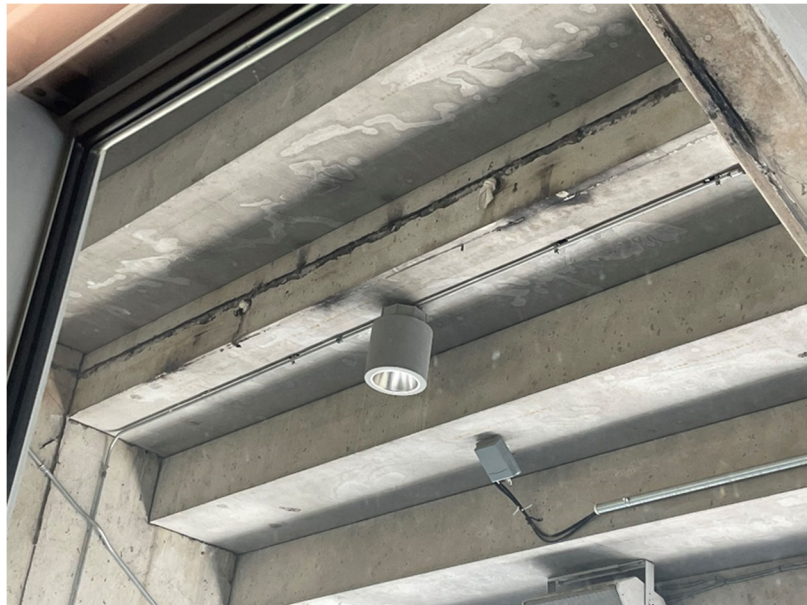
Figure S-5 shows a horizontal crack along a support beam, above where it appears two towels are placed into holes in the concrete. Further south, an equipment box is hanging from its supports on the horizontal beam.

Figure S-5: Support Frame Deterioration
Location: Looking Out From H&R Block Private Suite

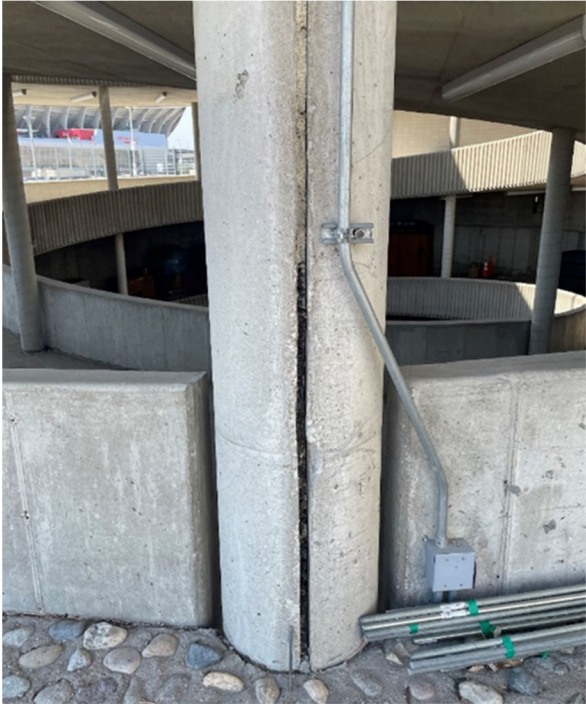
More exterior structural members showed different signs of weathering. Helix Ramp columns at Gate D were missing caulk, as shown in **Figure S-6**. Horizontal cracking was seen on the upper concourse wall near a helix ramp, as shown in **Figure S-7**.

Figure S-6: Support Column Caulk Deterioration
Location: Gate D

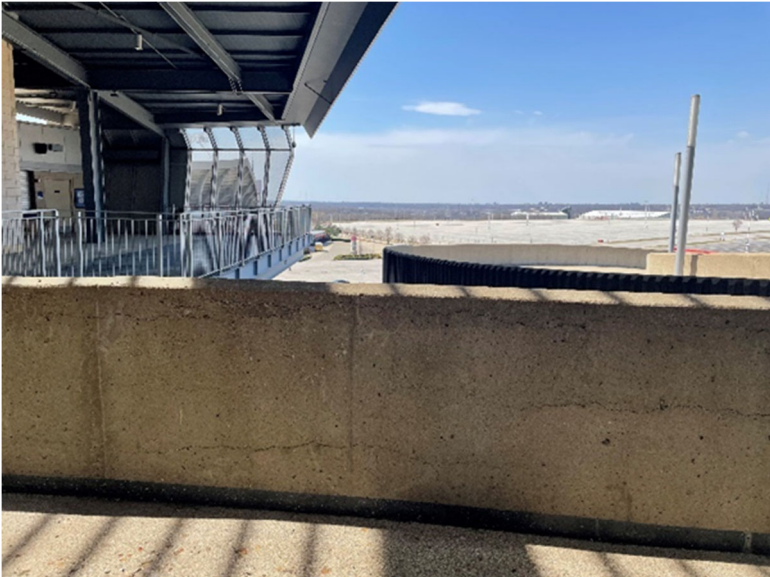
Figure S-7: Wall with Horizontal Cracks
Location: Upper Concourse Near Helix Ramp

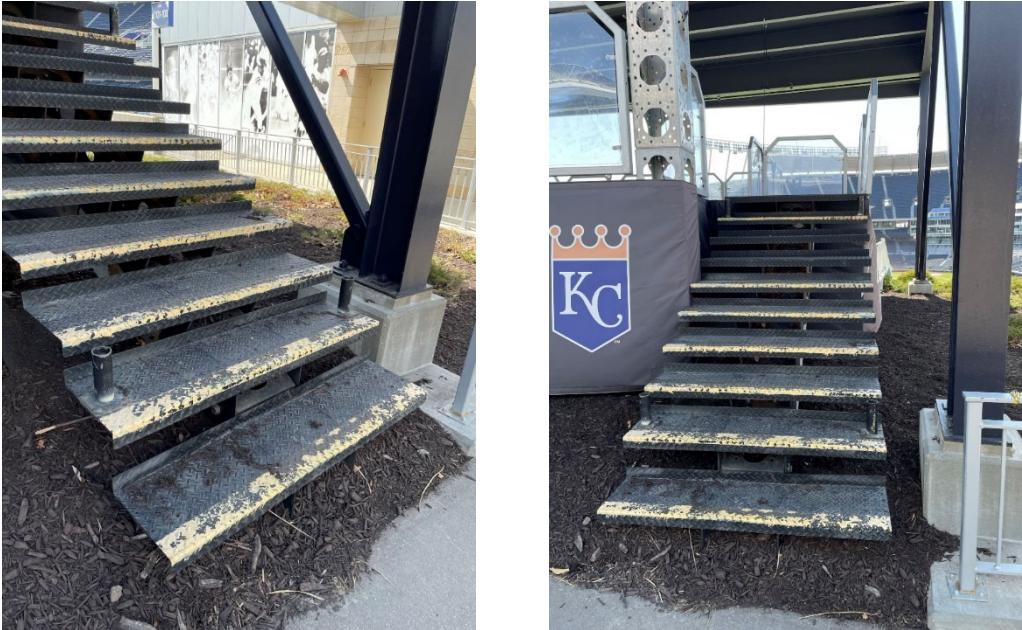
Handrails and handrail anchorage was inspected in various locations throughout the stadium. It was observed that handrails were completely missing from the stairs shown in **Figure S-8**. It is unknown if they were missing or just in the process of being replaced prior to the start of the season.

Figure S-8: Missing Handrail
Location: Miller Lite Fountain Bar Deck

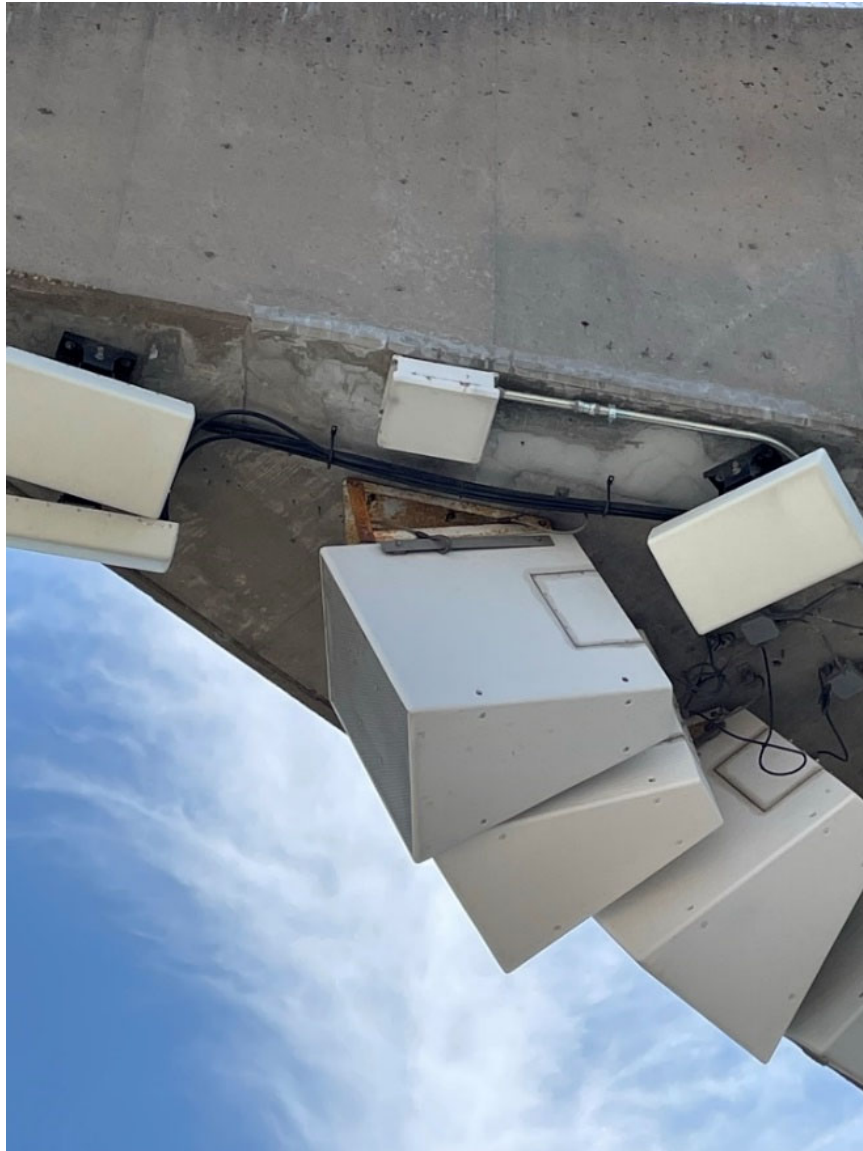
The steel support bracket, which supports large speakers, appears to be rusting, as show in **Figure AME-1**.

Figure AME-1: Surface Rust on Platform Support Brackets
Location: Section 201 Looking Up

- It is recommended that the damaged guardrail outside Section 417 be repaired immediately to ensure safety for all patrons.
- It is recommended that the rusting bracket holding a large speaker be replaced immediately.
- Consider reapplying all warning strips where deterioration is observed. All transition strips need to be repaired to comply with ADA code.

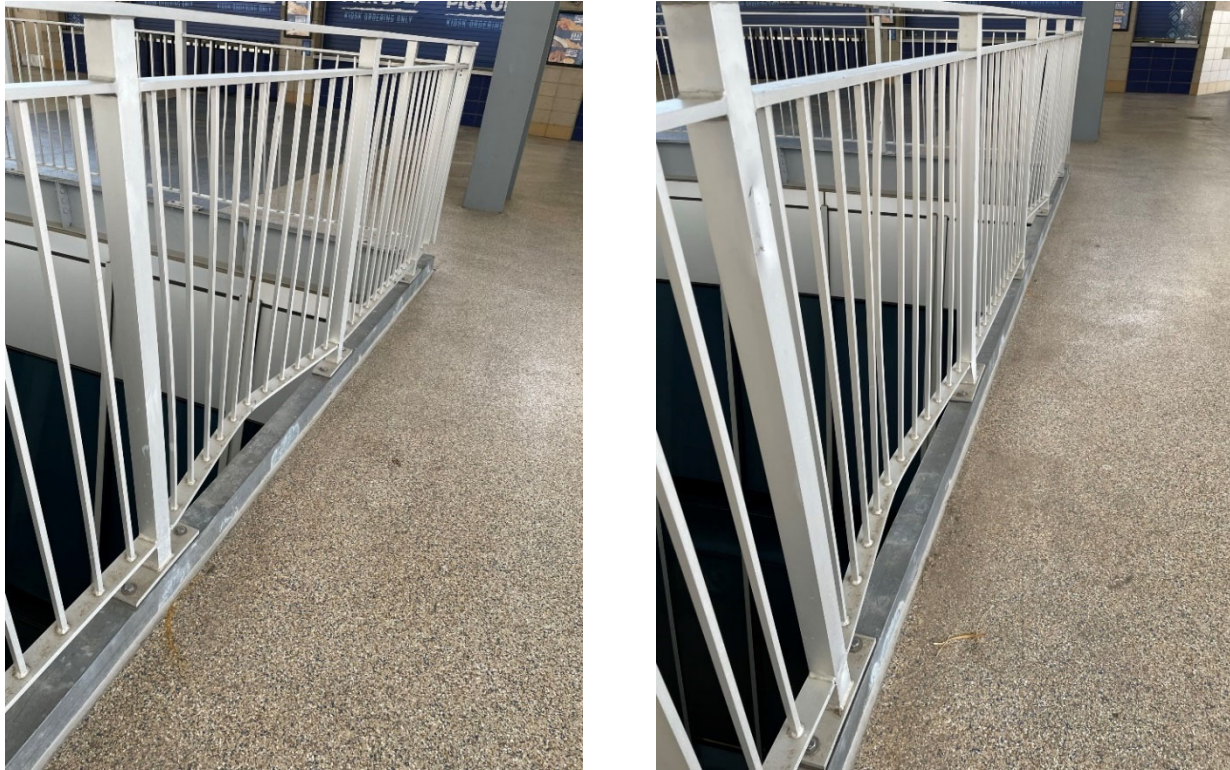
At the guardrail outside section 417 appears to be damaged / bent, as shown in **Figure AME-2**. This damage could prove to be hazardous to fans who may put too much pressure on the guardrail. It is recommended that this be addressed quickly.

Figure AME-2: Damaged / Bent Guardrail
Location: Section 417

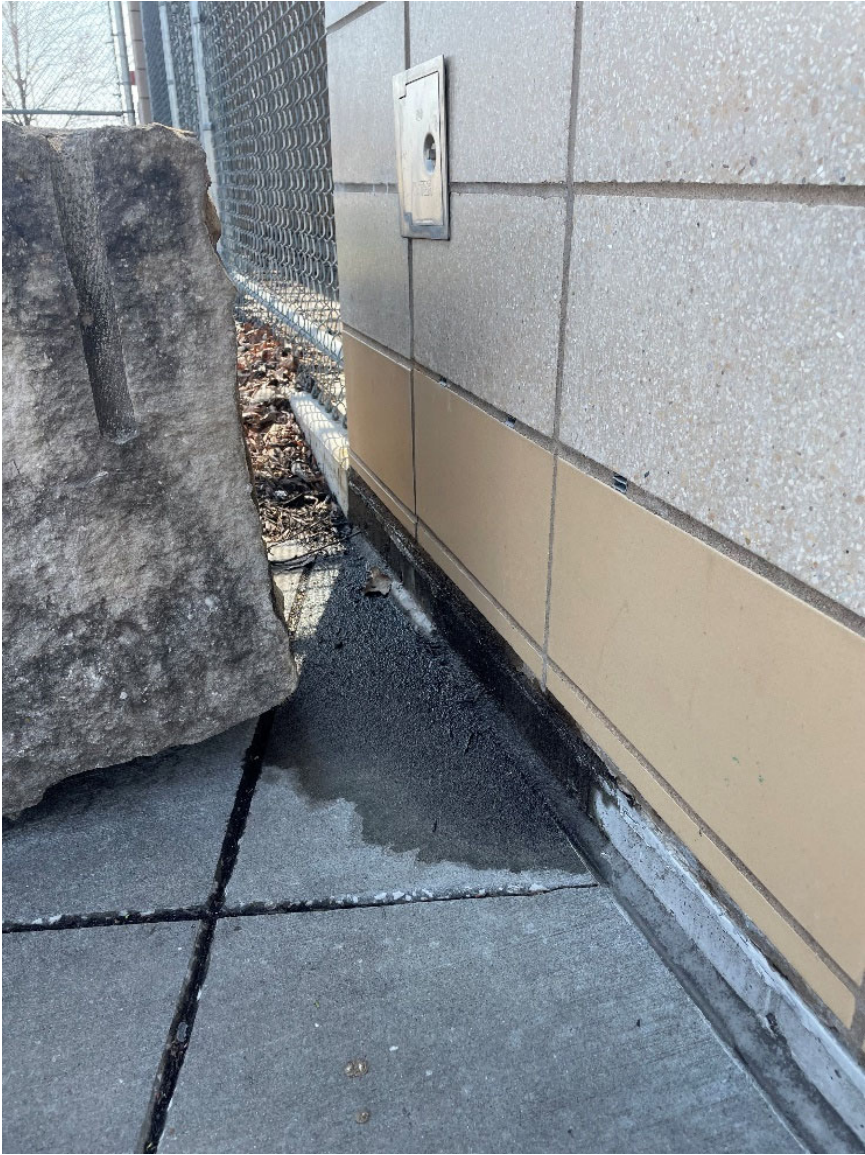
In most locations joint sealant and caulking appears to be in satisfactory condition. However, at various locations throughout the stadium, sealant was observed to be cracked or separating, as shown in **Figure AME-3**, at Janitor closet J251

Figure AME-3: Deteriorating Sealant
Location: Janitor's Closet J251 – Outfield Experience

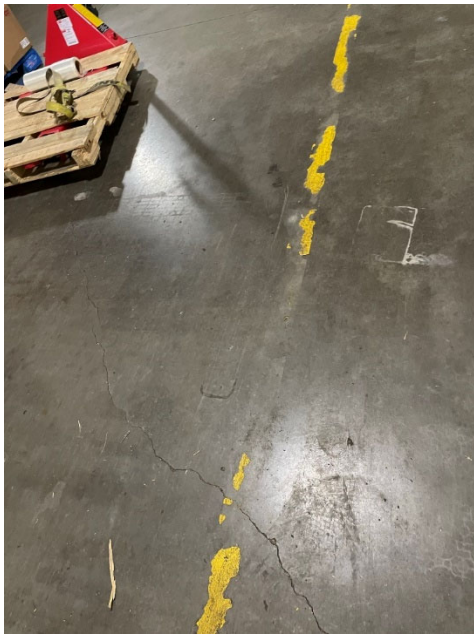
It was observed that the non-slip texture & warning strips are beginning to wear away from typical use in various locations, as shown in **Figure AI-1** and **Figure AI-2**. This could become a slip and fall hazard to patrons, especially during the earlier and later portions of the MLB season.

Figure AI-1: Caution Strip
Location: Back of House Food Storage

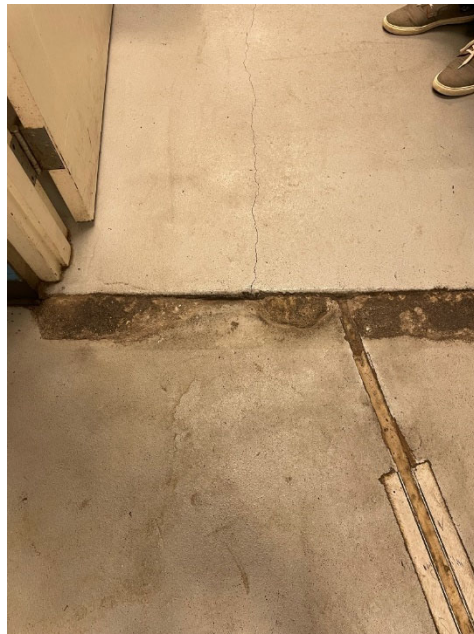
Figure AI-2: Transition Strip
Location: Back of House Food Storage

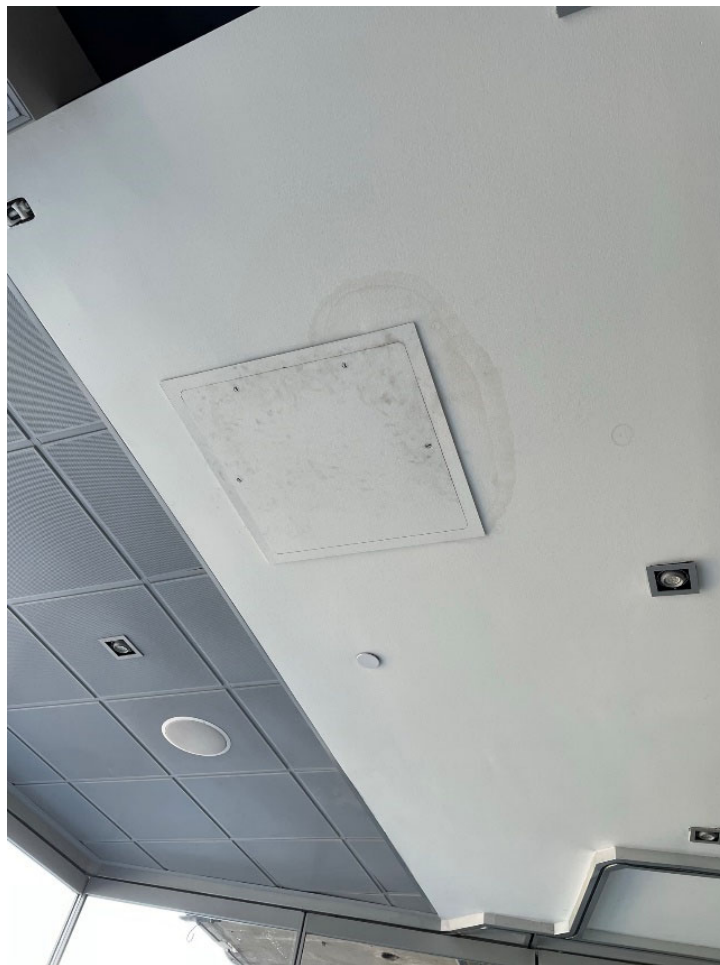
Figure AI-3: Water Damage
Location: Diamond Club

Gypsum board ceilings appear to be in satisfactory condition, typically. There were 3 missing light fixtures in the Diamond Club, as show in **Figure AI-4**. There was water damage observed at the ceiling access panel in the Diamond club, as shown in **Figure AI-3**.

- Consider replacing ceiling tiles and/or grids which have water damage or are falling to maintain a clean appearance and prevent further deterioration which may result in pieces of material falling from the ceiling.

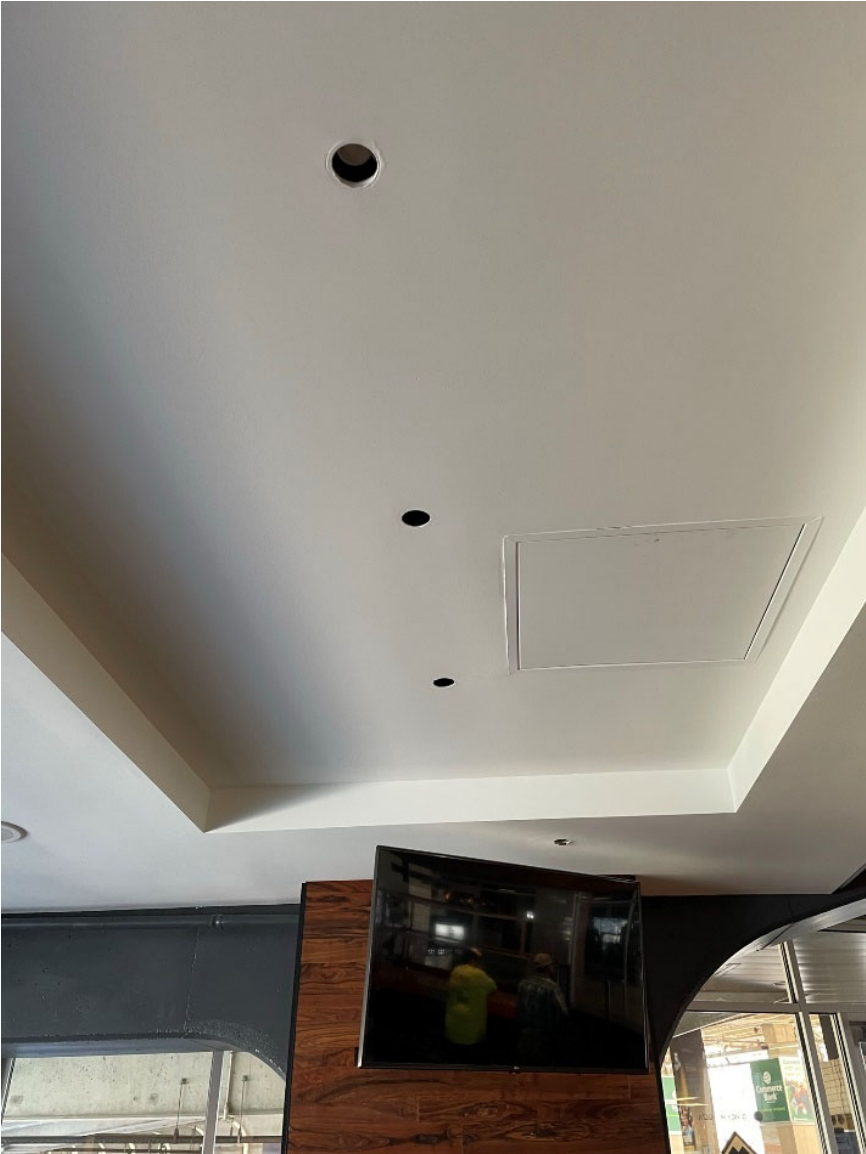
Figure AI-4: Missing Light Fixtures
Location: Diamond Club

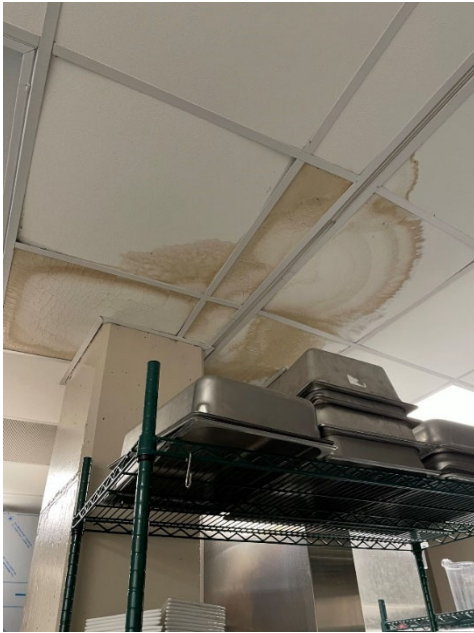
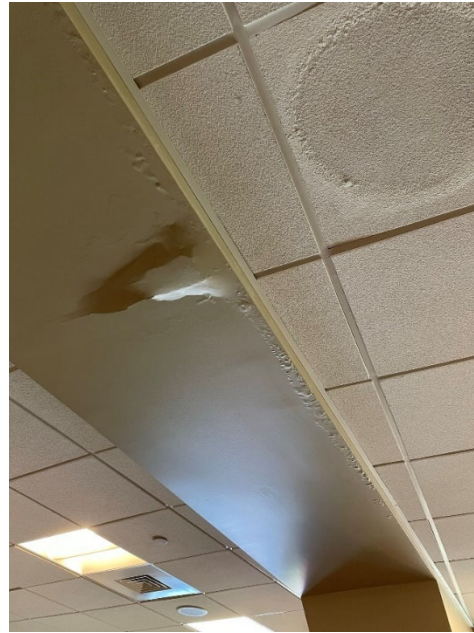
The General conditions of the concession stands were acceptable, however there were several locations where the ACT was falling or in need of repair, as shown in **Figure AI-5**. The ACT panels and structure was observed to be falling in the Liquor storage closet as show in **Figure AI-6**.

Figure AI-5: Water Damage
Location: Various Concession Stands

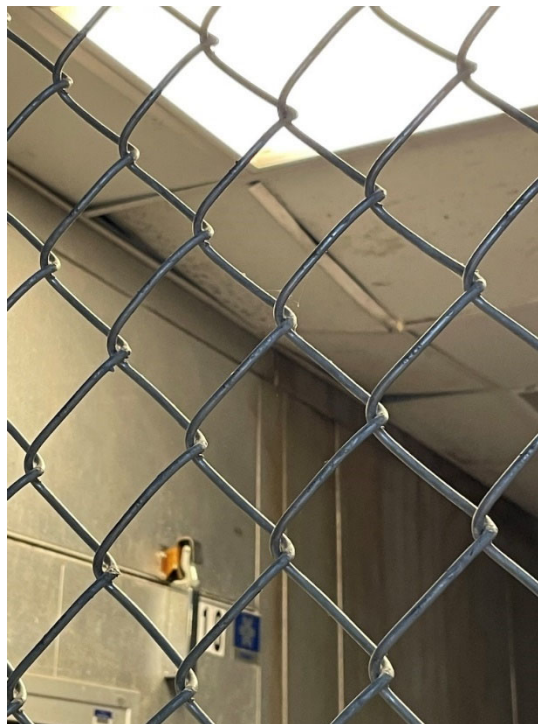
Figure AI-6: Damage to Acoustic Ceiling Tile
Location: Liquor Storage Closet – Signature Suite Level

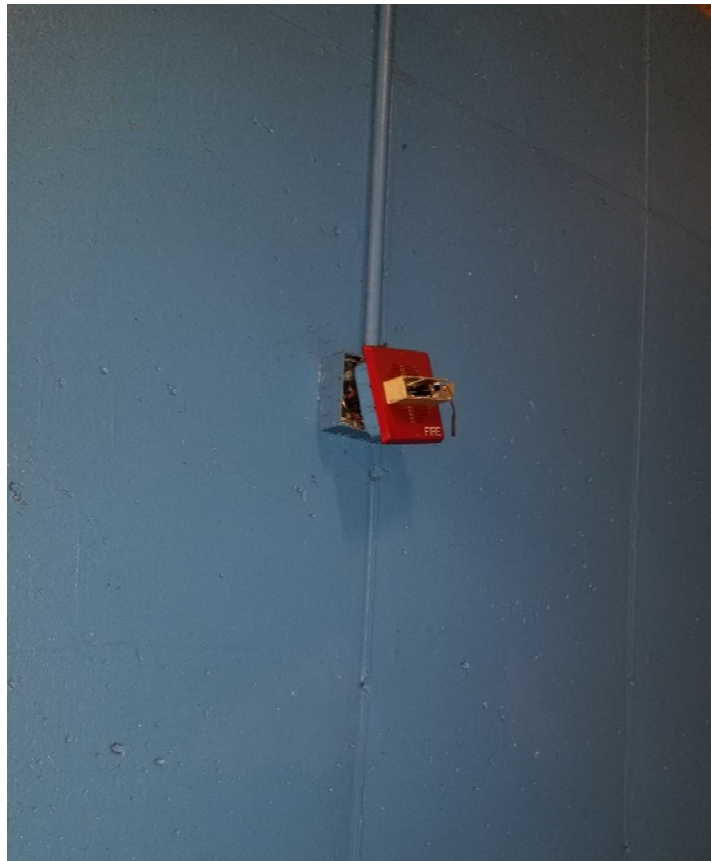
In the underground tunnel connecting Kauffman and Arrowhead it was observed that a fire alarm strobe near the exit on the Kauffman side, as shown in **Figure E-1**, has been hit by a vehicle in the tunnel. This device needs to be replaced with a new UL listed strobe device.

Figure E-1: Fire Alarm Strobe
Location: Kauffman-Arrowhead UG Tunnel

- It is recommended that this device is replaced with a new UL listed strobe to ensure proper fire alarm coverage is compliant with NFPA 72.
