Kauffman Stadium Assessment

JCSCA + Burns & McDonnell

This document contains information pertaining to the condition of Kauffman Stadium as documented by the Jackson County Sports Complex Authority (JCSCA), including descriptions, conditions, and exhibits which have been reviewed by Burns & McDonnell and documented in this report.

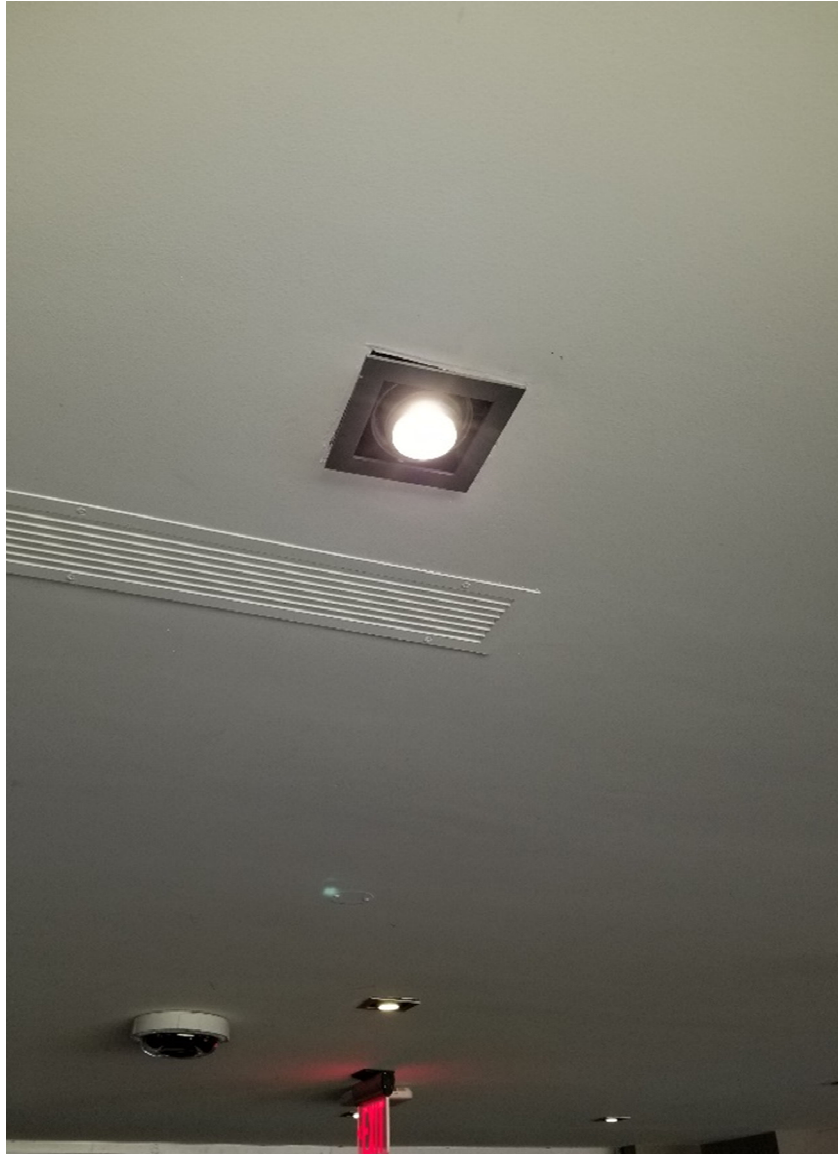
On the plaza level near the diamond club, it was observed that the housing on some lighting has come loose. One example shown in **Figure E-2**.

Figure E-2: Ceiling Mounted Fixture
Location: Kauffman-Arrowhead UG Tunnel

- It is recommended that the housing is repaired so the light is properly protected from the elements, and pedestrians below do not get injured by falling fixtures.

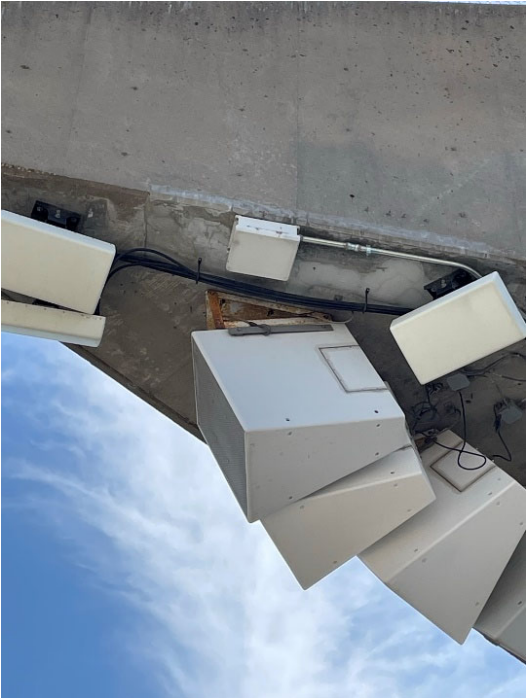
There are weatherproof devices that have lost their integrity in various locations throughout the ballpark. In one example, as shown in **Figure E-3**, the speaker supports were rusting and device supporting the speakers had come apart exposing the internals to the elements. Another view shown in **Figure E-4** is on the Loge level looking up that the grandstands above. The area beneath the grandstands had various devices that needed maintenance.

Figure E-3: Speaker System
Location: Near 03.50.02 Concessions

- It is recommended that weatherproof devices and bracing are properly maintained to protect the device as well as pedestrians below to ensure injuries don't occur.

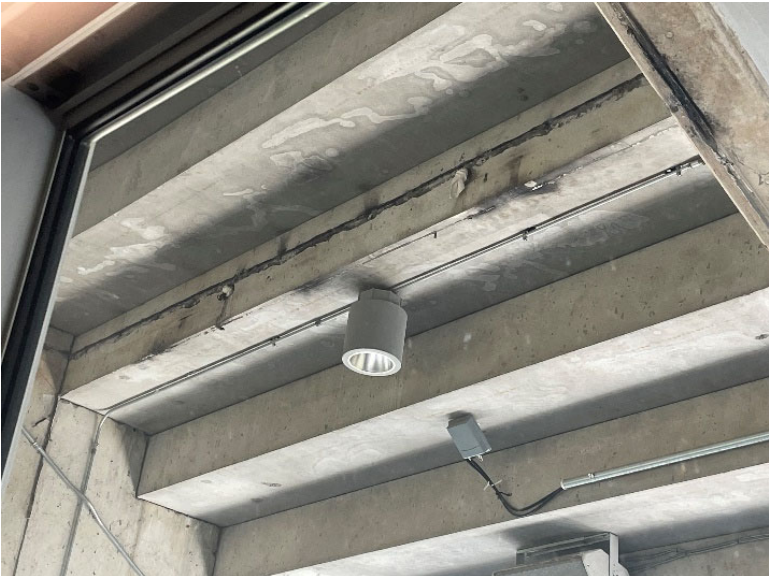
Figure E-4: Beneath Grandstands
Location: Loge Level Suite
