# Rich Passage Clam Bay Net Pens Review - DNR

October 10, 2017

State of Washington  
Department of Natural  
Resources  
1111 Washington Street SE  
Olympia Washington 98504

**Document reference:** 385629 | 2 | C

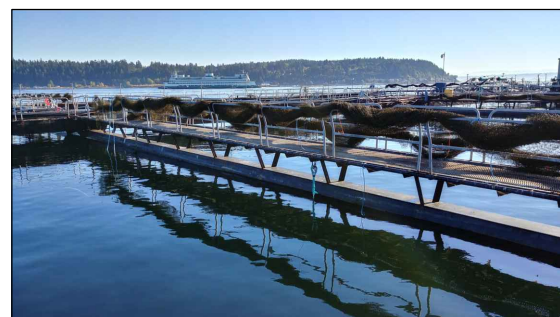
**PHOTO 1**  
PONTON WALKWAY

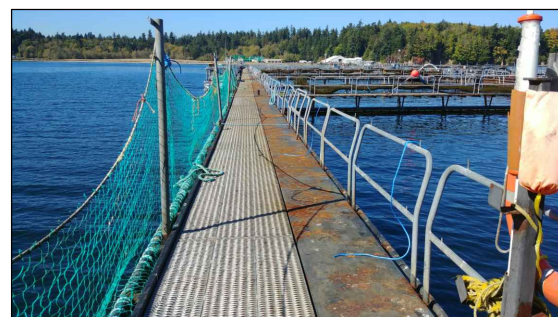
**PHOTO 2**  
EXTERIOR WALKWAY / PREDATOR NET

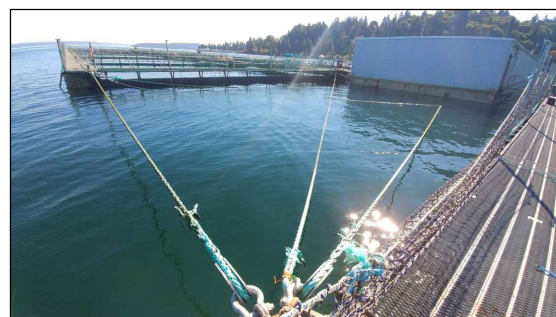
**PHOTO 3**  
LINES AND SHACKLES BETWEEN NORTH AND SOUTH NET PENS

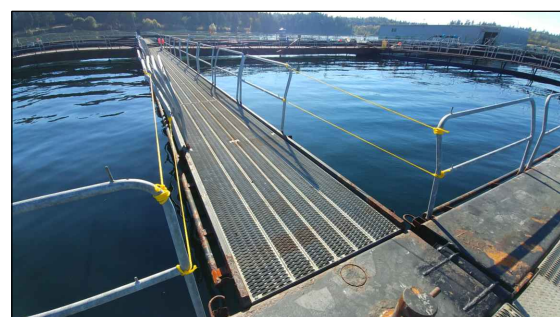
- The walkways include steel grating panels with diamond surfacing. The main walkway grating runs down the center of the pens and is 78 inches wide, 5 inches deep. It is a heavy duty grating capable of supporting net pen equipment and forklifts, as observed on site. The grating was loose and damaged in places.

- The exterior and pontoon walkways are narrower and use 3-inch deep steel grating. Several panels were observed to be either missing bolts and/or damaged by heavy objects. Instead of replacing grating panels, localized repairs have been made by welding steel plate on top of the grating.

**PHOTO 6**  
PONTON WALKWAY SURFACE

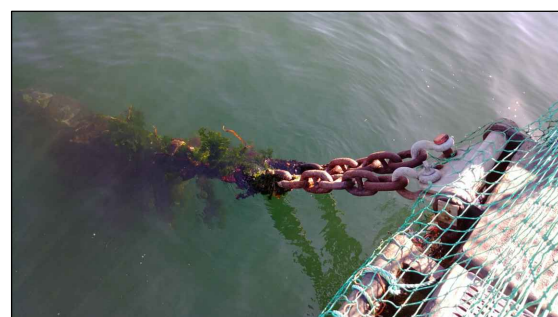
**PHOTO 7**  
MOORING CHAINS

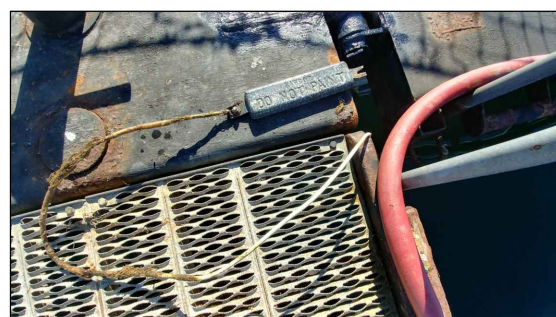
- Corrosion protection includes coating (paint) and sacrificial anodes.

**PHOTO 8**  
ZINC ANODE SUSPENDED FROM COPPER WIRE

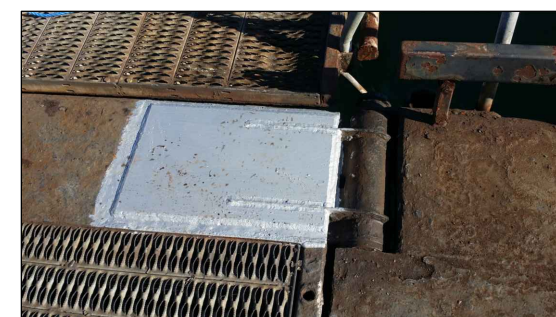
- Primary structure elements and hinges were exhibiting severe corrosion in places and should be repaired.

**PHOTO 9**  
EXTERIOR WALKWAY HINGE CONNECTION

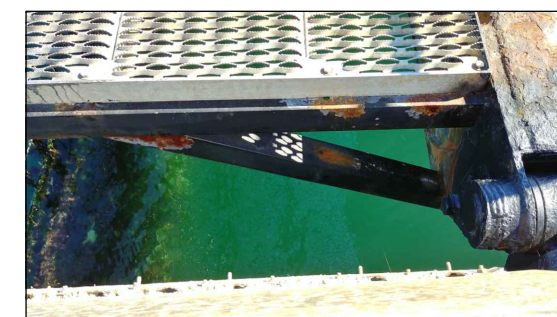
- The railings are galvanized 1.5" diameter pipe and border all sides of the walkways. They are removable as needed, slotted into brackets connected to the steel framing. Most of these brackets were moderately covered in rust, with localized cases of major corrosion. The deterioration of the brackets caused the railing to become loose and rotate when pressure was applied.

**PHOTO 10**  
GRATING AND PREDATOR NET RAIL SUPPORTS

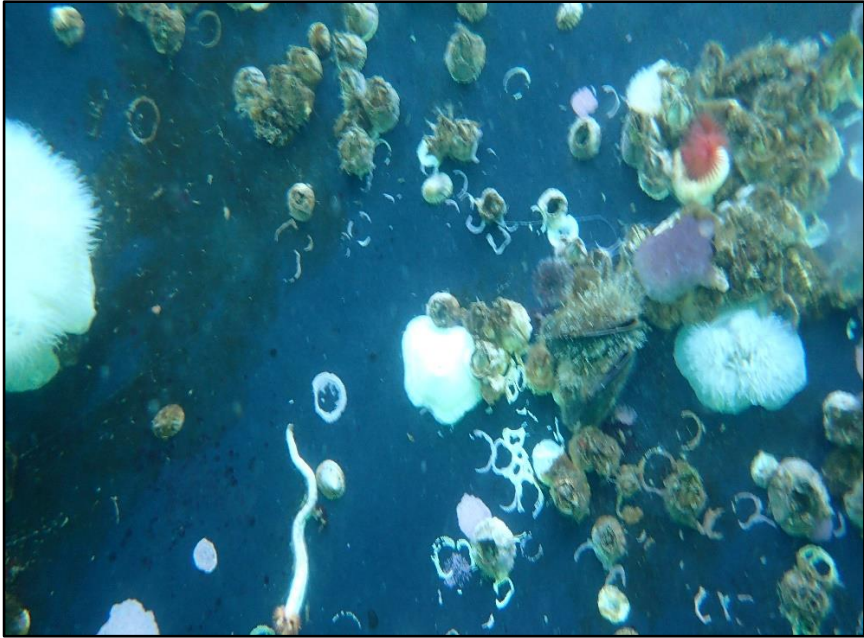
Photograph 3 : Underwater View of the Typical Marine Growth and Coating on the Pontoons.

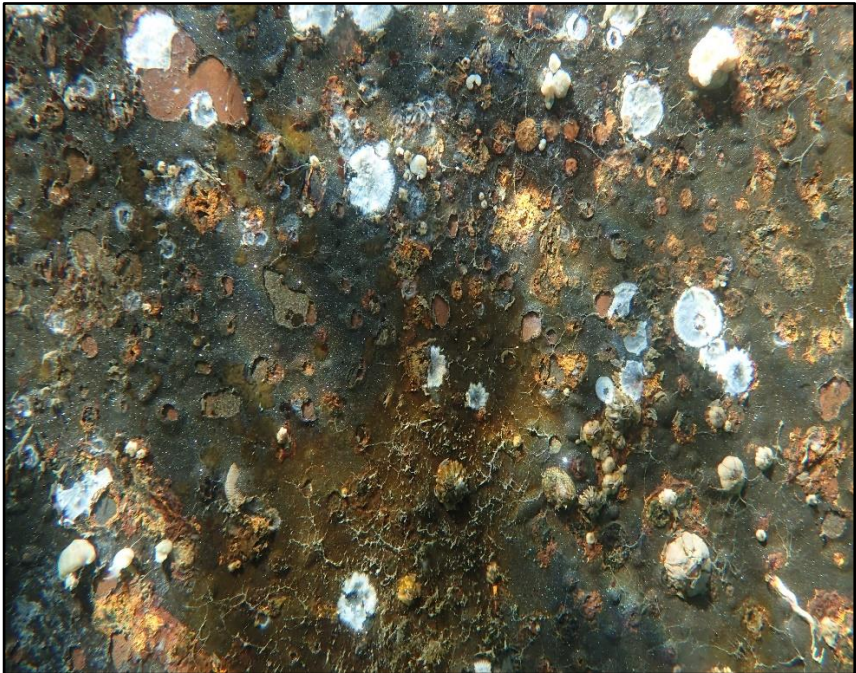
- Below water conditions are described in the dive inspection report (Appendix B) which includes “the floating pontoons of the net pen system ... overall in good to satisfactory condition with no notable deterioration, damage or any other reasons for concern identified. ... the submerged surfaces had the majority of their protective coatings intact and well-adhered”.

Photograph 4 : Underwater View of the Coating Loss and Surface Corrosion on the Pontoons.

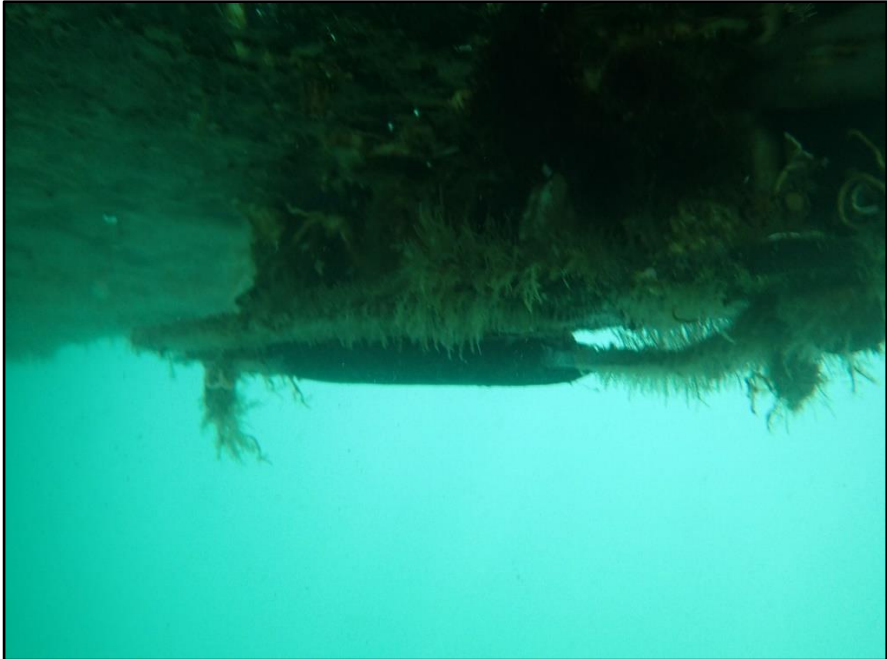
Photograph 7 : Underwater View of the Consumed Bolted Style Anode.

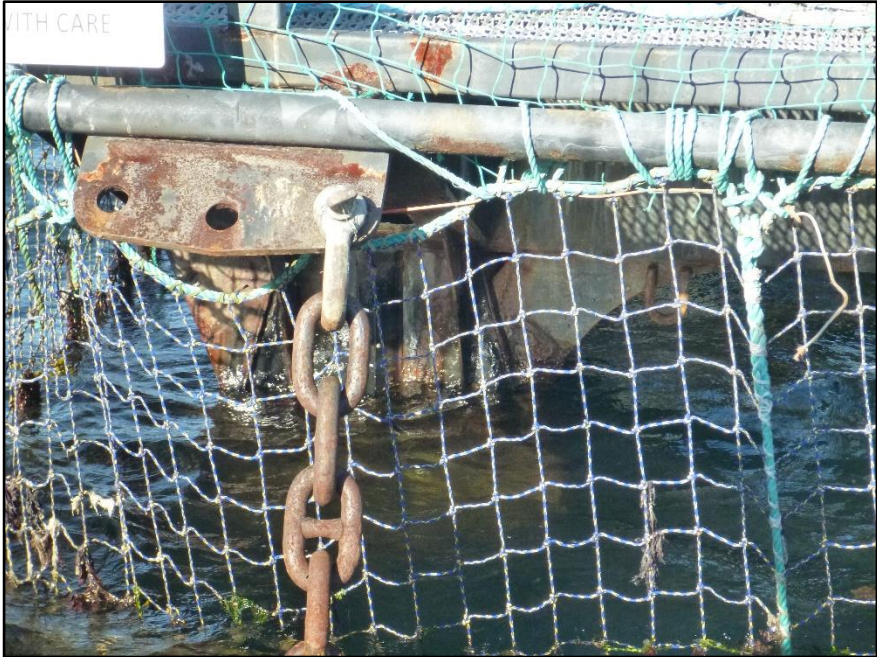
Photograph 9 : View of the Typical Corrosion of the Steel Plate and Shackle.

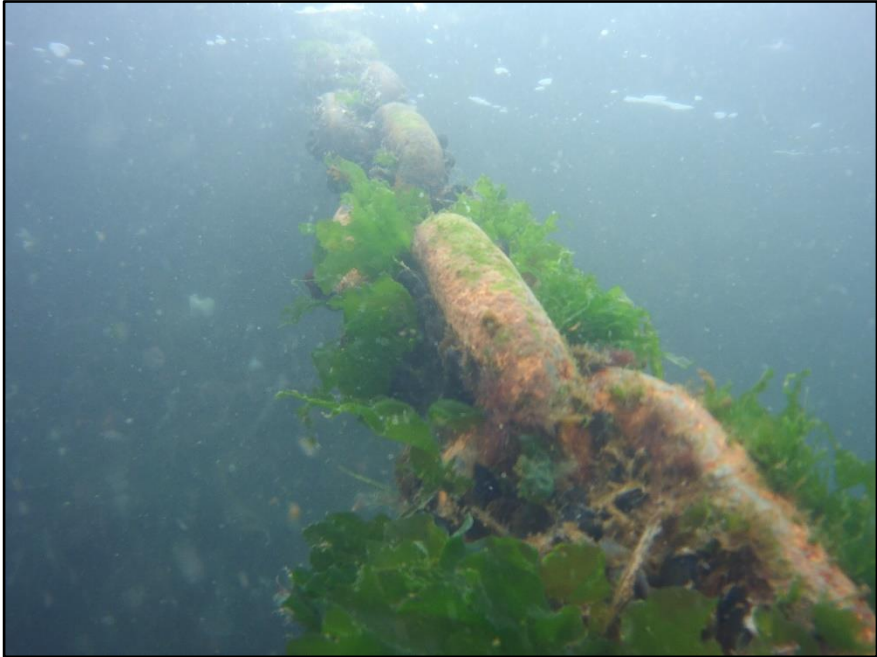
Photograph 10 : Underwater View of the Typical Marine Growth on the Anchor Chain.

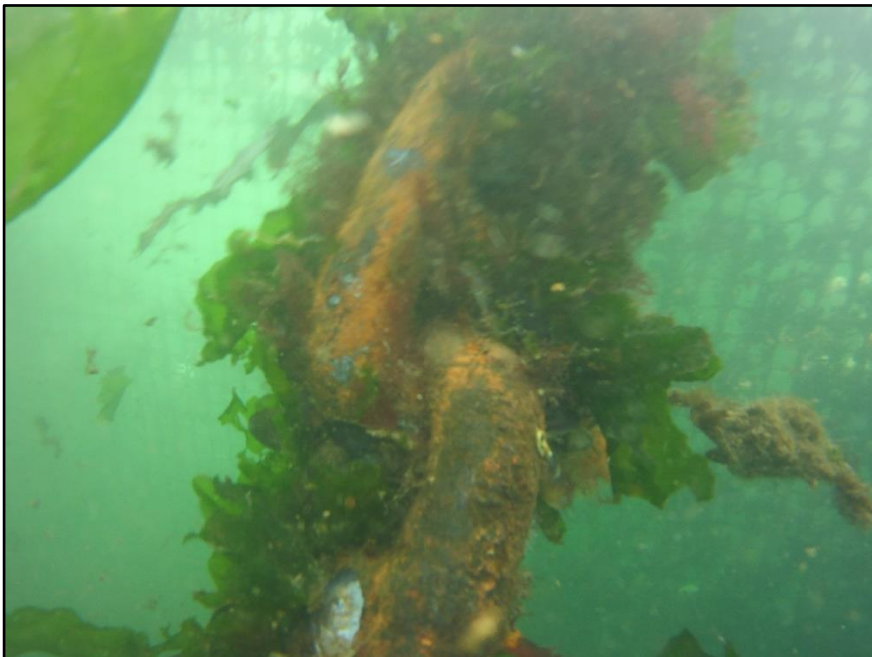
Photograph 12 :  
Underwater View of the  
Typical Surface Corrosion  
on the Anchor Chain.

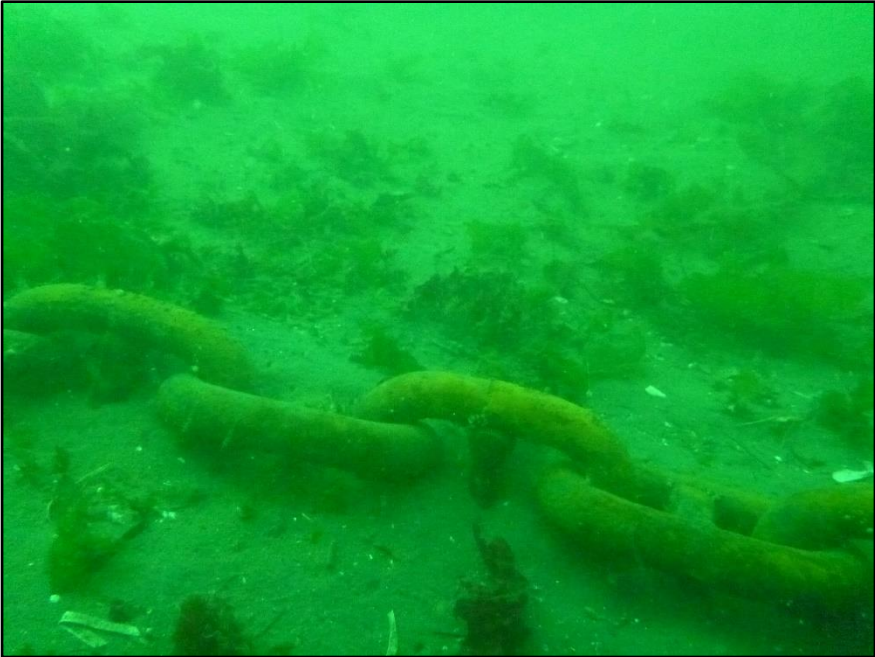
Photograph 15 :  
Underwater View of the  
Typical Buried Conditon of  
the Anchor Chain at the  
Channel Bottom.

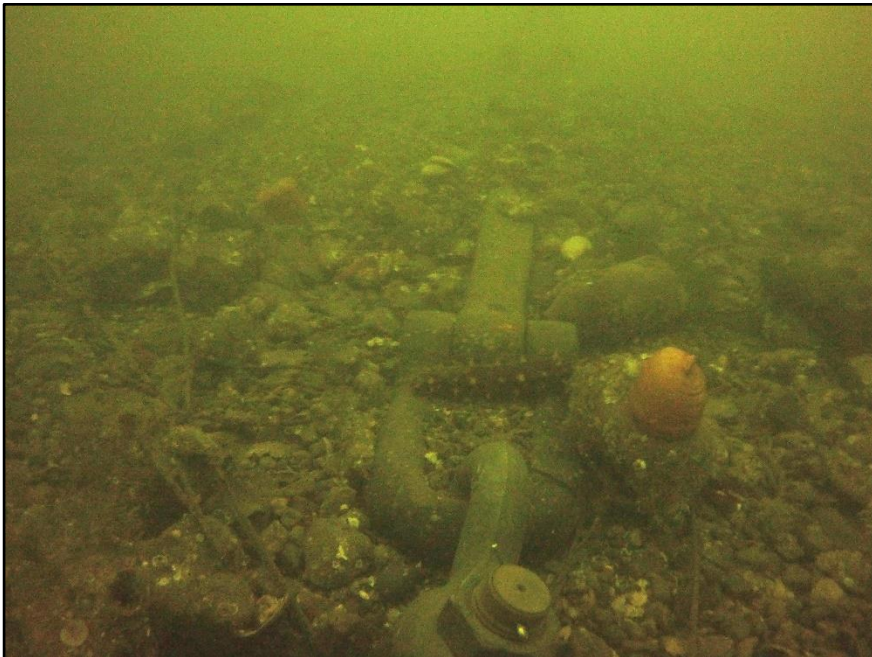
Photograph 18 :  
Underwater View of the  
Typical Buried Anchor  
Exposure.

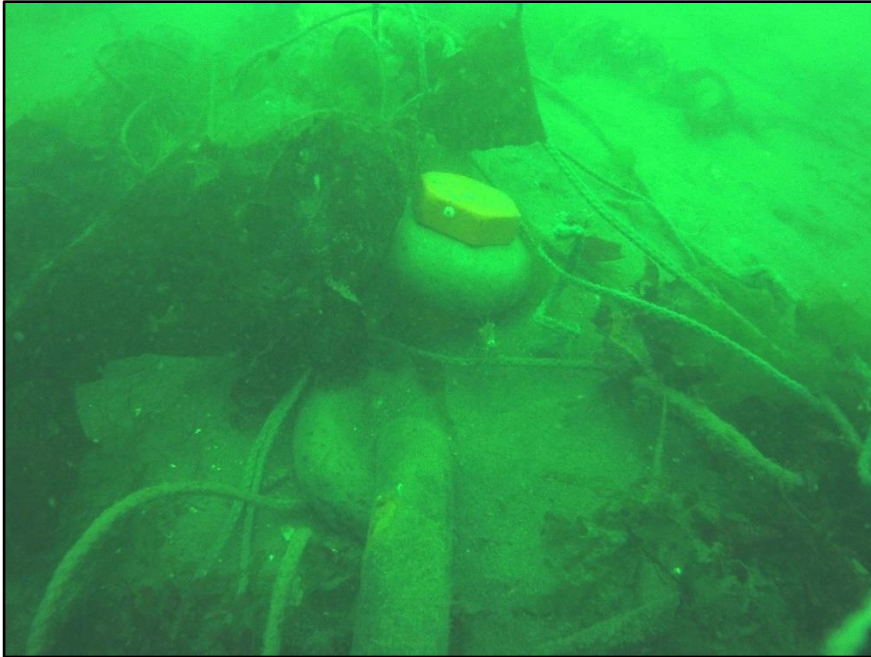
Photograph 19 :  
Underwater View of the  
Typical Buried Anchor  
Exposure.

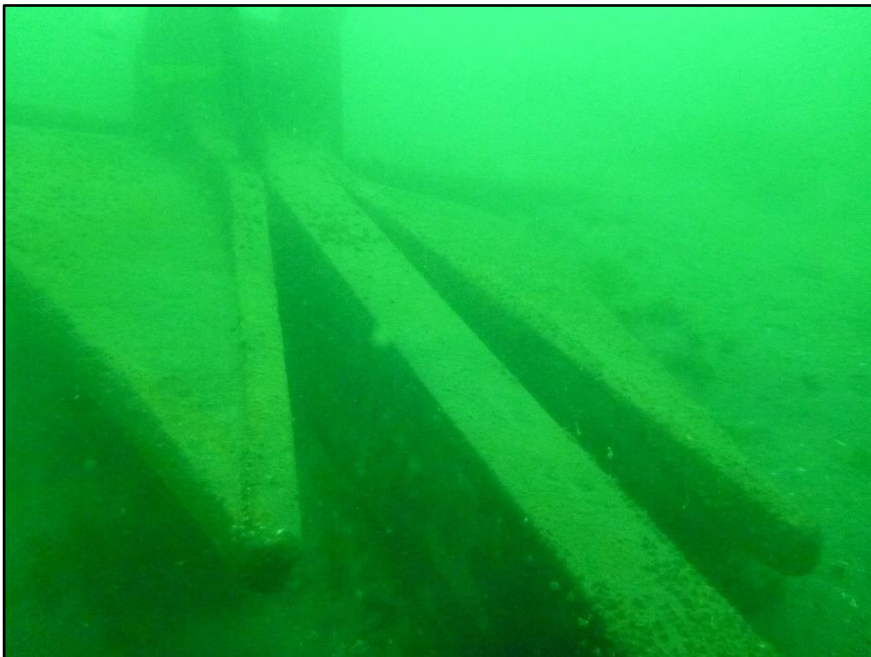
- The International Inspection report in 2015 identifies corrective actions for the anchors and mooring system. A dive inspection by Collins Engineers observed that the anchors appear to be in generally newer condition, with a number of anchors that appeared to be recently installed. The divers were able to inspect 23 of 35 mooring lines. 16 of these mooring lines included inspection to the seabed and the anchors. Drag anchor No. 6 is not buried, the others were buried as expected.

Photograph 20 :  
Underwater View of the  
Unburied Anchor (Anchor 6  
Shown).
