WILDFIRE-ASSOCIATED LANDSLIDE EMERGENCY RESPONSE TEAM REPORT

Cedar Creek and Cub Creek 2 Fires

Okanogan County, Washington

WASHINGTON
GEOLOGICAL SURVEY
WALERT Report
September 8, 2021

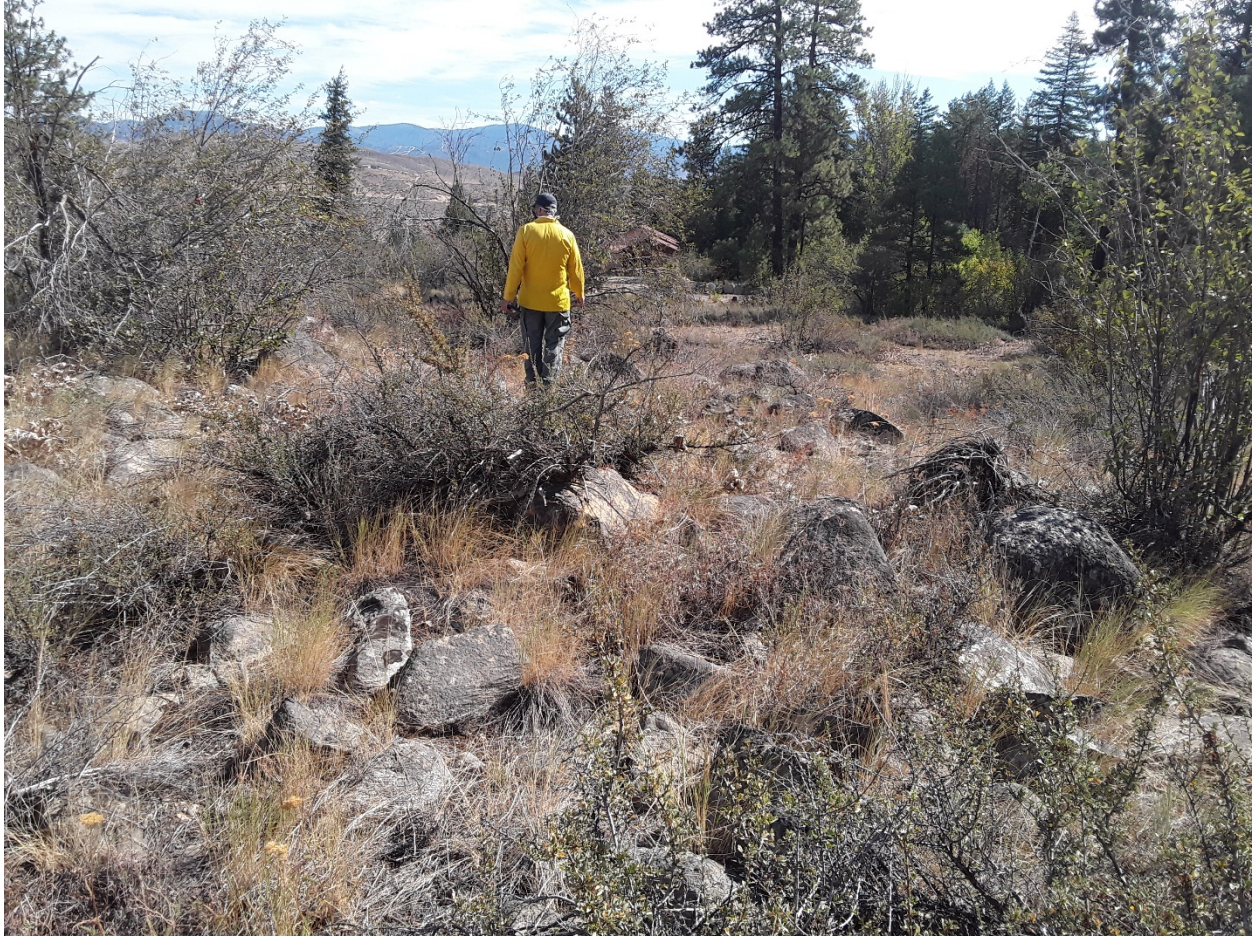
The basin above the Wolf Creek fan was modeled with various hazard ratings, including Low, Moderate, and High. Previous flooding of Wolf Creek was noted in 1948 and 1974 (USBR, 2008; Inter-Fluve, 2020) and distributary channels are visible in lidar and aerial photos. We wouldn't typically expect debris flows to travel far from the apex of an alluvial fan that drains such a large basin, however, we observed very large boulders and dry channels over 2,000 feet from the apex of the alluvial fan. This suggests that debris flows have occurred on the fan in the past (Fig. 1). The Inter-Fluve (2020) report outlines the channel shifting several thousand feet to the south between 1895 and 1947.

Figure 1. Boulders on Wolf Creek fan approximately 2,000 feet downstream of the apex of the alluvial fan. The boulders suggest previous debris flow activity in the area.

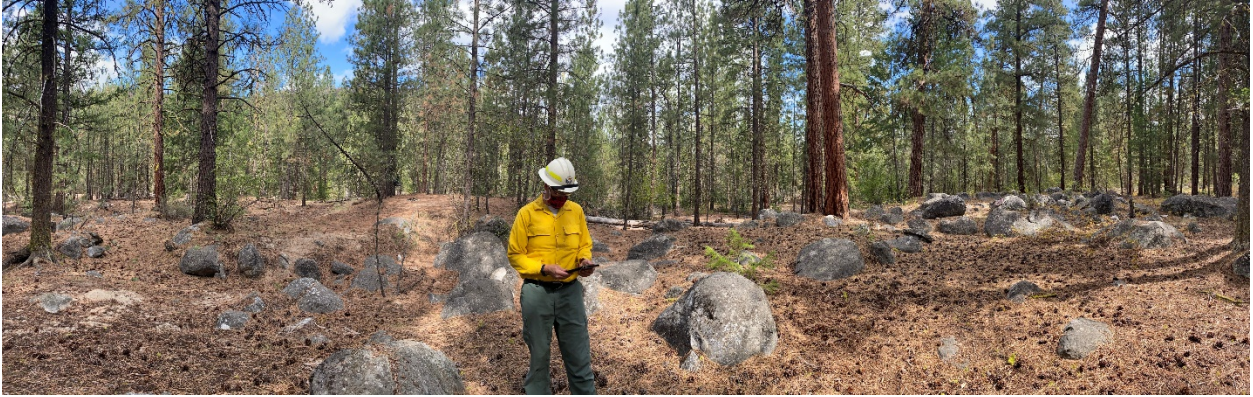
Most of the Boulder Creek drainage basin was modeled as Moderate and Low debris flow hazard. Where the channel starts to become confined, there are a few areas modeled as High and Moderate. Where the channel becomes unconfined, Boulder Creek emerges onto an alluvial fan. Large boulders (up to 8 ft in diameter) are present on the fan (Fig. 2). Dispersed campsites from the Boulder Creek Campground are intermixed between these boulders. Toward the southern portion of the fan, activity appears older and less active. With the noted past debris flow activity and the Low, Moderate, and High debris flow hazard modeled in basins along the creek, the fan may experience debris flows and flash flooding in the future.

Figure 2. Large boulders from previous debris flow activity at Boulder Creek. Campsites are dispersed amongst the boulders at Boulder Creek Campground.

The parking lots and camping areas at Falls Creek, Chewuch, and Boulder Creek Campgrounds may need signs to warn the public of flash flood and debris flow hazards during heavy rainstorms. Some campsites may need to be temporarily closed due to the hazard.

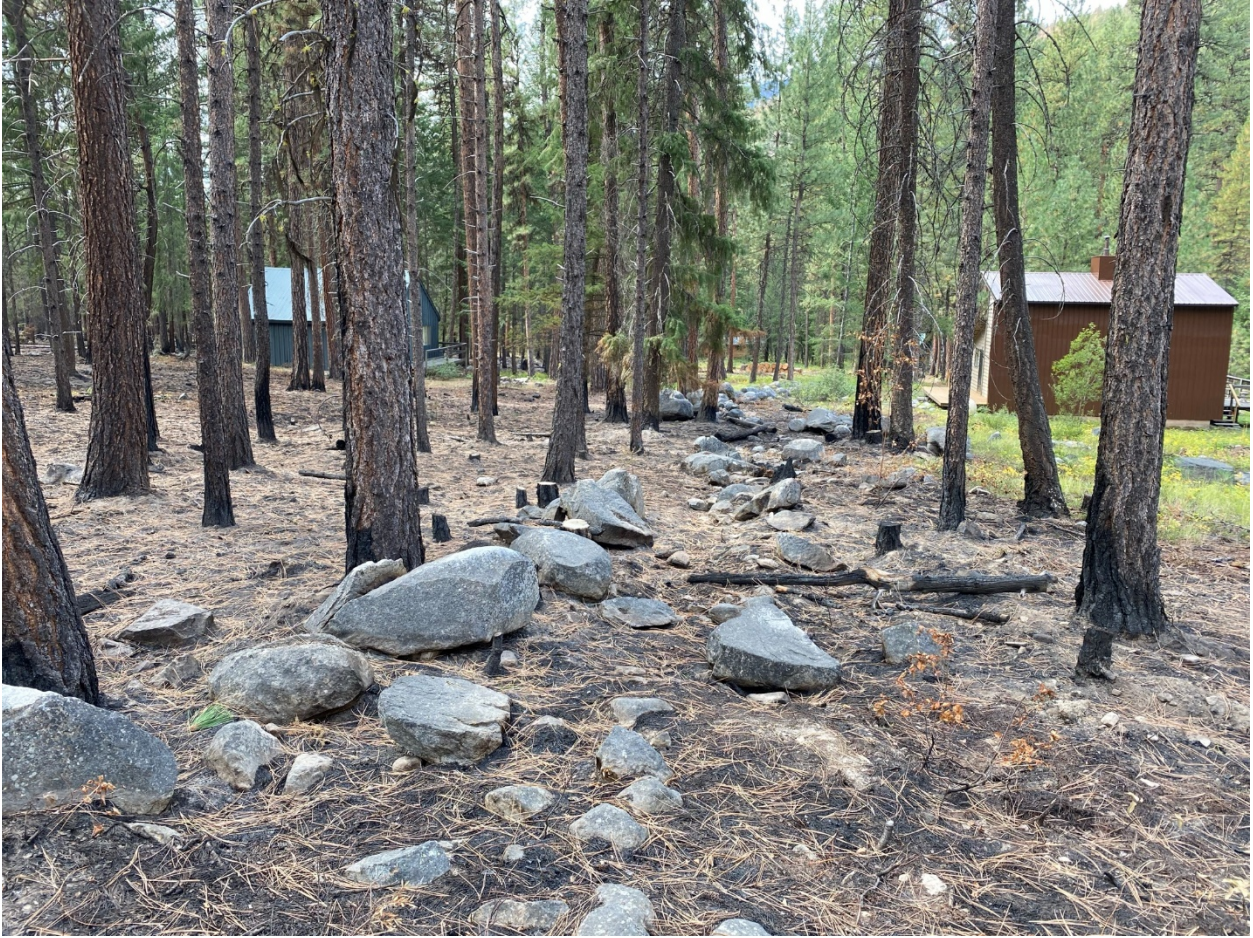
Several cabins exist on the Brevicomis Creek alluvial fan. We observed large boulders across the fan and smaller boulders down past the cabins (approximately 1,900 feet away from the apex of the fan), suggesting previous debris flow activity (Fig. 3). Two steep drainages (Brevicomis Creek and an unnamed drainage) remain confined until they merge and exit onto the fan. Both drainages were modeled as having Moderate hazard for debris flows, with 34 percent probability of a debris flow occurring for Brevicomis Creek and 14 percent for the unnamed drainage for the

modeled storm event. Based on evidence of past debris flows and the Moderate debris flow hazard, cabin residents should be made aware of post-fire flooding and the possibility of debris flows to the fan.

Figure 3. Boulders near the cabins on the Brevicomis Creek alluvial fan, suggesting previous debris flow activity.

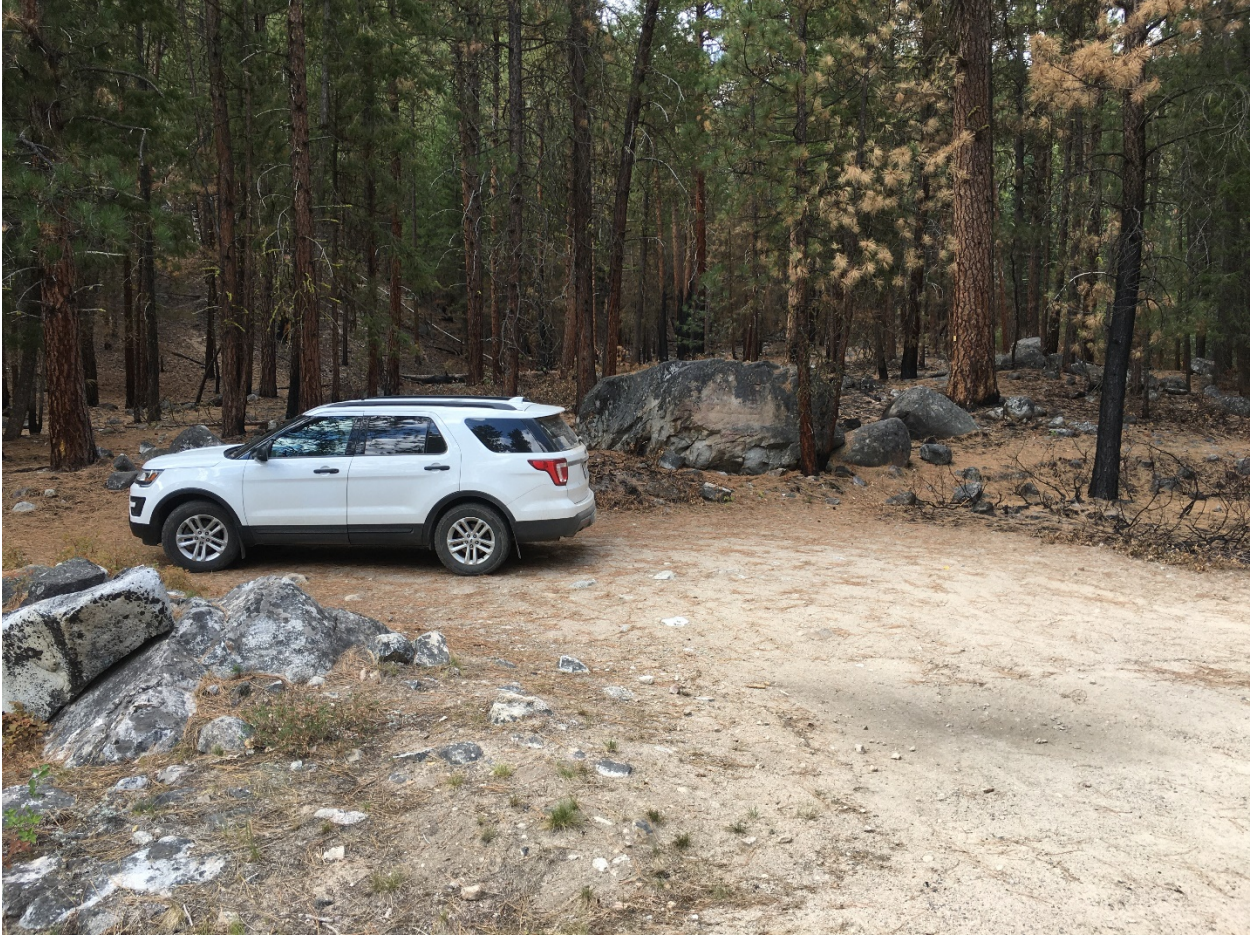
The top of the Falls Creek drainage basin was modeled as Moderate and Low debris flow hazard. Where the channel starts to become confined, most of the area was modeled as having High and Moderate hazard, with the High debris flow probabilities ranging from 78–93 percent for the modeled storm event. As Falls Creek loses confinement, material deposits onto an alluvial fan. The majority of campsites at Falls Creek Campground are situated on this alluvial fan. Large boulders ranging in size from 3–10 ft across are present west of USFS road 51 and toward the apex of the fan (Fig. 4). One foot diameter boulders could be seen in the campsites on the distal edge of the fan by the Chewuch River, suggesting previous debris flow activity. Based on past debris flows activity and the High and Moderate debris flow hazard, future debris flows and flash flooding may impact the fan.

Figure 4. Large boulders from past debris flows on the west side of USFS Road 51 at the Falls Creek alluvial fan.
