# WILDFIRE-ASSOCIATED LANDSLIDE EMERGENCY RESPONSE TEAM REPORT

## Chuweah Creek Fire

Nespelem Water Tanks, Okanogan County, Washington

WASHINGTON  
GEOLOGICAL SURVEY  
WALERT Report  
August 3, 2021

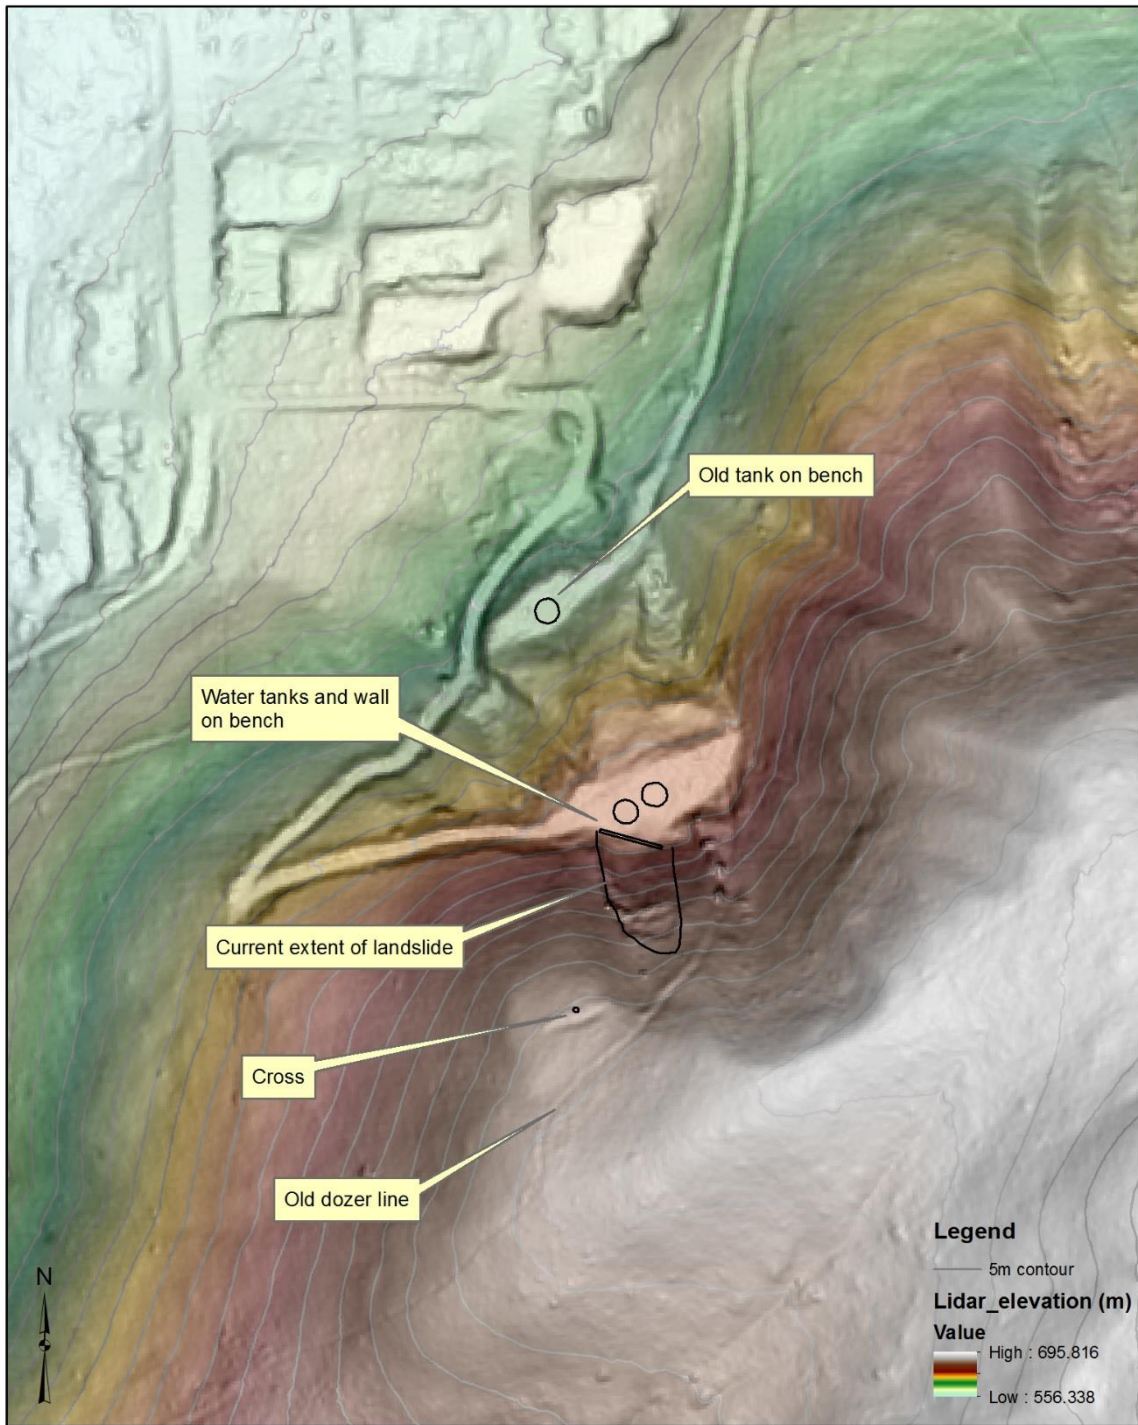
The landslide that has the potential to impact the two water tanks appears to be an ongoing problem just south of the water tanks (Fig. 1). Due to the fire, the potentially unstable area may receive additional surface water runoff that could impact the infrastructure. Quick landslide stabilization and installing an adequate drainage system will ensure that this water system can continue to operate normally after the fire.

A review of the surrounding lidar topographic data (Fig. 1) suggests that the likely style of landslide movement is shallow failure of a few tens of feet. Movement occurs where the slope is oversteepened and periodically saturated.

**Figure 1.** Map showing lidar data for the area surrounding the water tanks. Key features are labeled.

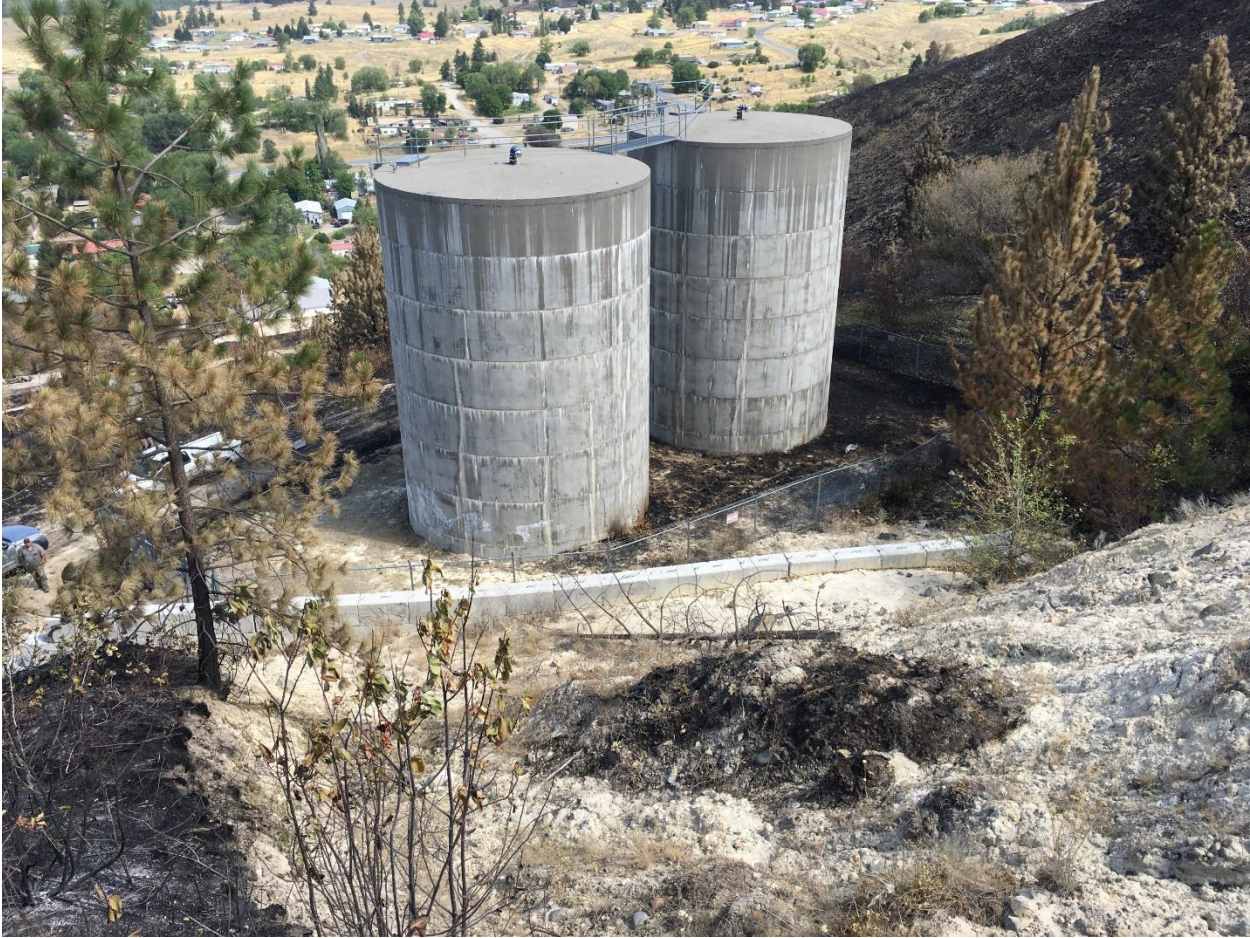
**Figure 2.** Retaining wall made of ecology blocks behind water tanks, approximately 15 feet from the western tank. Photo shows recent sediment deposited against the wall.

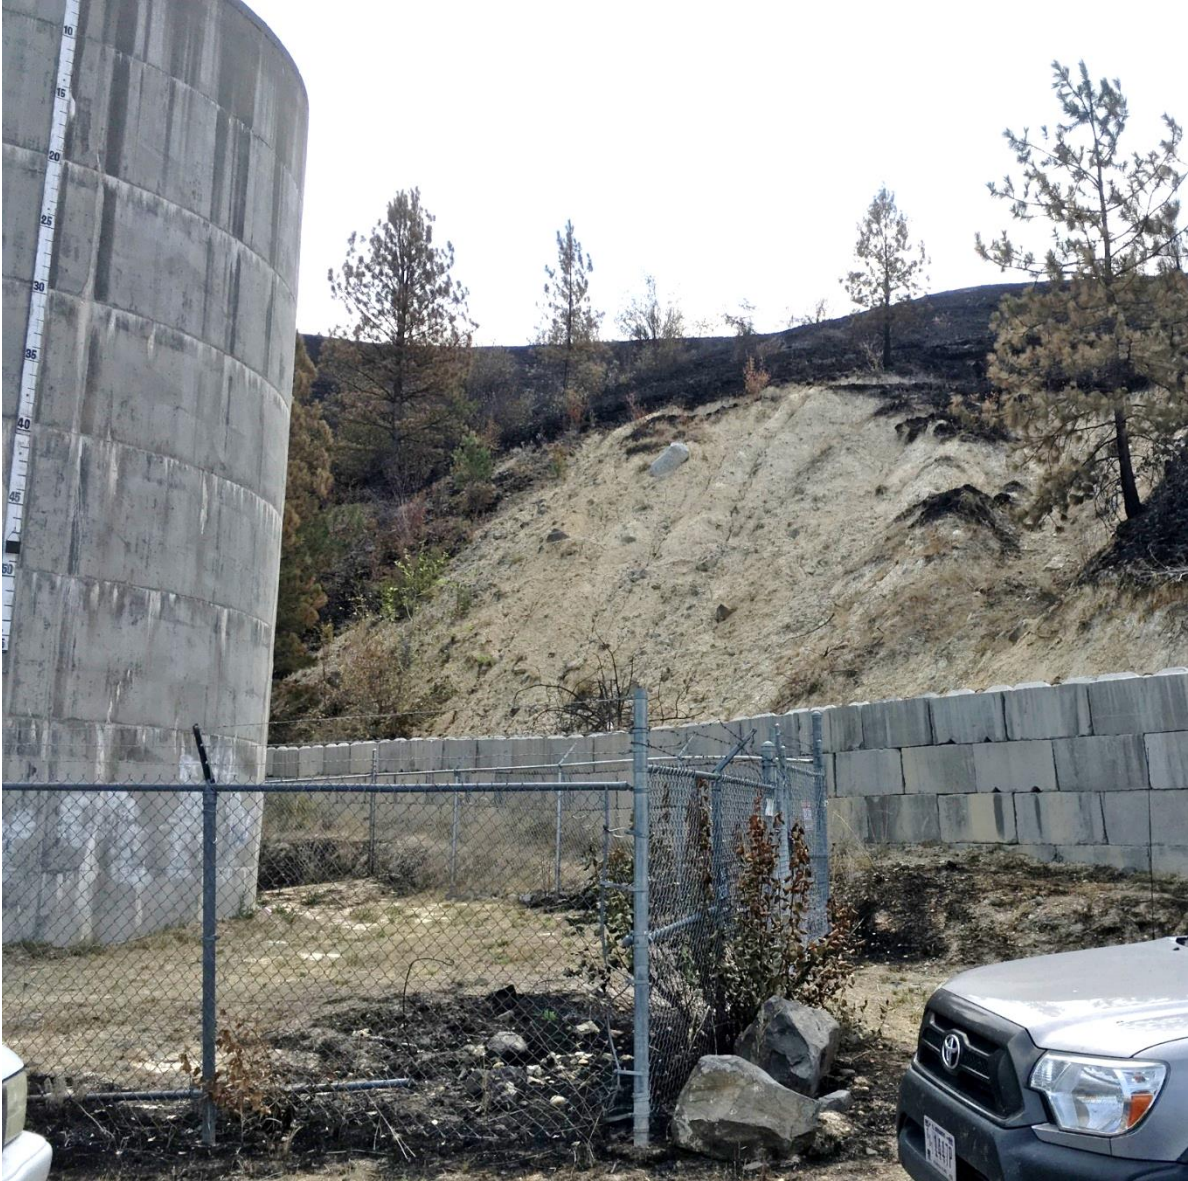
**Figure 3.** Landslide with glacial diamict exposed behind wall and light-colored sediment deposited within security fence.

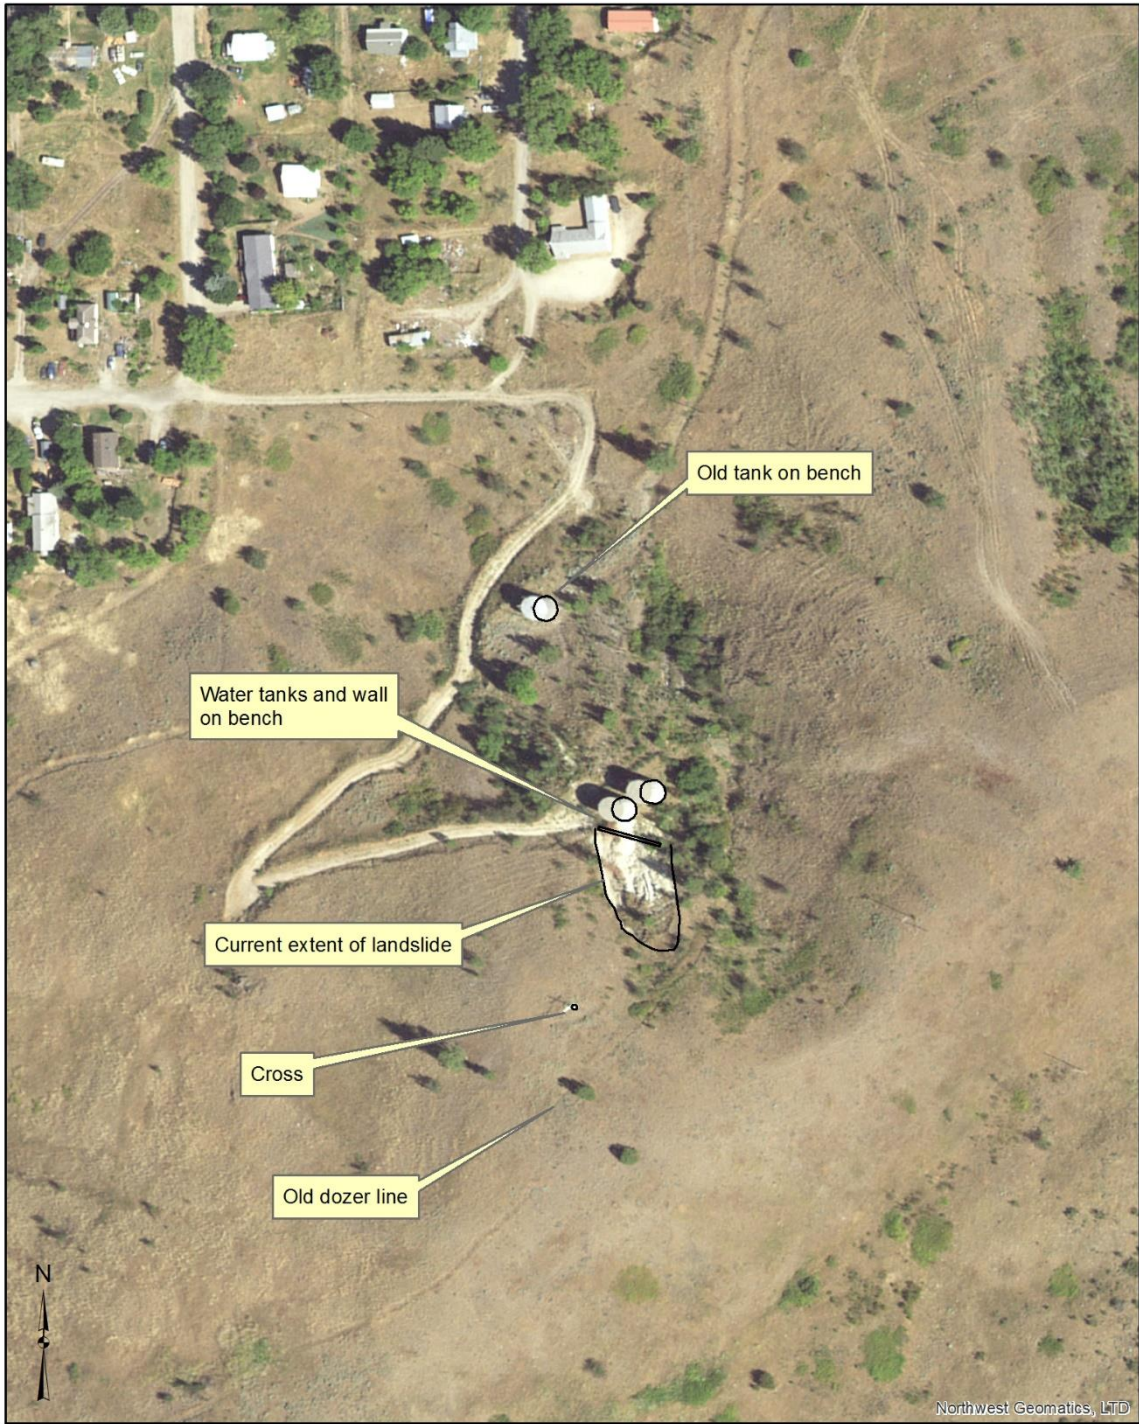
The landslide appears in all aerial photos on Google Earth Pro, going back to at least July 1991. The landslide likely initiated when the hillside was cut to construct the water tanks. It has continued to be active in aerial photos through 2017 (the most recent; see Fig. 4), showing bare soil and incorporating larger trees through time.

Figure 4. Orthophoto from 2017 showing vegetation on the hillslopes surrounding the water tanks.

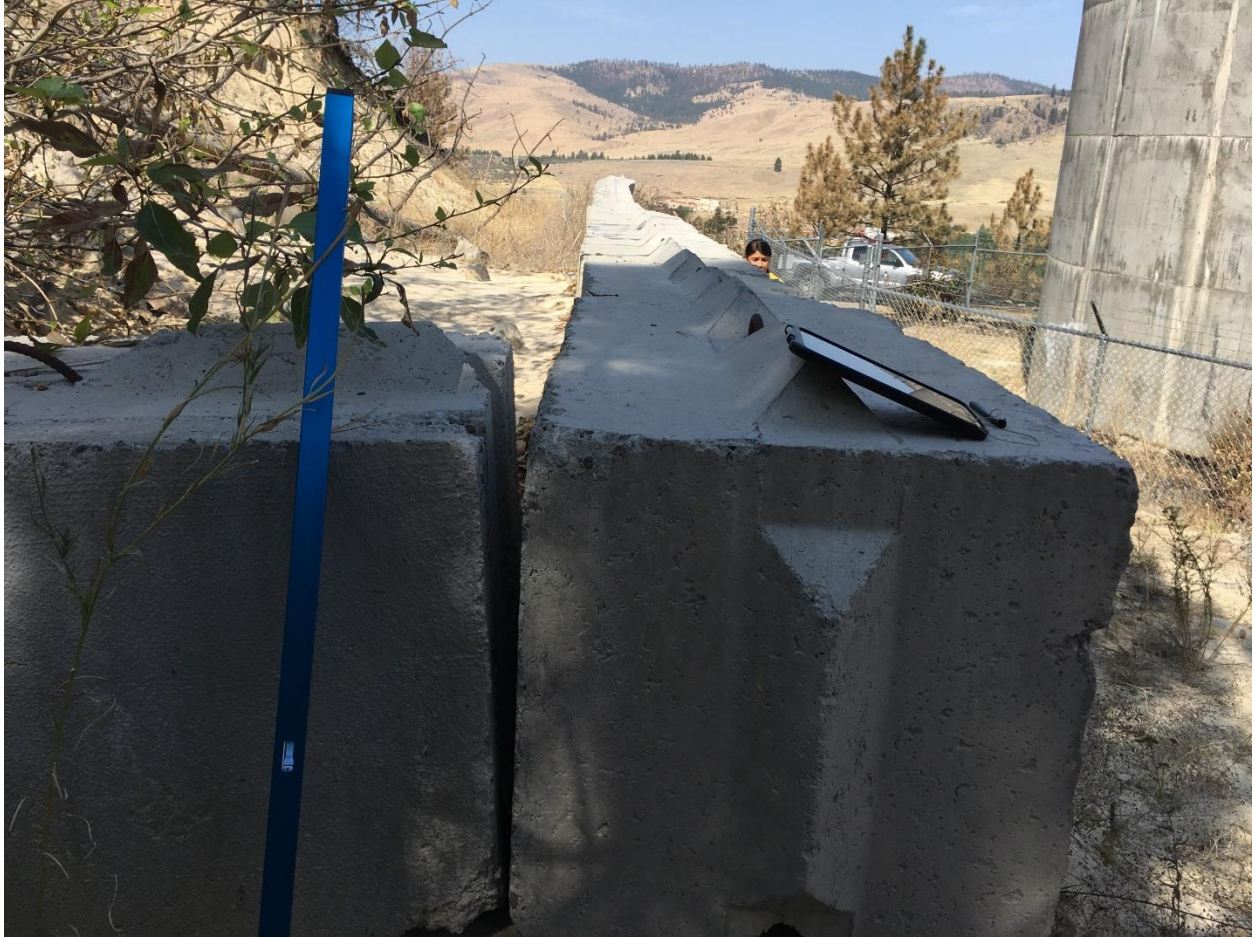
The wall is holding back some sediment from the slide but has also been deformed by the landslide. The whole stack has tilted to the north approximately 2 inches, and the middle and west ends are both noticeably deformed. The middle is sagging down approximately 1 foot while the western edge is warped northward up to 1.5 feet (Fig. 5).

**Figure 5.** Deformation of 5-year-old retaining wall made of ecology blocks, looking west.

We recommend getting geotechnical engineering support to develop plans and stabilize the landslide and drain any surface or subsurface water away from the water tank infrastructure. Additional water to the area will continue to destabilize the area.
