Burned Area Emergency Response (BAER)

Cougar Creek Fire

Geology: Entiat River Road Debris Flow Evaluation

Okanogan-Wenatchee Ranger District, Washington

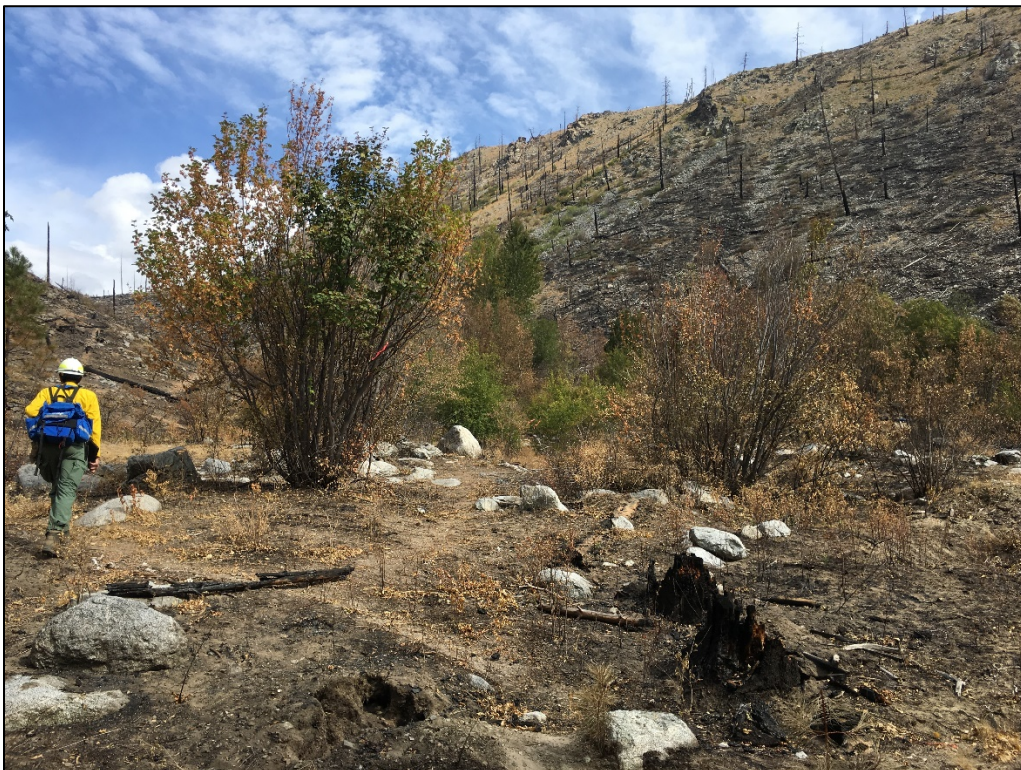
Boulders at the apex of Gray Canyon

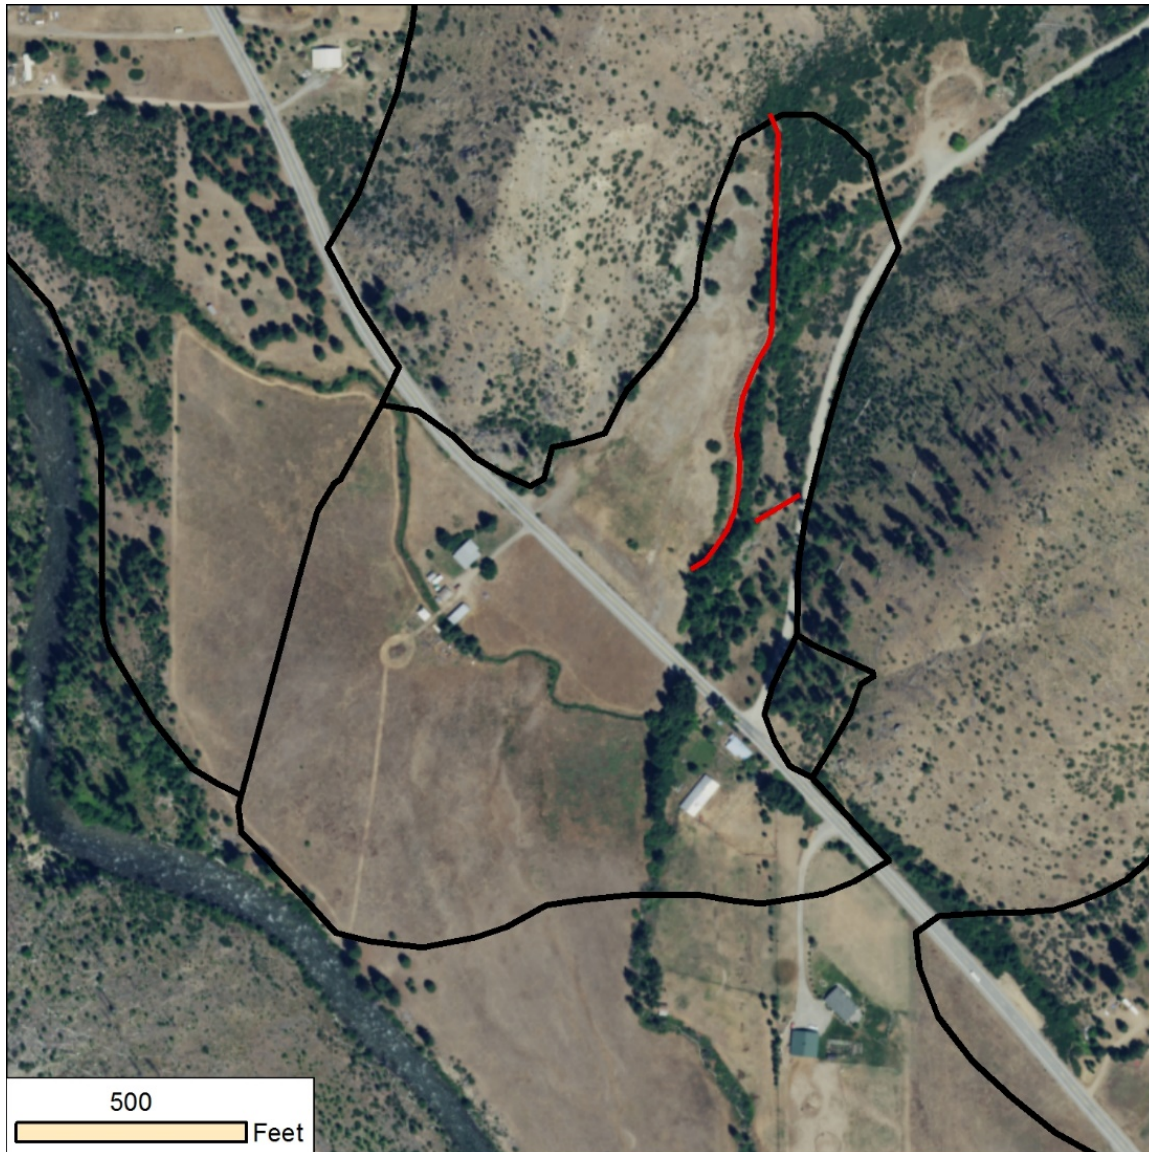
An additional observation is an extensive berm on the fan and paralleling USFS-managed lands. A 1,000 foot long berm confines Potato Creek to USFS lands and the east side of the fan (Figure 2). This berm would likely confine flood waters to the east side of the fan and places two structures and a portion of the Entiat River Road at the greatest likelihood of impact from a flooding event. Damage includes debris, sedimentation, water erosion, and (or) water inundation.

Figure 2. Potato Creek fan and modifications to the channel. Black lines delineate fans and the red lines are berms observed in the field and mapped in a GIS using 1-foot resolution lidar digital elevation model. The berm confines Potato Creek to the east side of the fan. Imagery is from 2017.

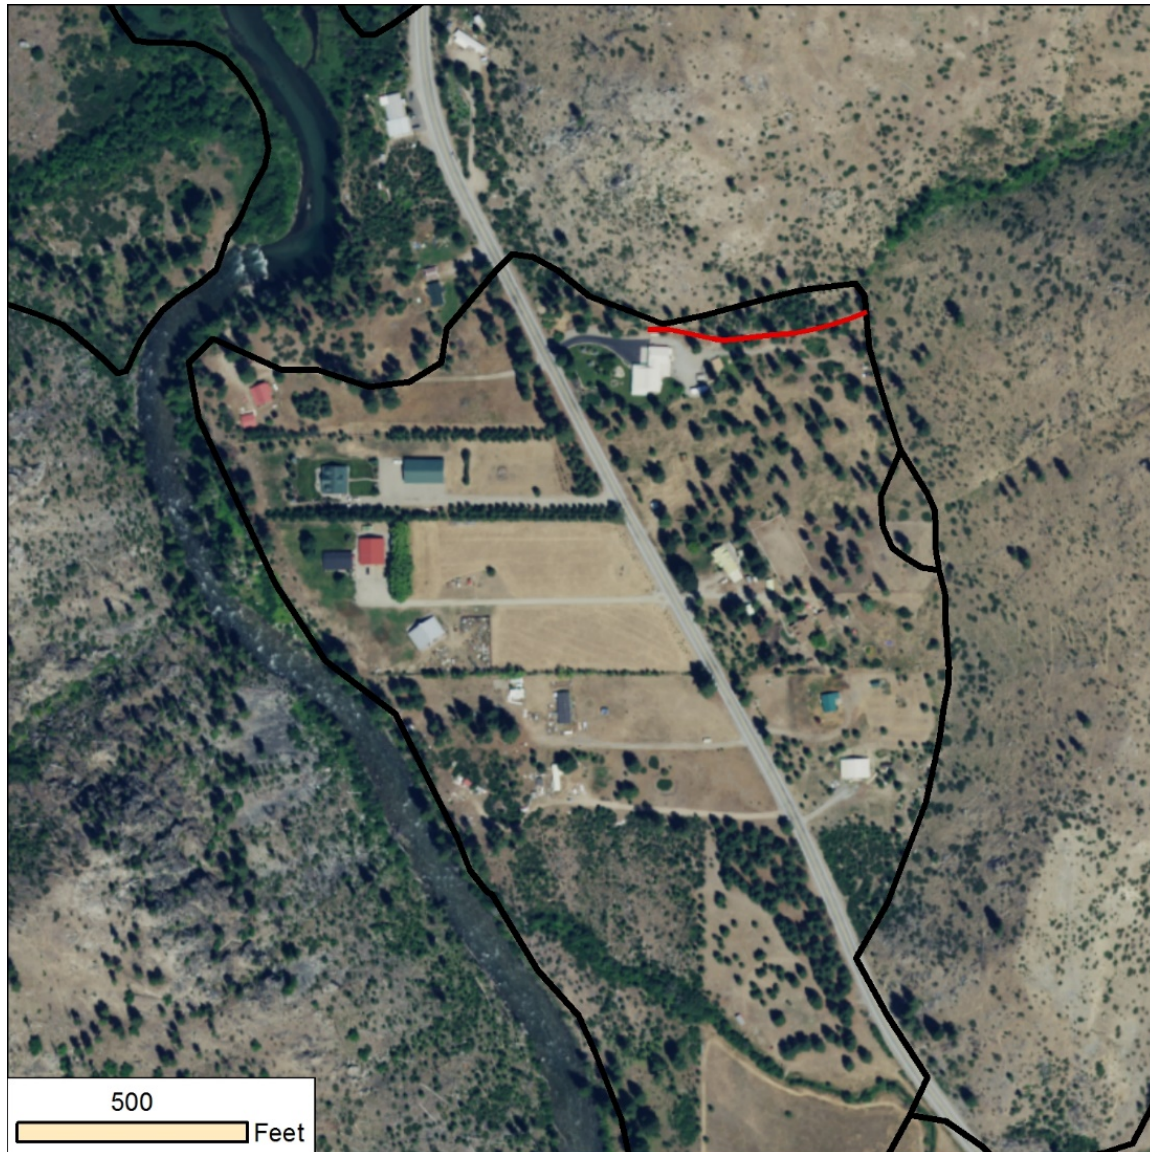
An additional observation is at the apex of the fan and the mouth of Decker Canyon, an approximately 150 foot long earthen berm, up to 6 feet high and 30 to 40 feet wide, directs the active channel to the north side of the fan. The berm continues downslope an additional 300 feet; however, it is significantly smaller and is as tall as 3 feet. The smaller berm is armored in places with cobbles and some boulders. The berms appear to be of various vintages and design and also directs the water to the north away from a private structure. The channel goes into a sub-18 inch culvert that passes under Entiat River Road.

Figure 3. Decker Canyon Creek fan and modifications to the channel. Black lines delineate fans and the red lines are berms observed in the field and mapped in a GIS using 1-foot resolution lidar digital elevation model. The berm confines Decker Canyon Creek to the north side of the fan. Imagery is from 2017.

- An evaluation of the fan channel morphology and berm design could help property owners in preparations for additional sediment and flooding from the Decker Canyon watershed.

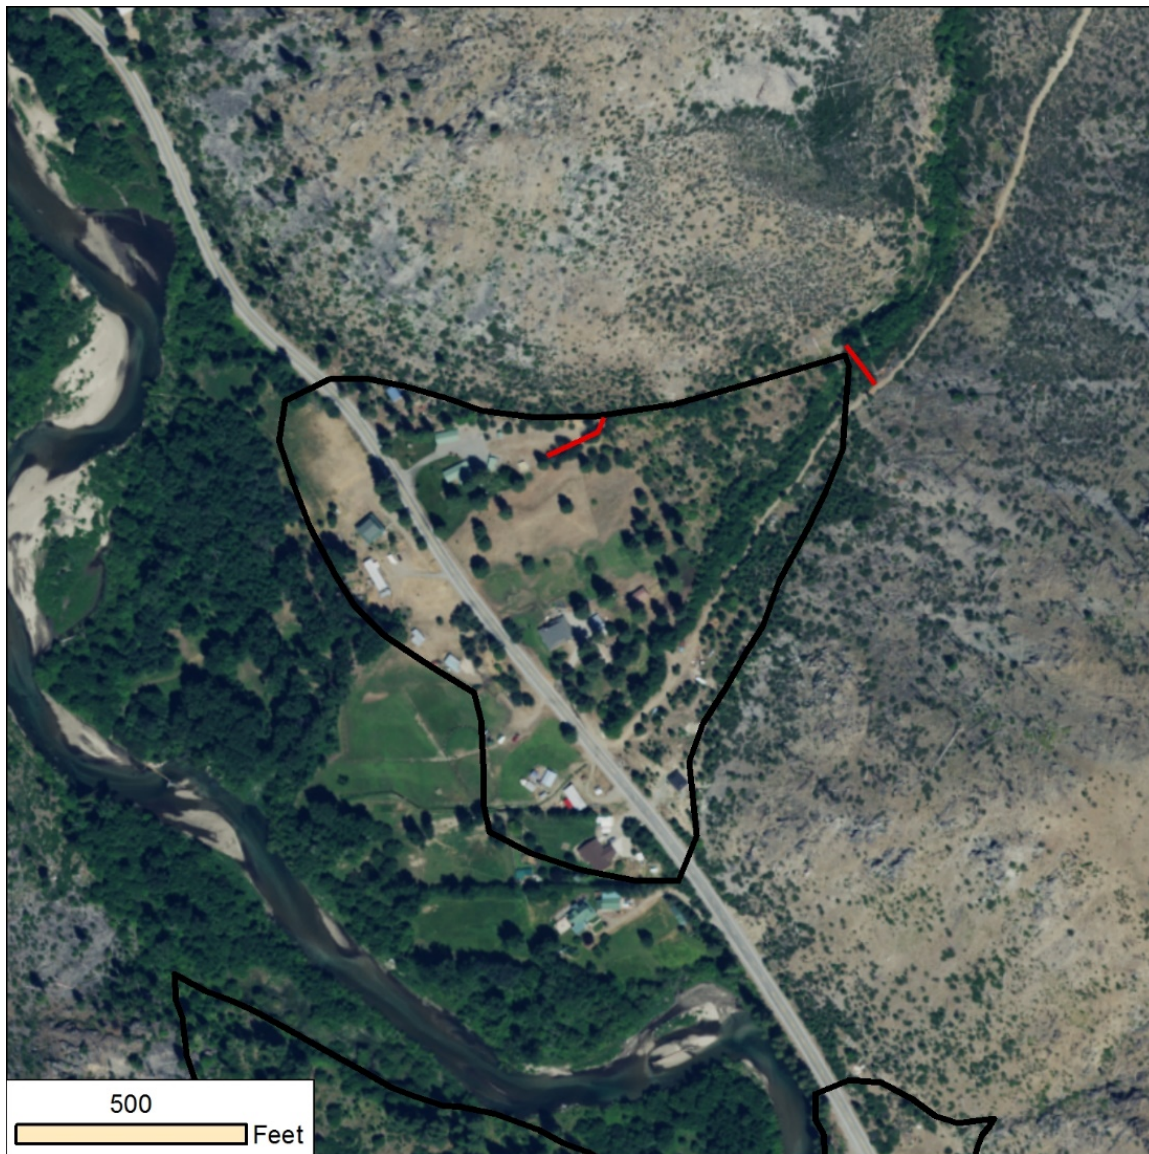
An additional observation is immediately upstream from the fan is a channel spanning structure approximately 8 feet high and 100 feet long (Figure 4). It appears armored with boulders on the downstream side and the upstream side is filled with sediment. We are unsure when the structure was constructed and the purpose of the structure.

Figure 4. Gray Canyon Creek fan and modifications to the channel. Black lines delineate fans and the red lines are berms observed in the field and mapped in a GIS using 1-foot resolution lidar digital elevation model. The berm on the upper right (northeast) at the apex of the fan, is approximately 8 feet high and crosses the span of the channel. The upstream side is filled with sediment. Human modification confines Grays Creek to the south side of the fan. Imagery is from 2017.

- The channel-spanning berm in Gray Canyon should be evaluated for potential future treatments. If it was constructed as a sediment retention structure, it has exceeded capacity and should be evaluated for hazards related to capacity and future events that deliver sediment onto the fan.

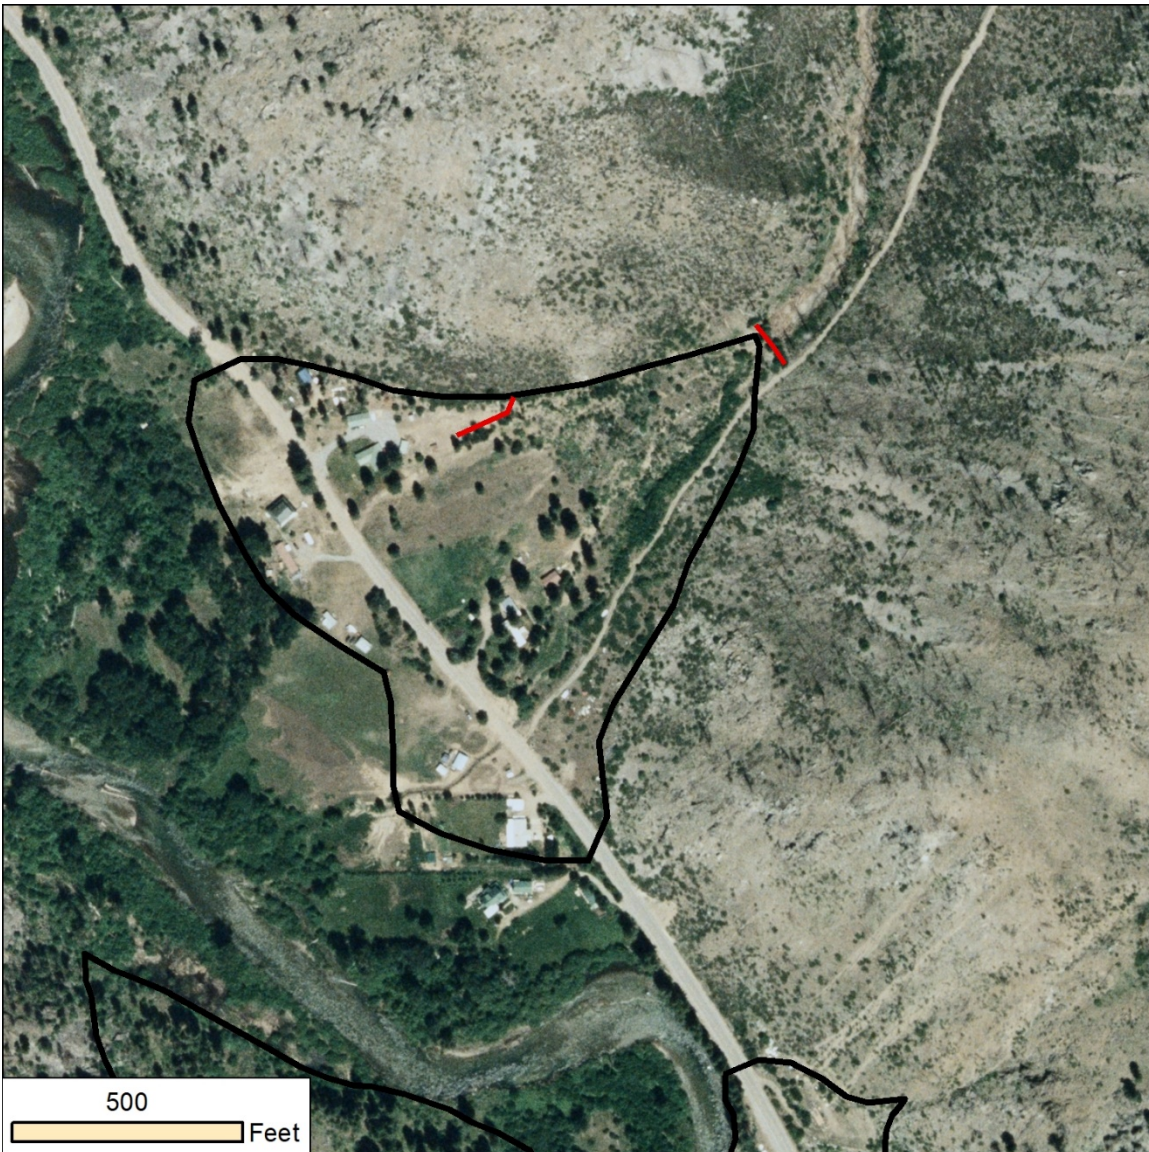
in approximately 7 inches of mud and debris that impacted structures. We were not able to verify the date of this event; however, orthoimagery 6/23/2006 (Figure 5) suggest that this event may have occurred between 7/31/2005 and 6/23/2006. The 2006 air photo clearly shows dozens of shallow debris slides in the watershed and the main channel was impacted by debris. Both the southern and northern channels of the fan received sediment from this event.

Figure 5. 2006 USDA photo of Gray Canyon Creek fan showing impact from sediment onto the fan, both on the northwest and southwest lobes. The southwest lobe shows sediment beyond the mapped fan. Note the channel above the fan apex on the northeast corner is light in color suggesting that vegetation in the channel was impacted.

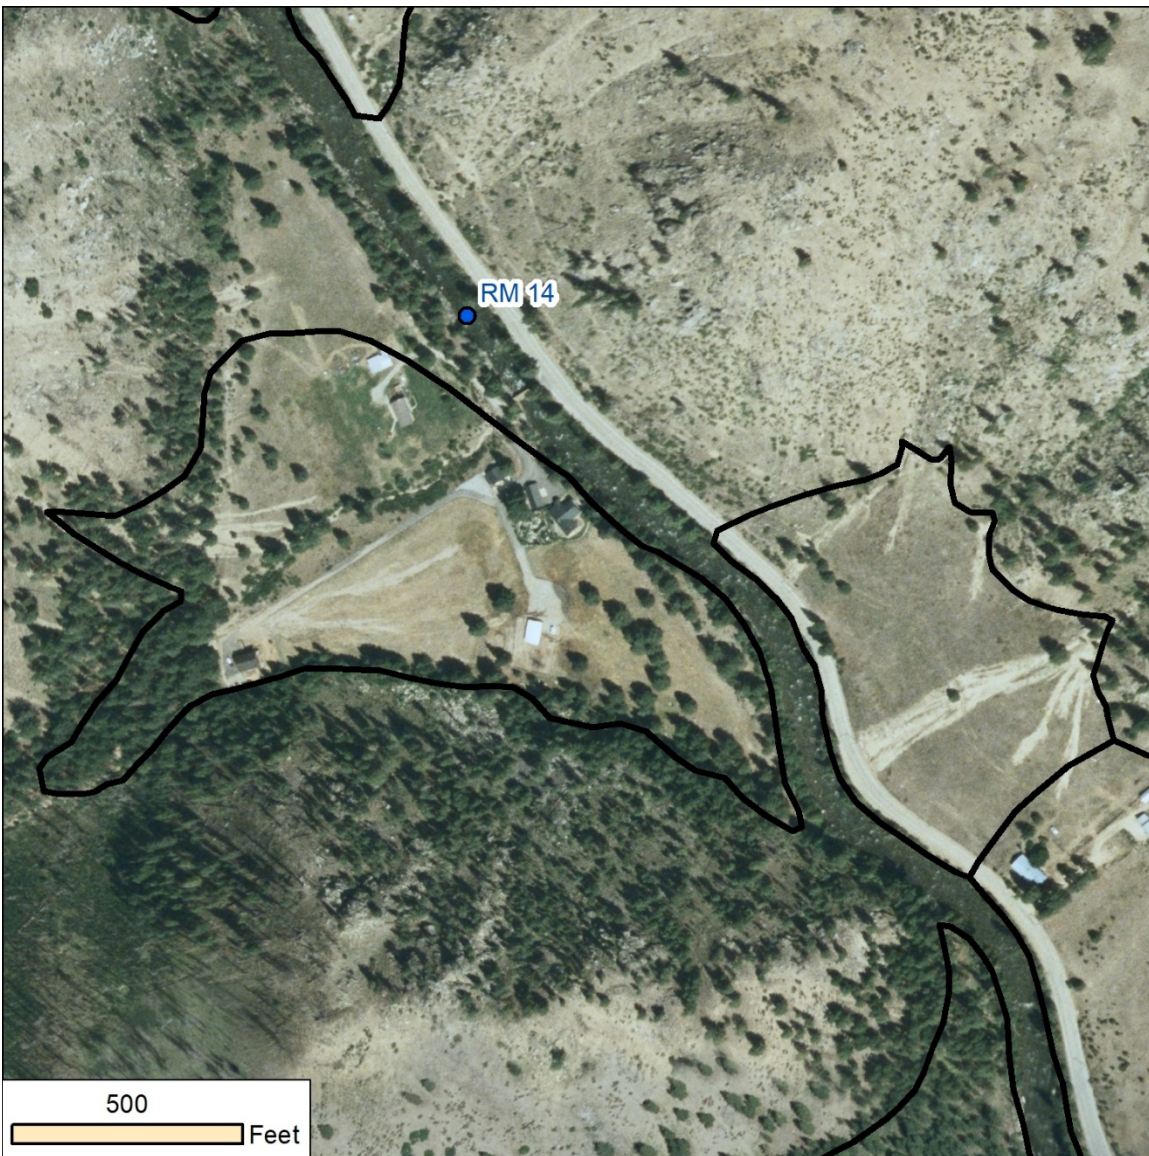
This fan has a well-defined channel on the main body of the fan; however, near the apex of the fan, the channel disappears for 300 feet before reappearing again. This area is near a home and according to a resident near the river, the creek on the fan rarely flows and water in the upper valley typically goes subterranean prior to the apex of the fan. The resident also stated that a 1994 storm event manifested as “a little water in the channel” and stated that typically the channel is dry. Orthoimagery from 2006 show sediment deposition to the fan both by the main creek and from a small watershed to the north. The deposits appear as light colored lines on the pasture suggesting sediment and water came down the fan (Figure 6).

Figure 6. 2006 USDA photo of Tye Ridge Spring No. 1 fan and unnamed fan to the east showing impact from sediment onto the fans, from the 2006 event. This is obvious from light colored lobes on the fans.

- The home at the apex of the Tye Ridge Spring No.1 fan, 11125 Entiat River Road, may need to consider improving drainage in the dry creek channel to accommodate potential future flooding.
