Crescent Mountain Fire

Twisp River Debris Flow Evaluation

Washington Geological Survey

Okanogan-Wenatchee Ranger District, Washington

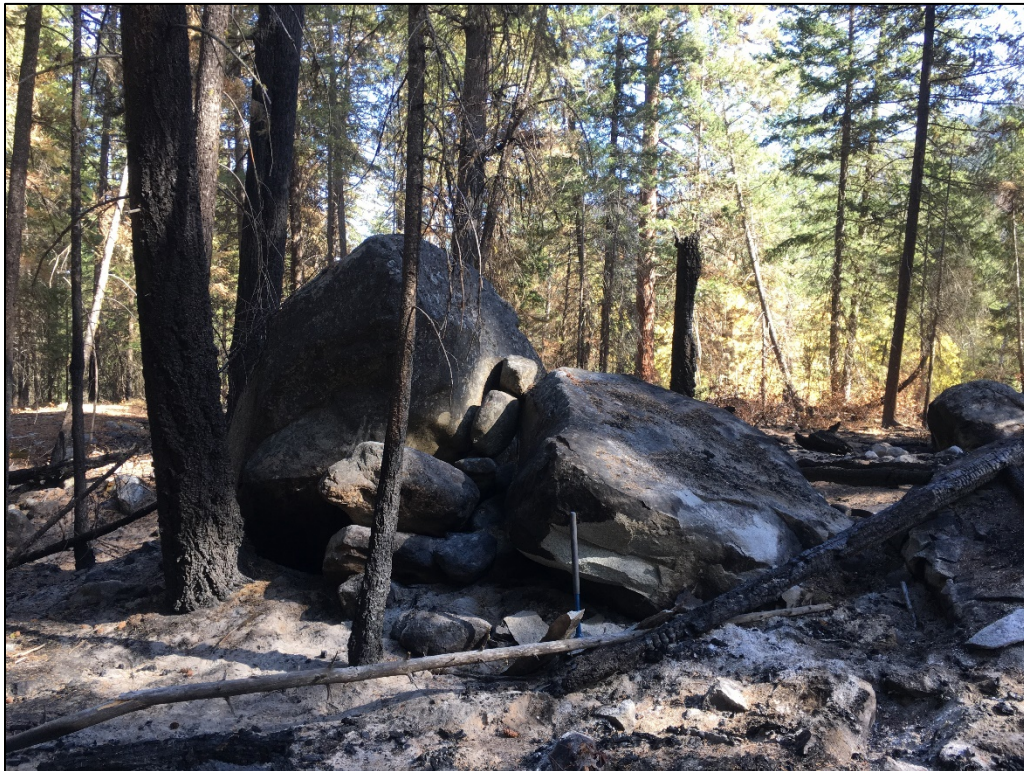
Image: Evidence of past debris flows on the Scaffold Camp Creek fan:
Imbricated boulders up to 8 feet in diameter 285 feet south of West Buttermilk Creek Road.

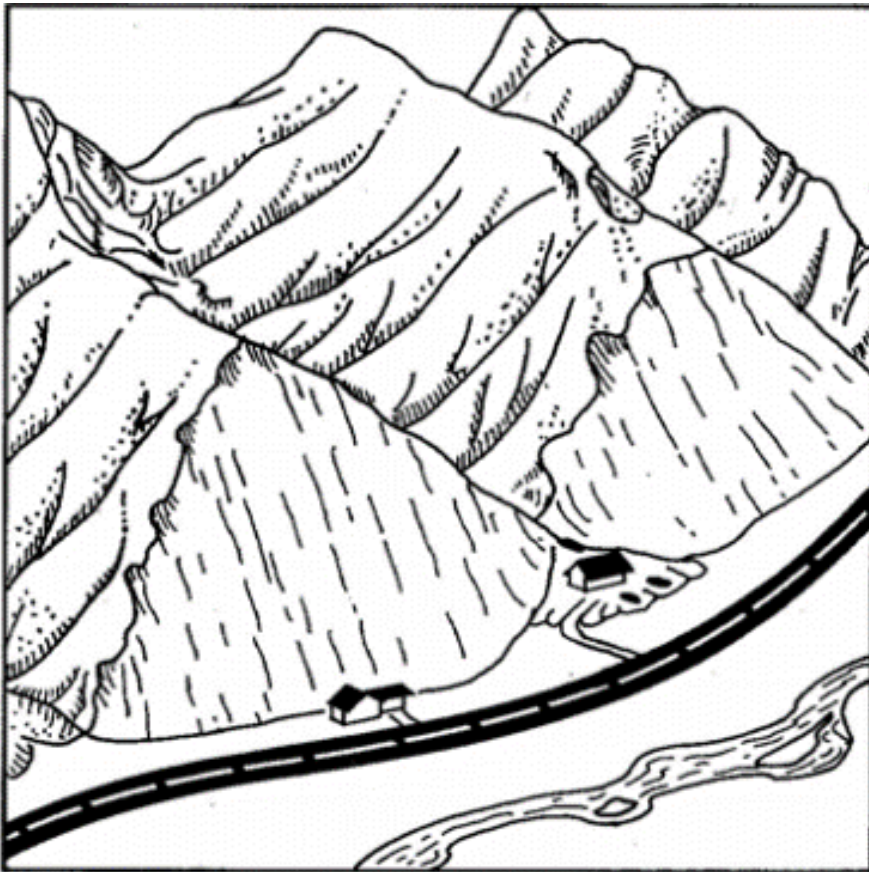
Fans are attractive locations to build cabins and homes due to the slight elevation above river floodplains and (or) the occasion to have a view of the floodplain (Figure 1). However, fans are there because they are active depositional areas that accumulate sediment over time. The sediment can be deposited both slowly, such as during a spring melt when high streamflow during spring runoff transports and deposits fine sediment on the fan or quickly, when a flash flood, HCF, or debris flow transports sediment and debris to the fan. As stated previously, both flash floods and HCF can inundate areas not typically wetted by regular streamflow, so channel-adjacent roads, trails, building, and other infrastructure can still be damaged by impact from debris, sedimentation, water erosion, and (or) water inundation. In addition, a debris flow can be very destructive due to the ability of a debris flow to buoy cobbles, boulders, and woody debris at the front of the moving mass. Debris flows are extremely dangerous to public safety and infrastructure.

Figure 1. Homes and road in debris flow-prone locations on fans. Oregon Dept. of Forestry (2003).

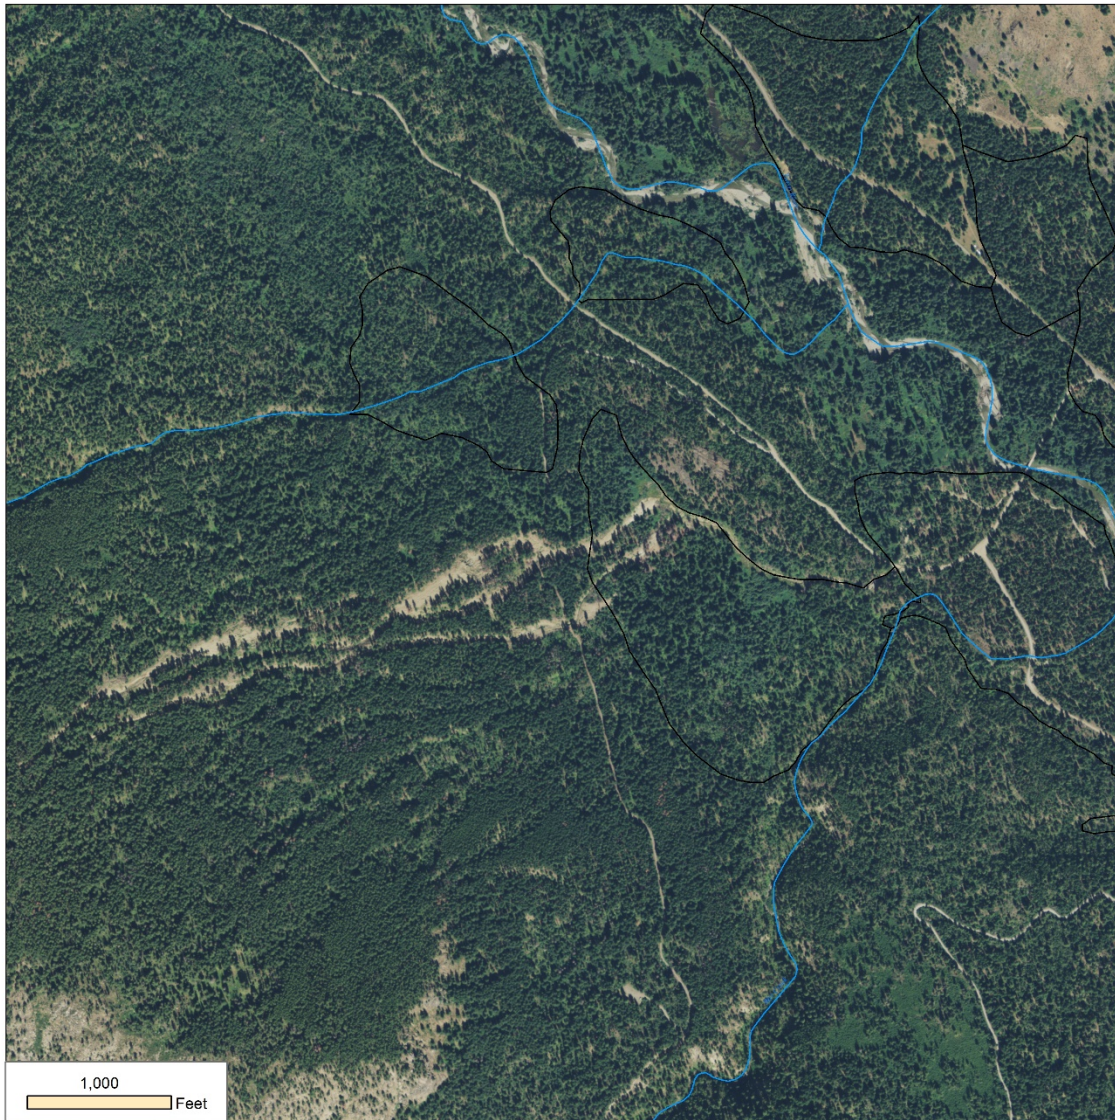
In 2011, a landslide and subsequent debris flow occurred about 2500 feet west of the War Creek fan. The event did not occur in the main stem of War Creek but in an isolated inner gorge above the river valley at approximately 4200 feet in elevation. The landslide likely initiated in glacial deposits that veneer the bedrock in this portion of the valley. Interpretation of 2013 orthoimagery suggests the subsequent debris flow likely mostly deposited on the glacial bench, above the valley floor (Fig. 2).

Figure 2. 2011 Debris flow scar west of War Creek where the FR4430 and FR100 meet. Imagery is from 2013.

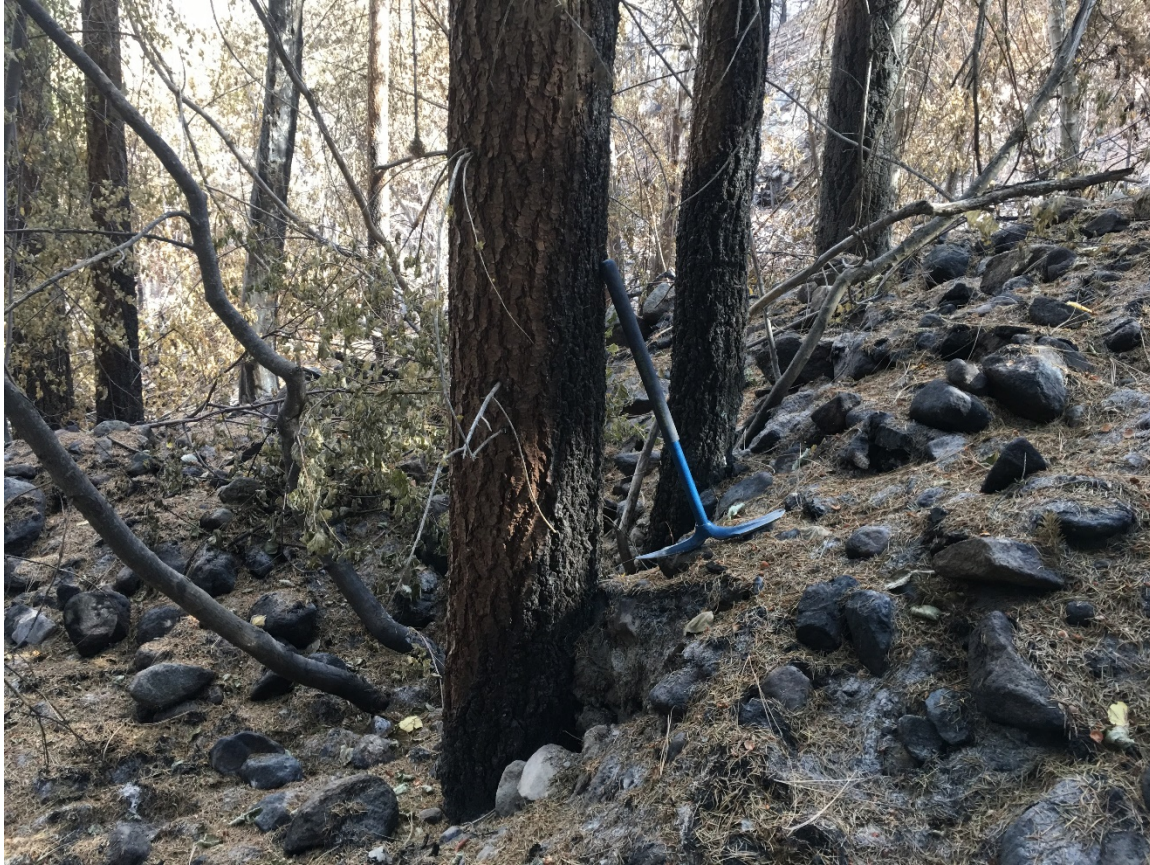
During the site visit of the fan, we observed multiple dry channels typically 10 to 12 feet wide and 4 to 5 feet deep. We also observed lobes and levees of boulders and cobbles oriented north south. These lobes show various ages of activity based on the varying thickness of soil formation on the deposits. Some deposits appear to have occurred in the past 20 to 30 years based on trees that have cobble deposits piled up against them (Fig. 3). The photo on the front of this report shows smaller boulders stacked up between two large boulders. The largest is approximately 8 feet in the longest axis. These boulders are approximately 1275 feet from the apex of the fan, about 285 feet from the road, and 550 feet west of the home at 211 West Buttermilk Creek Rd. Boulders were also noted 200 feet west of the home. These boulder and cobble deposits are interpreted as evidence for debris flows and flood events on the fan.

Figure 3. Cobbles piled up against Douglas fir trees on the west side of Scaffold Camp Creek, suggest recent activity in the past 20 to 30 years. Notice thin soil development on cobbles. Blue pick is just over two feet in length.
