# WILDFIRE-ASSOCIATED LANDSLIDE EMERGENCY RESPONSE TEAM REPORT

## Ford Corkscrew Fire

Stevens County, Washington

WASHINGTON  
GEOLOGICAL SURVEY  
WALERT Report  
September 15, 2021

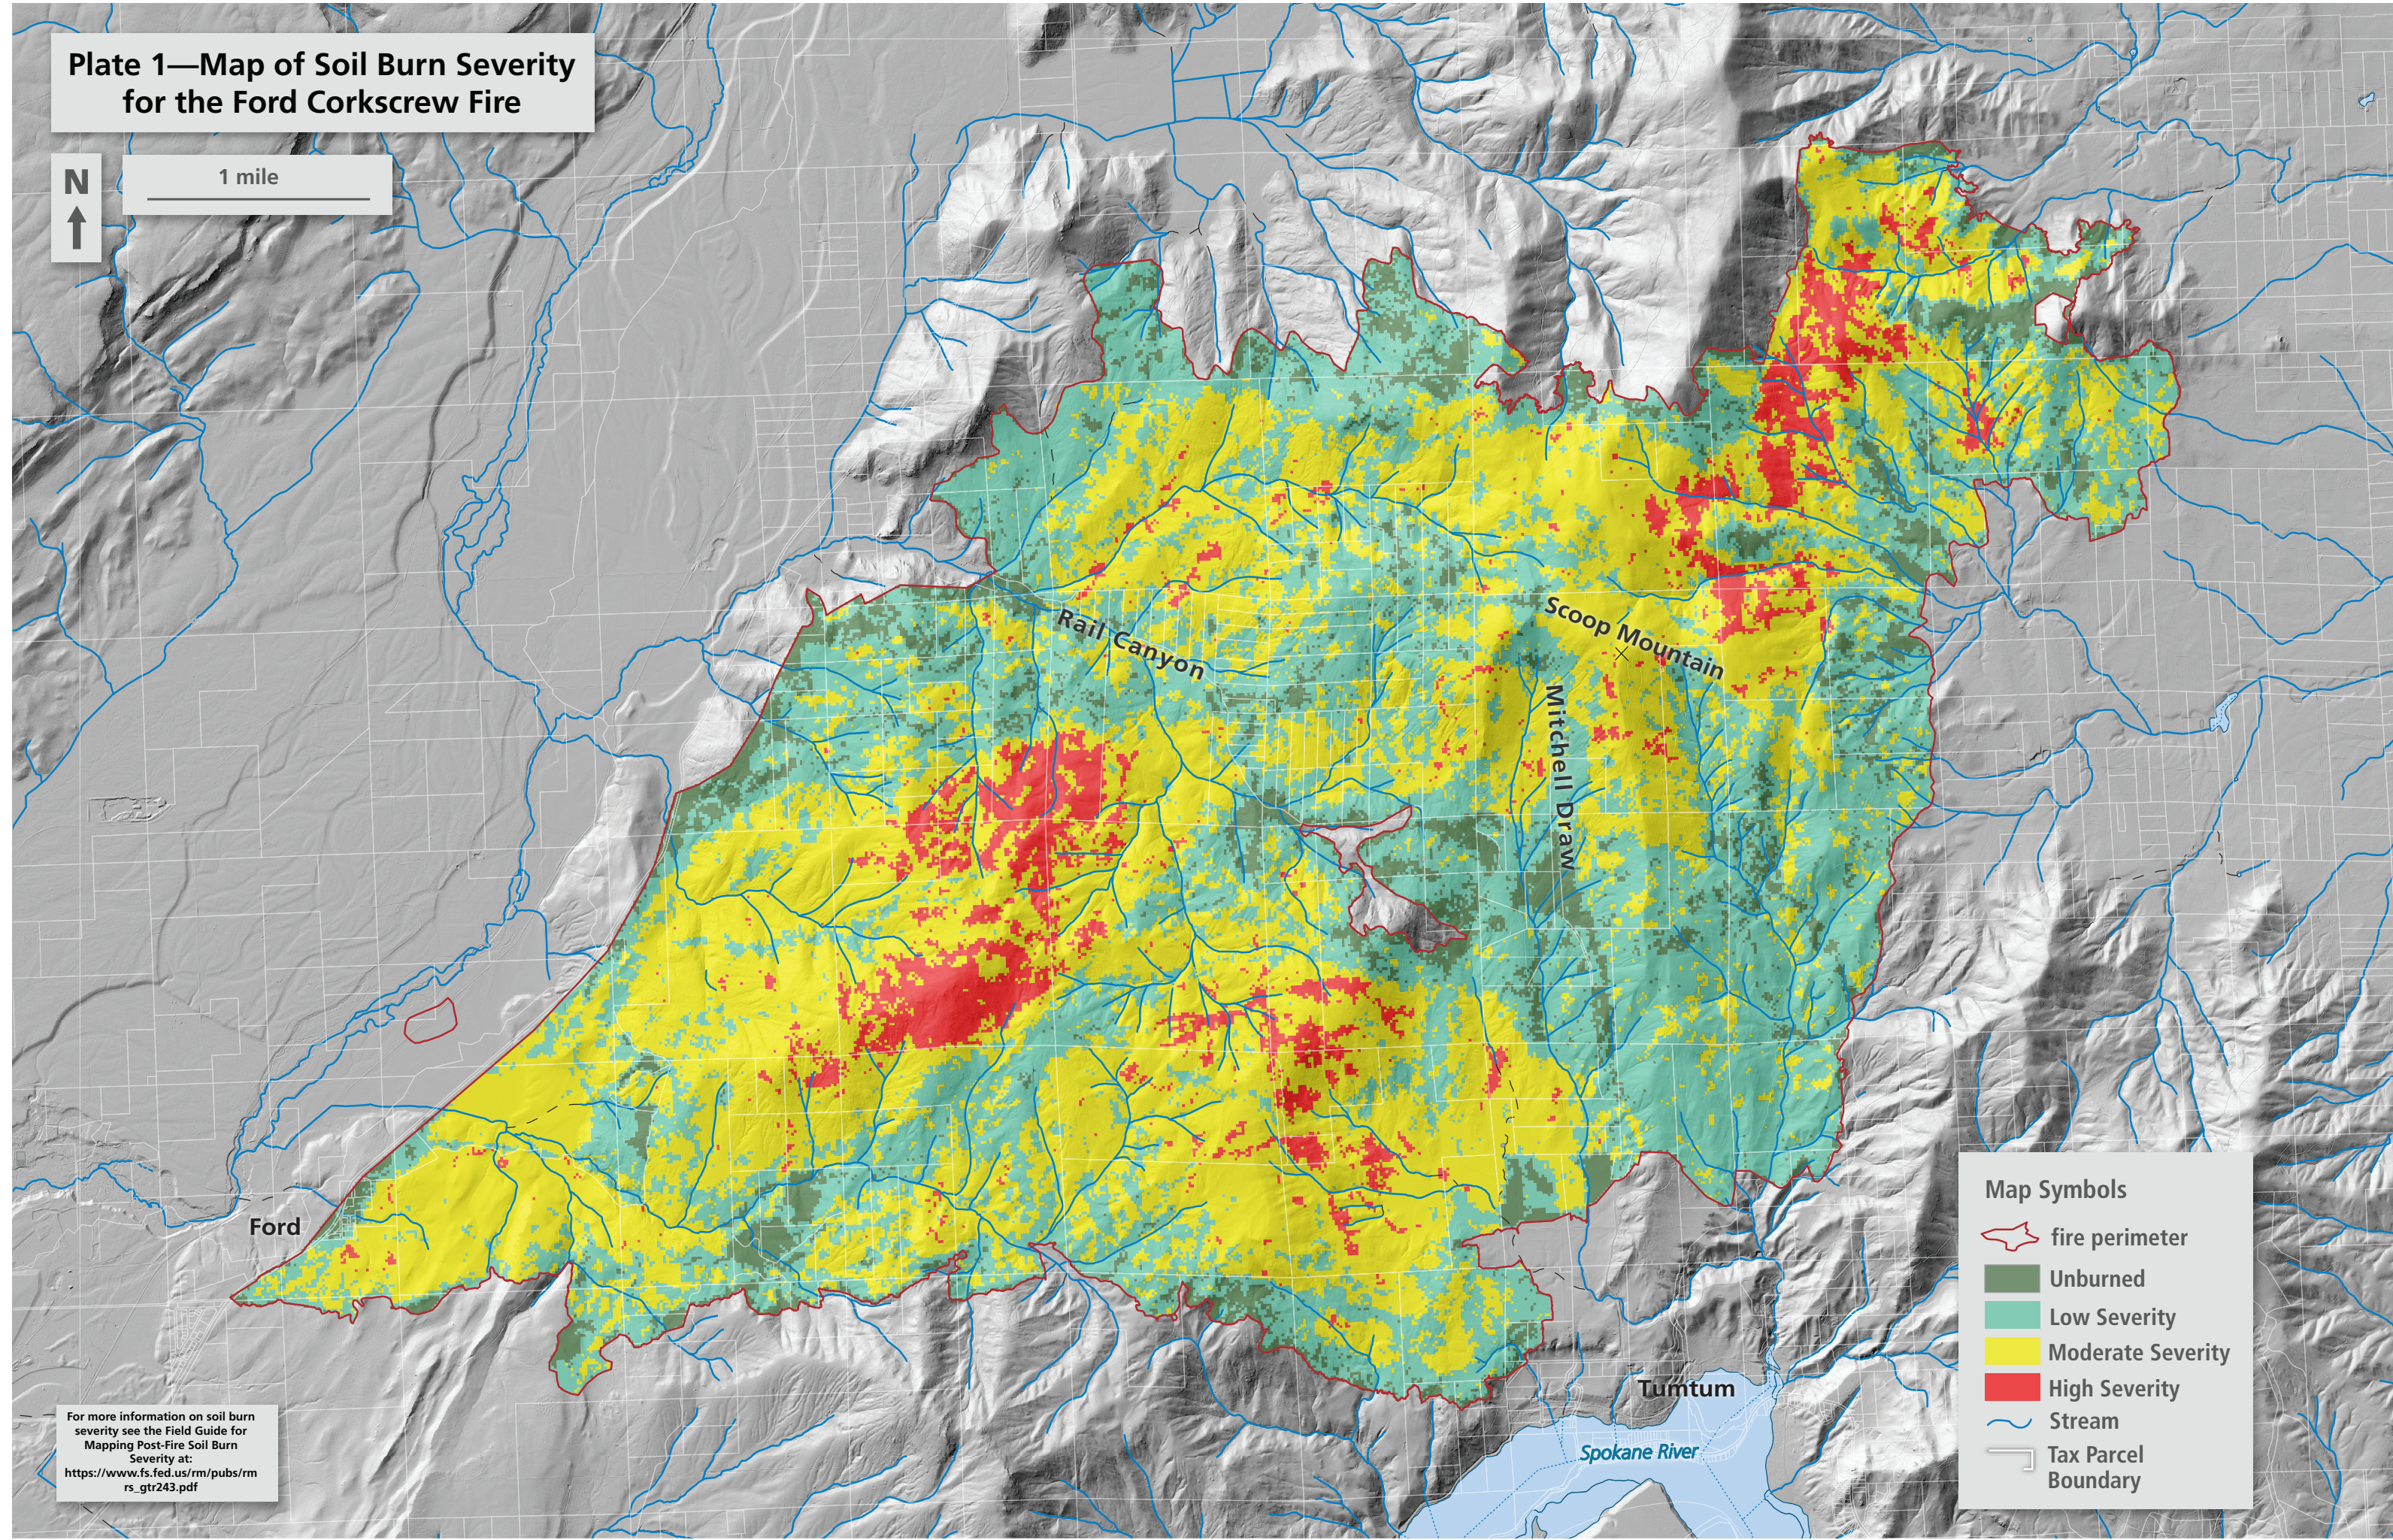
# Plate 1—Map of Soil Burn Severity for the Ford Corkscrew Fire

Approximately 46 percent of the area affected by the fire was either unburned or had low soil burn severity, and 7,390 acres (47%) burned with moderate soil burn severity. The 1,022 acres (6.5%) that were marked as high burn severity are predominantly restricted to riparian corridors and north- and east-facing drainages in higher elevations of the burned area. See Table 3 and Plate 1.

A few drainages had some high soil burn severity on steeper slopes. These include the north-facing slopes along the southern portions of Rail Canyon, and the headwaters of unnamed, west-flowing drainage basins to the south. East-facing slopes in the northeast portion of the burned area, approximately 1.5 miles northeast of Scoop Mountain, experienced moderate soil burn severity; however, the soil burn severity data locally show high soil burn severity. We did not alter the data here as these isolated inconsistencies may be related to recent timber harvests or fire suppression activities. In general, field observations of soil burn severity were generally consistent with the remotely mapped conditions.

concerns about future flooding were voiced by landowners within Rail Canyon, where relatively steep north-facing slopes along the southern portions of the canyon experienced high soil burn severity (Plate 1).

Landowners and managers may choose to take action to prevent excessive soil erosion, reduce flooding, and promote revegetation to meet their management and economic goals. Utilizing the soil burn severity map provided to find areas of high and moderate burn severity should assist in this evaluation. Seeking technical assistance from Stevens County Conservation District may also be helpful.
