Burned Area Emergency Response (BAER)

Jolly Mountain Fire

Geology: Landslides

Okanogan-Wenatchee National Forest, Washington

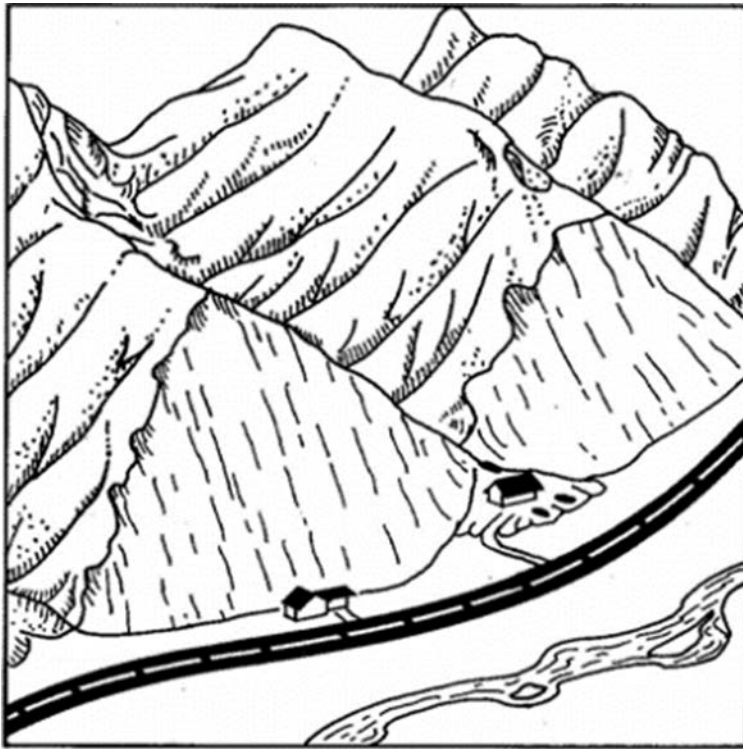
Alluvial fans are attractive locations to build cabins and homes due to the slight elevation above river flood plains and (or) the occasion to have a view of the flood plain (Figure 1). However, alluvial fans are there because they are active depositional areas that accumulate sediment over time. The sediment can be deposited both slowly, such as during a spring melt when high streamflow during spring runoff transports and deposits fine sediment on the fan or quickly, when a flash flood, HCF, or debris flow transports sediment and debris to the fan. As stated above, both flash floods and HCF can inundate areas not typically wetted by regular streamflow, so channel-adjacent roads, trails, building, and other infrastructure can still be damaged by impact from debris, sedimentation, water erosion, and (or) water inundation. In addition, a debris flow can be very destructive due to the ability of a debris flow to buoy

Figure 1. Homes and road in debris flow-prone locations on alluvial fans. Courtesy of Oregon Dept. of Forestry.
