Wildfire-associated Landslide Emergency Response Team (WaLERT) Report for the Left Hand Fire

Naches Ranger District—Okanogan–Wenatchee National Forest, Washington

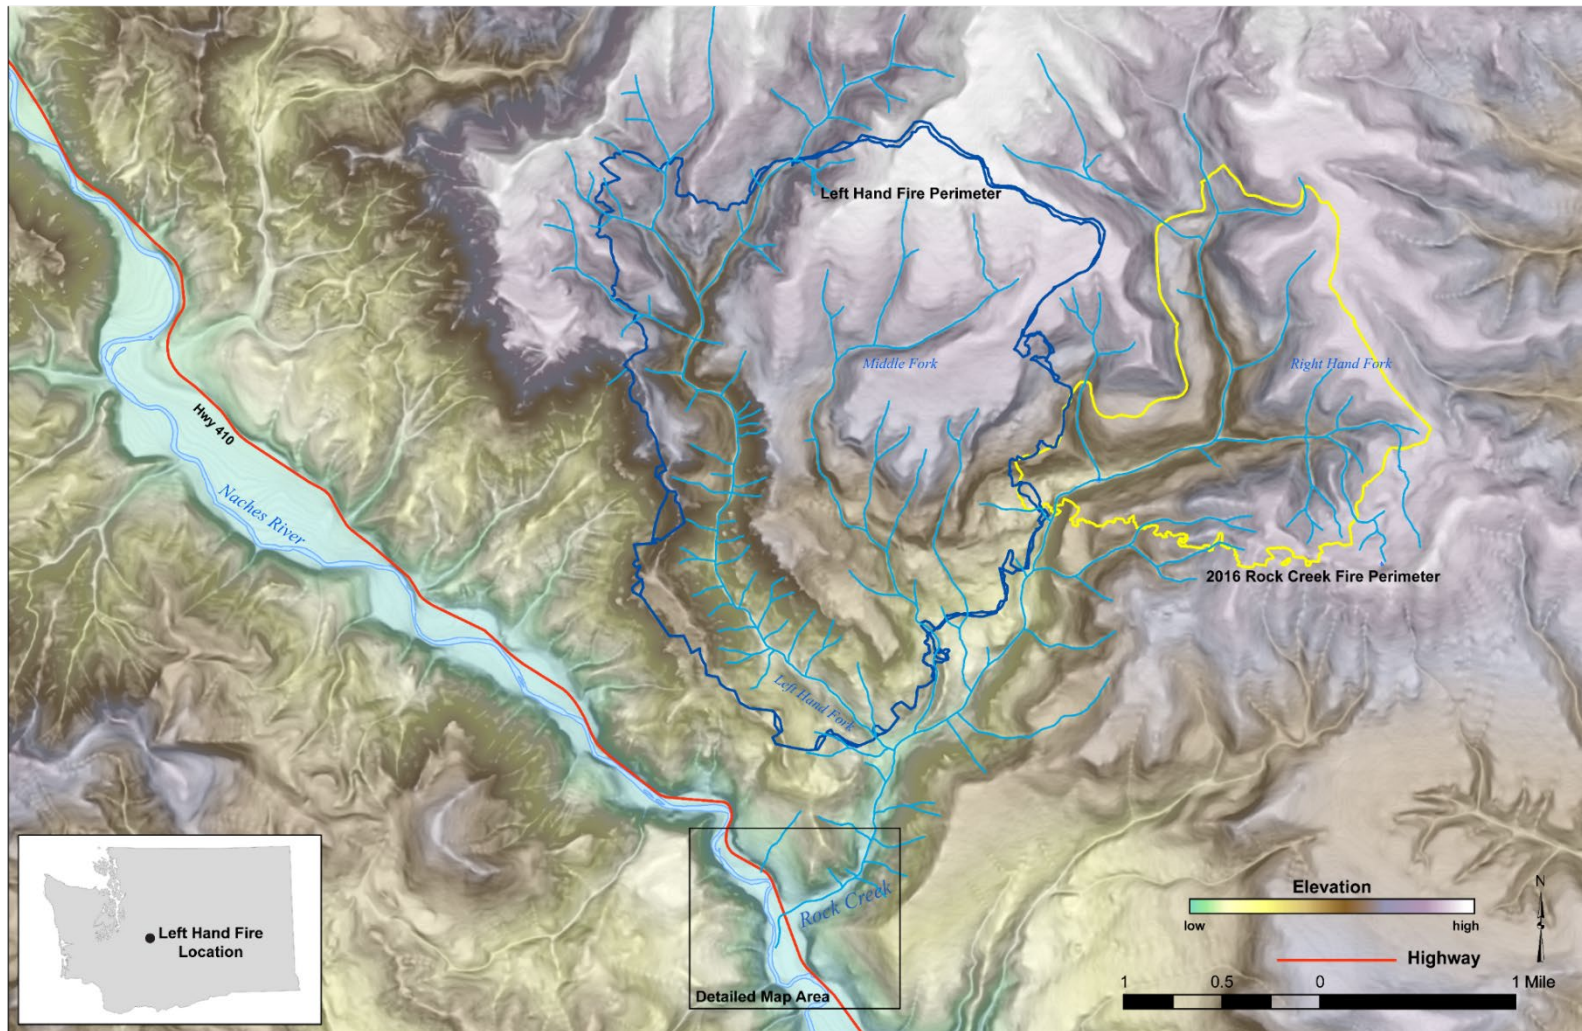
Figure 1. Left Hand Fire location, showing 2019 Left Hand Fire burned area perimeter on Left Hand Fork Rock Creek and the informally named Middle Fork Rock Creek. Also shown is the 2016 Rock Creek Fire burned area perimeter on Right Hand Fork Rock Creek.

The Left Hand Fire burned approximately 30 percent of the Rock Creek basin (Fig. 1); however much of the burned area was of low soil burn severity based on the findings of the U.S. Forest Service BAER team (Table 1).

We observed stream deposits along Right Hand Fork Rock Creek and an unnamed branch of Rock Creek that we refer to as Middle Fork Rock Creek (Fig. 1). Middle Fork joins Right Hand Fork approximately 800 feet upstream from the confluence of Right Hand Fork and Left Hand Fork. The Middle Fork catchment basin lies nearly completely within the Left Hand Fire burned area. Most of Right Hand Fork Rock Creek lies within the burned area of the 2016 Rock Creek Fire. We sought evidence of debris flows in the lower unburned catchment of Right Hand Fork Rock Creek. Both Middle Fork and Right Hand Fork show evidence of flooding but no evidence of debris flows.

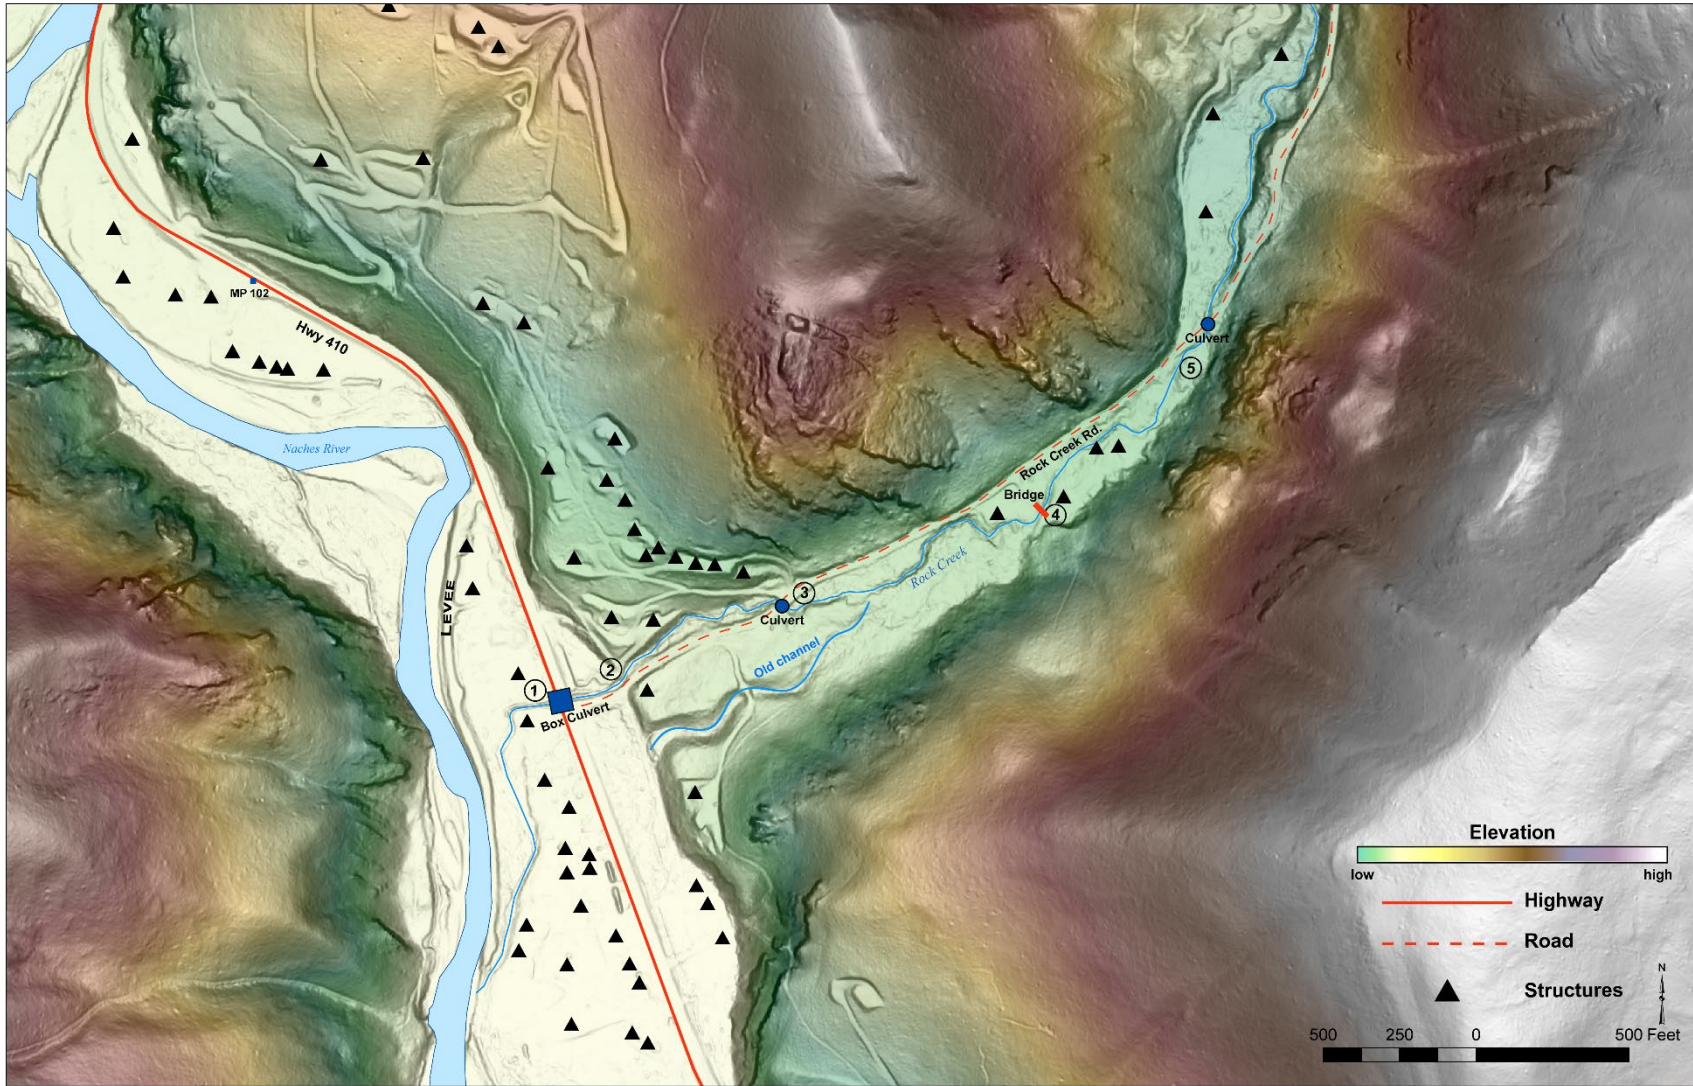
Figure 2. Rock Creek downstream of the Left Hand Fire, where the creek enters the Naches River. Site numbers refer to sites discussed in report. Black triangles indicate the locations of structures taken from Bing Maps team data. Rock Creek was digitized from lidar and limited field observations.

Upstream of SR410 the channel is confined by a berm along Rock Creek Road (FS1702) where the road ascends an older alluvial fan. Topped by this berm, the channel walls extend vertically 6–12 ft from the channel bottom, and the berm extends at least 300 ft upstream from the SR410 culvert (Fig. 2, Site 2). The berm appears to have been repaired within the past five years. Along with road surface damage and piles of woody debris, the berm repairs suggest that the channel has recently flooded the road along this stretch.

Upstream from the SR410 box culvert, we observed two culverts on Rock Creek (Fig. 2 , Sites 3 and 5) and one culvert on Right Hand Fork Rock Creek immediately above its confluence with Left Hand Fork Rock Creek. These metal culverts are all approximately four ft in diameter or less. There is also a cement girder residential bridge over Rock Creek (Fig. 2, Site 4). These culverts and bridges all lie downstream of the Left Hand burned area.

On the stream reach from SR410 to the confluence of Right Hand and Left Hand Fork Rock Creek, the stream bank is locally armored with boulders to protect house pads. It is unclear whether the dry old channel to the south of the active Rock Creek channel lacks flow due to stream modification or due to natural avulsion (Fig. 2). The current channel is shown as active on the 1899 topographic map.

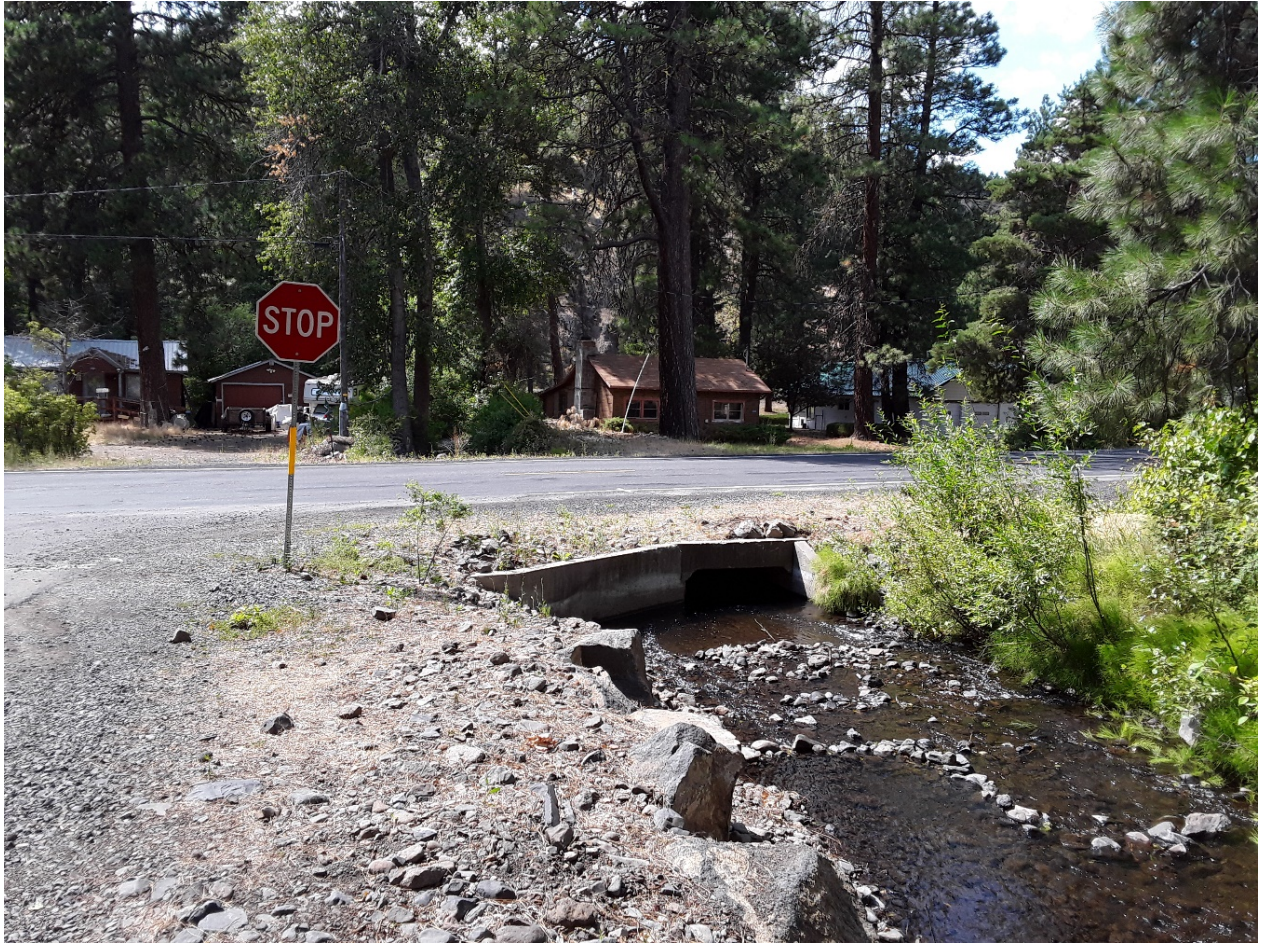
Where Rock Creek flows under SR410, the creek is confined to a box culvert approximately five ft across. The channel appears to have been recently cleared of rocks and debris on the upstream side. Piles of straw and yard waste extend along the north side of the upstream culvert wall.

Figure 3. Box culvert at SR410, looking west toward homes 14710 and 14680 WA-410. Site 1 on Figure 2.

- Rock Creek (MP 102.3) passes under SR410 through a five-ft box culvert that conveys water under the highway and between two homes. A flash flood event magnified by hydrophobic soil conditions could mobilize large volumes of woody debris that could block the intake of the box culvert, potentially impacting the state highway. We recommend providing WSDOT with hydrological modeling for Rock Creek from the U.S. Forest Service BAER report. The box culvert could be impacted and needs additional maintenance. Additionally, if the channel is impacted by debris above the culvert under Rock Creek Road (Fig. 2, Site 3), water could migrate to the south and use the abandoned old channel, flooding the area east of SR410.

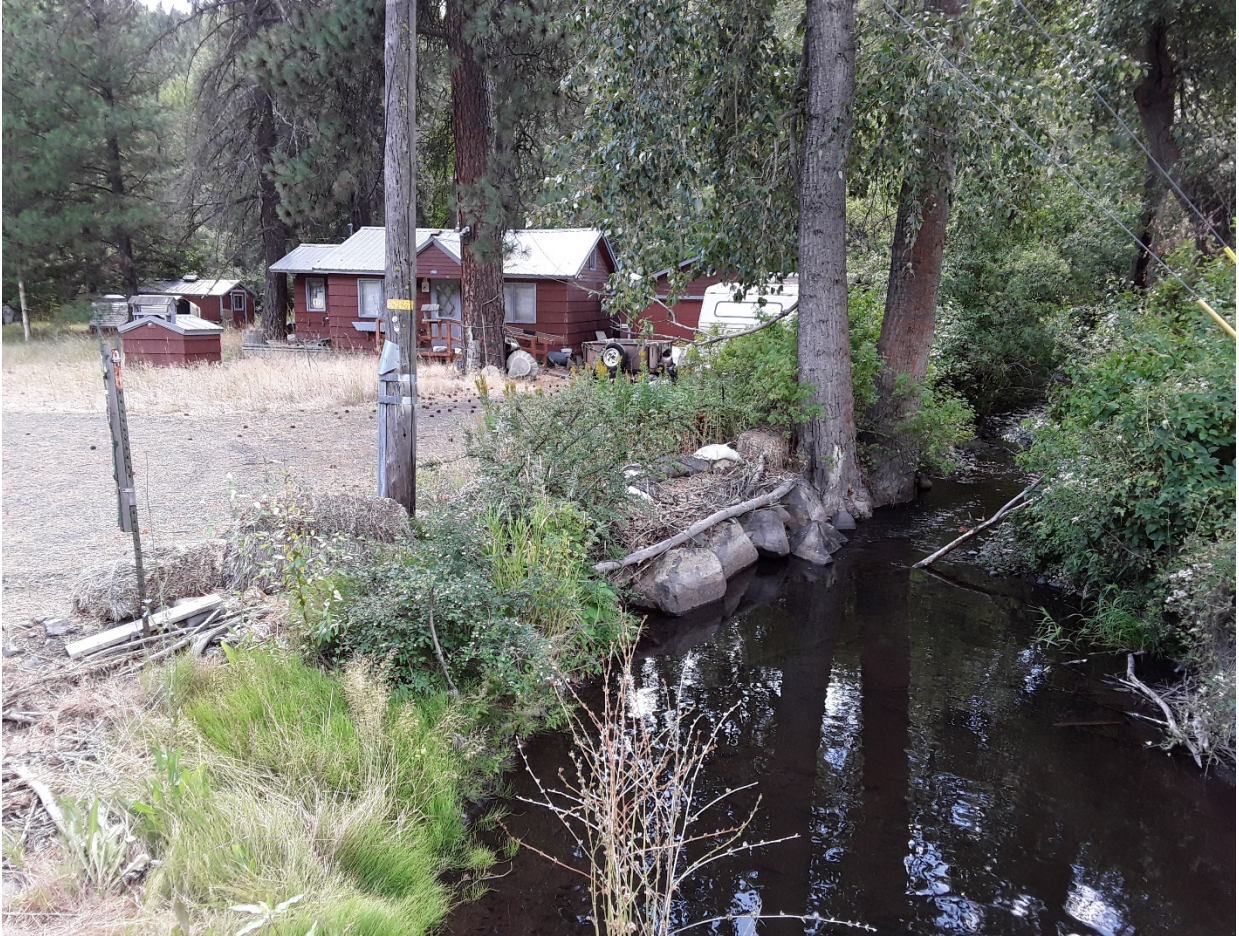
Accounts from local residents suggest that Rock Creek has suffered flood events at least as recently as 1996 and 2011. We observed sandbags, straw bales, and berms downstream of SR410 where Rock Creek passes between two residences before turning south and passing between the levee at the Naches River and six additional homes (Fig. 2, Site 1; Figs. 3, 4, and 5). Residents told us that three of these homes had flooding problems in the 2011 flood event with at least one home condemned due to flooding. We observed two vacant homes on the downstream side of SR410, associated with damage due to the 2011 flood event.

Figure 4. Home at 14680 WA-410, downstream of box culvert along Rock Creek. Note sandbags, boulders, and damage to the base of the tree trunk, second from right, as evidence for previous flooding events. Site 1 on Figure 2.

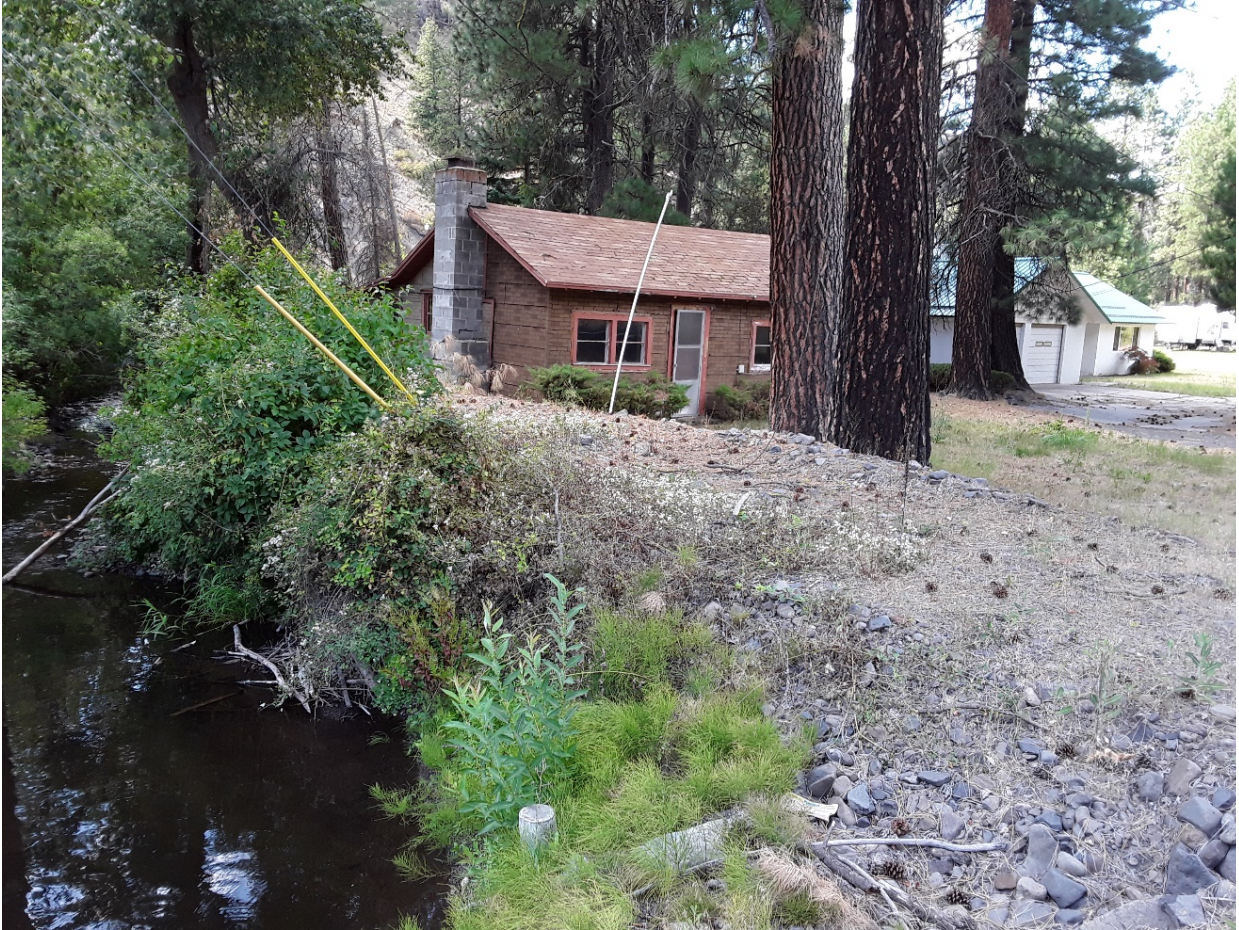
Figure 5. Home at 14710 WA-410 downstream of box culvert under SR410 along Rock Creek. Note berm built to protect house. Site 1 on Figure 2.

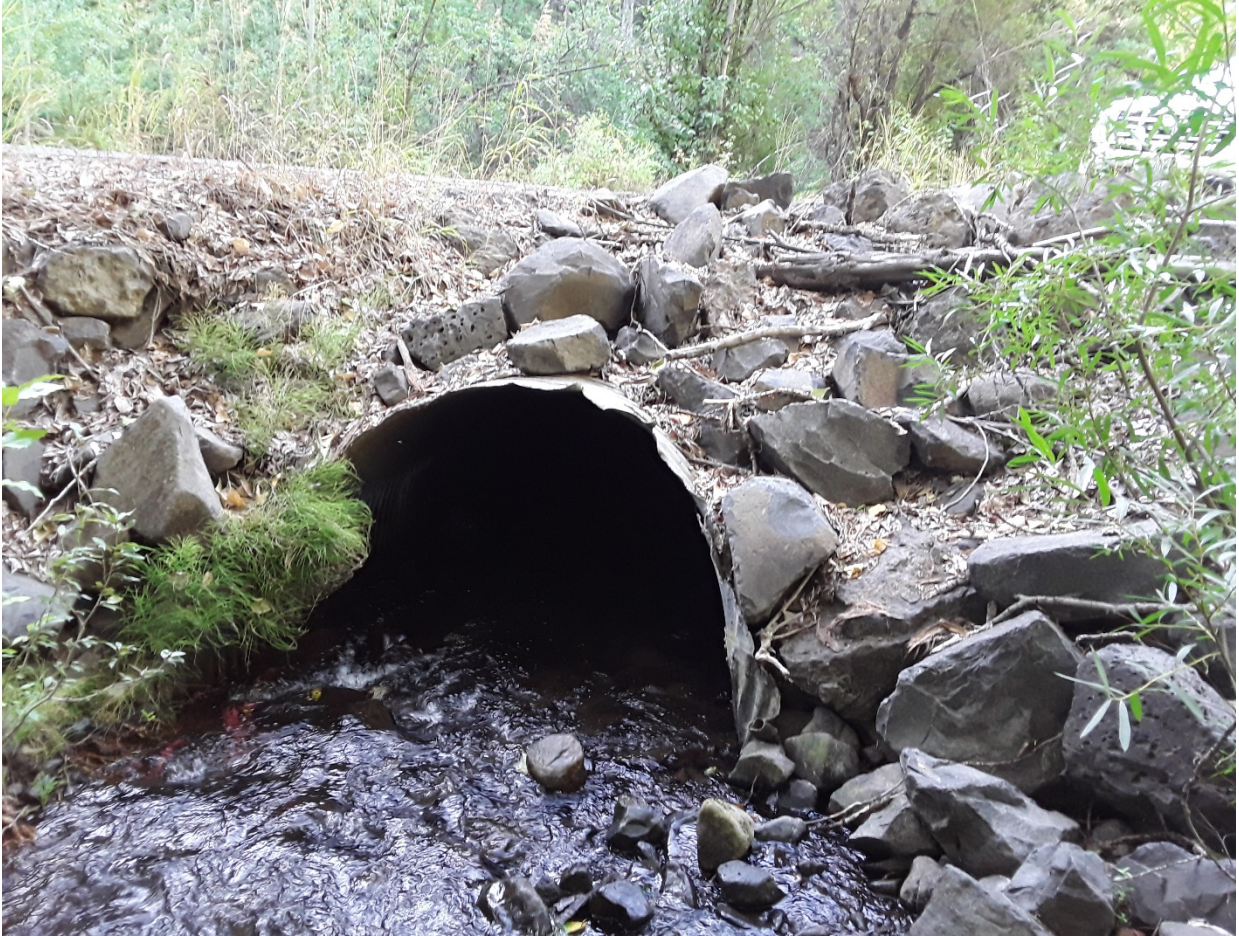
At each culvert there is evidence of past flooding damage. This evidence is in the form of piled woody debris, stream boulders carried as bedload, damage to metal culverts from boulder impacts (Fig. 6), and signs of efforts to manage floodwaters that topped the road when the culverts clogged or did not have the capacity to carry floodwater. Signs of floodwater mitigation efforts are ditches around the culvert area and small boulder berms. A resident informed us that the residential driveway bridge (Site 4) had been raised a few feet to allow more freeboard for floodwater flow.

Figure 6. Site 5 on Figure 2, showing culvert under Rock Creek Road. Note bent and torn metal culvert edges from flood-borne rock impacts. Blockage of this culvert could divert the creek, blocking and damaging the road.

- Culverts and the bridge along Rock Creek could become plugged during heavy precipitation events and exacerbate flooding downstream. Land managers and landowners should consider additional monitoring and maintenance of culverts.
