WILDFIRE-ASSOCIATED LANDSLIDE EMERGENCY RESPONSE TEAM REPORT

Lick Creek and Silcott Fires

Asotin and Garfield Counties, Washington

WASHINGTON
GEOLOGICAL SURVEY
WALERT Report
August 27, 2021

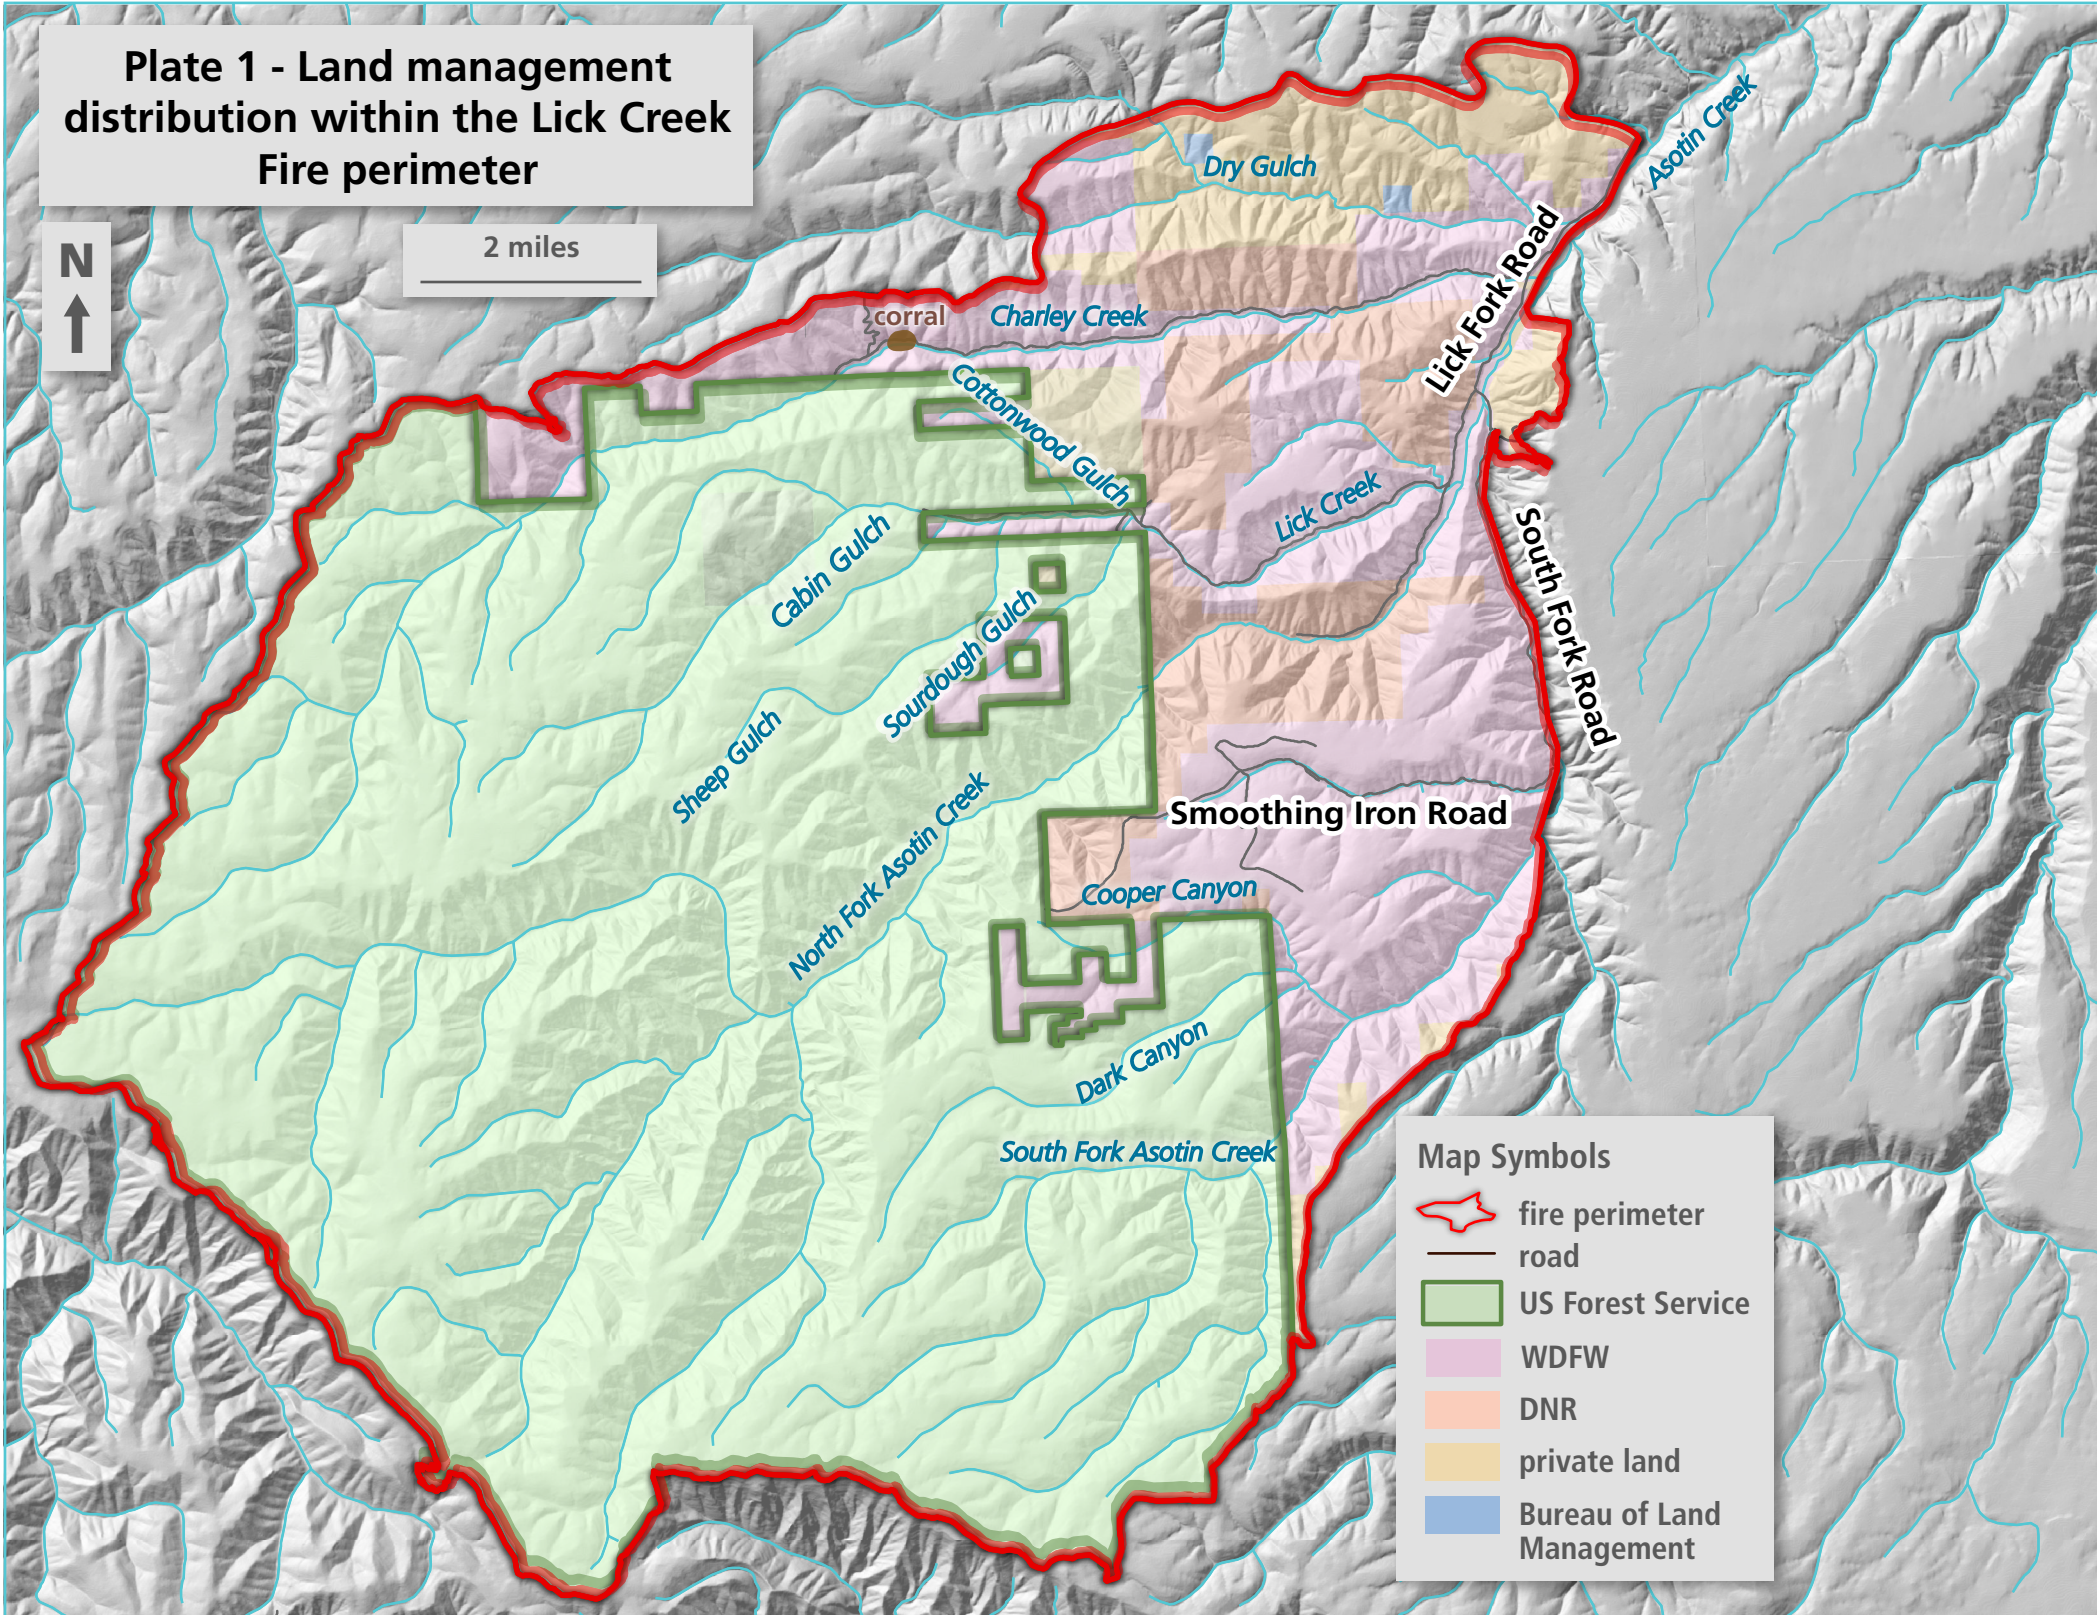
Plate 1 - Land management distribution within the Lick Creek Fire perimeter

Lightning strikes on July 7 ignited several fires southwest of Asotin, Washington. The Dry Gulch Fire merged with the Lick Creek Fire on July 8. The combined fire retained the name Lick Creek. The fire burned 80,421 acres, primarily in tall grass, brush, and timber (INCI Web, 2021). See Table 1 and Plate 1 for more information on land management distribution in the burned area.

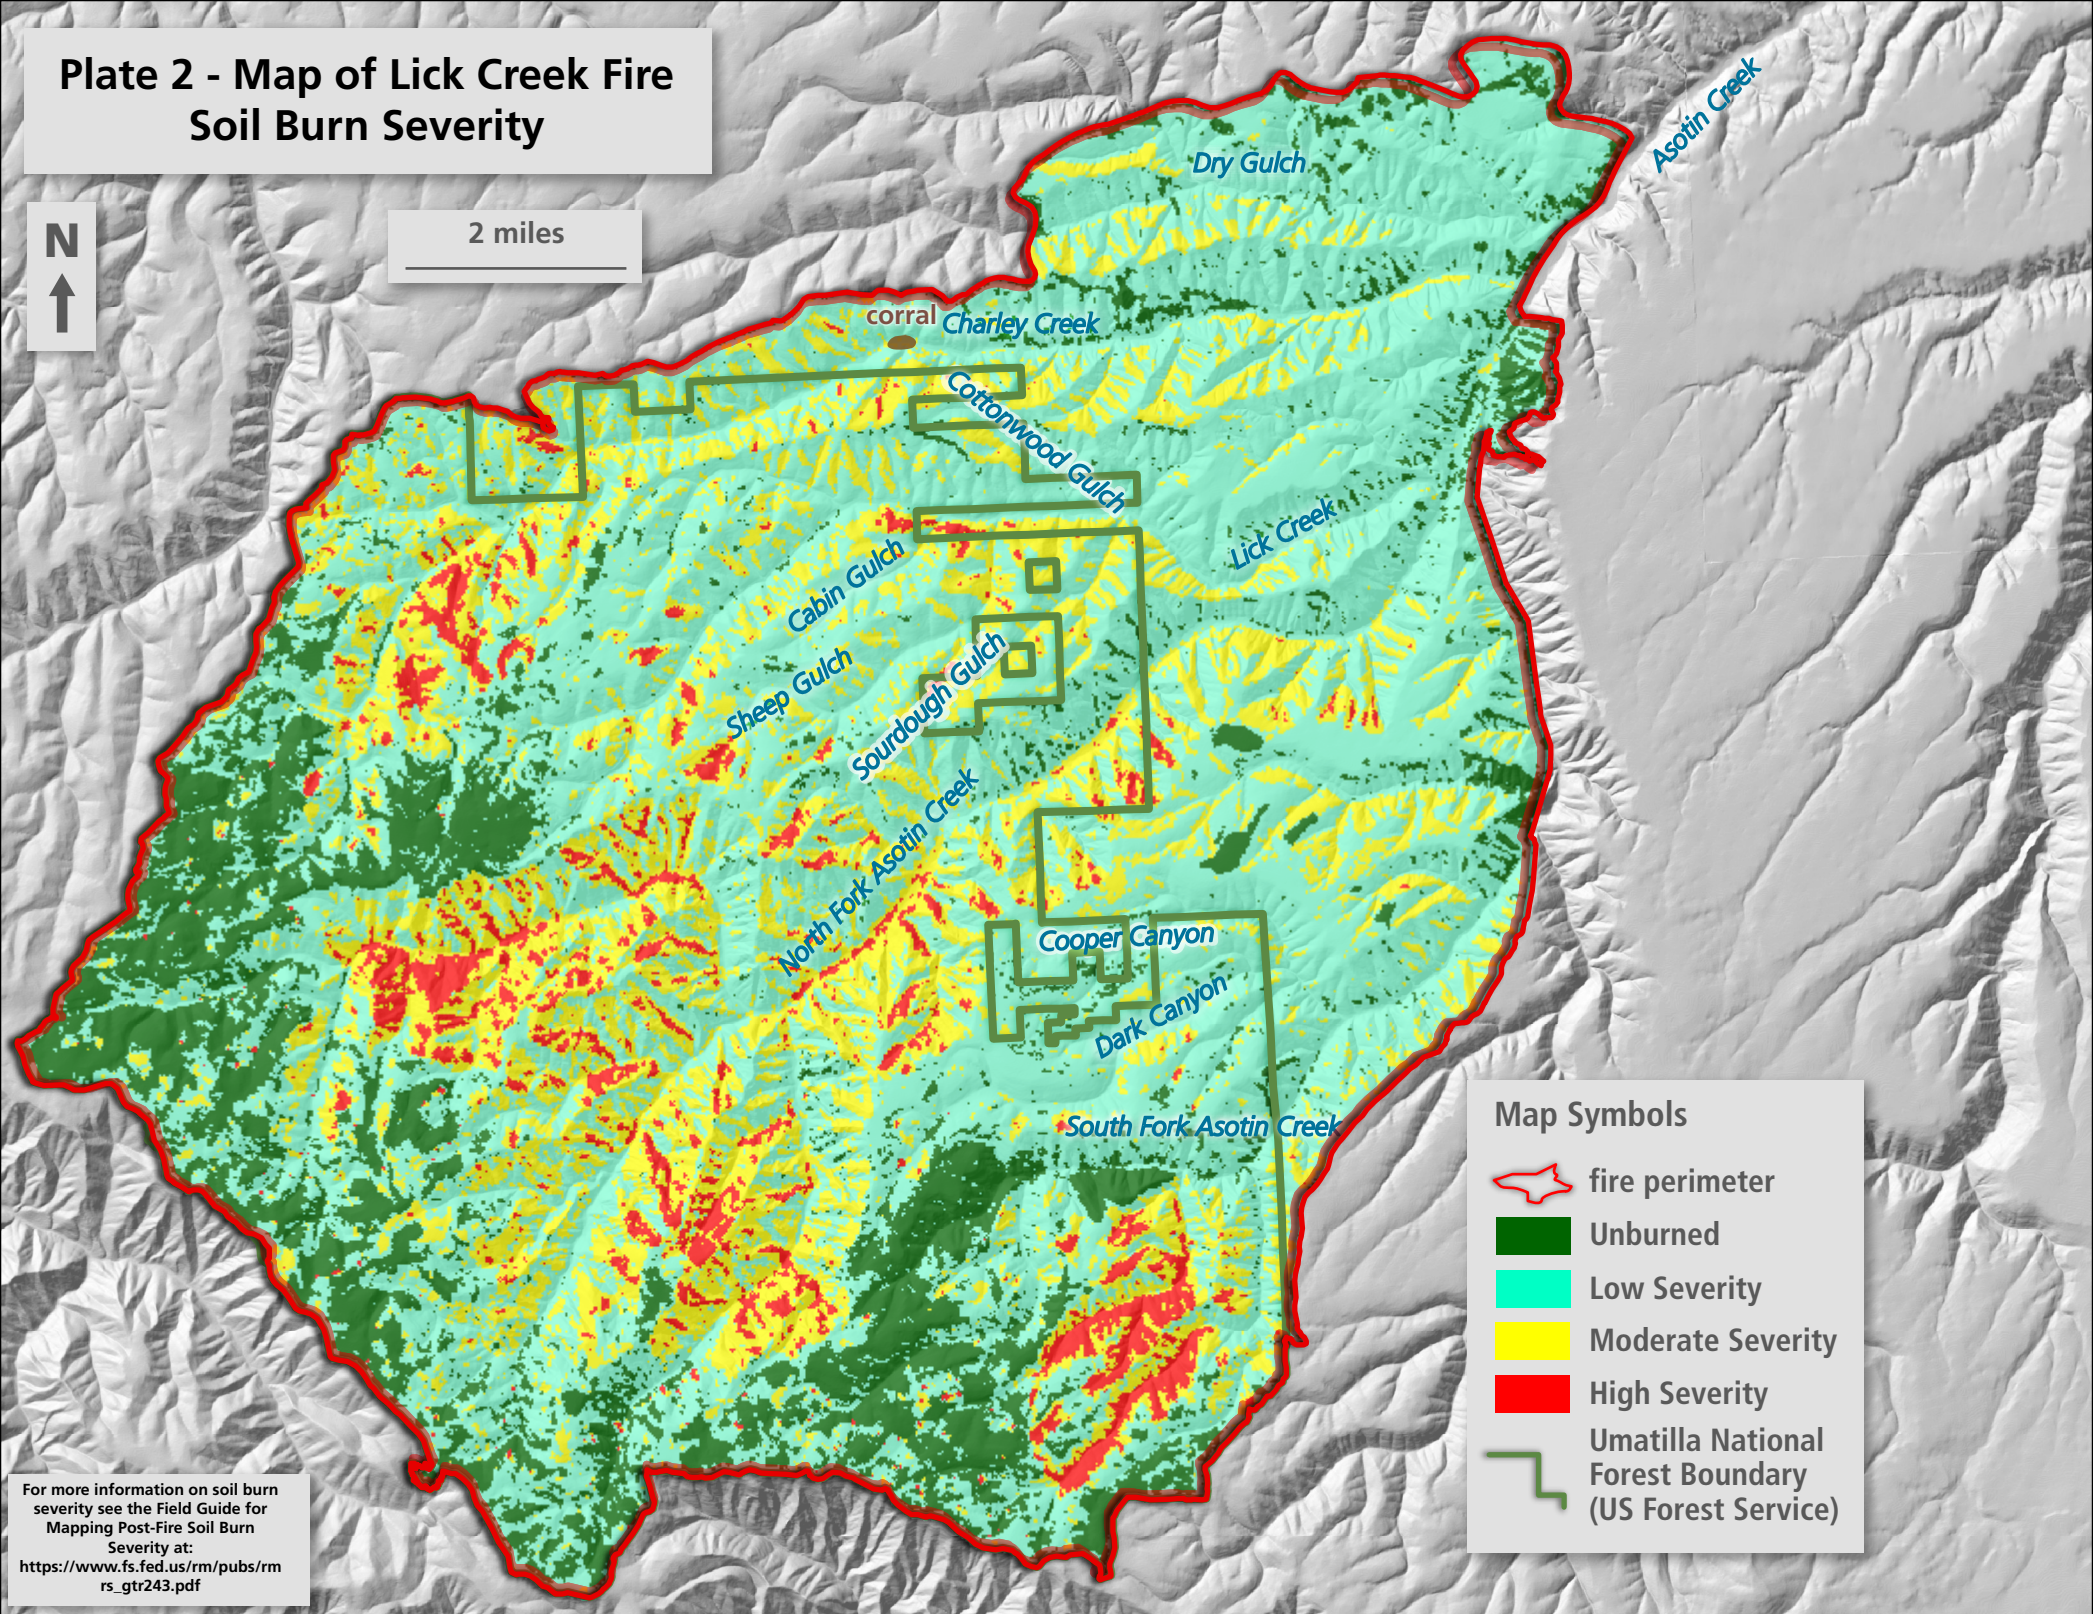
Plate 2 - Map of Lick Creek Fire Soil Burn Severity

The soil burn severity was assessed by the USFS BAER team using Burned Area Reflectance Classification (BARC) data for the Lick Creek fire only. The BARC data was field-checked using guidance from the report of Parson and others (2010), and the data was found to be accurate enough that no changes were necessary to utilize as Soil Burn Severity mapping. We provide a portion of the Soil Burn Severity mapping for the properties outside of the National Forest that include private land and Washington State managed land (Plate 2). We encourage interested parties to consult the USFS data for further information. If you need assistance accessing or analyzing the data, please contact us and we can provide support.

Outside of the Umatilla National Forest, on the eastern portion of the burned area, the Lick Creek Fire burned mostly light fuels of grasses and shrubs. The majority of this area burned with low soil burn severity, while drainages along north-facing slopes with more dense vegetation burned with moderate soil burn severity. The vast majority of the high soil burn severity was within the Umatilla National Forest. The few drainages outside of the National Forest with some high and moderate soil burn severity include most drainages within the burned area that drain into the North and South Forks of Asotin Creek. These include Lick Creek, North Fork Asotin Creek, and other isolated areas.

Dry Gulch on the north end of the fire did not have any high soil burn severity but some basins did have moderate soil burn severity in the north-facing drainages with more available vegetation.

Low soil burn severity occurred throughout the burned area and was likely the result of sparse vegetation (grasses and lighter fuels), such that plants and roots were not subjected to intense heat by the fire. If precipitation and snow pack allow it, the vegetation will likely reestablish in these areas.

Moderate soil burn severity primarily affected the riparian corridors and north-facing drainages where vegetation was denser. Areas with moderate and high soil burn severity may need additional mitigation to get vegetation reestablished, depending on the long-term goals of the land owners and managers.

A few drainages had some high soil burn severity on steeper slopes with more dense vegetation. Erosion is expected in the steeper portions of these drainages during periods of heavy precipitation. Sedimentation may occur in the valley bottom downslope of these channels.

Landowners and managers may choose to take action to prevent excessive soil erosion, reduce flooding, and promote revegetation to meet their management and economic goals. Utilizing the soil burn severity map provided

by the USFS as a tool to find areas of high and moderate burn severity should assist in this evaluation (see Plate 2). We are willing to provide the data in various formats as needed.

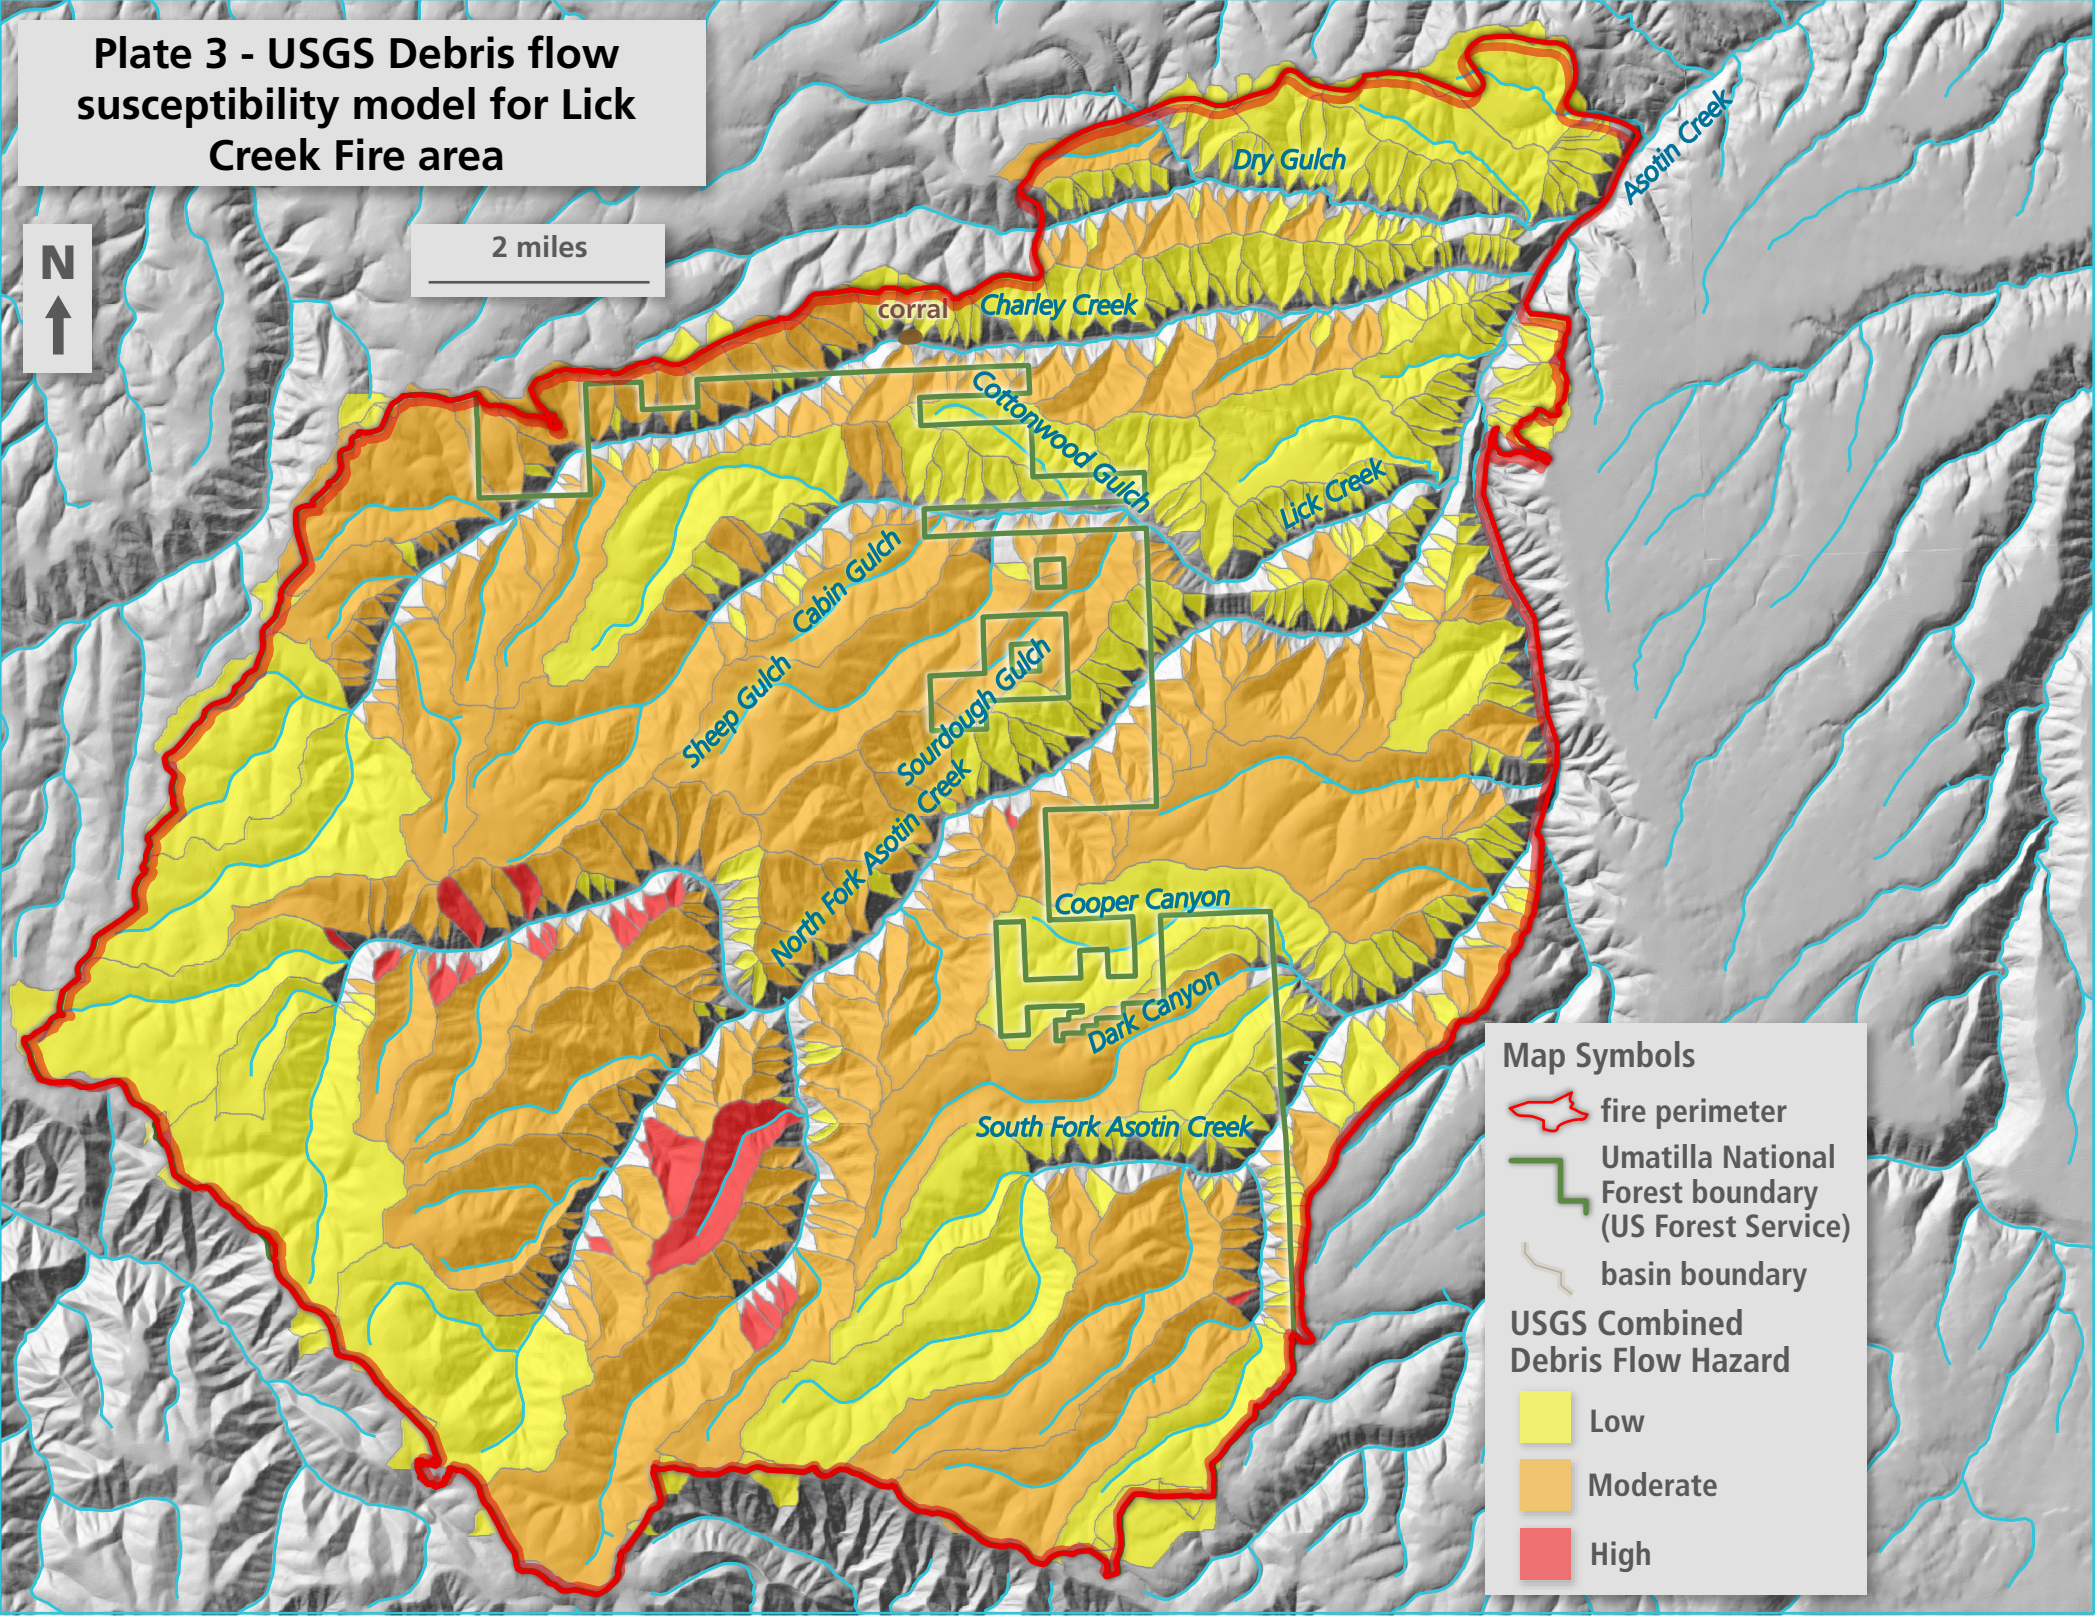
Plate 3 - USGS Debris flow susceptibility model for Lick Creek Fire area

The USGS modeling suggests that there is Low, Moderate, and High debris flow hazard in drainages throughout the burned area (see Plate 3). This is based on a modeled storm event with a peak rainfall intensity of approximately one quarter of an inch of rain in a 15-minute period. The private and state-managed lands appear to be a patchwork of Low and Moderate debris flow hazard and the High debris flow hazard areas appear to be confined to basins within the National Forest. During heavy precipitation events these drainages could be impacted by flooding, erosion and sedimentation, and (or) debris flows. This would most likely occur as a result of thunderstorms in the spring or summer within the next few years following the fire, or until vegetation is reestablished.

Along the eastern perimeter of the fire, most of the steep, short drainages that drain directly into Asotin Creek from the east and west sides of the valley (downstream from the confluence of the North and South Forks) are shown as very low to low debris flow susceptibility.

In Dry Gulch, an east–west trending drainage that flows into Asotin Creek, the USGS debris flow model shows mostly Low hazard basins on the north side and a patchwork of Low and Moderate hazard basins on the south side.

In Charley Creek, the first 1.5 miles on both sides are modeled with Low debris flow hazard. Upstream there are many small basins with Moderate hazard. They seem to concentrate in the drainages on the south side of Charley Creek up to a point marked as “Corral” on topographic maps, approximately 5.8 miles upstream. Upstream of the “Corral”, both sides of the creek are modeled as Moderate hazard and this extends into the National Forest.

The first 2.7 miles of Lick Creek are modeled as Low hazard. Two isolated basins on the south side of the creek are modeled as Moderate hazard, and these are approximately 1.3 miles upstream of the confluence with Asotin Creek. Beyond this, the creek models show Moderate hazard on the south side. At the mouth of Cottonwood Gulch there are a few buildings that are apparent in aerial photos. The Cottonwood basin is modeled as Low debris flow hazard but there are areas upstream with moderate soil burn severity that could shed sediment down Cottonwood Gulch in an intense rainstorm and impact these buildings. The south side of the creek above the state-managed parcels and into the National Forest is consistently modeled as Moderate hazard.

The basins along the North Fork of Asotin Creek are modeled as Low debris flow hazard for approximately 1 mile upstream of the confluence with Lick Creek. Above this, the north side of the creek is Low hazard and the south side is Moderate hazard for most drainages, and this pattern continues upstream into the National Forest.

The basins along the South Fork of Asotin Creek are a patchwork of Low and Moderate debris flow hazard. Further upstream, smaller tributaries flowing into the South Fork show Moderate to High debris flow hazard. These drainages are located within the National Forest.

Our assessment suggests that flash flooding is the hazard most likely to impact the areas evaluated downstream of the burned area. However, there are drainages where Moderate debris flow hazards exist, and during periods of intense precipitation (approximately one quarter of an inch of rain in a 15-minute period), these drainages may have debris flow activity.

Residents of homes built on alluvial fans and (or) adjacent to streams flowing from burned areas should be informed of potential post-fire flash flood hazards. This is most likely closest to the burned area, in the areas near Charley Creek and Dry Gulch.
