WILDFIRE-ASSOCIATED LANDSLIDE EMERGENCY RESPONSE TEAM REPORT

Muckamuck Fire

Okanogan County, Washington

WASHINGTON
GEOLOGICAL SURVEY
WALERT Report
November 4, 2021

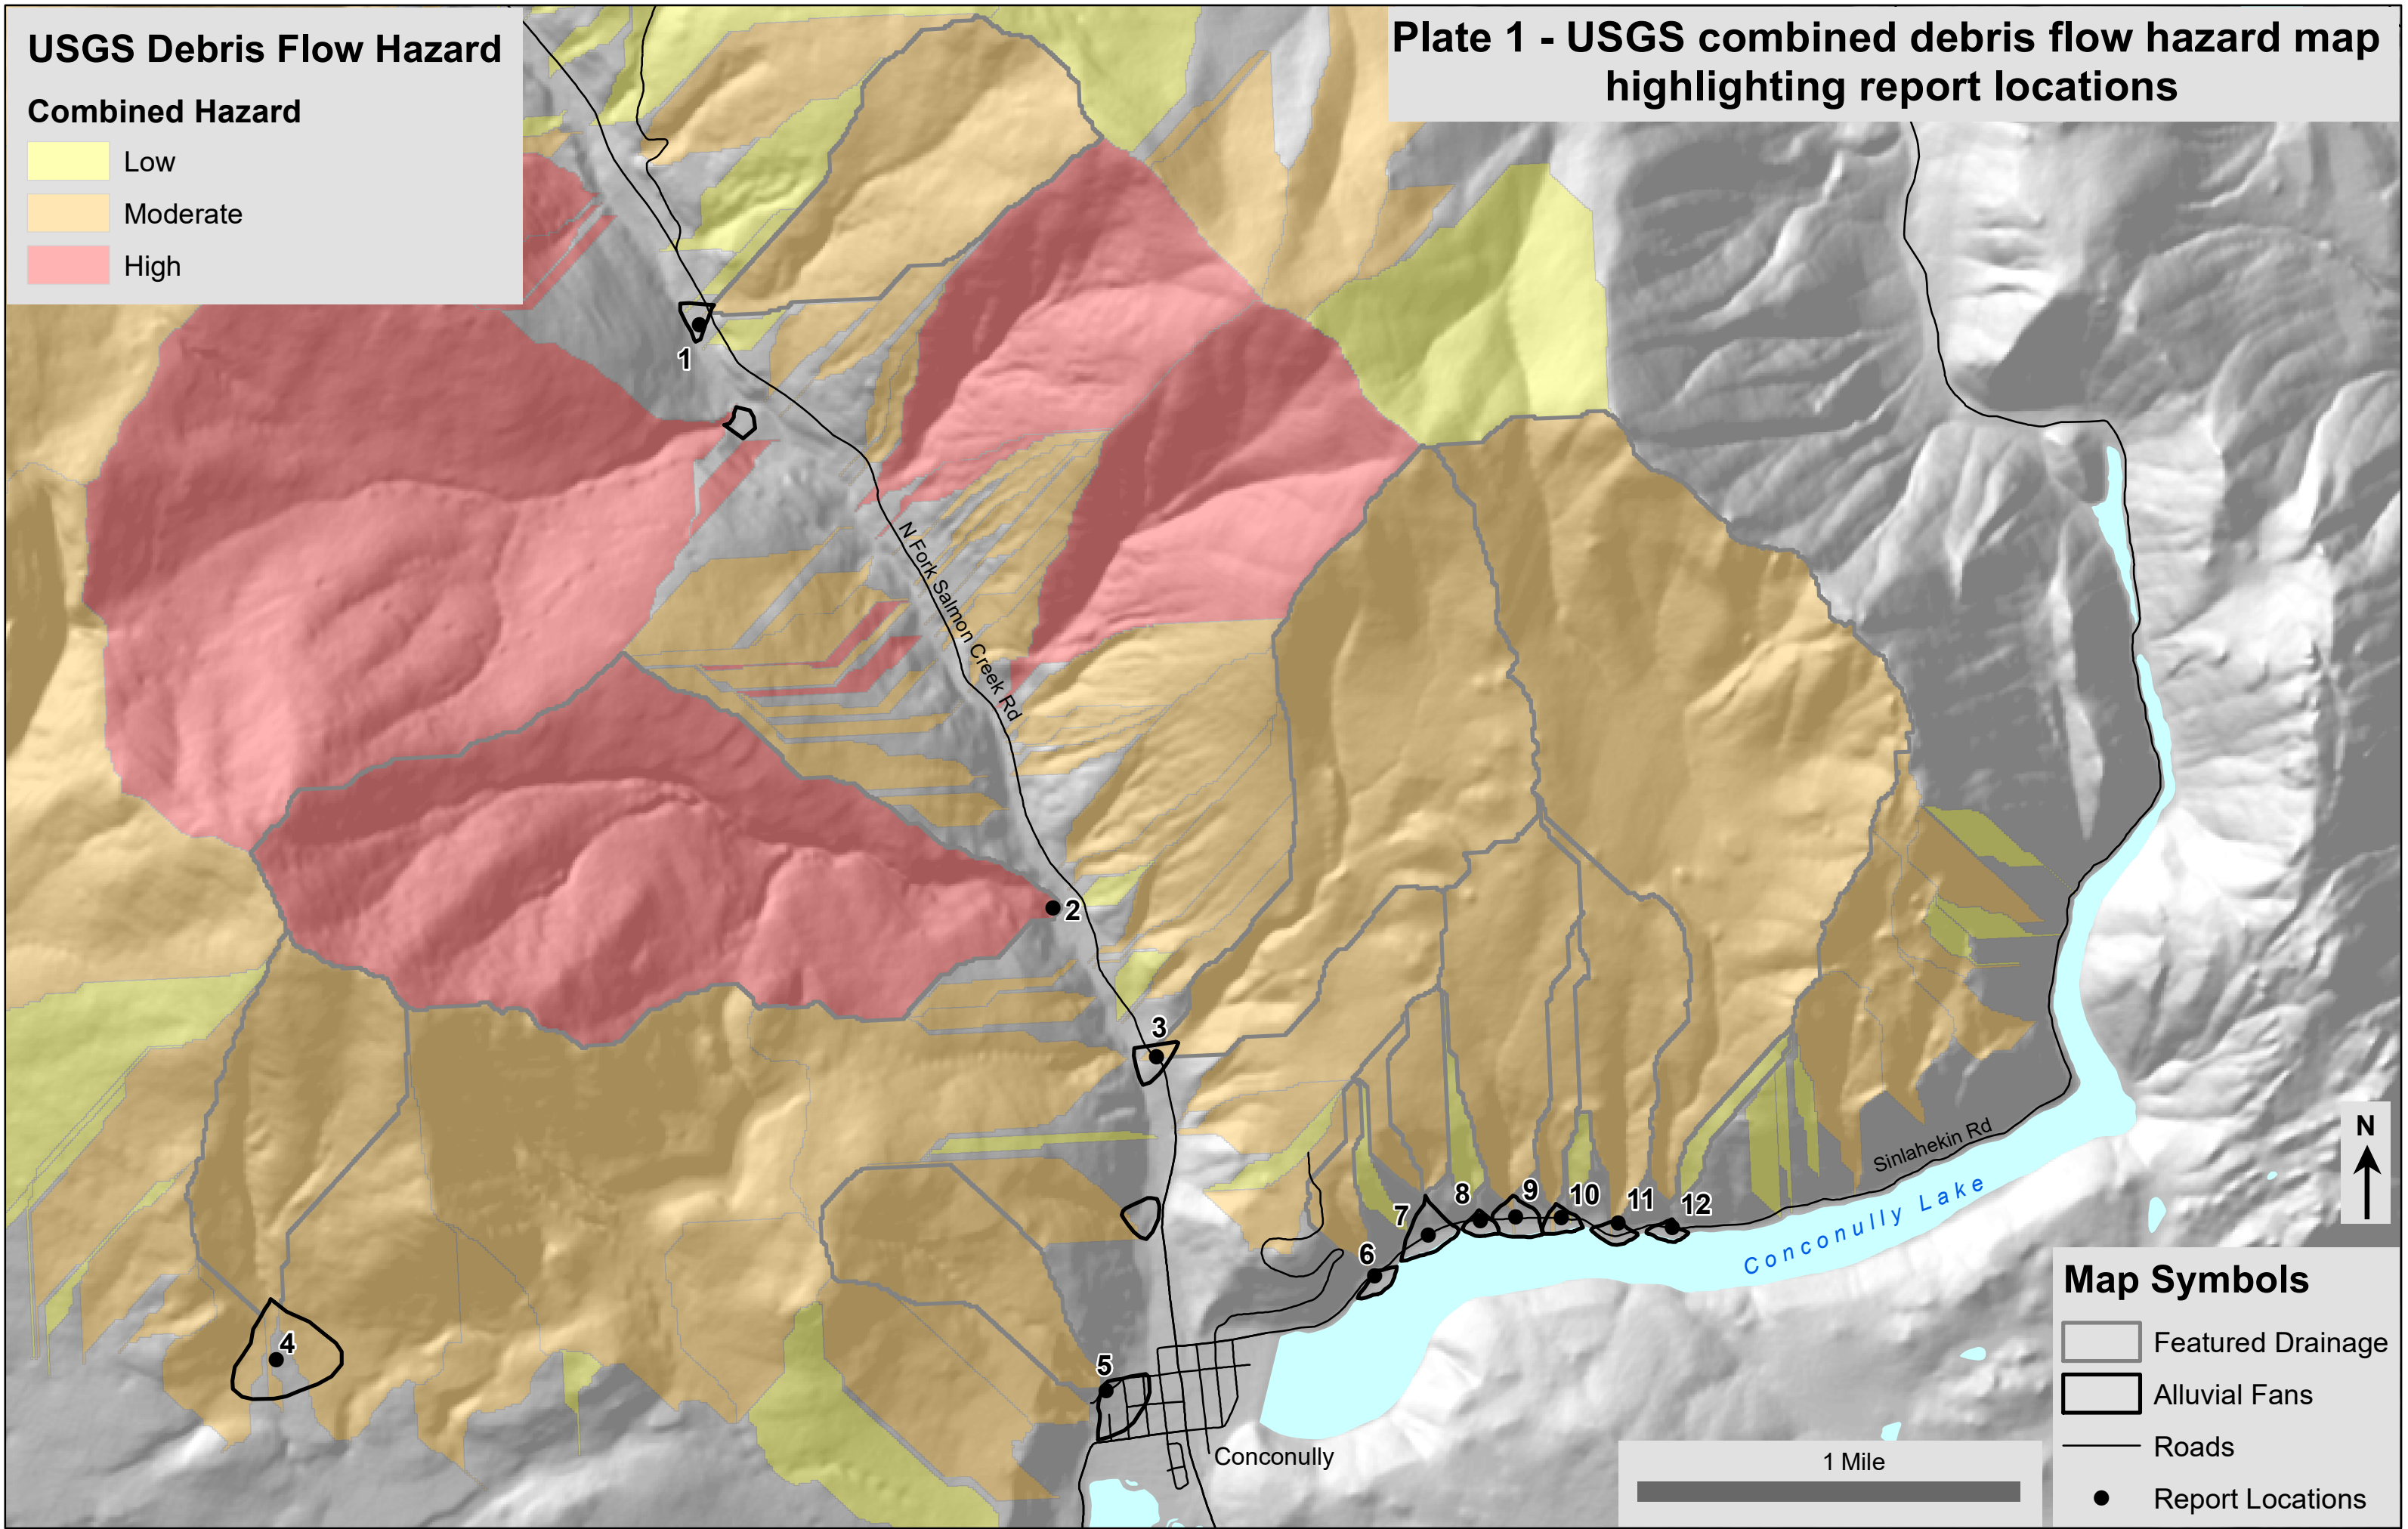
Plate 1 - USGS combined debris flow hazard map highlighting report locations

Multiple recreation cabins exist along the northeast side of Salmon Creek. At this site, there is an alluvial fan that has a Moderate debris flow hazard with a 54 percent probability of a debris flow. Cabins on the north end of the fan could be impacted if a debris flow comes down the channel and crosses the road. Culverts should be evaluated to ensure they can pass material during smaller flooding events.

Construction of a building was occurring at this site during the field assessment. We did not directly evaluate the proximity of the house pad to the nearby channel due to the posted 'no trespassing' signs. The channel to the west-northwest has a High debris flow hazard with an 84 percent probability of a debris flow. Further evaluation of the site may be needed to determine if the new structure could be impacted by debris flows generated in the drainage.

There is a basin to the northeast of Site 3 with a Moderate debris flow hazard and a 42 percent probability of debris flows. There is a home on the east side of the road that may need additional review to determine if it could be impacted by debris flows generated in the channel. There appears to be an alluvial fan in the vicinity of the house and road, so we coarsely mapped the fan on Plate 1.

There appears to be a home on an alluvial fan, though we did not evaluate the area during field work due to 'no trespassing' signs on the access road. The basin above the fan has a Moderate debris flow hazard with a 65 percent probability of debris flows.

There is an alluvial fan on the western edge of Conconully near Silver Street and Bernice Avenue. The basin above this fan has a Moderate debris flow hazard with a 41 percent probability of debris flows. Homes nearest to the top of

the alluvial fan may need additional review to evaluate the potential hazards and the neighborhood should be warned of debris flow potential.

At this site multiple homes sit on an alluvial fan along Conconully Lake. The basin above the fan is modeled with a Moderate debris flow hazard with a probability of 35 percent of generating debris flows.

At this site multiple homes sit on an alluvial fan along Conconully Lake. The basins above the fan are modeled with a Moderate debris flow hazard with a probability of 33 percent of generating debris flows.

At this site, the campground of Upper Conconully Lake Park is situated on an alluvial fan. The basin above the fan is modeled with a Low debris flow hazard with a probability of 29 percent of generating debris flows.

At this site the boat ramp and water well for Upper Conconully Lake Park sit on an alluvial fan. The basin above the fan is modeled with a Moderate debris flow hazard with a probability of 44 percent of generating debris flows.

At this site there is an alluvial fan with multiple homes on it along Conconully Lake. The two basins above the fan are modeled with both Low and Moderate debris flow hazard with probabilities of 27 to 31 percent of generating debris flows, respectively. According to one resident, the eastern side of the fan was active approximately 30 years ago.

At this site there is an alluvial fan with multiple homes on it along Conconully Lake. The basin above the fan is modeled with Moderate debris flow hazard with a probability of 39 percent of generating debris flows.

At this site there is an alluvial fan with multiple homes on it along Conconully Lake. The basins above the fan are modeled with Low and Moderate debris flow hazard with probabilities of 27 to 20 percent of generating debris flows, respectively. This alluvial fan has been active twice in the recent past, flooding homes and depositing material on the fan as recently as April 2017.

Our assessment suggests that flash flooding and debris flows are most likely to impact the areas evaluated downstream of the burned area. In drainages where High and Moderate debris flow hazards exist, debris flow activity may occur during periods of intense precipitation (approximately one quarter of an inch of rain in a 15-minute period). Residents of homes built on alluvial fans and (or) adjacent to streams flowing from burned areas should be informed of potential post-fire flash flood and debris flow hazards. Parking lots and camping areas such as

Upper Conconully Lake Park may need signs to warn the public of flash flood and debris flow hazards during heavy rainstorms.

Managers of transportation networks should be reminded of the increased likelihood of sediment transport, sediment deposition, and (or) erosion to roads, as well as potential issues with blocked culverts. We suggest reminding transportation network managers and land owners to inspect culverts from channels draining areas impacted by the fires both before and after storm events, otherwise culverts could be blocked, causing additional flooding and damage.
