# Burned Area Emergency Response (BAER)

## Norse Peak and American Fires

### Geology: Landslides

Snoqualmie Ranger District - Mount Baker-Snoqualmie National Forest, Washington

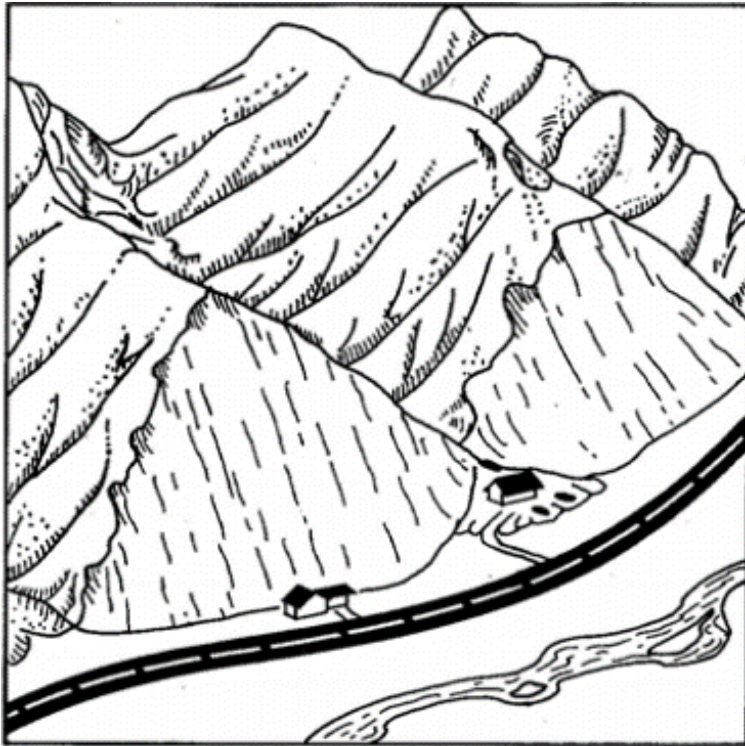
Alluvial fans are attractive locations to build cabins and homes due to the slight elevation above river flood plains and (or) the occasion to have a view of the flood plain (Figure 1). However, alluvial fans are there because they are active depositional areas that accumulate sediment over time. The sediment can be deposited both slowly, such as during a spring melt when high streamflow during spring runoff transports and deposits fine sediment on the fan or quickly, when a flash flood, HCF, or debris flow transports sediment and debris to the fan. As stated above, both flash floods and HCF can inundate areas not typically wetted by regular streamflow, so channel-adjacent roads, trails, building, and other infrastructure can still be damaged by impact from debris, sedimentation, water erosion, and (or) water inundation. In addition, a debris flow can be very destructive due to the ability of a debris flow to buoy

Figure 1. Homes and road in debris flow-prone locations on alluvial fans. Courtesy of Oregon Dept. of Forestry.

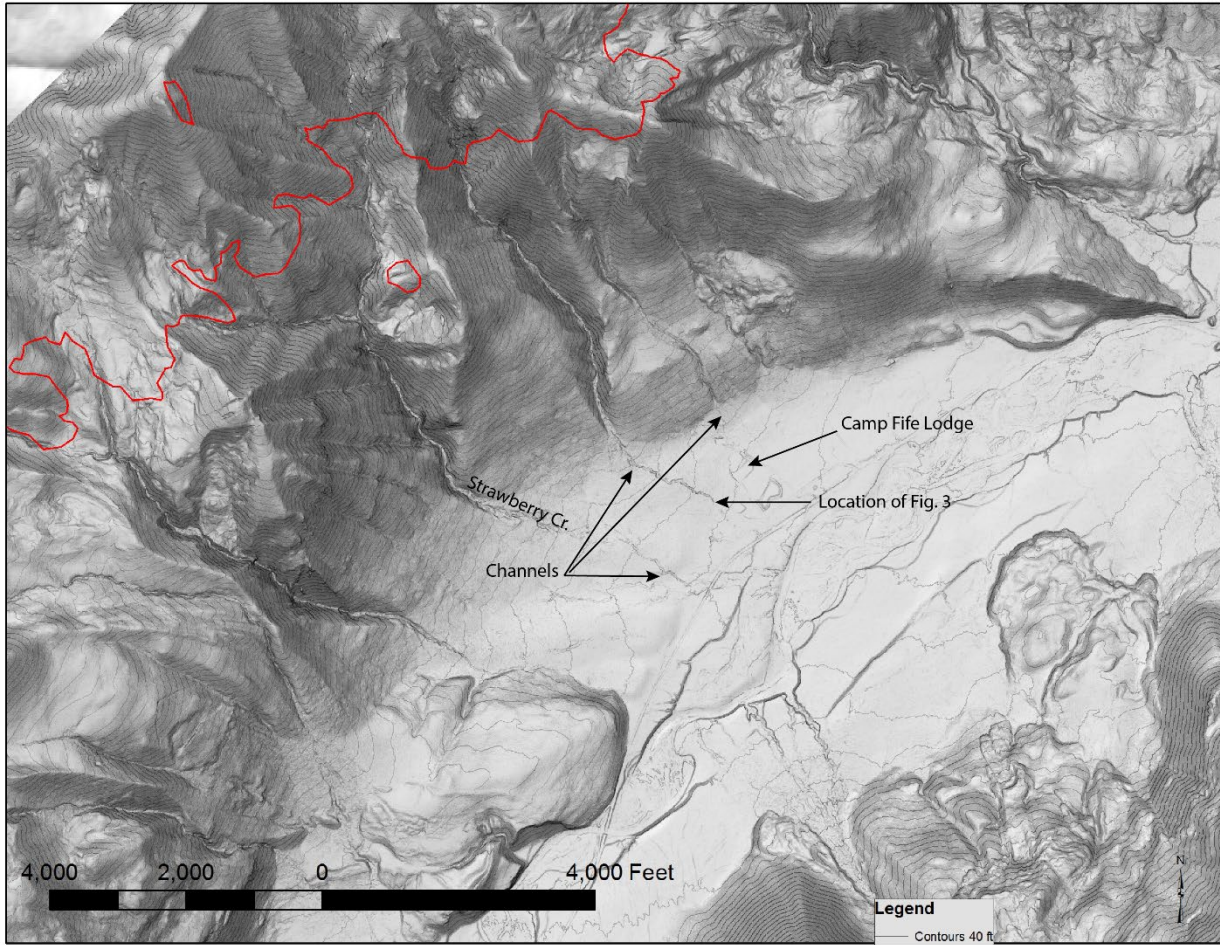
Camp Fife is located on coalescing alluvial fans for Strawberry Creek and two unnamed creeks above the camp (Figure 2). Field evidence revealed that the western side of the BSA camp has experienced recent floods or HCF deposition of gravel and cobbles, likely within the past year (Figure 3 and image on title page). A crude levee has been constructed to prevent floodwaters from affecting adjacent structures at the camp. It appears that flood deposition behind the levee have accumulated sufficient sediment to be higher elevation than the adjacent structures, so flooding will be a continuing concern at the camp. We expect that the camp will continue to be impacted by flood waters as experienced in the recent past and this may be difficult to parse from fire-induced flash flooding in the future. Results of the post-wildfire hydrologic modeling are included in the final BAER report and should be consulted for this site.

Figure 2. Camp Fife Lidar based topographic map showing location of alluvial channels and the main camp lodge. Fire perimeter in red.

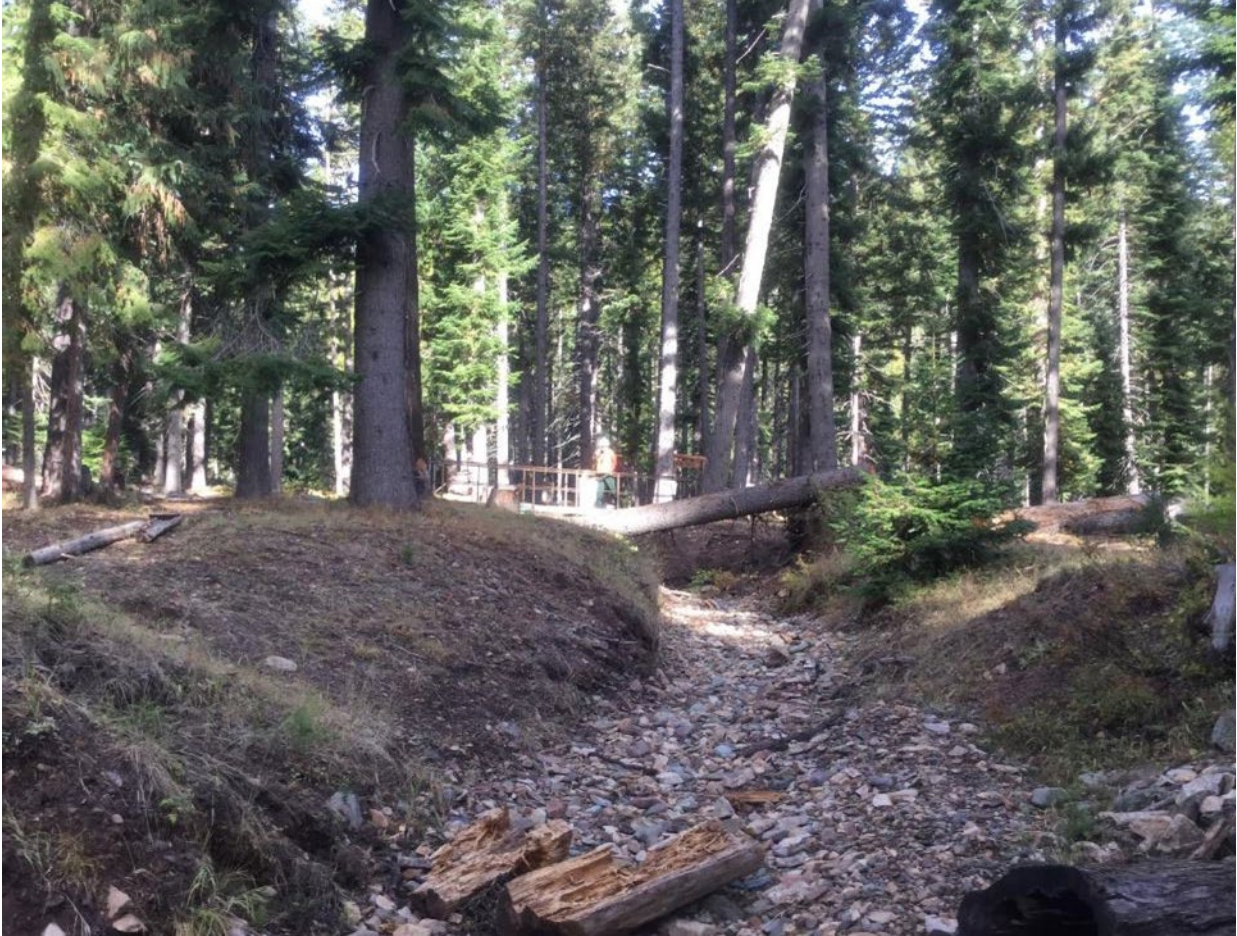
Figure 3. Channel at Camp Fife showing bridge and recent alluvial deposition in channel. Channel is unconfined below this where sediment deposits spread out on the alluvial fan.

- Boy Scouts of America Camp Fife is located below areas the USGS modeled as “moderate” combined relative debris flow hazard during storm events of 24mm (0.94in) in a 15-minute storm intensity. The camp administration should be notified of this and seek appropriate professional consulting services to help them identify the potential impacts to the camp safety and operations.

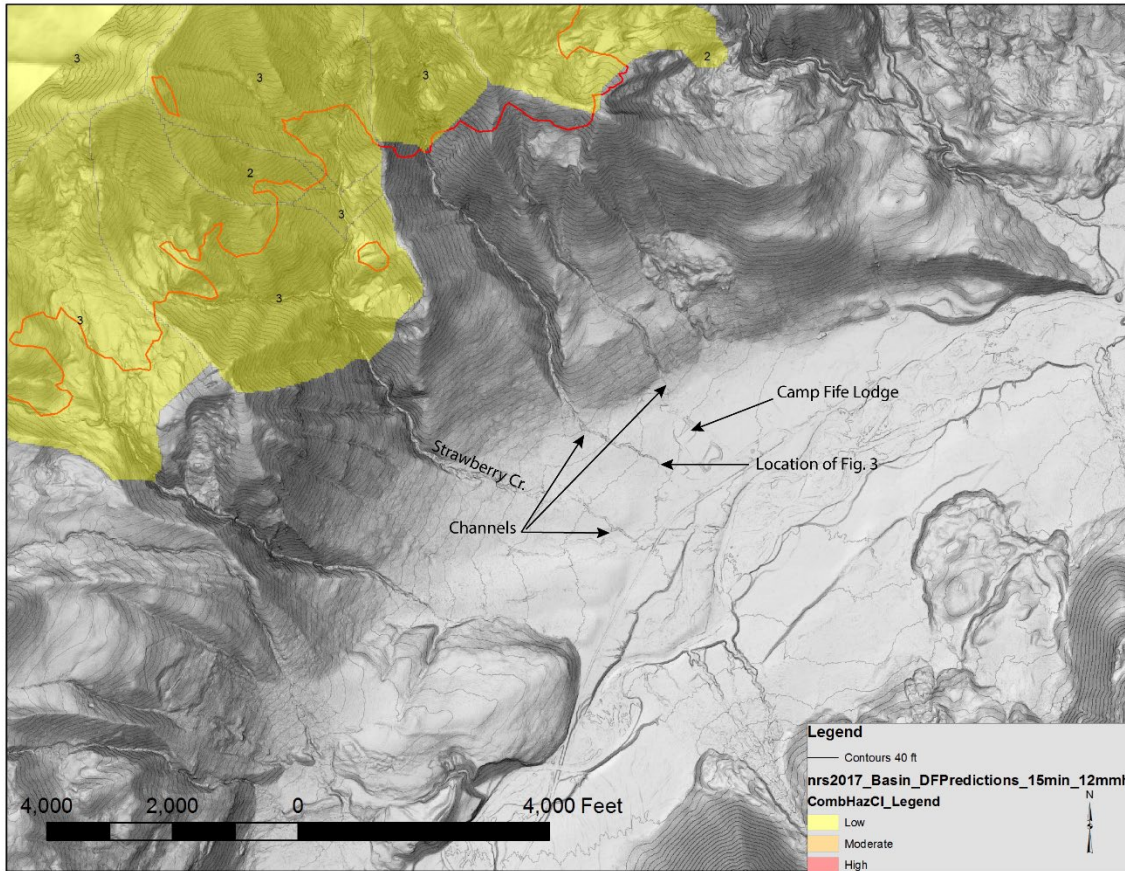
The USGS modeled the debris-flow potential in the drainages above the BSA camp as “low” for a 12mm (0.47in) in 15-minute storm event and “moderate” for a 24mm (0.94in) in 15-minute storm event (see Figures 4 and 5). While it is unlikely that debris flows would reach the camp, existing channels on the alluvial fan and adjacent to the camp could convey debris and flood water and impact the camp. Overall, all creeks that flow into the vicinity of the BSA camp should be further evaluated for flash flooding, HCF,

Figure 4. USGS Debris flow prediction model for a 12mm (0.47in) in 15 minutes storm intensity above Camp Fife BSA.

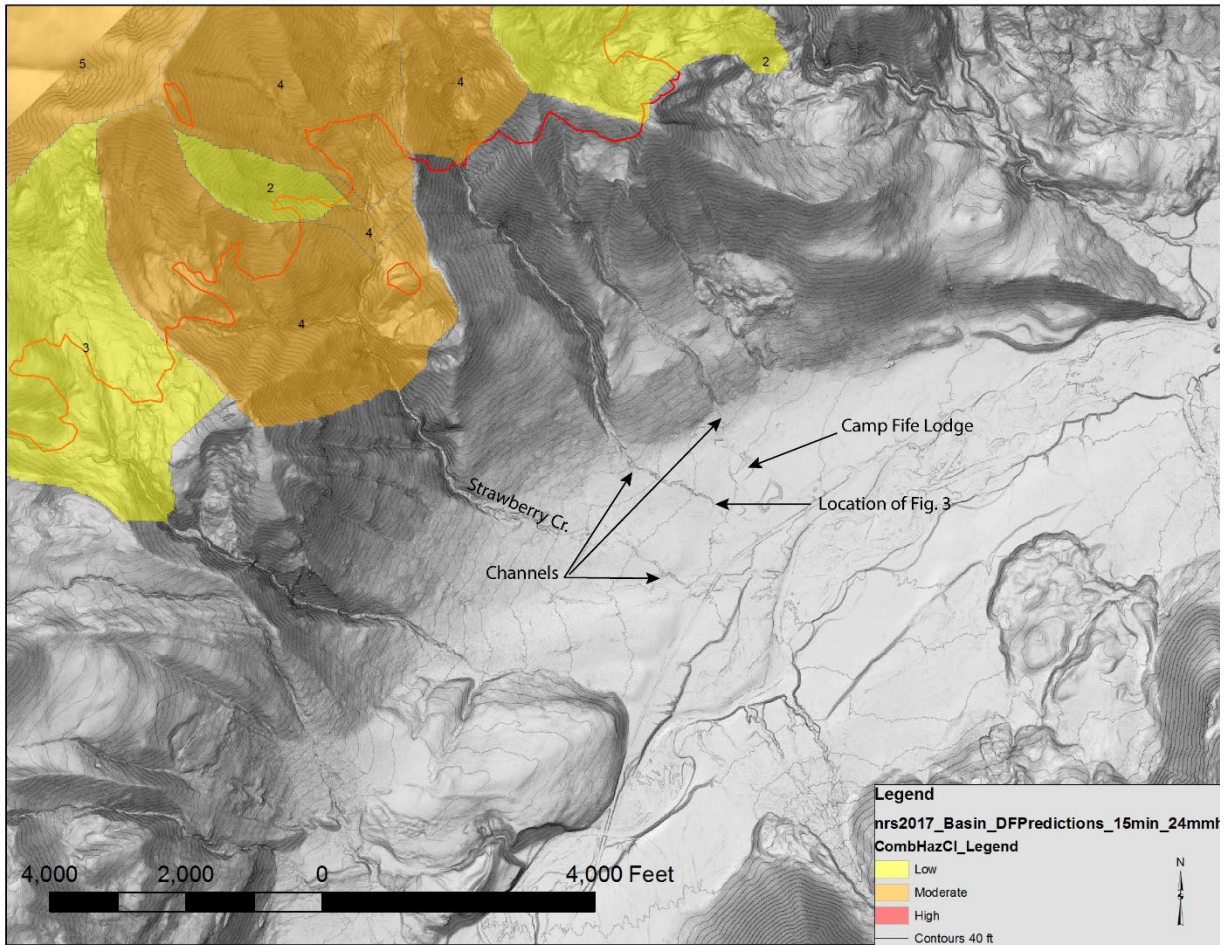
Figure 5. USGS Debris flow prediction model for a 24mm (0.94in) in 15 minutes storm intensity above Camp Fife BSA.

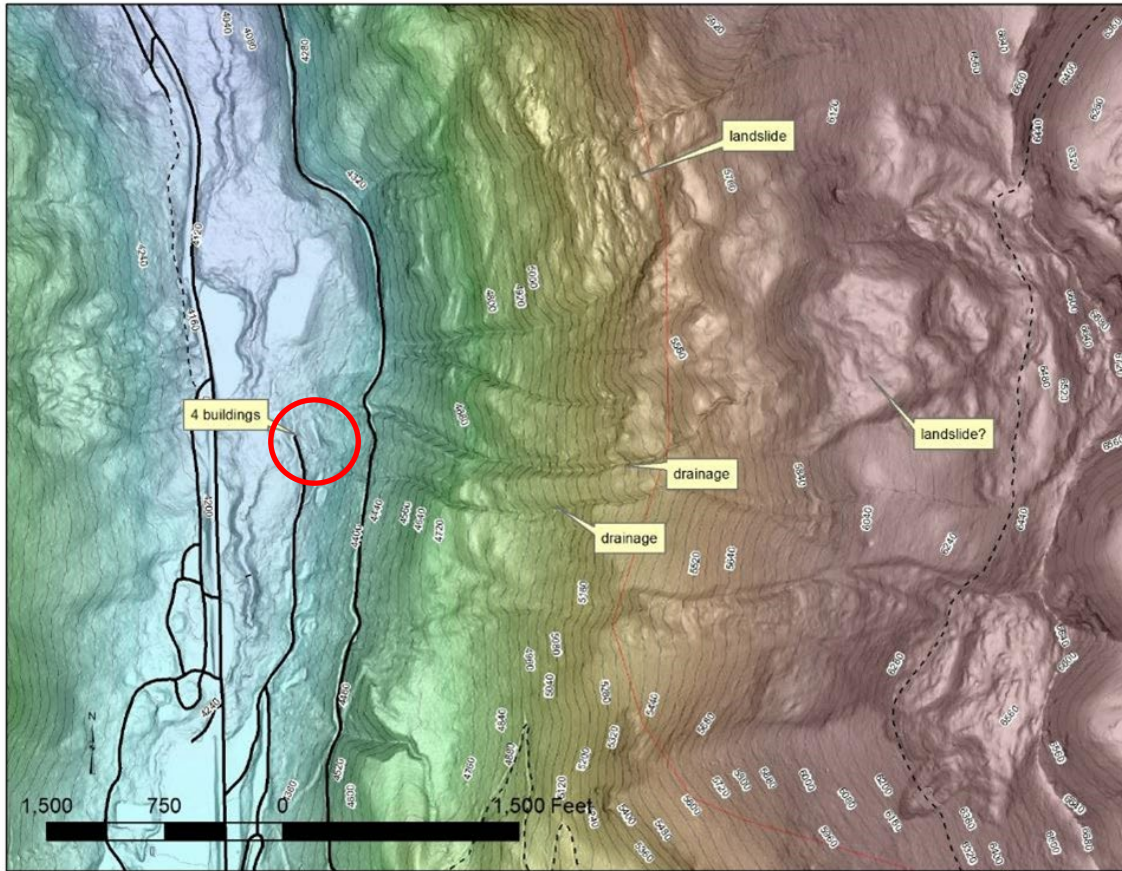
There are four buildings between FS410 and FS7190 northeast of Chrystal Mountain Resort (Figure 6). These building may need additional review due to their proximity to avalanche chutes and intermittent streams. Based on lidar interpretation, at least three of the buildings appear to be sited in areas where streams may have historically occupied. In addition, northeast and east of the buildings are landslides that are evident in the lidar topographic data. These landslides appear to be deep and are not expected to reactivate based on short term changes to hydrology due to the fire; however, the steep portions of these landslides could initiate shallow landslides that could impact the structures below. It is likely that the landslides provided the material that the current buildings are built. The USGS combined relative debris flow hazard modeling suggest “low” hazard for both the 12mm (0.47in) and 24mm (0.94in) storm events.

Figure 6. Crystal Mountain area with lidar topography showing location of buildings that may need additional review. Note landslide features to northeast and east of the site.

- Four buildings at Crystal Mountain Resort may need additional review as they are built near small drainages that may be unstable.
- The cabins near Union Creek should be notified of potential flash flood hazards associated with alluvial fans. Landowners and forest managers may need additional review and study of these cabins and the associated flood hazard.
