WILDFIRE-ASSOCIATED LANDSLIDE EMERGENCY RESPONSE TEAM REPORT

Red Apple Fire

Burch Mountain, Chelan County, Washington

WASHINGTON
GEOLOGICAL SURVEY
WALERT Report
August 11, 2021

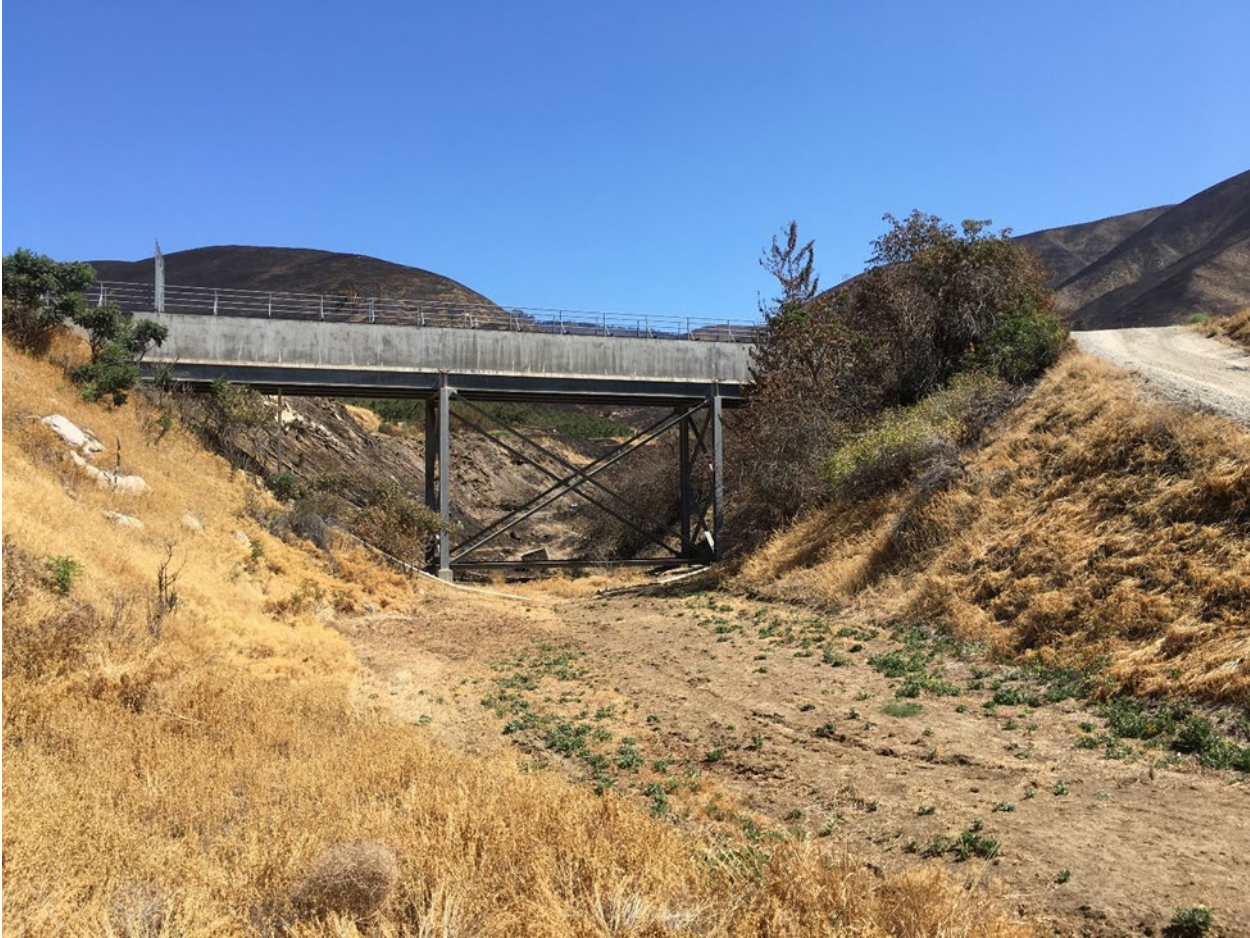
The unnamed drainage above Red Apple and Kenoyer Roads (Location 4 on Plate 1; Fig. 1) had 773 acres burned with moderate and high soil burn severity. The drainage is steep and is modeled with a High hazard (see section *U.S. Geological Survey post-fire debris flow hazard assessment* below) of debris flows. The irrigation canal is elevated where it crosses the drainage in a flume but could be impacted if enough debris were to pass through the drainage and undermine the canal. See Table 4 for additional data on soil burn severity for the basin.

Only one of the basins has a combined High debris flow hazard: the unnamed drainage on the west side of the fire above Red Apple and Kenoyer Roads above Location 4 (Plate 1). The irrigation canal at this location is elevated across this drainage but the footings and support structure of the canal likely weren't designed to take the impact of a debris flow, should one occur. If a debris flow occurs, this area of the canal could be vulnerable and undermined. There are other small drainages along the west side of the fire that are shown as having a Moderate debris flow hazard but have a higher probability of debris flow generation than other drainages in the burn area. These can be viewed on the USGS website by toggling on the *Basin Probability* data layer. We've noted these drainages as Locations 5 to 10 on Plate 1 for additional review of infrastructure and potential armoring in preparation for potential debris flows.

Figure 1. Photo taken where irrigation canal crosses unnamed drainage in a flume with high combined hazard for debris flows. This location is above the intersection of Kenoyer and Red Apple Roads (Location 4 on Plate 1).

Irrigation district managers should closely inspect storm water conveyance above the irrigation canal along the west and southern perimeter where drainages cross the canal. These crossings could be vulnerable to additional sedimentation, and if the irrigation water is running, additional damage to the system could occur. We made an attempt to highlight locations where issues might occur but not all areas were visited during this reconnaissance survey. These locations are described in Appendix B and marked on Plate 1.

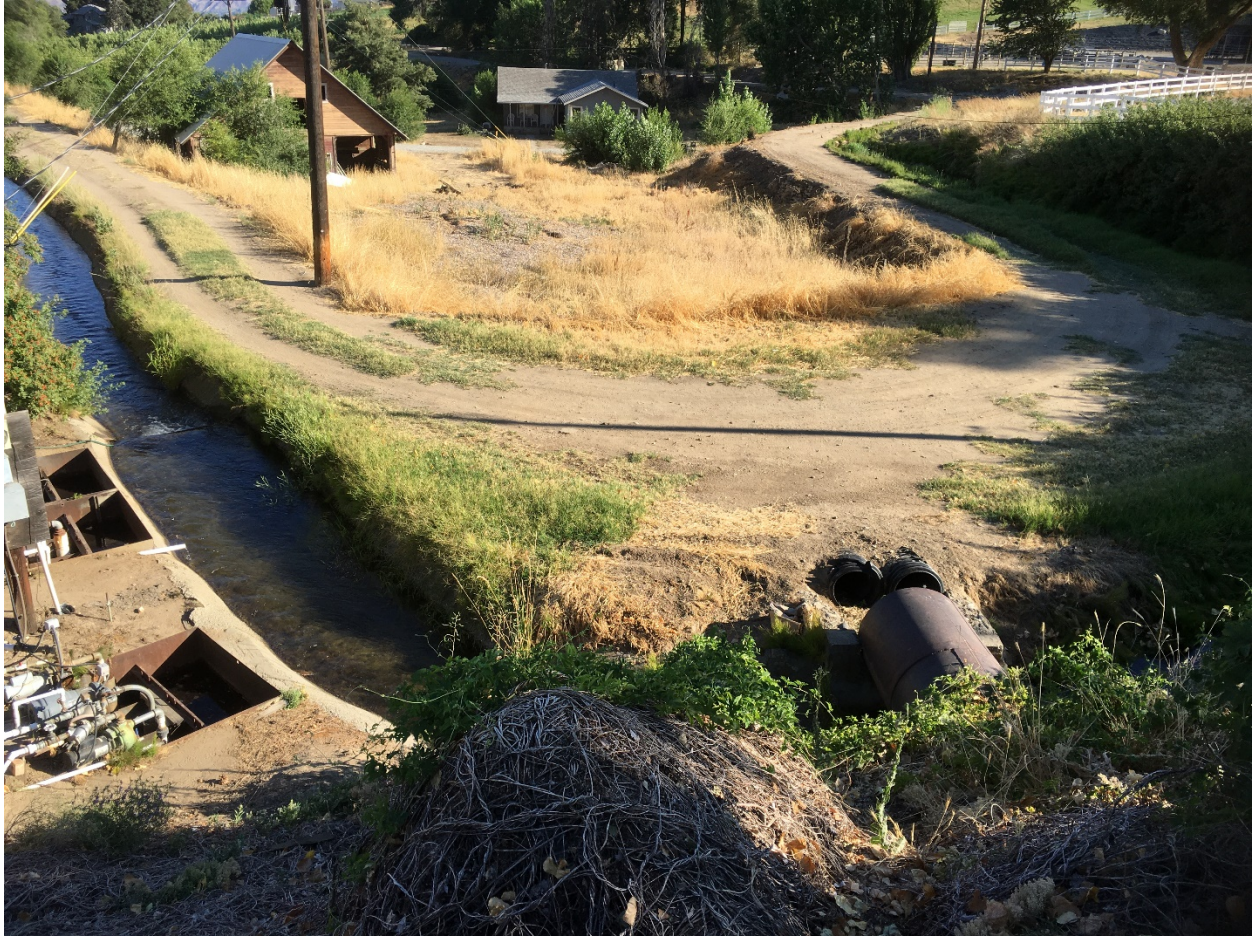
This drainage has a Moderate combined debris flow hazard rating for the modeled storm. Based on evidence of past debris flows and the Moderate debris flow hazard, nearby residents should be alerted to the hazard, and stormwater conveyance should be evaluated in case there are vulnerabilities to the irrigation canal (Location 20 on Plate 1; Fig. 2).

Figure 2. Photo taken downstream of Burch Hollow Lane, near 3510 Burchvale Rd (Location 20 on Plate 1). Depending on the amount of sediment that travels through the larger metal culvert, the smaller corrugated culverts could be clogged resulting in sediment in the canal.

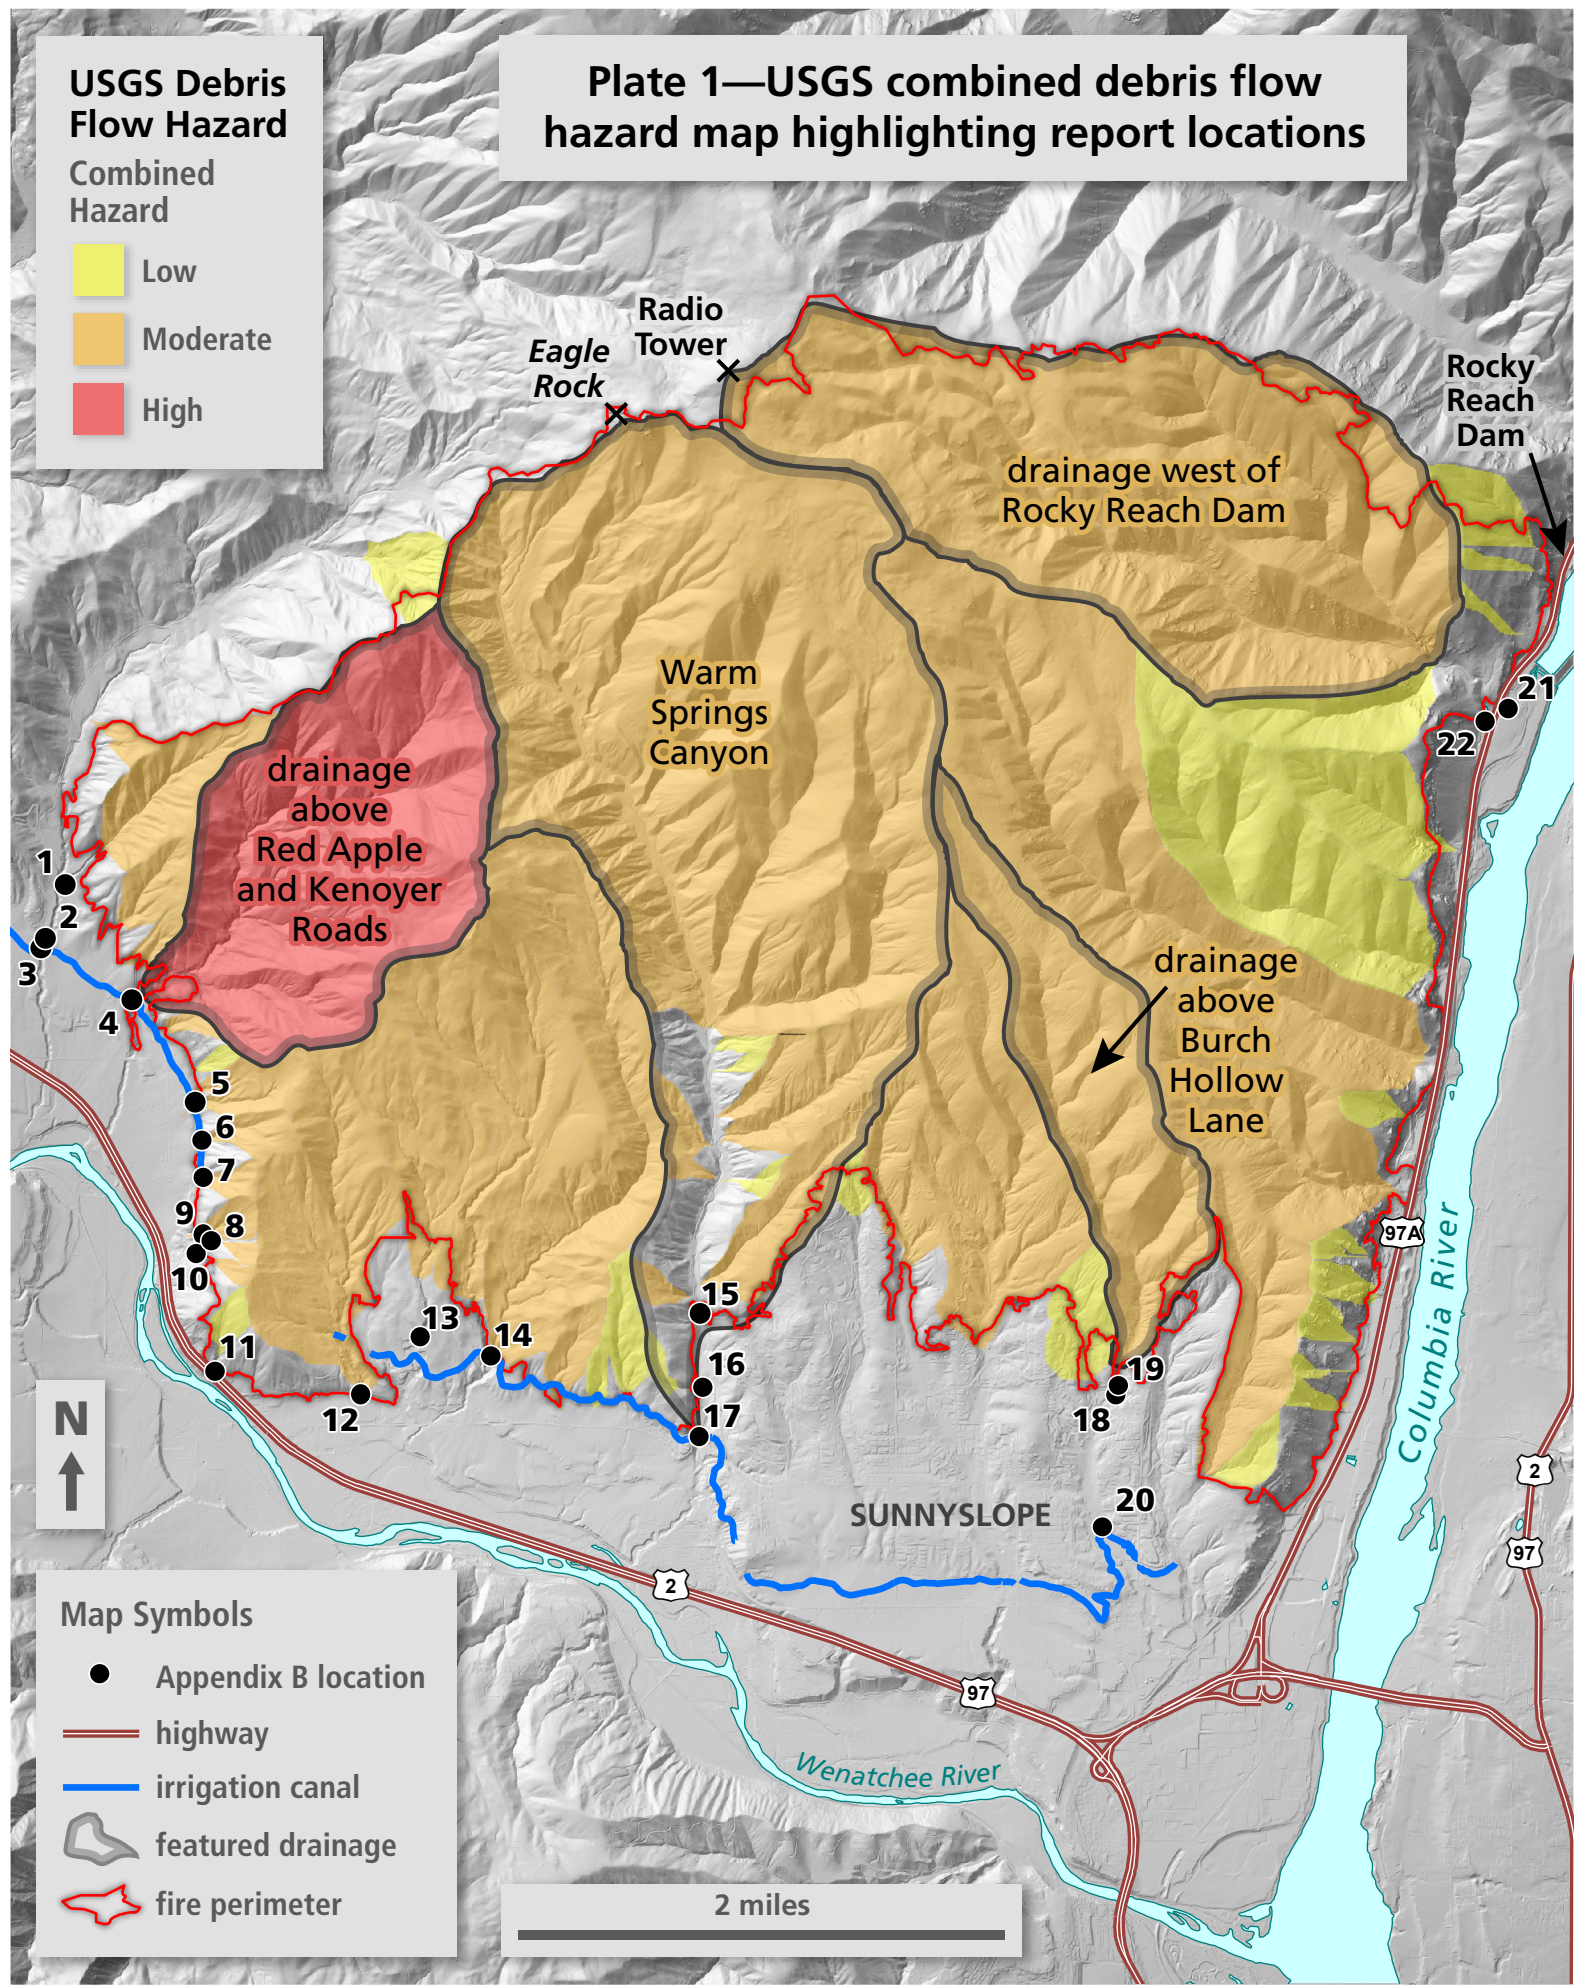
Plate 1—USGS combined debris flow hazard map highlighting report locations

The USGS modeling suggests that there is Low, Moderate, and High debris flow hazard in drainages throughout the burned area. This is based on a modeled storm event with a peak rainfall intensity of approximately one quarter of an inch of rain in a 15-minute period.

There are several smaller unnamed drainages along the western portion of the burned area (Locations 5 to 10 on Plate 1) that have a Moderate debris flow hazard but a higher probability of debris flow generation than other drainages. We show these locations on the map (Plate 1) and list them in Appendix B.
