Hope Island Atlantic Salmon Net Pens Engineering Assessment

January 29, 2018

State of Washington
Department of Natural
Resources
1111 Washington Street SE
Olympia Washington 98504

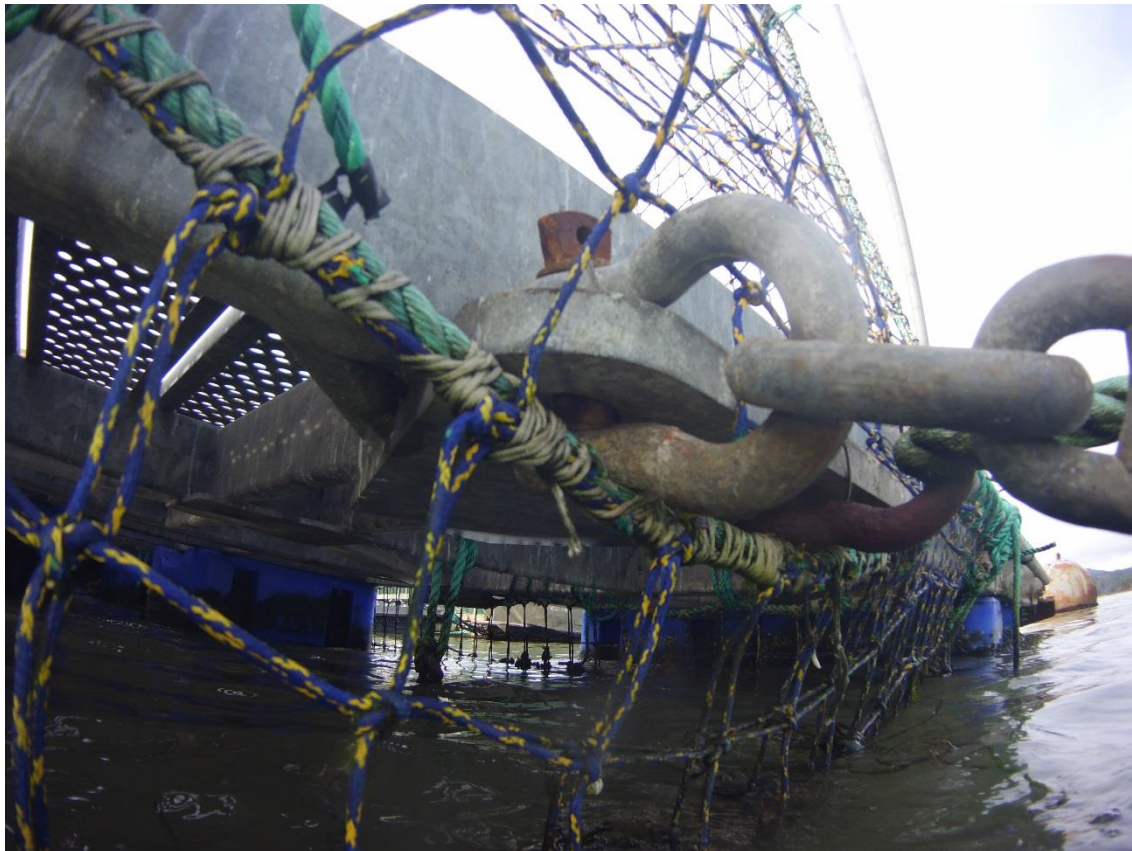
Figure 10: Typical Mooring Bracket at Hope Island

- Mooring brackets are attached to the walkway structure frame near the walking surface. The brackets are evenly distributed around the net pen facility, located at walkway intersections. Details of the connection are shown below in **Figure 10** and in **Figure 8**, and on sheet 4 of the drawings in Appendix A. The mooring brackets are not hinged, unlike mooring connections at other net pens observed in Washington waters, and typically have three holes for connecting three mooring lines. Typically, only one mooring line was connected to each bracket, typically the middle hole, but not always.
- Mooring brackets were observed during our site visit to be in good to satisfactory condition. Minor corrosion was observed in places but the galvanizing was generally intact.

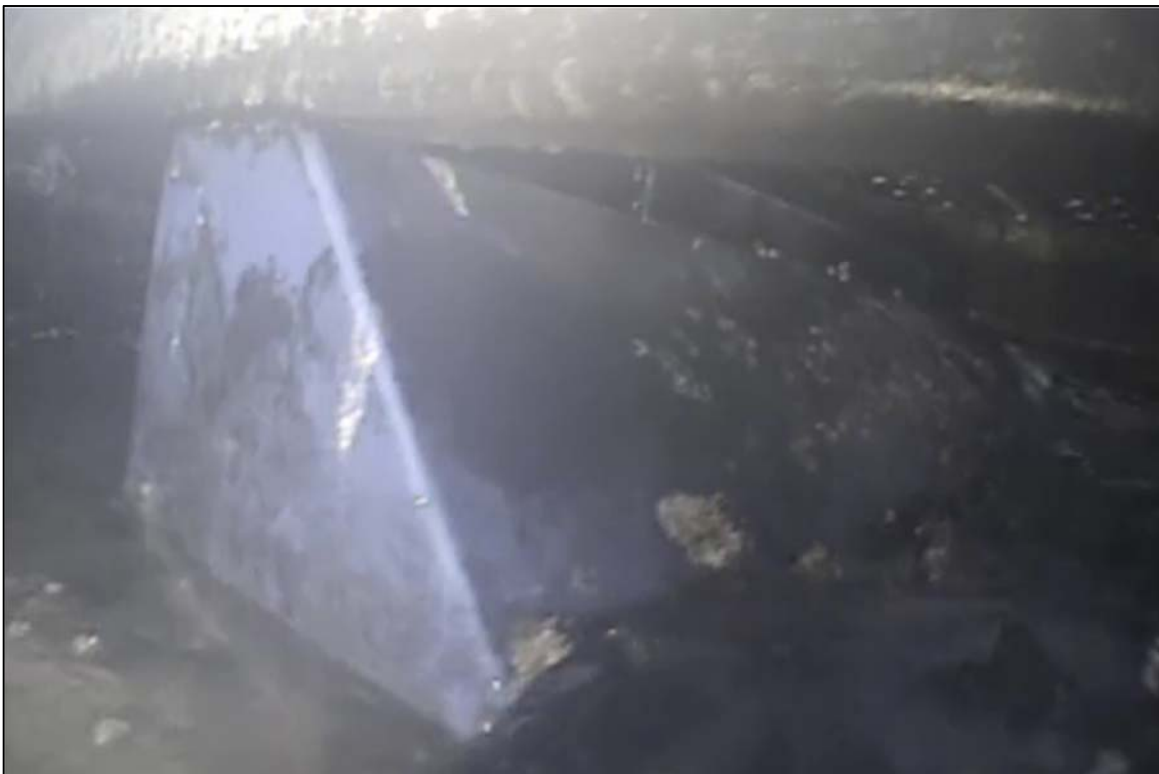
Photograph 12: View of the Northwest Corner Pen Support Float, Looking Southeast.

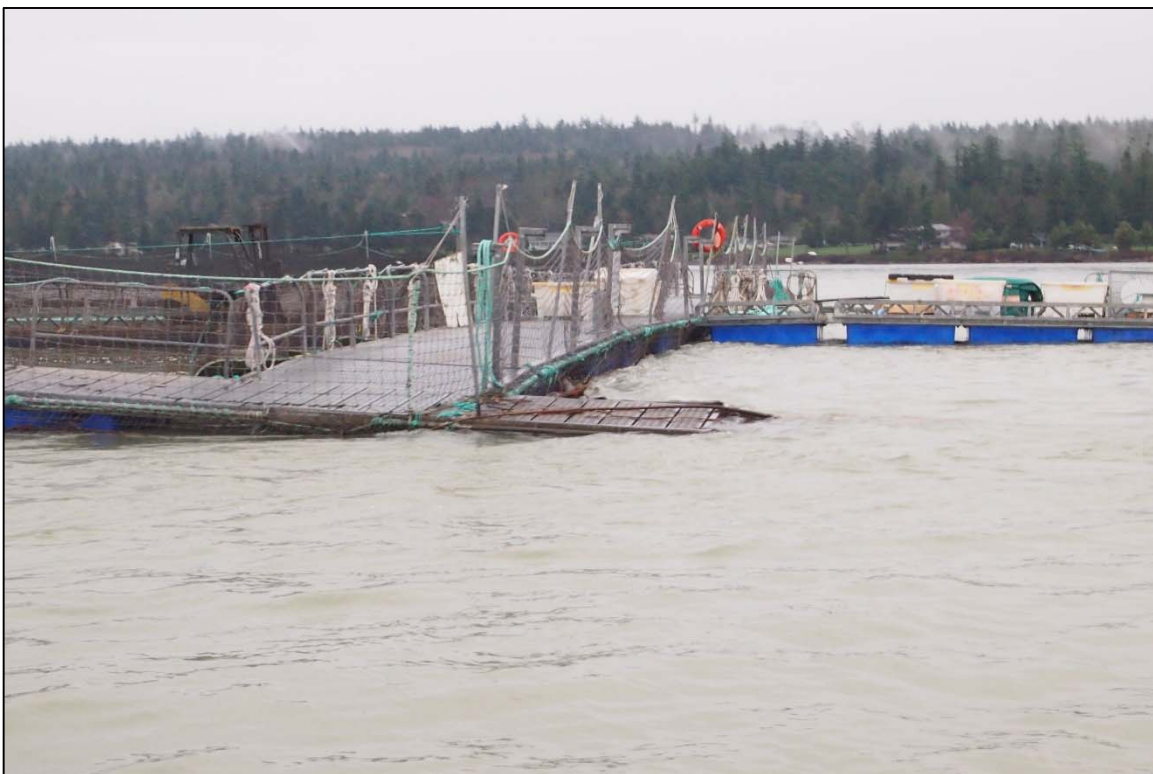
Photograph 18: View of the Depressed Pen Support Float (During High Ebb Tidal Flow) at the Southwest Corner, Looking Northeast.

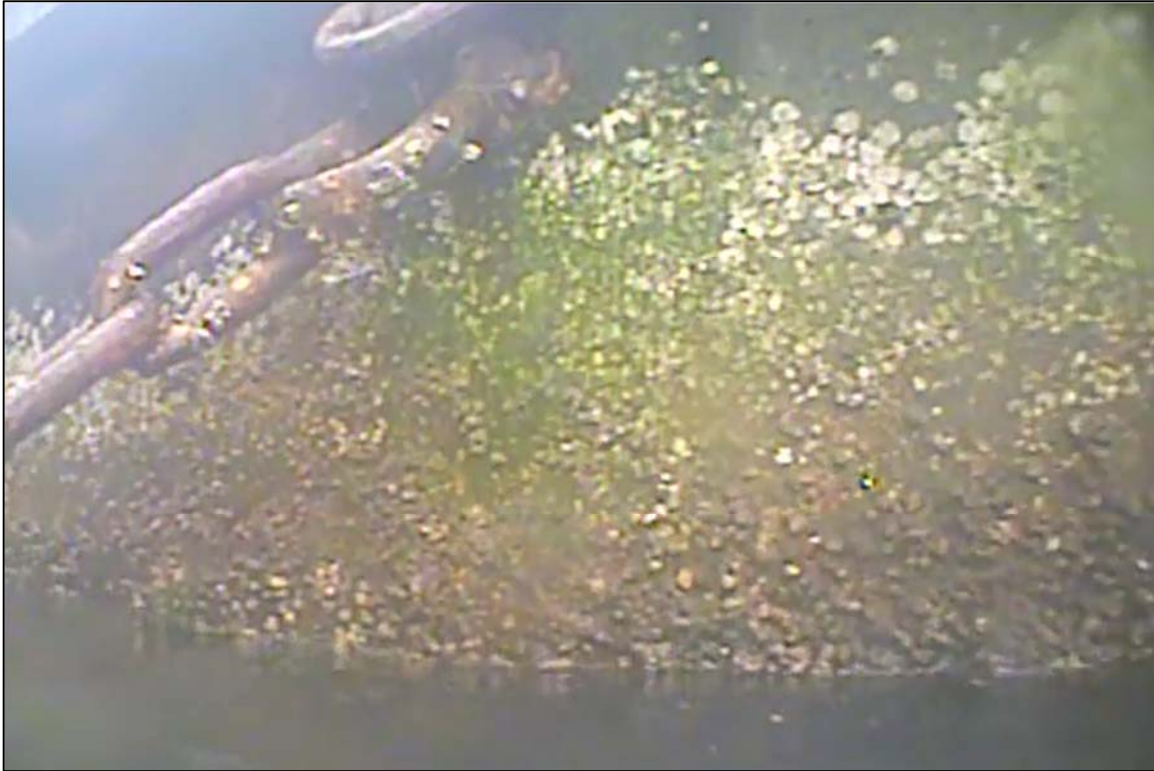
Photograph 21: View of the Typical Concrete Condition at the Waterline at the East Building Support Float, Looking East.

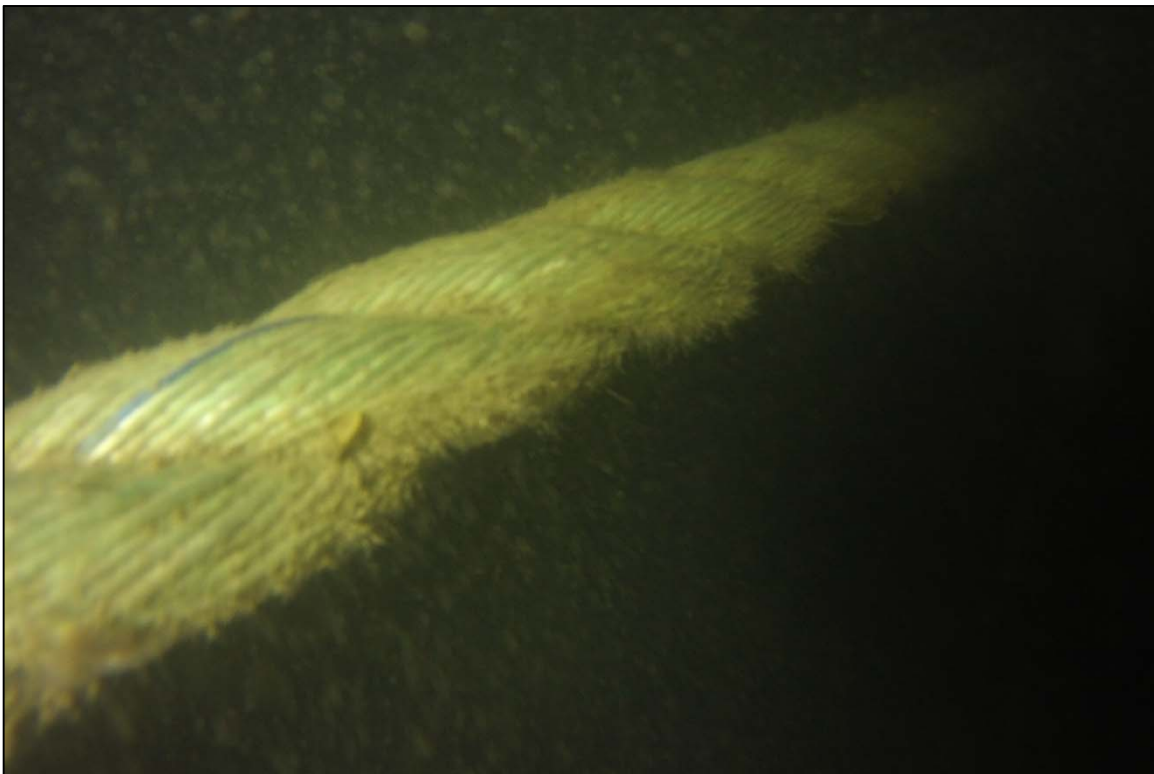
Photograph 30: View of Rope with Light Marine Growth at Anchor 22 (Typical), Looking Northwest.

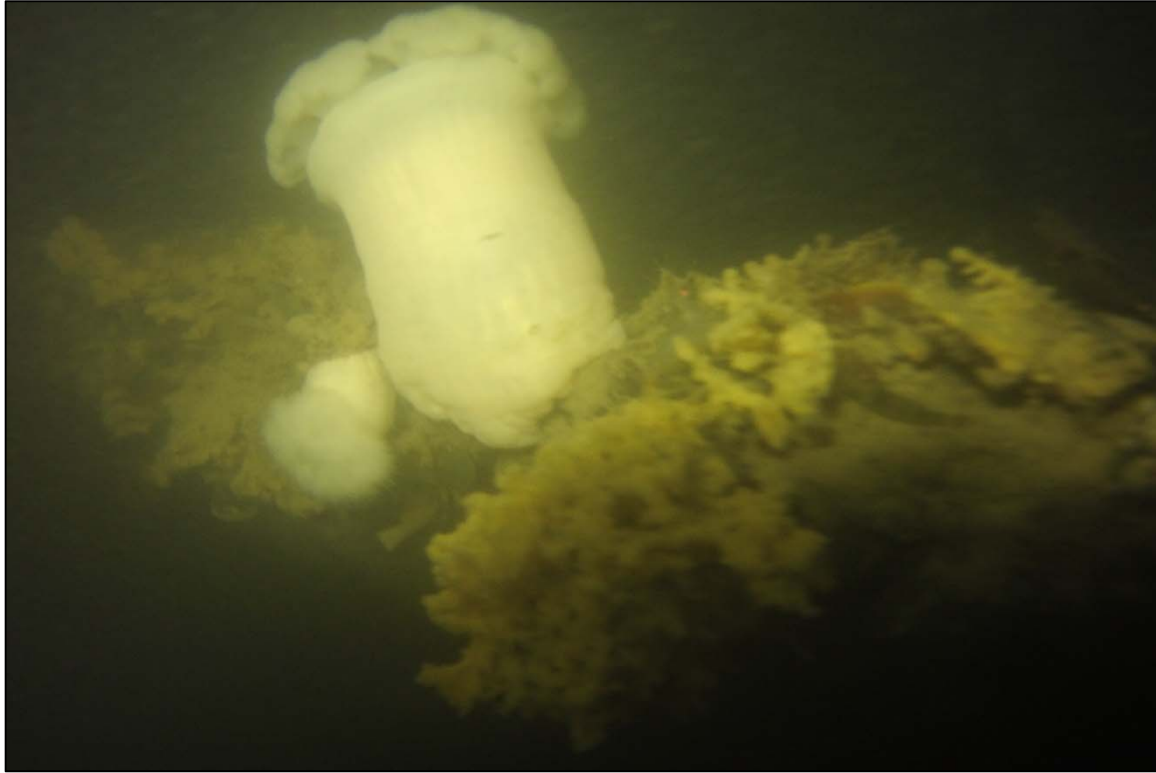
Photograph 31: View of Rope with Heavy Marine Growth at Anchor 17 (Typical), Looking South.

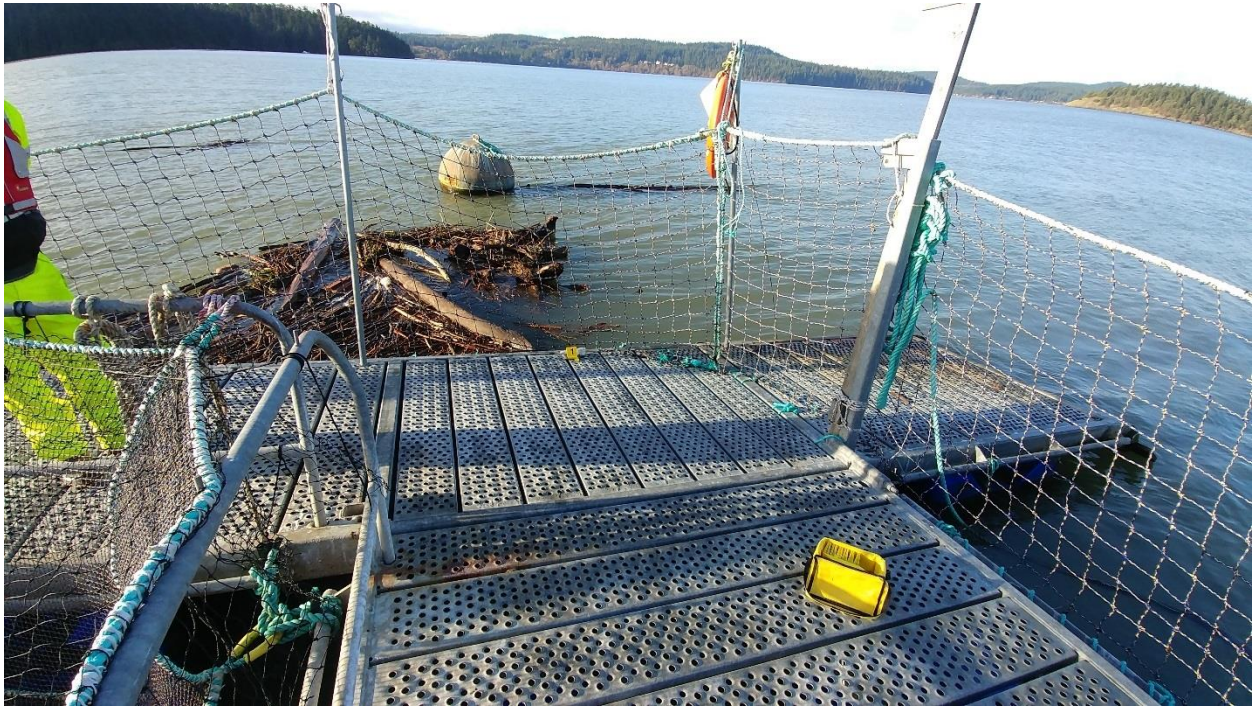
Figure C-10: Hope Island Net Pens - NW Corner, Inadequate Flotation

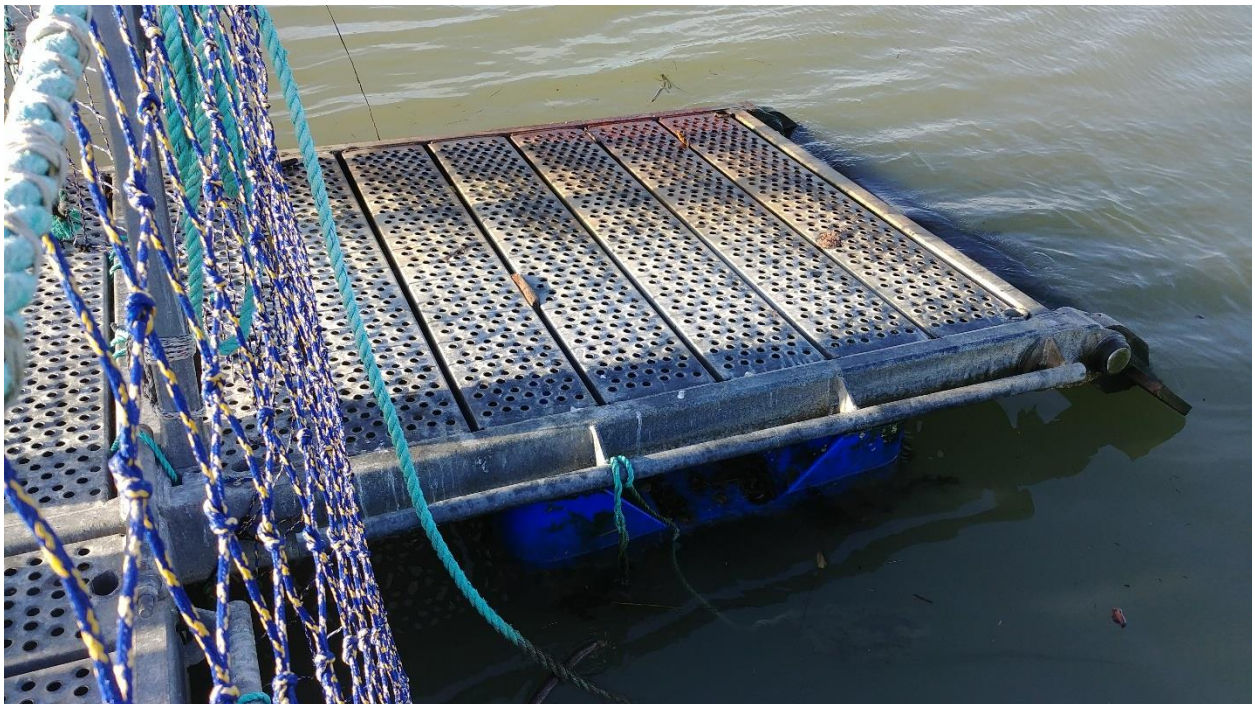
Figure C-11: Hope Island Net Pens - NW Corner, Sinking Platform

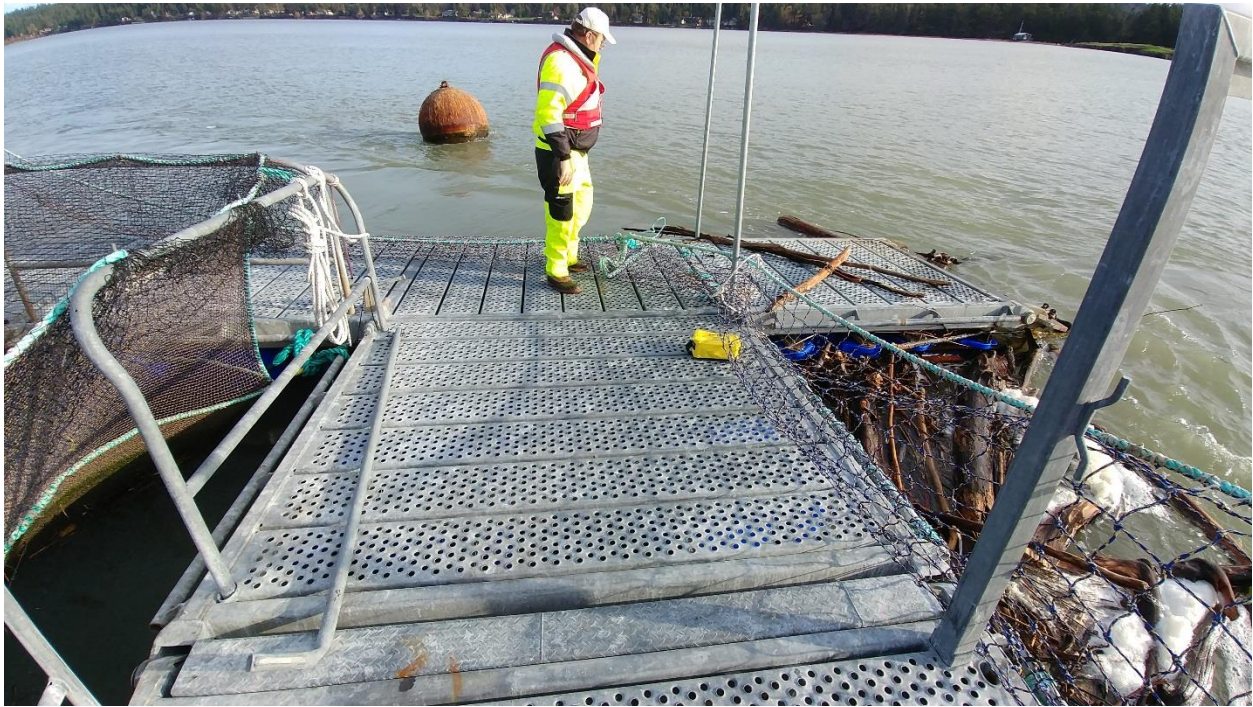
Figure C-12: Hope Island Net Pens - SE Corner, Inadequate Flotation

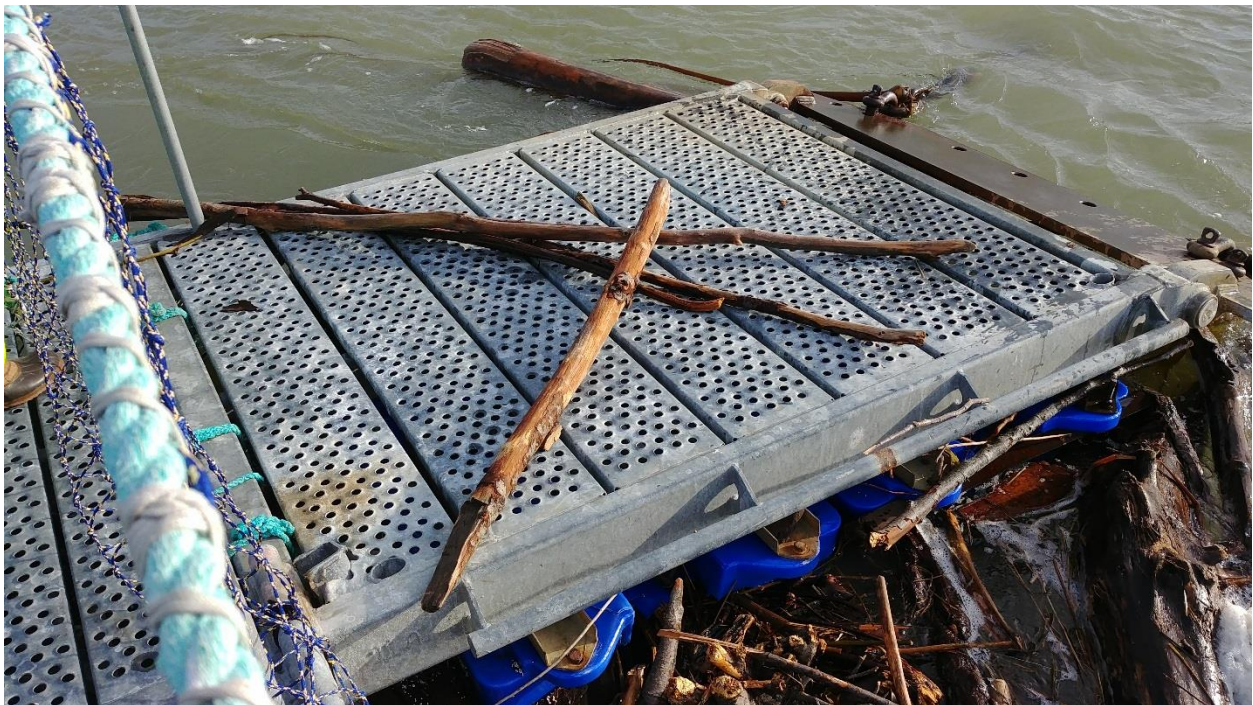
Figure C-13: Hope Island Net Pens - SE Corner, Sinking Platform

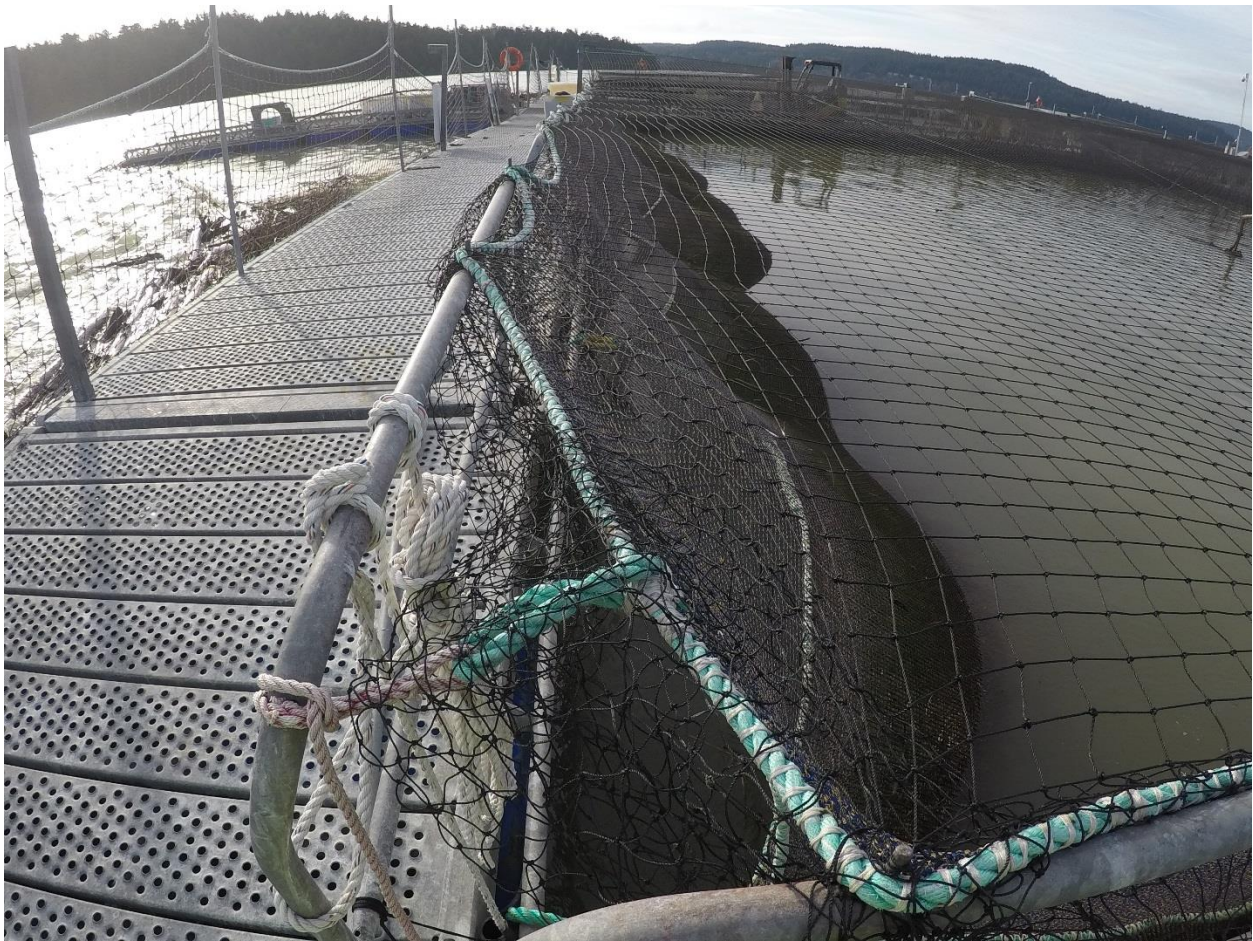
Figure C-18: Current from the South Creates Drag on the Containment Nets

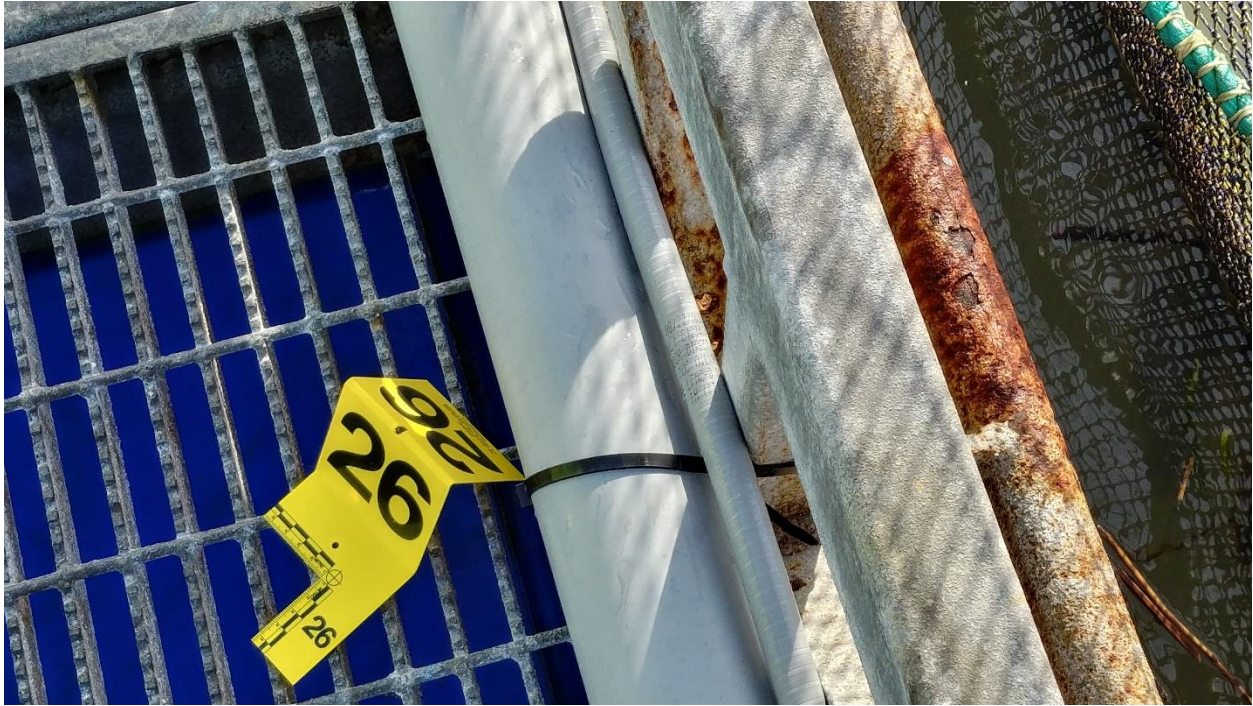
Figure C-70: Moderate Corrosion of

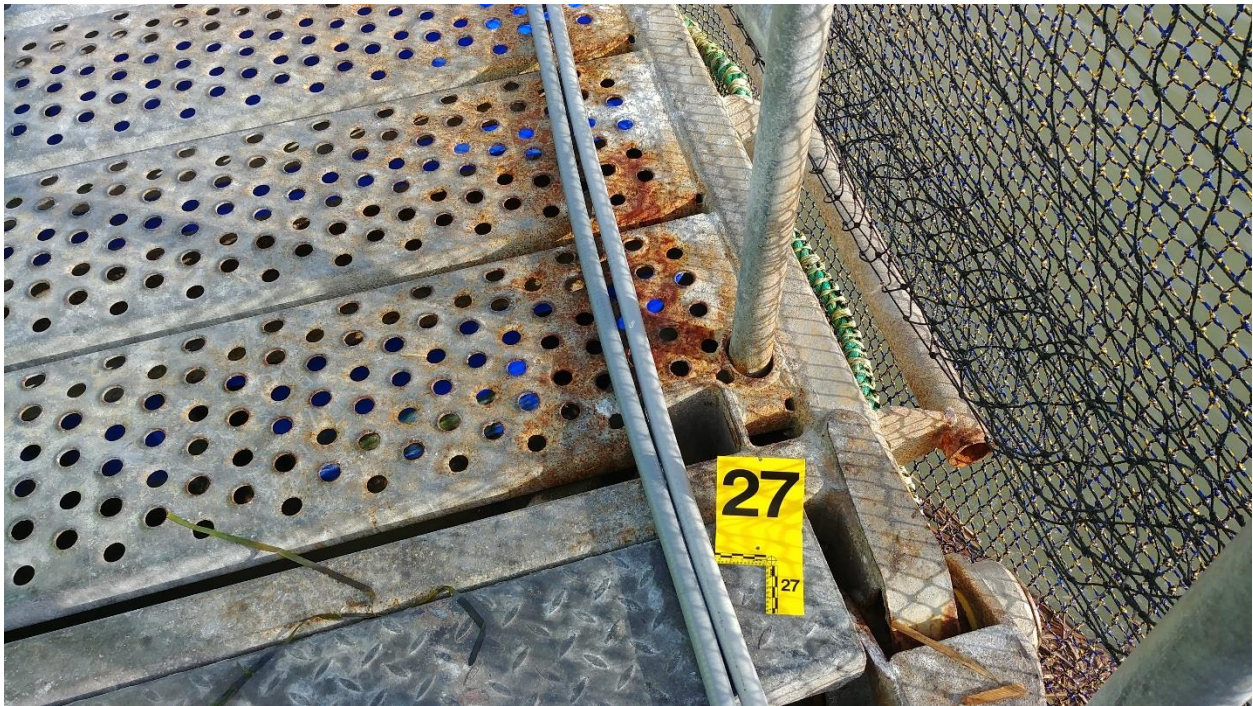
Figure C-71: Minor Corrosion

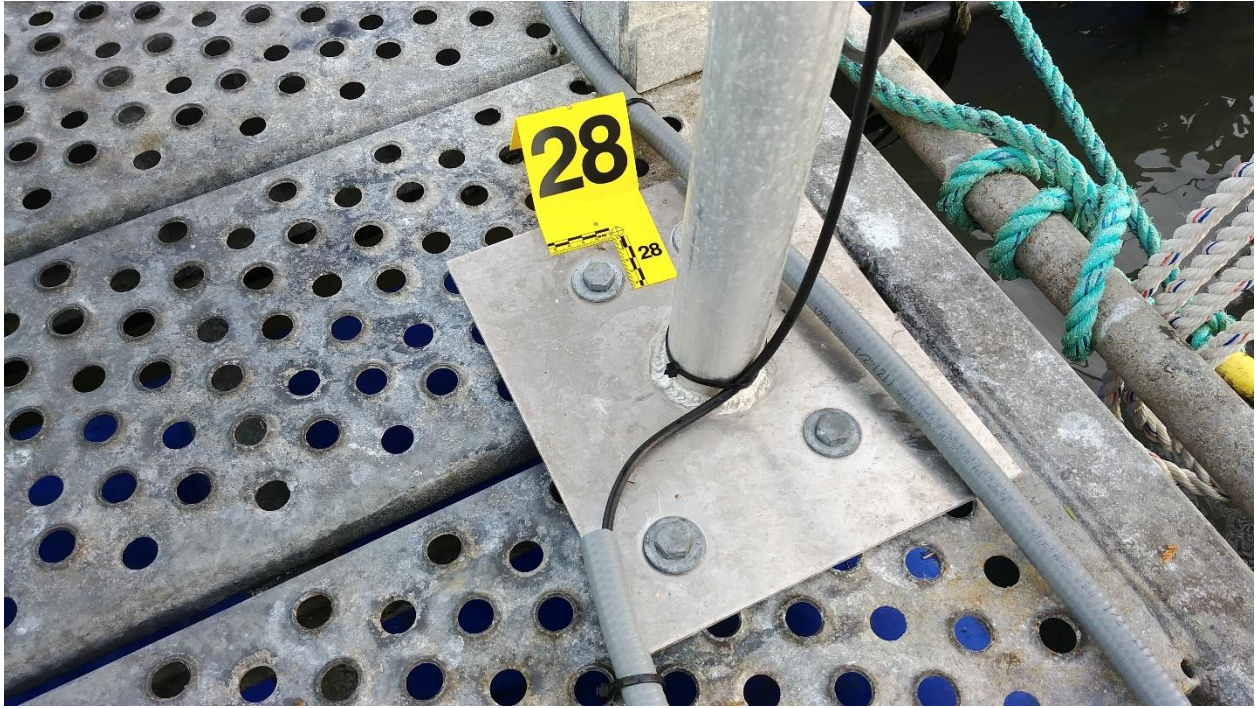
Figure C-72: Dissimilar Metals

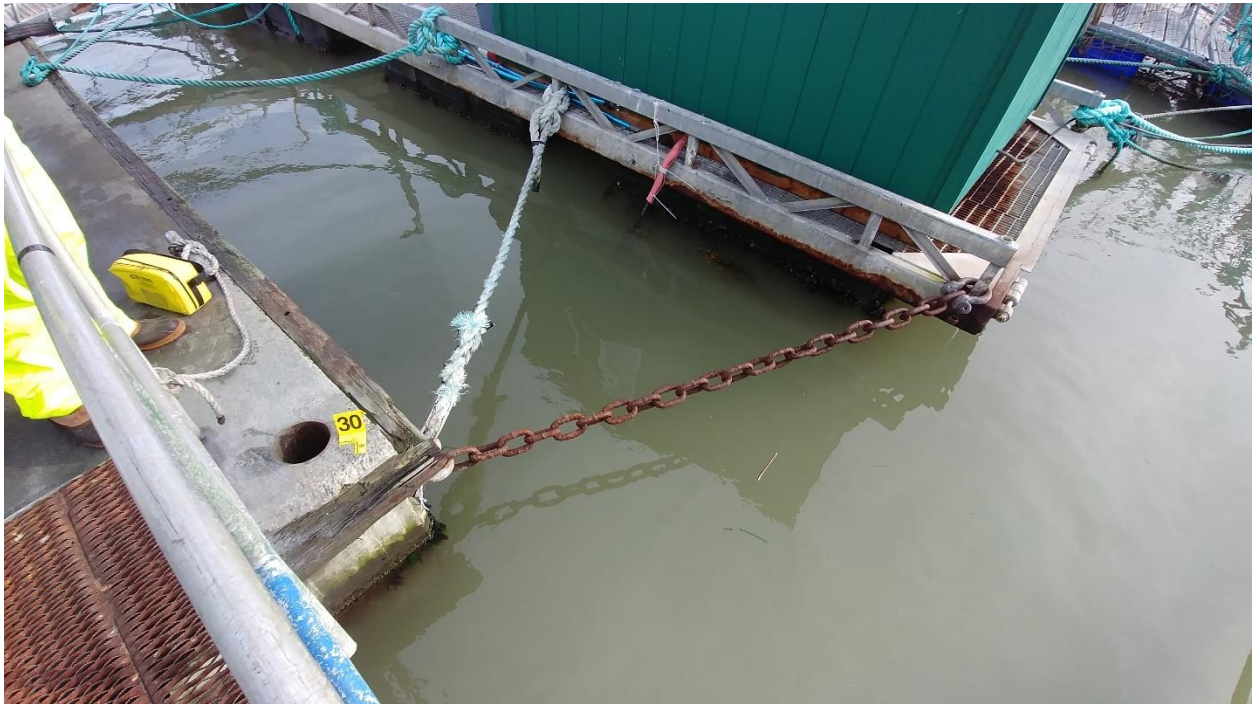
Figure C-74: Rusted chain and Barge Framing Members

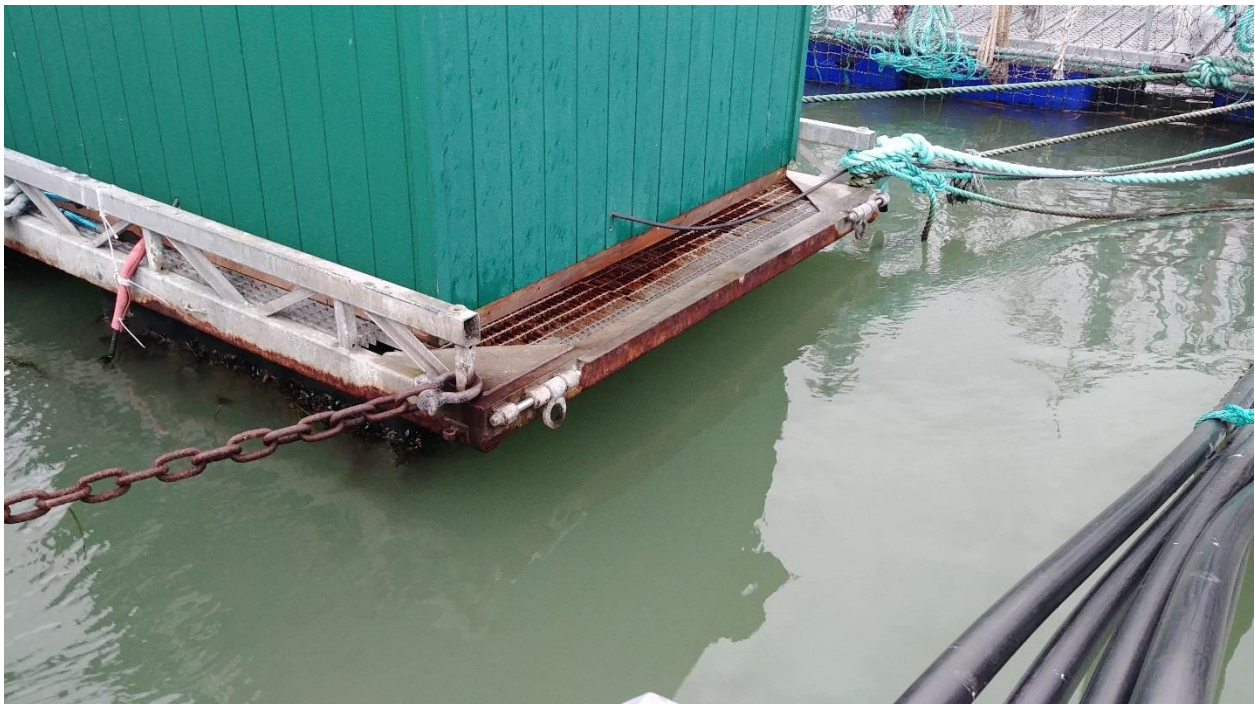
Figure C-75: Rusted chain and Barge Framing Members

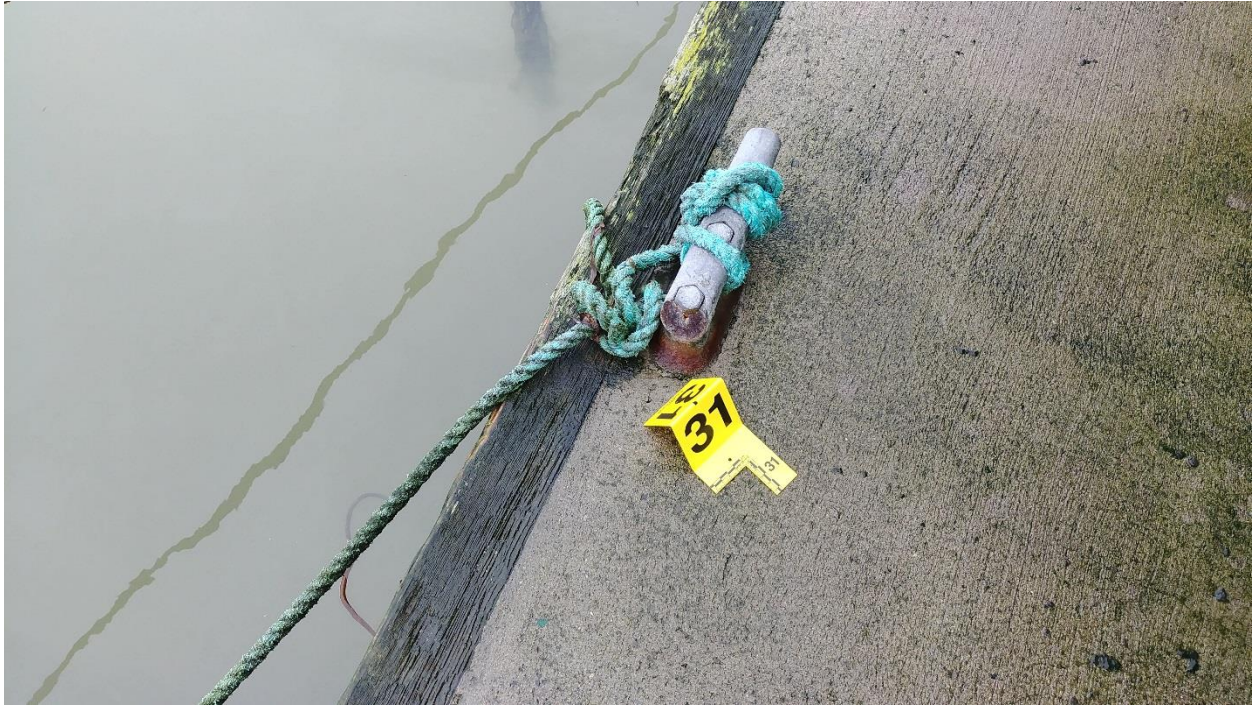
Figure C-76: Horn on Mooring Cleat Has Sheared Off at the Bolt

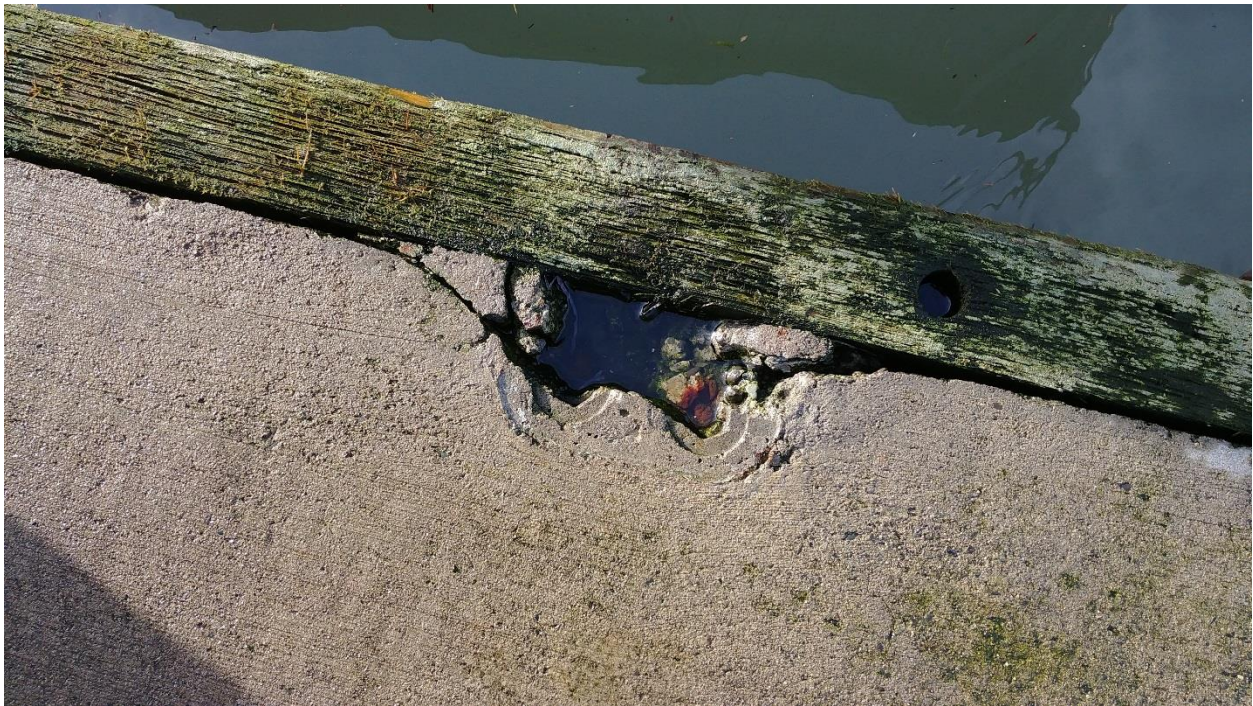
Figure C-79: Mooring Cleat has been Torn Out and is Missing

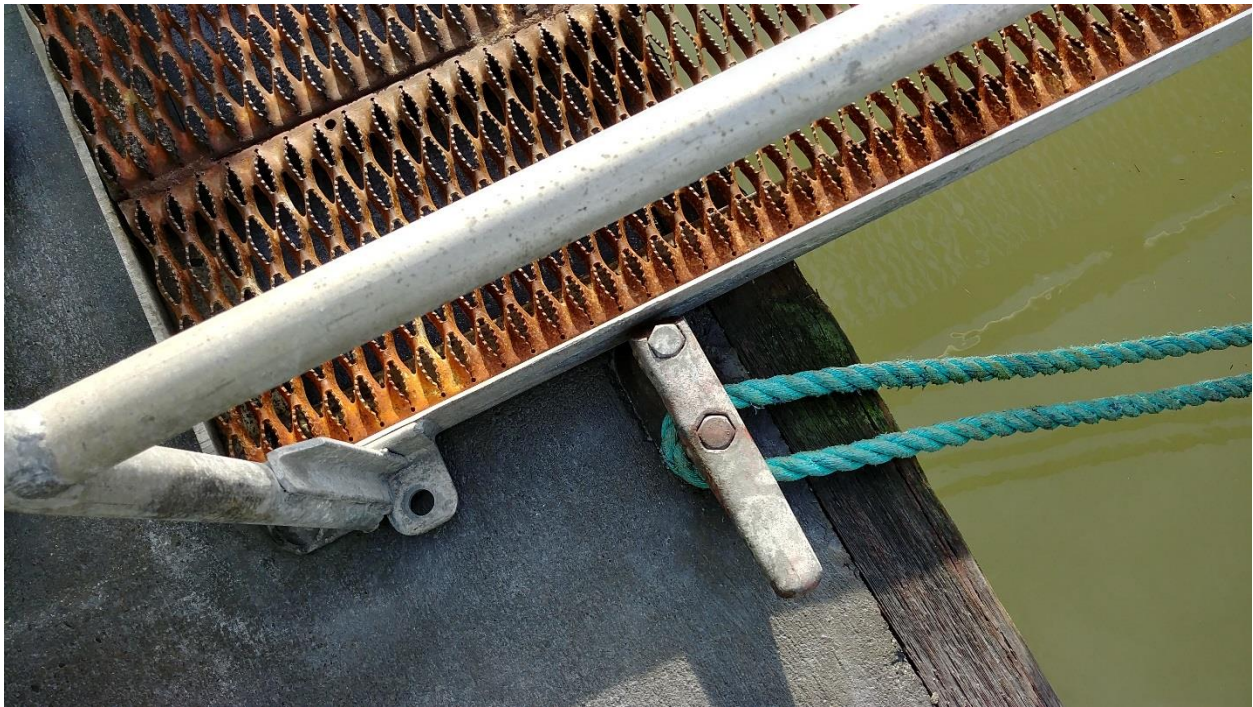
Figure C-80: Horn on Mooring Cleat Has Sheared Off at the Bolt.

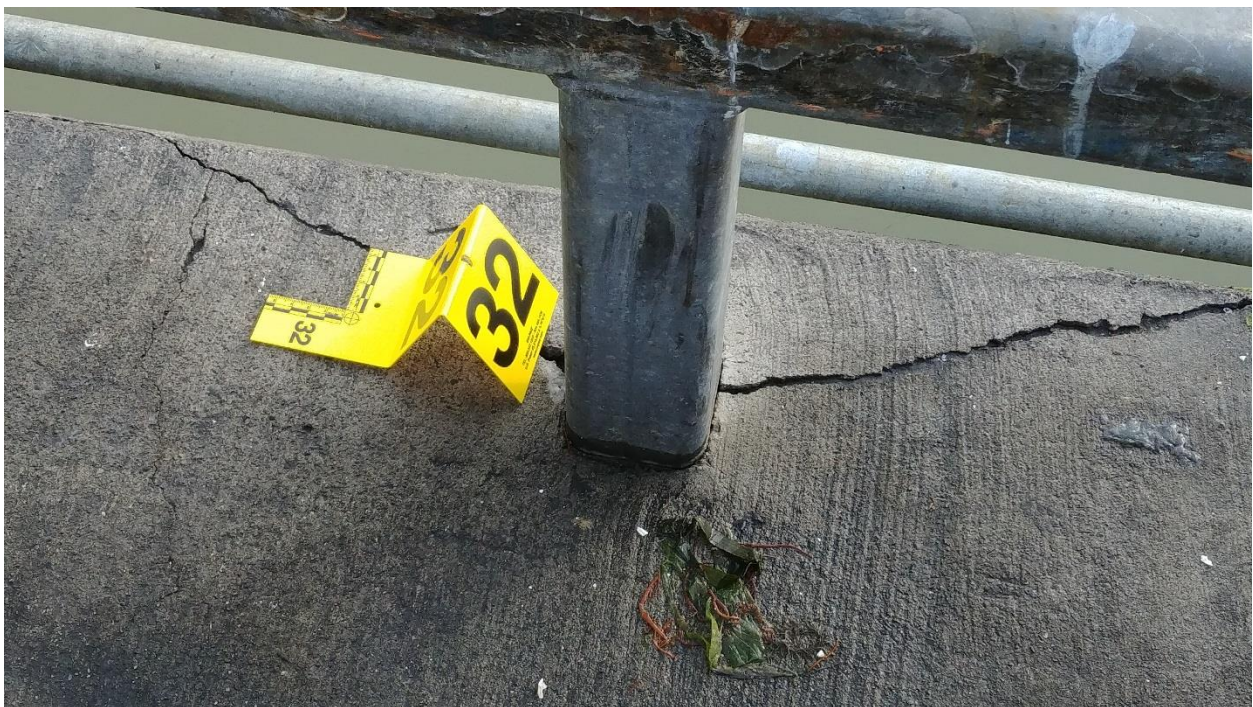
Figure C-81: Concrete on South Side of Feed Barge is Cracked and Nearly Spalling Off

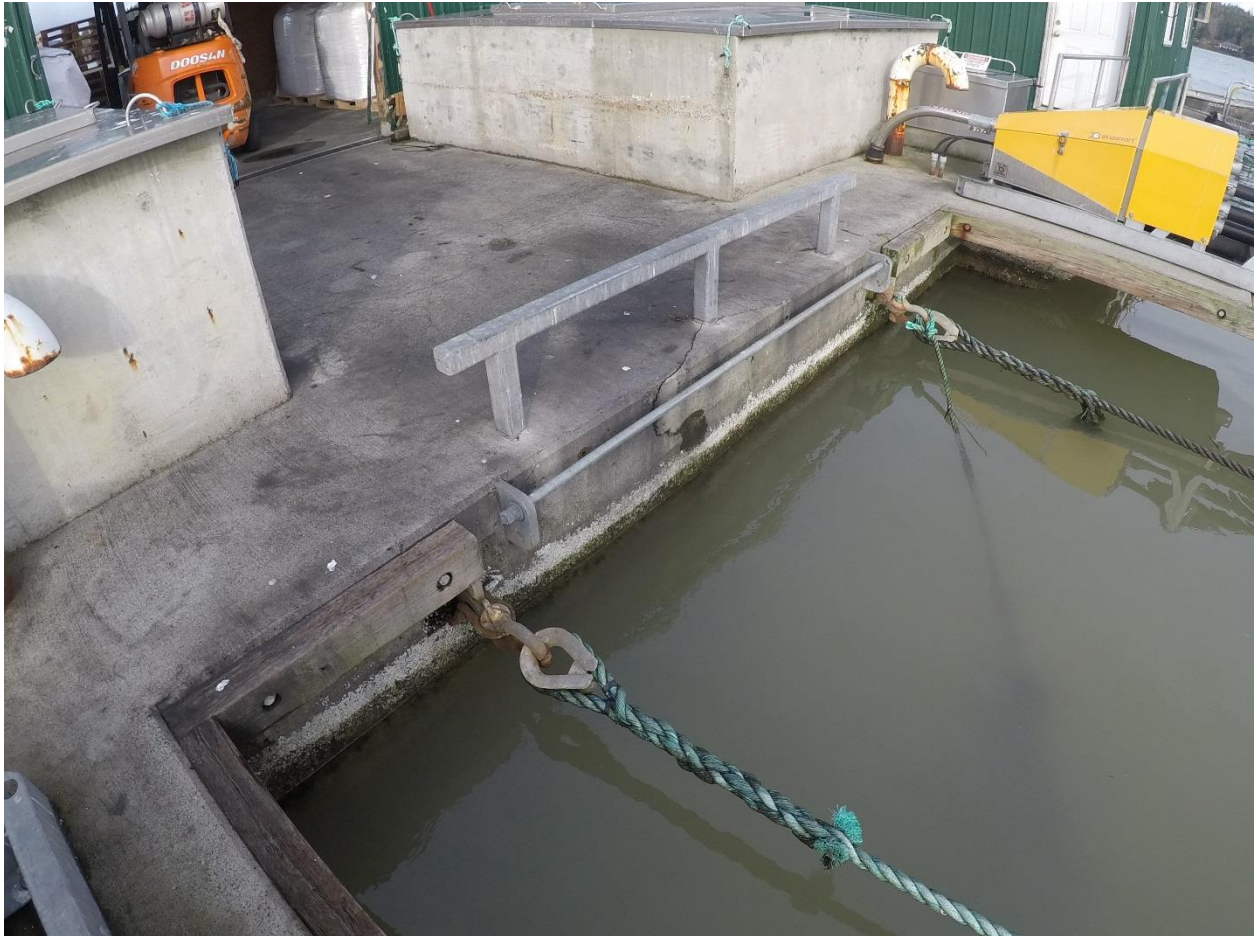
Figure C-82: Concrete on South Side of Feed Barge is Cracked and Nearly Spalling Off

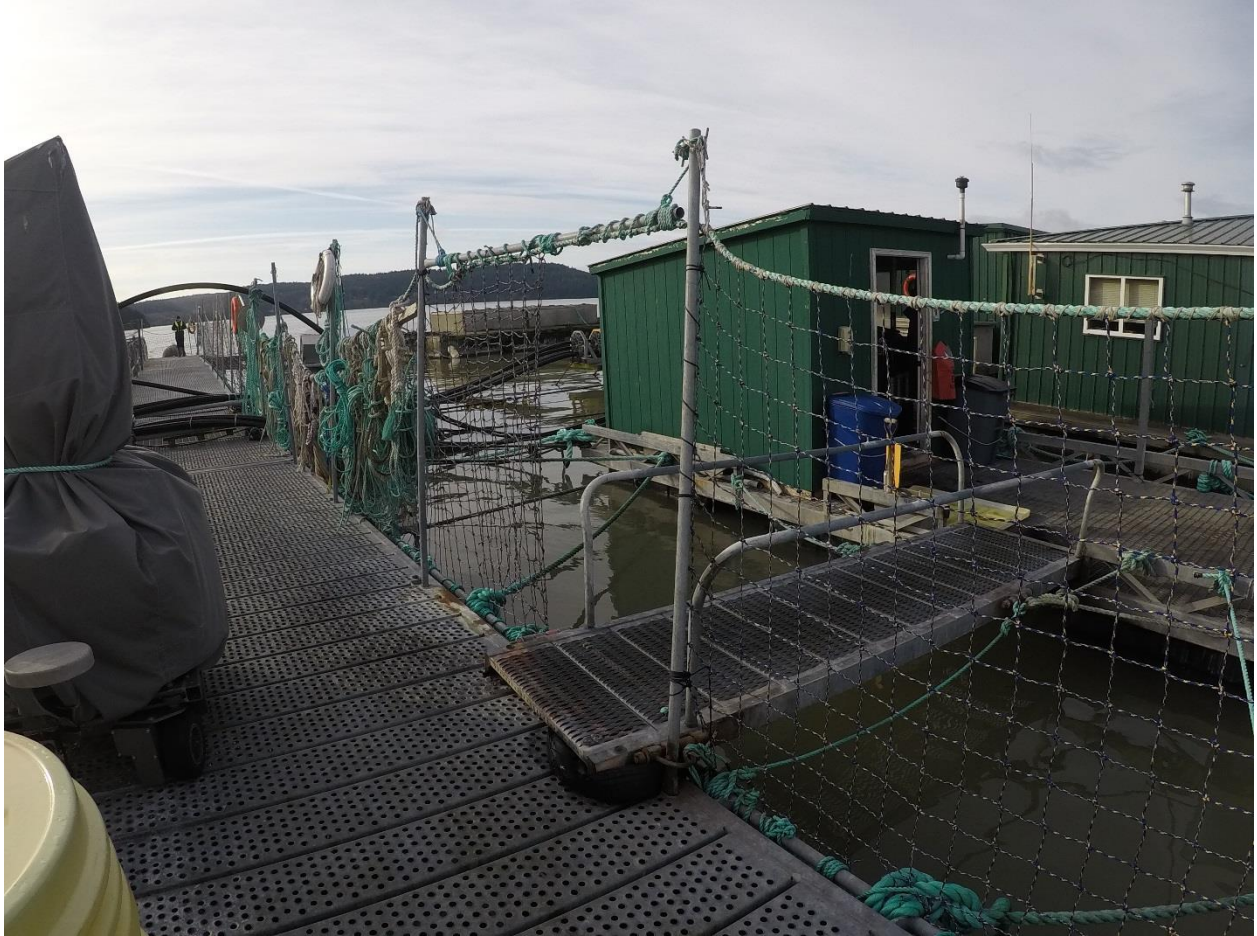
Figure C-84: Gangway Connecting Net Pens to Dive Float. Note Low Overhead Clearance.

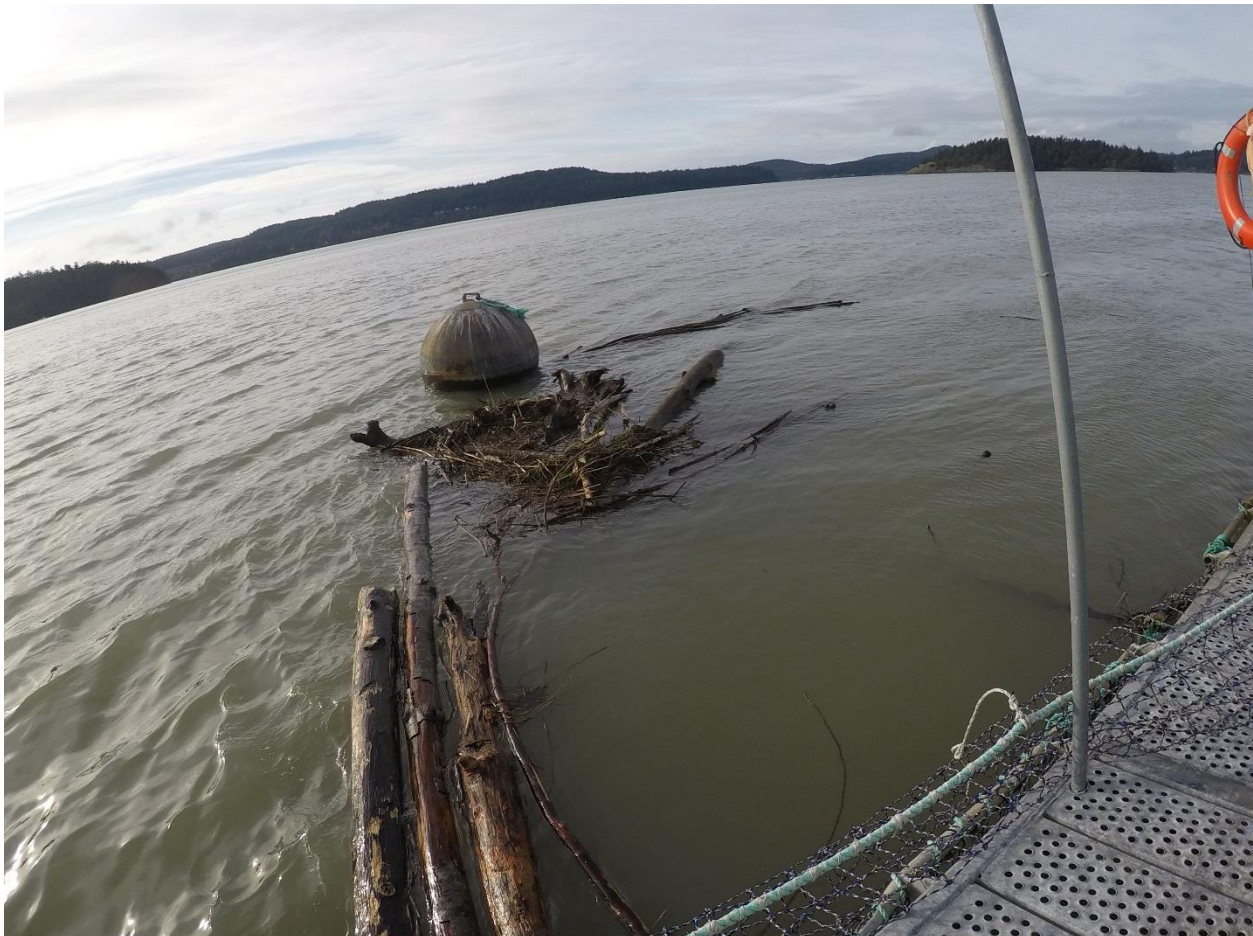
Figure C-105: Mooring Buoys, NW Corner. Floating Debris Has Built up around the Buoy.

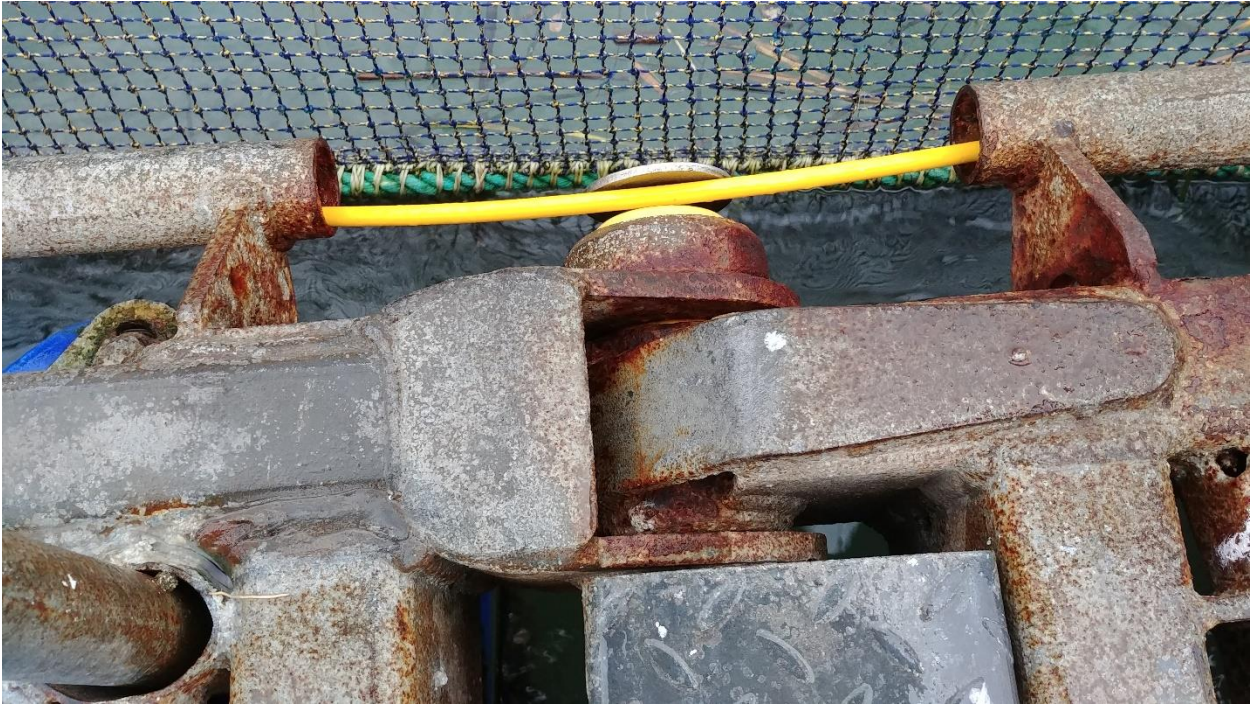
Figure C-106: Minor Corrosion of Walkway Hinge
