Hope Island Atlantic Salmon Net Pens Engineering Assessment

January 29, 2018

State of Washington
Department of Natural
Resources
1111 Washington Street SE
Olympia Washington 98504

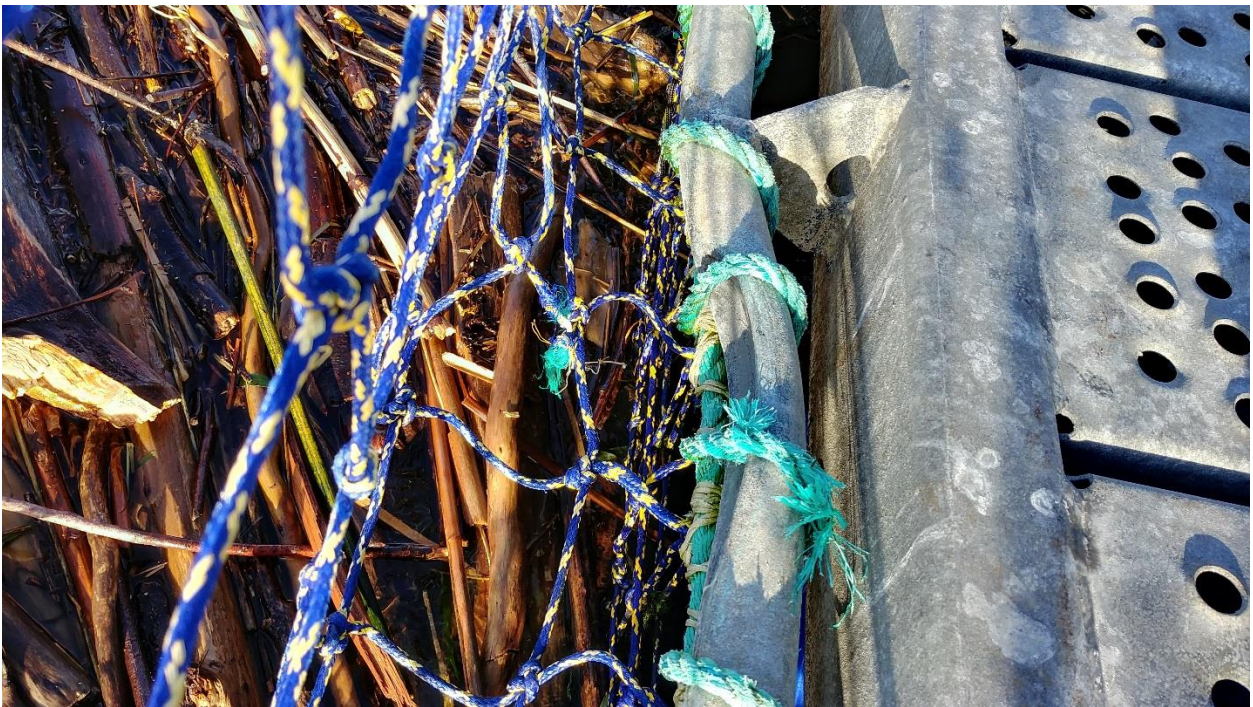
Figure C-107: Damaged Predator Net Railing, West Side of-Facility

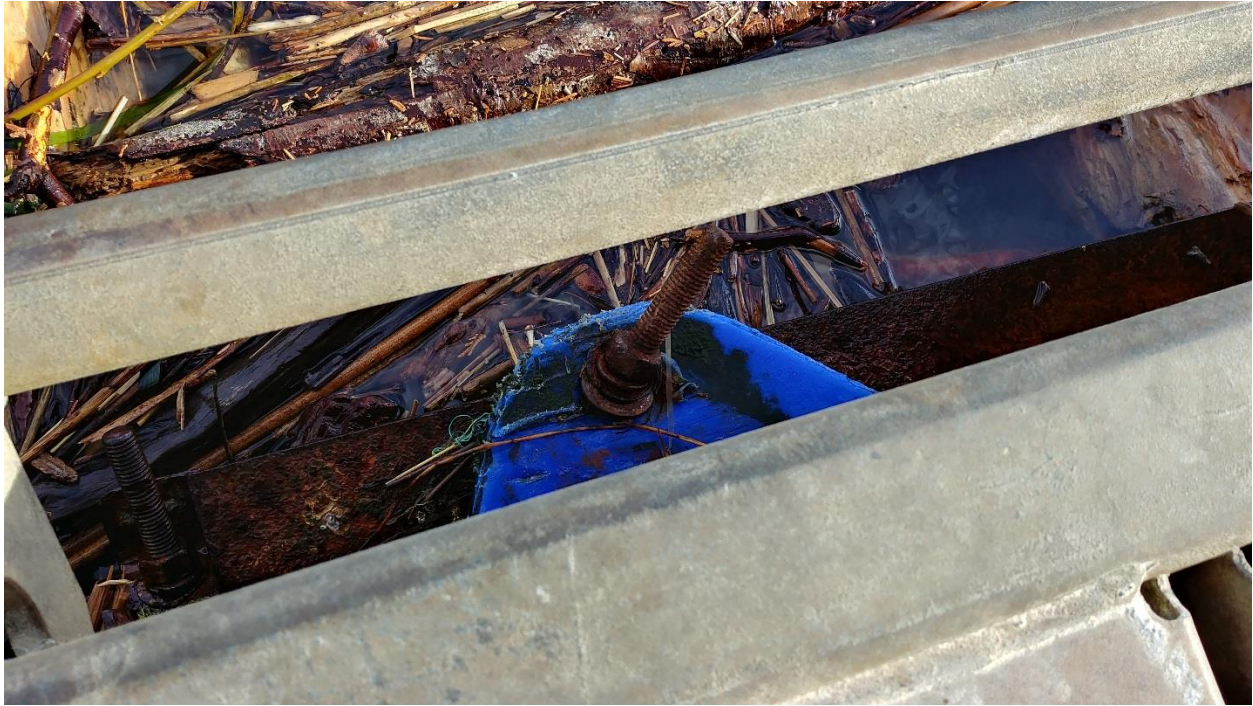
Figure C-108: Majorly Corroded Bolt and Steel Framing Connecting Float Tub

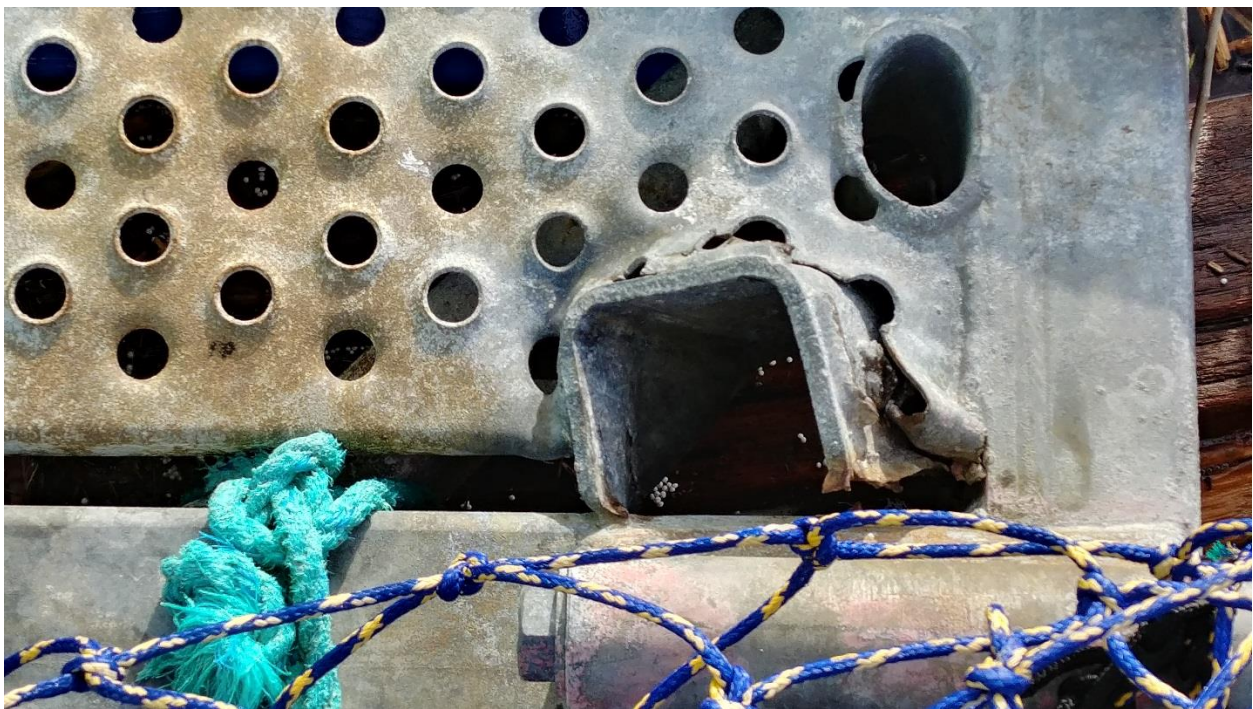
Figure C-109: Damaged Support Post Bracket

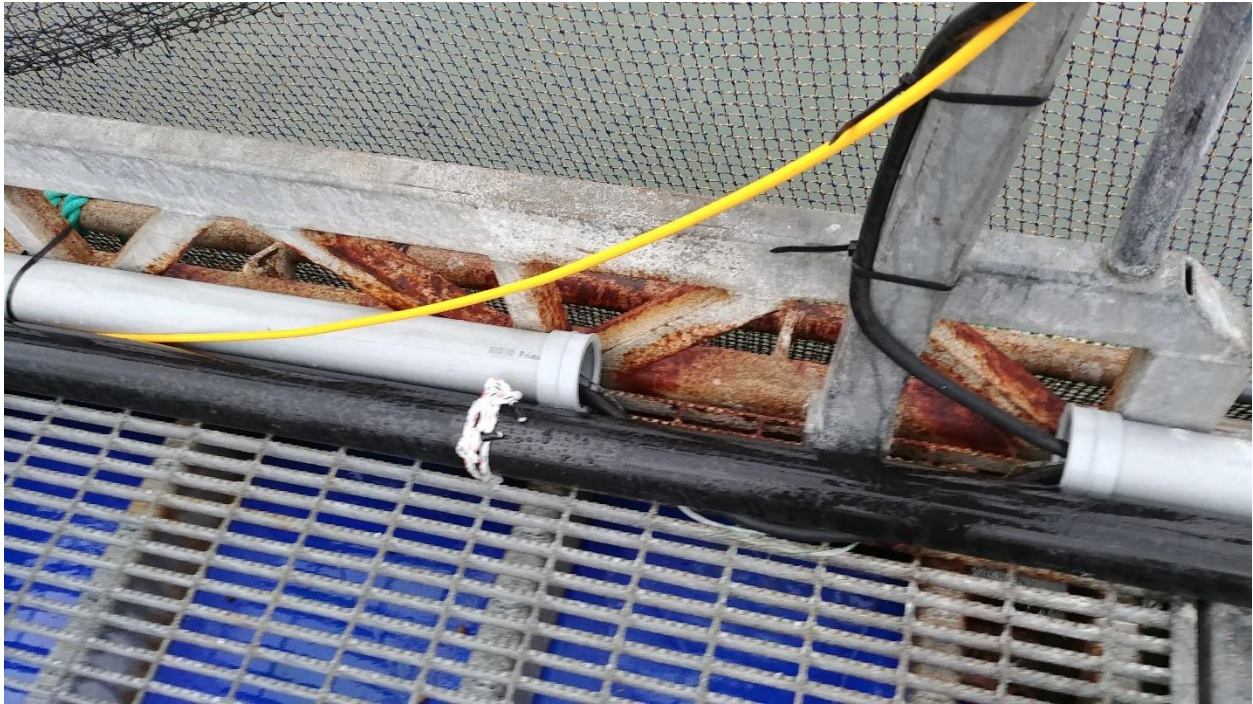
Figure C-110: Moderate Corrosion of Central Walkway Bullrail

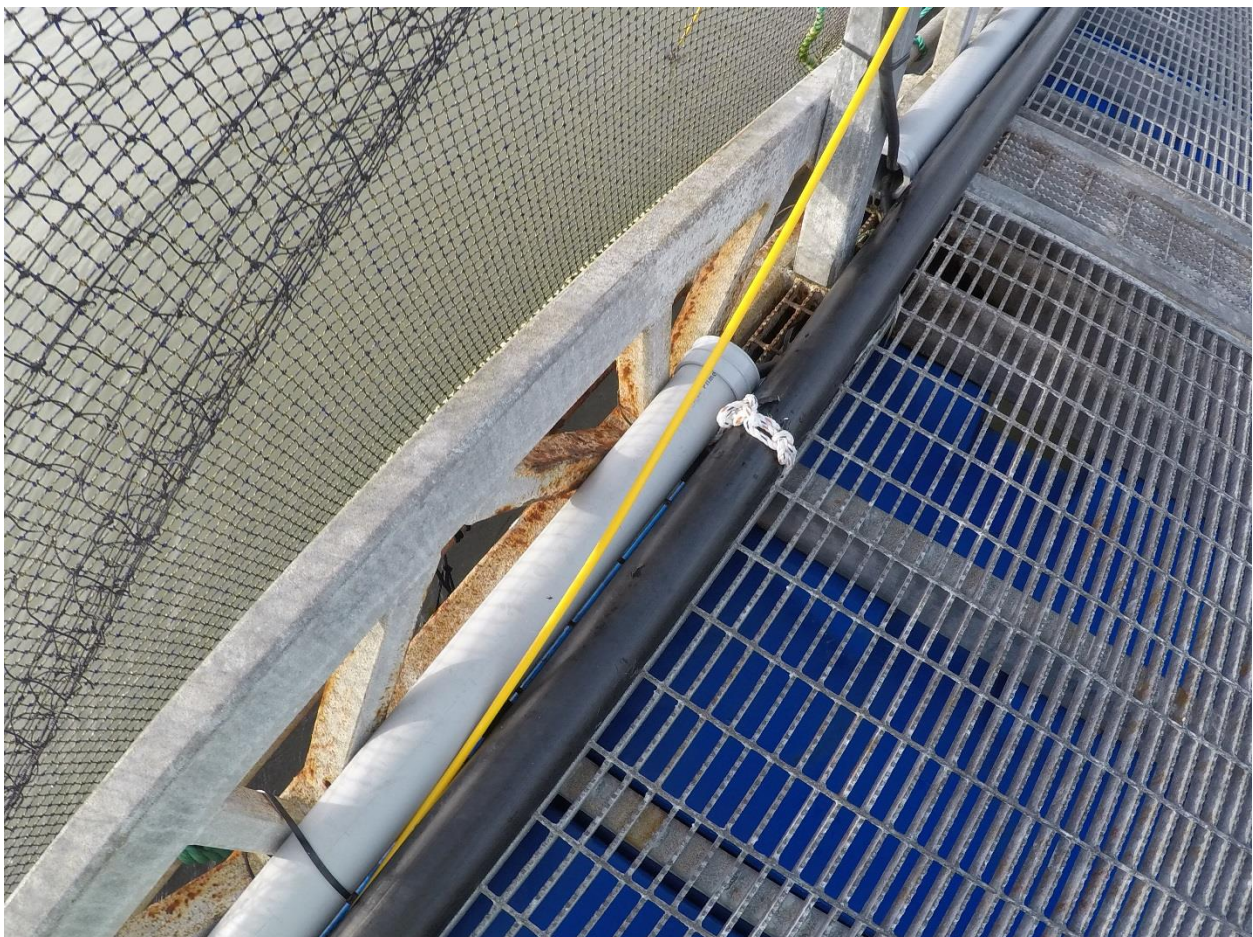
Figure C-111: Minor Corrosion of Central Walkway Bullrail

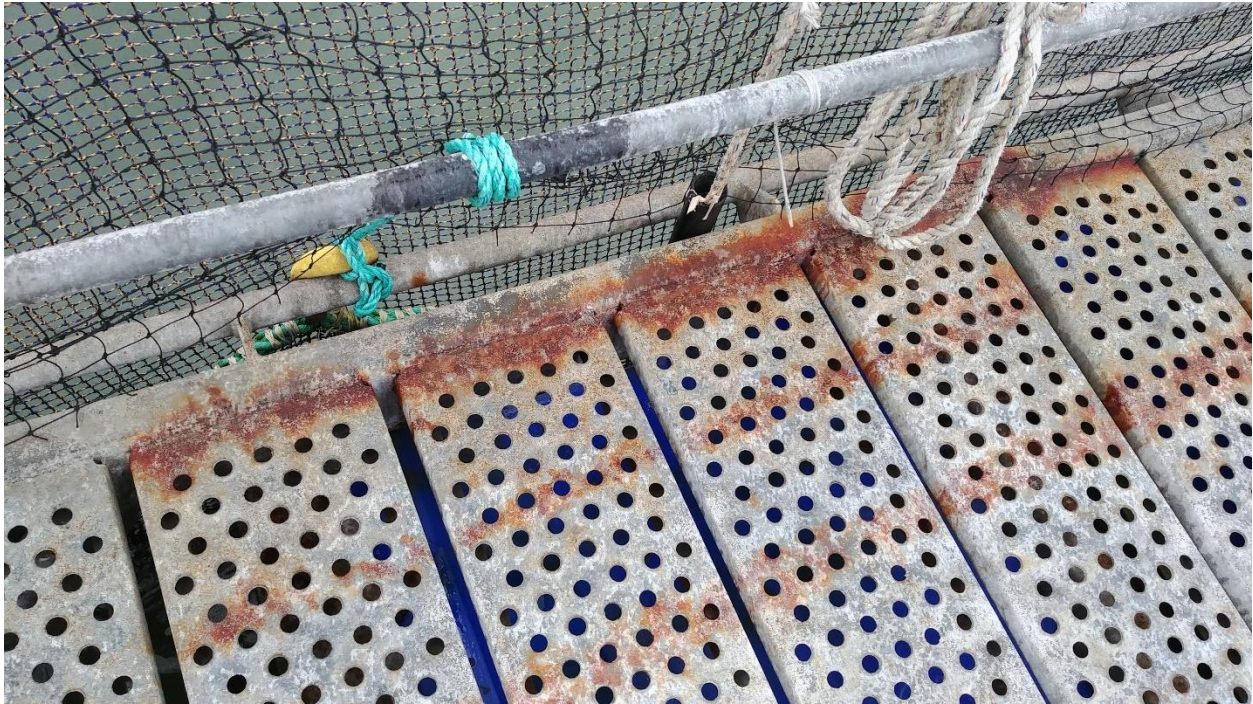
Figure C-112: Minor Corrosion of Steel Walkway Grating, Due to Fish Splash Back

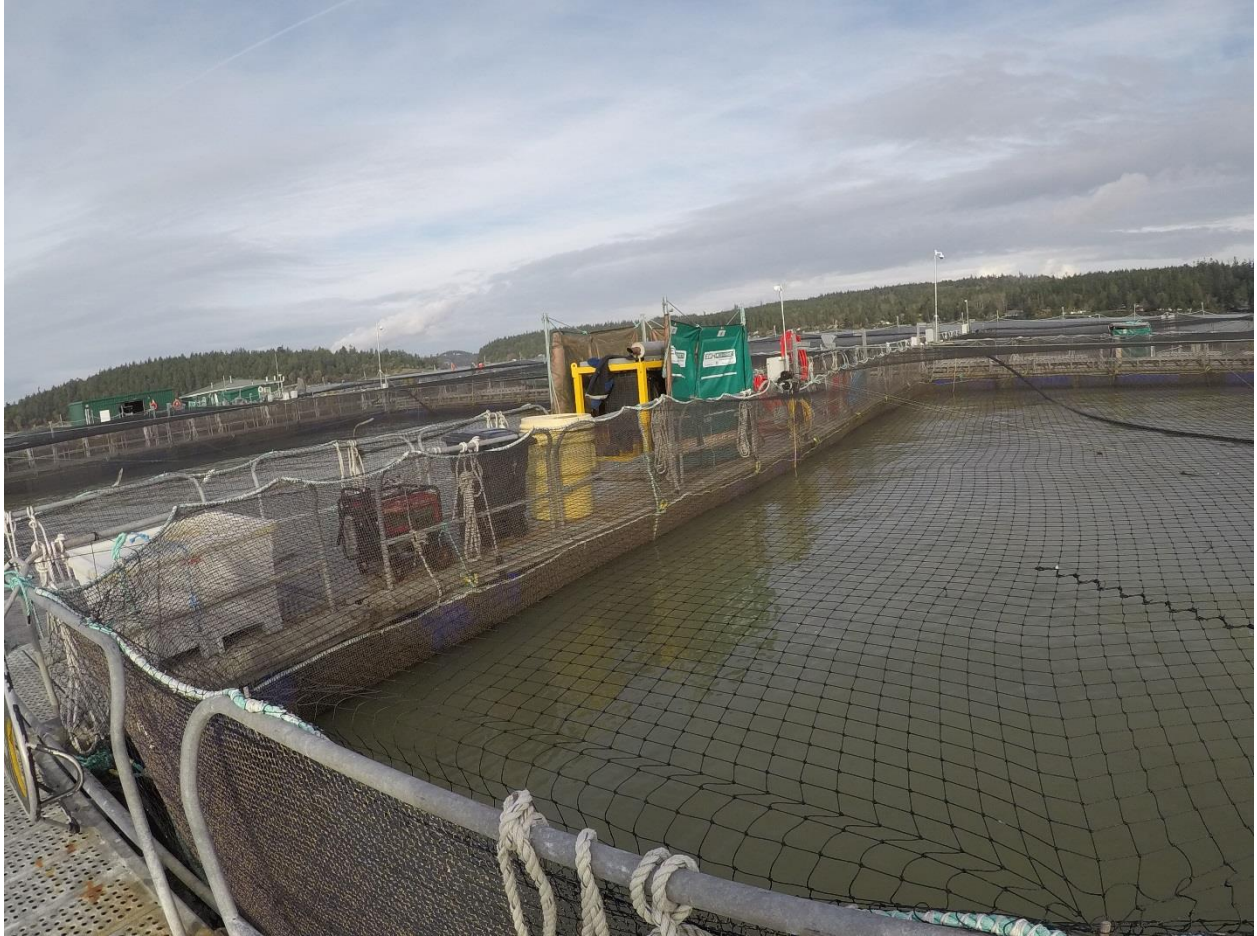
Figure C-116: Assorted Equipment is Causing Connecting Walkway to Deflect
