# **Cypress Island Site 1 Atlantic Salmon Net Pens Engineering Assessment**

January 29, 2018

**Document reference:** 391980 | 6 | b

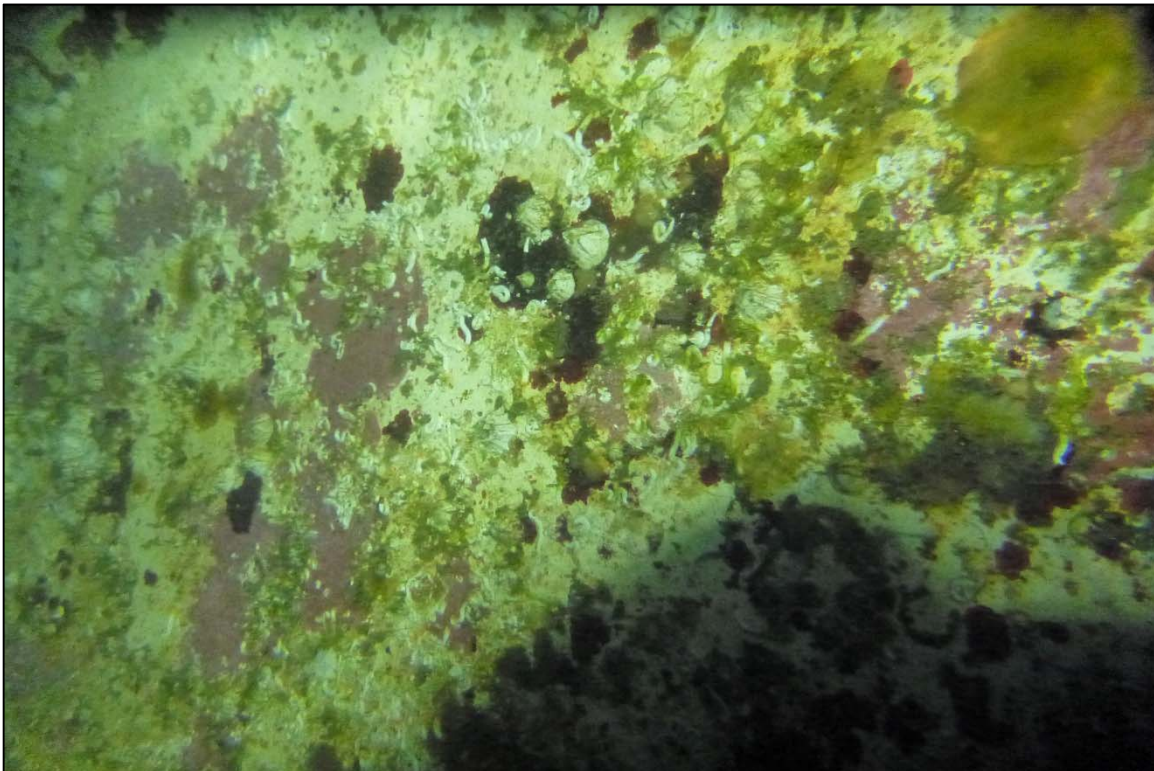
Photograph 5: View of the Barge Float Condition at Site 1 Fish Net Pens System, Looking East.

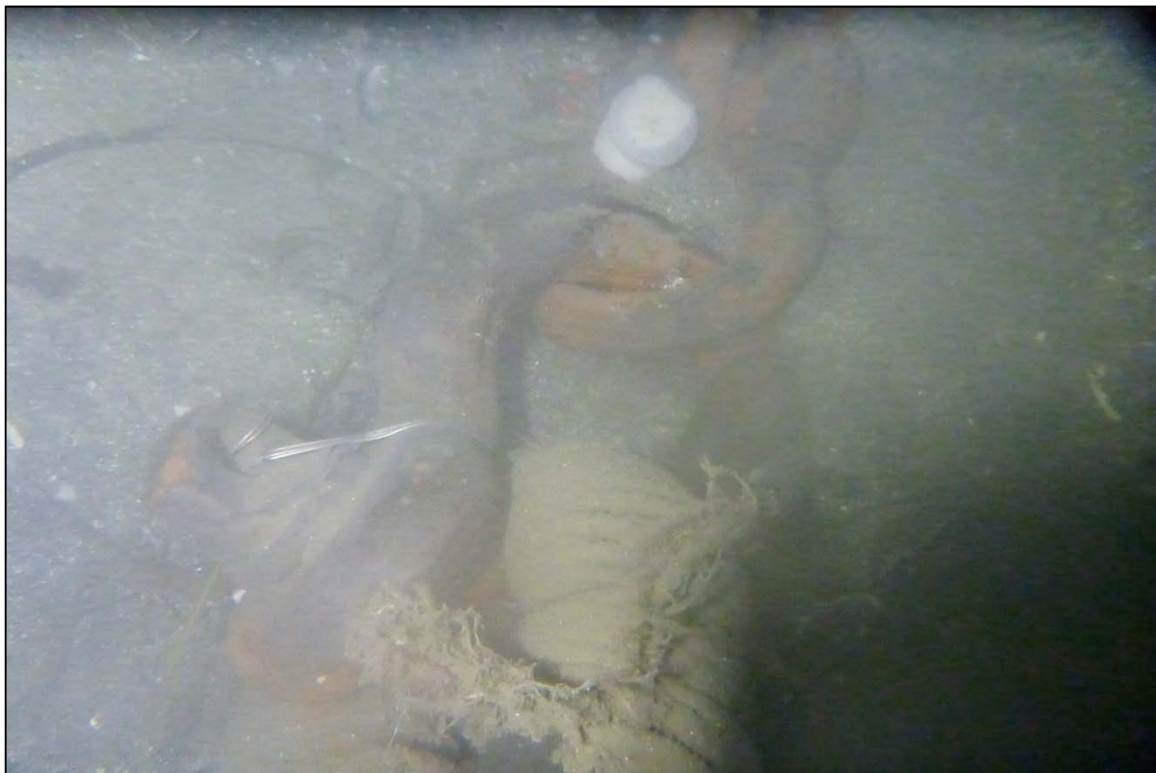
Photograph 9: View of the Severe Corrosion in the Upper Anchor Chain at Site 1 Feed Barge North Anchor Line, Looking East.

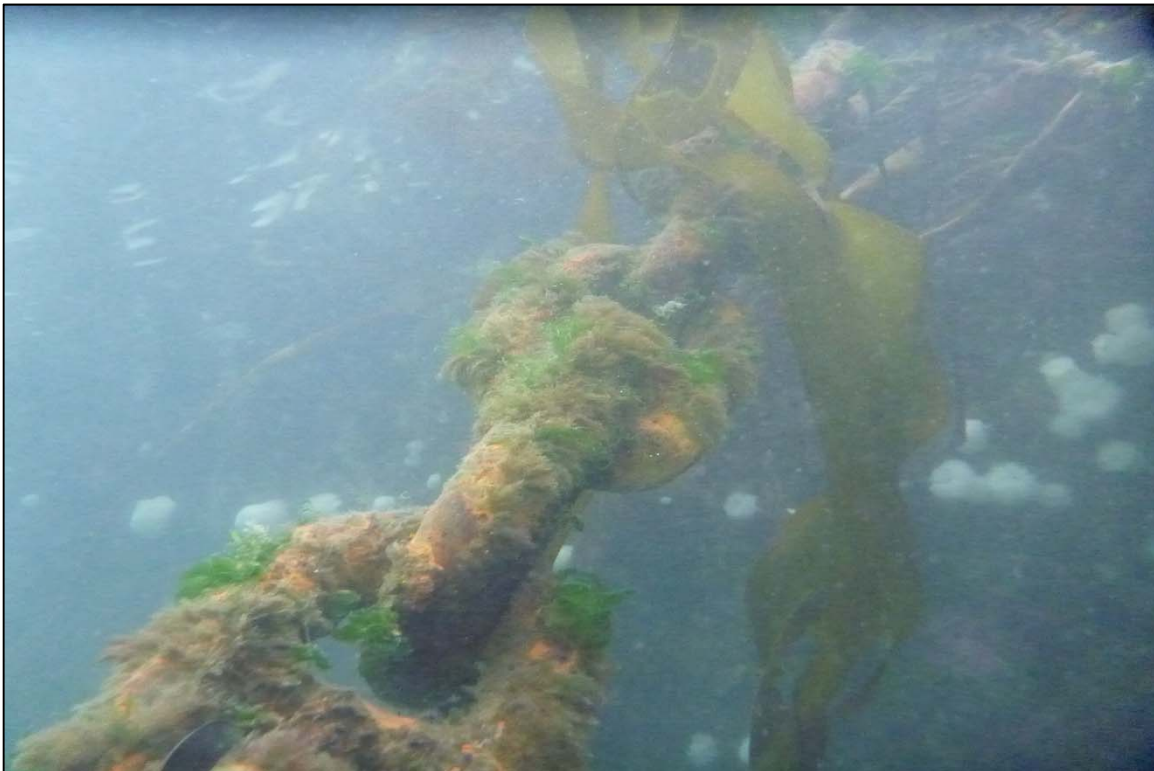
Photograph 21: View of the Lower Anchor Chain on the Channel Bottom at Site 1 Anchor Line 3, Looking West.

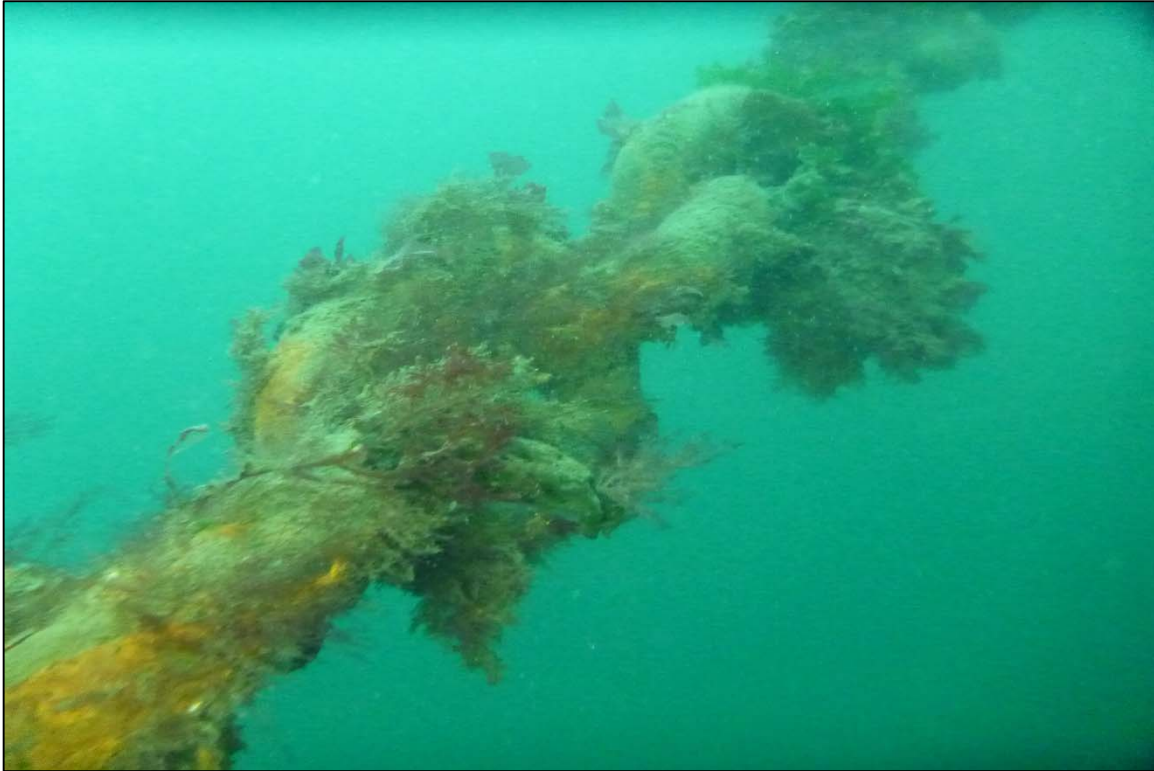
Photograph 22: View of Marine Growth and Light Corrosion on the Upper Anchor Chain at Site 1 Anchor Line 4, Looking Northeast.

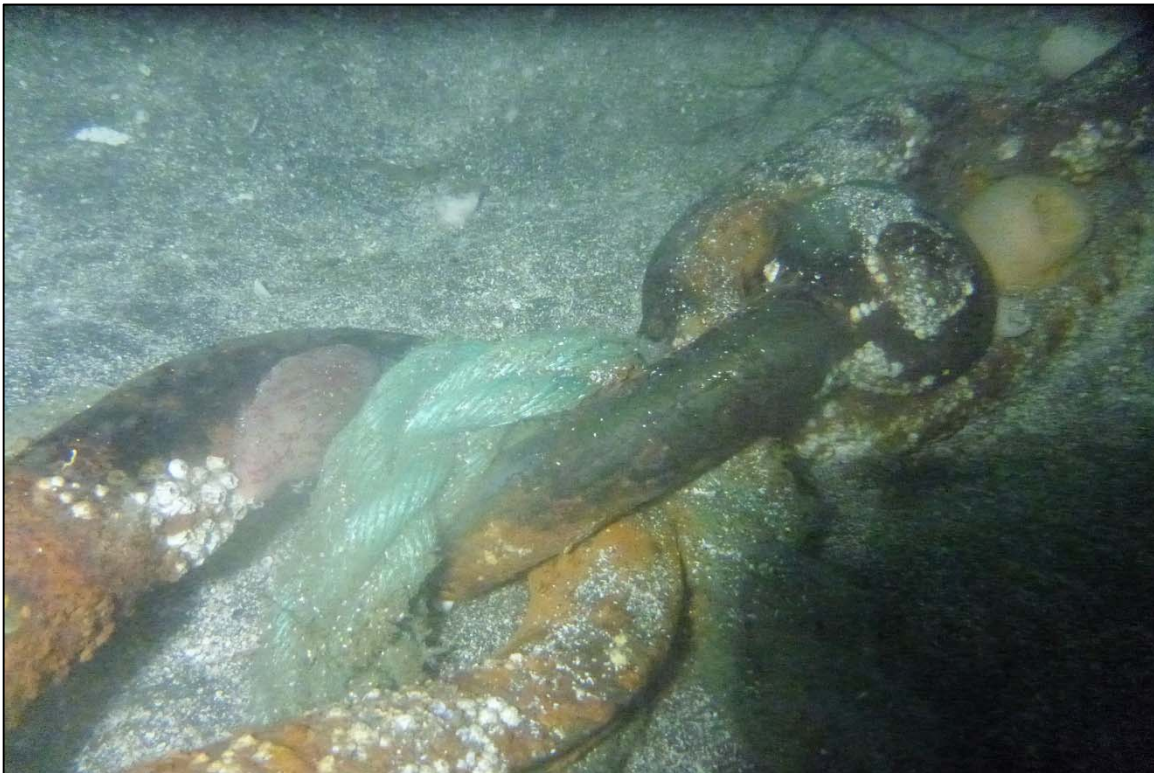
Photograph 35: View of Moderate Corrosion in the Buoy Chain at Site 1 Anchor Chain 8, Looking East.

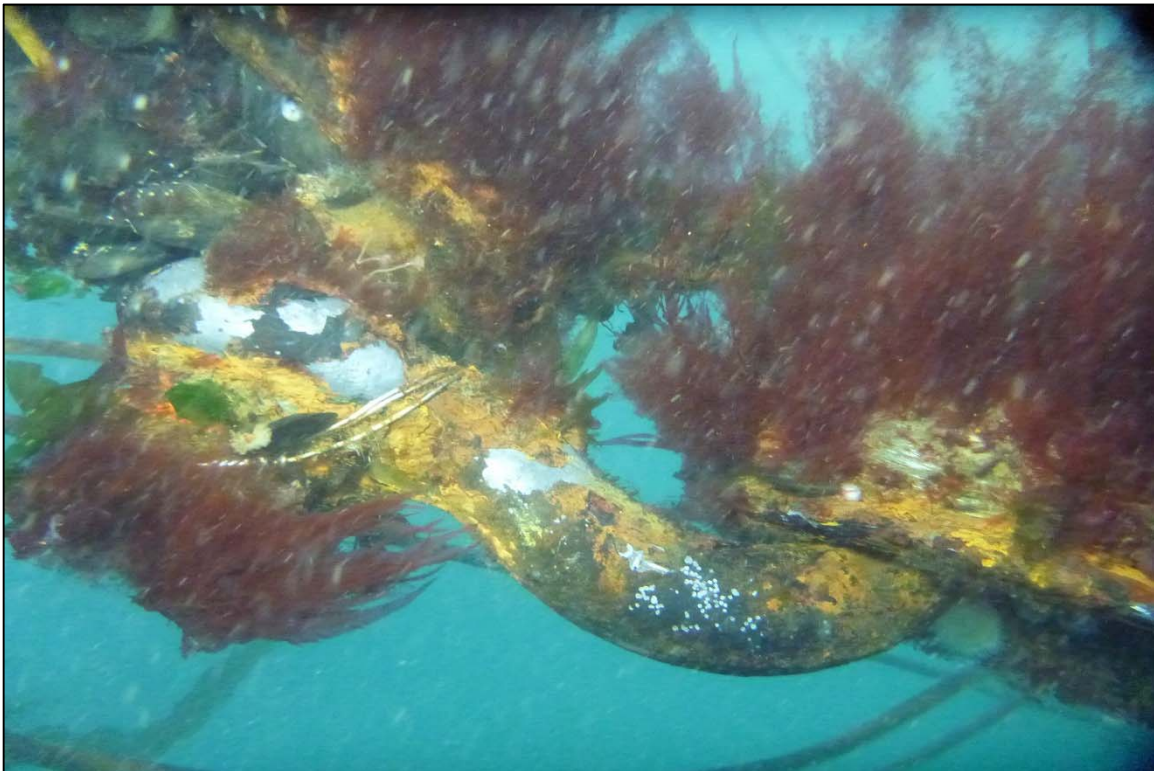
Photograph 43: View of the Lower Anchor Chain on the Channel Bottom at Site 1 Anchor Chain 10, Looking North.

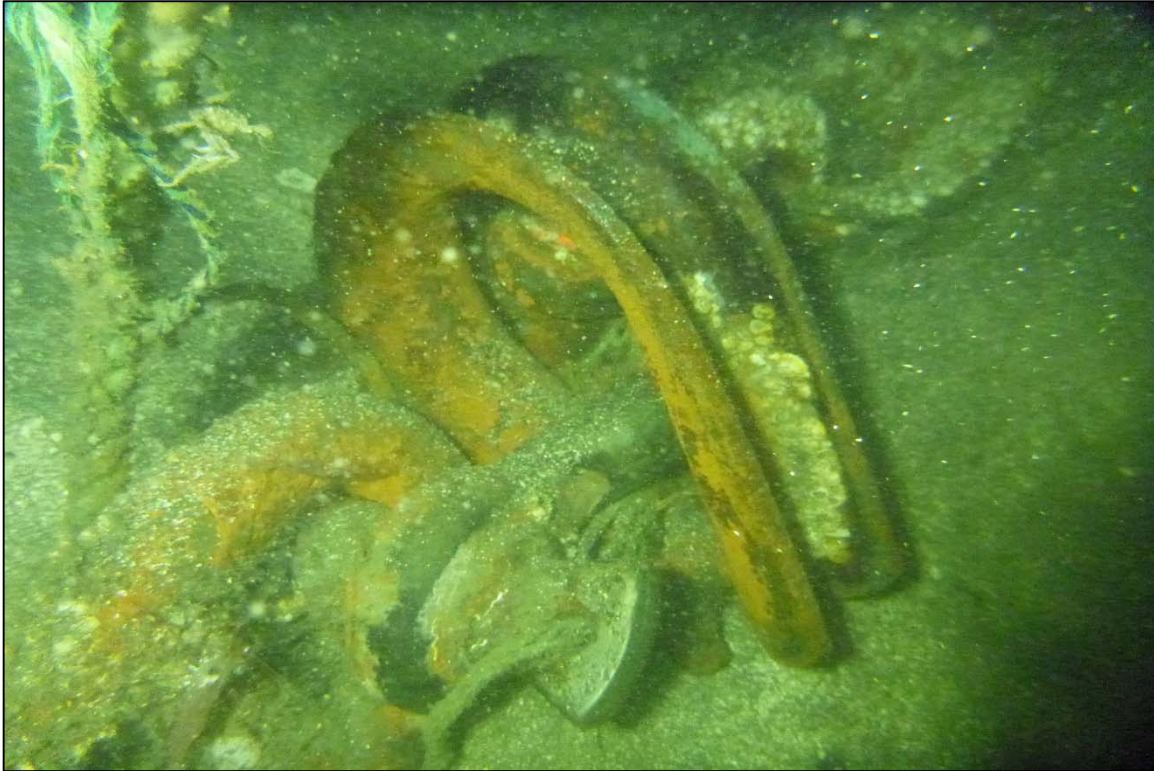
Photograph 44: View of Moderate Corrosion and Moderate Marine Growth on the Upper Anchor Chain to Rope Connection at Site 1 Anchor Line 11, Looking West.

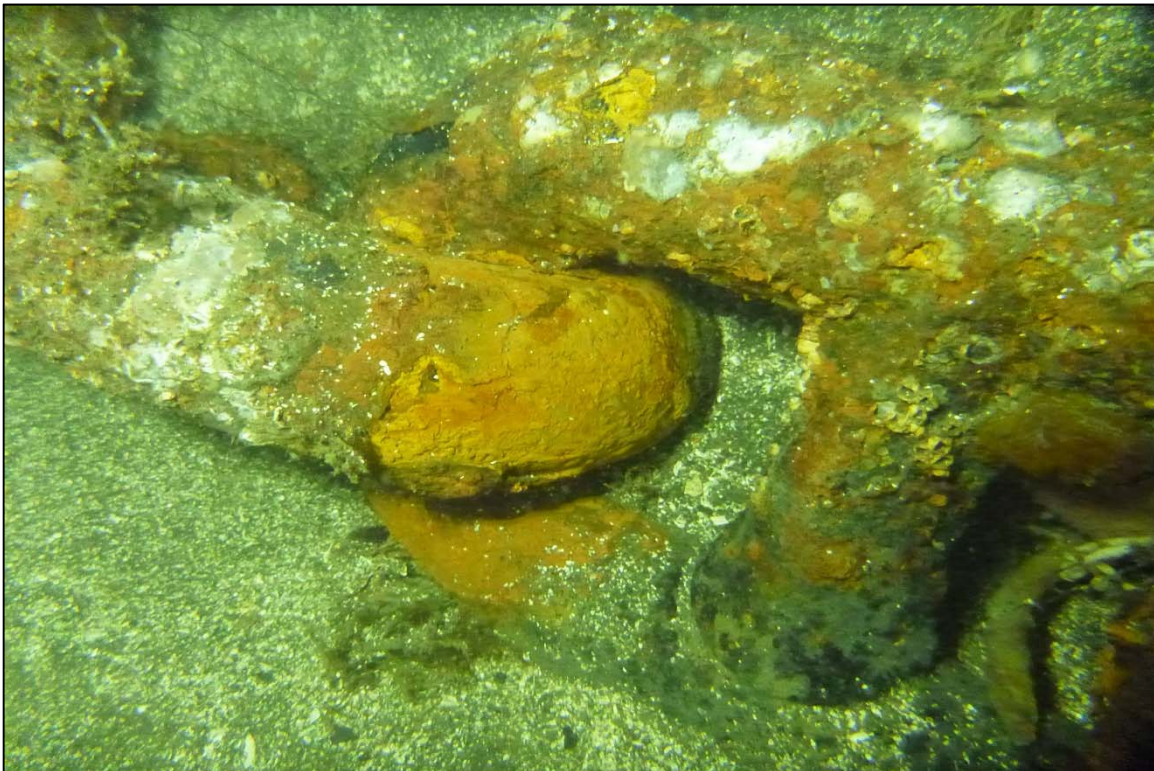
Photograph 45: View of the Loose Thimble at the Rope to Lower Anchor Chain Connection at Site 1 Anchor Chain 11, Looking Northwest.

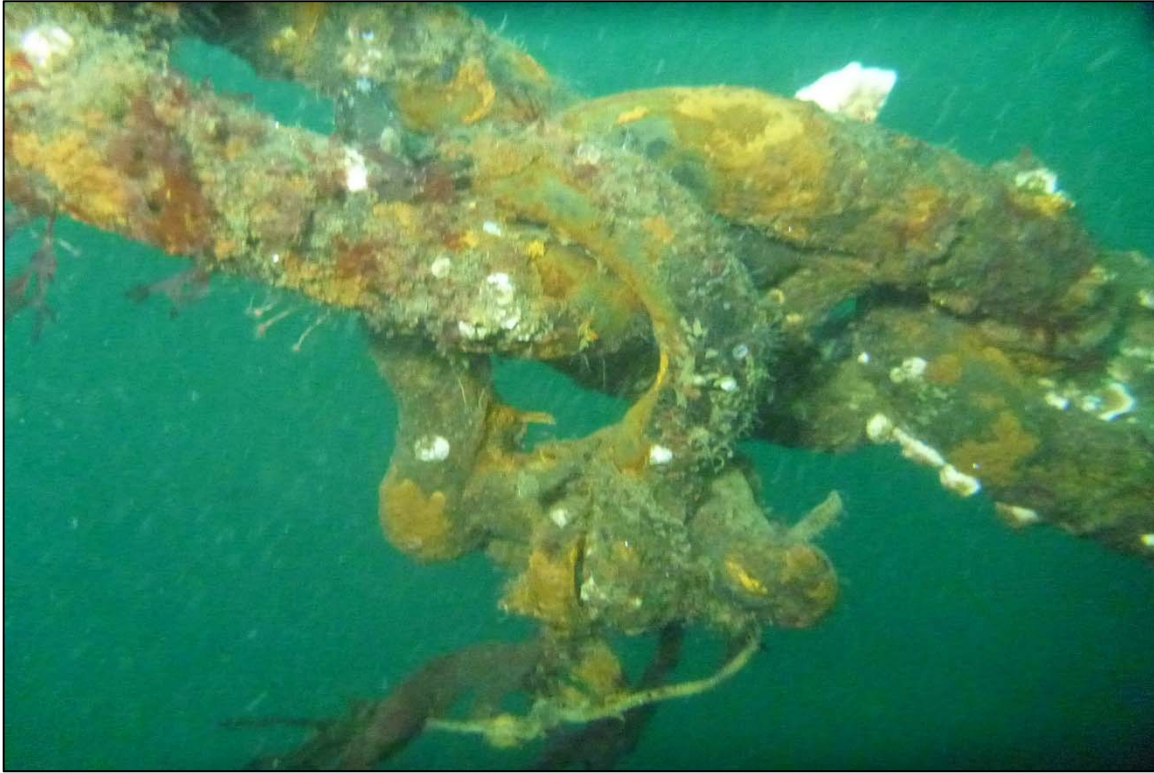
Photograph 46: View of Moderate Corrosion on the Lower Anchor Chain at Site 1 Anchor Line 11, Looking West.

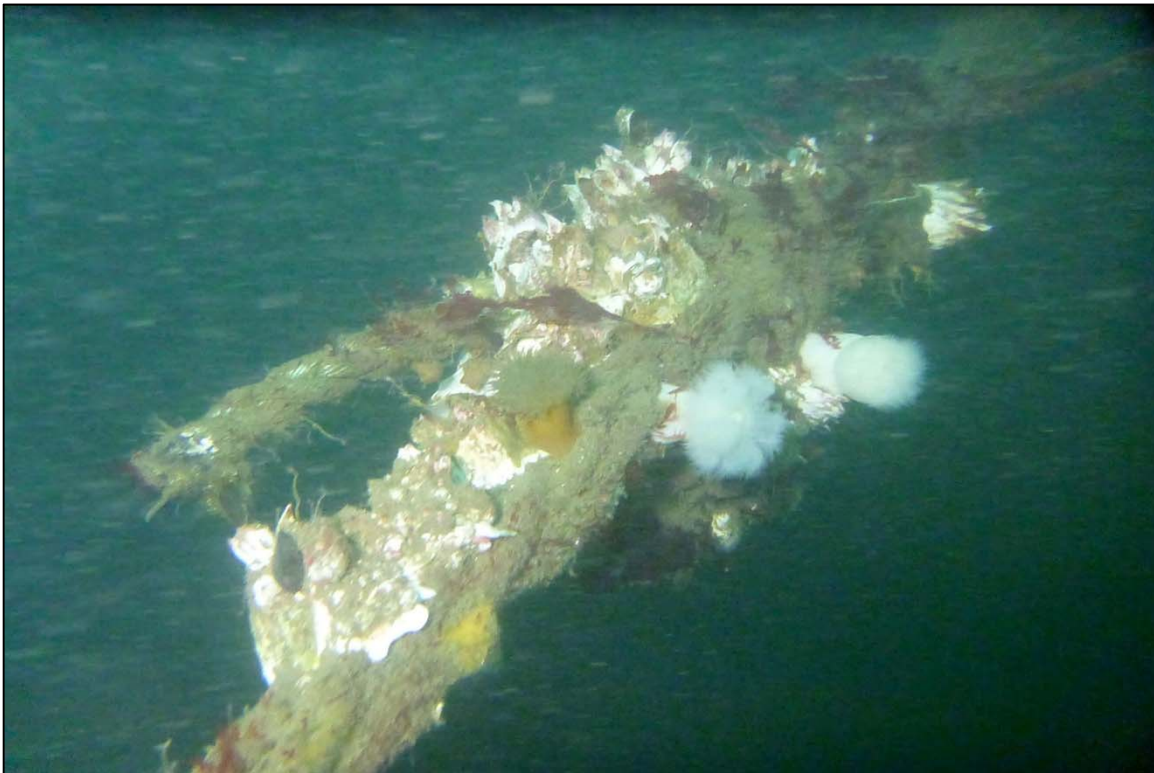
Photograph 47: View of Moderate Corrosion on the Upper Anchor Chain at Site 1 Anchor Chain 12, Looking North.

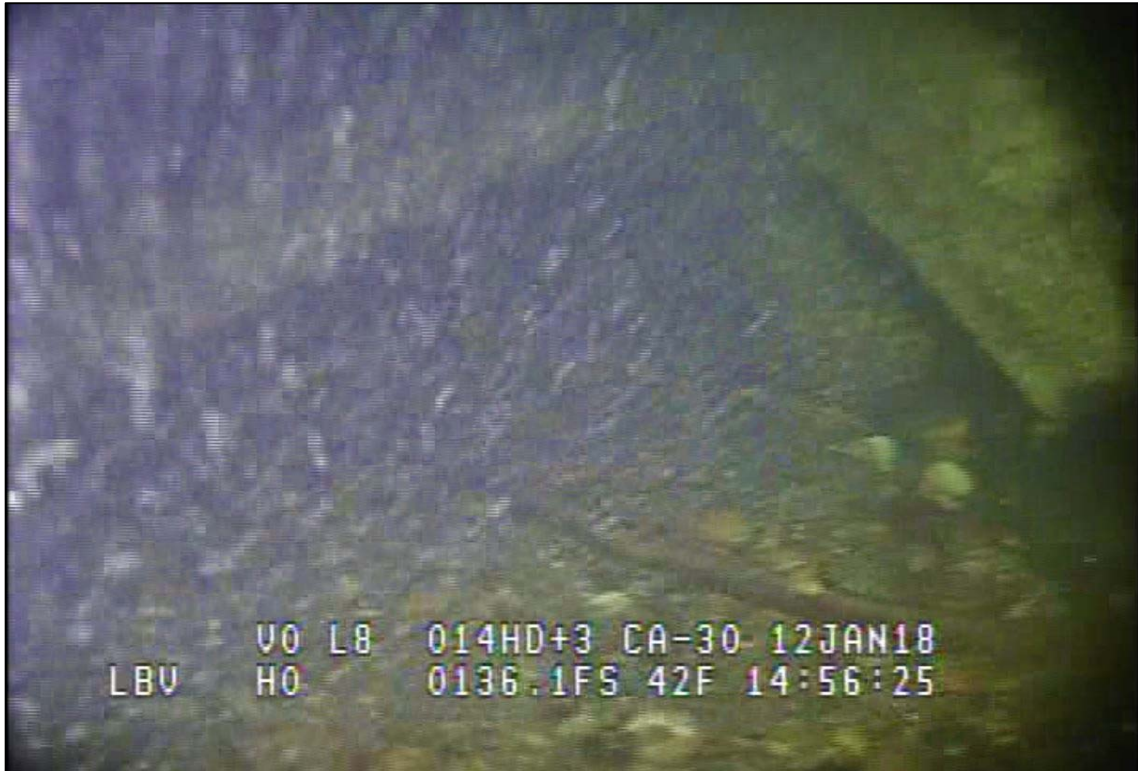
Photograph 50: View of Light Surface Corrosion Upper Anchor Chain at Site 1 Anchor Line 13, Looking Northwest.

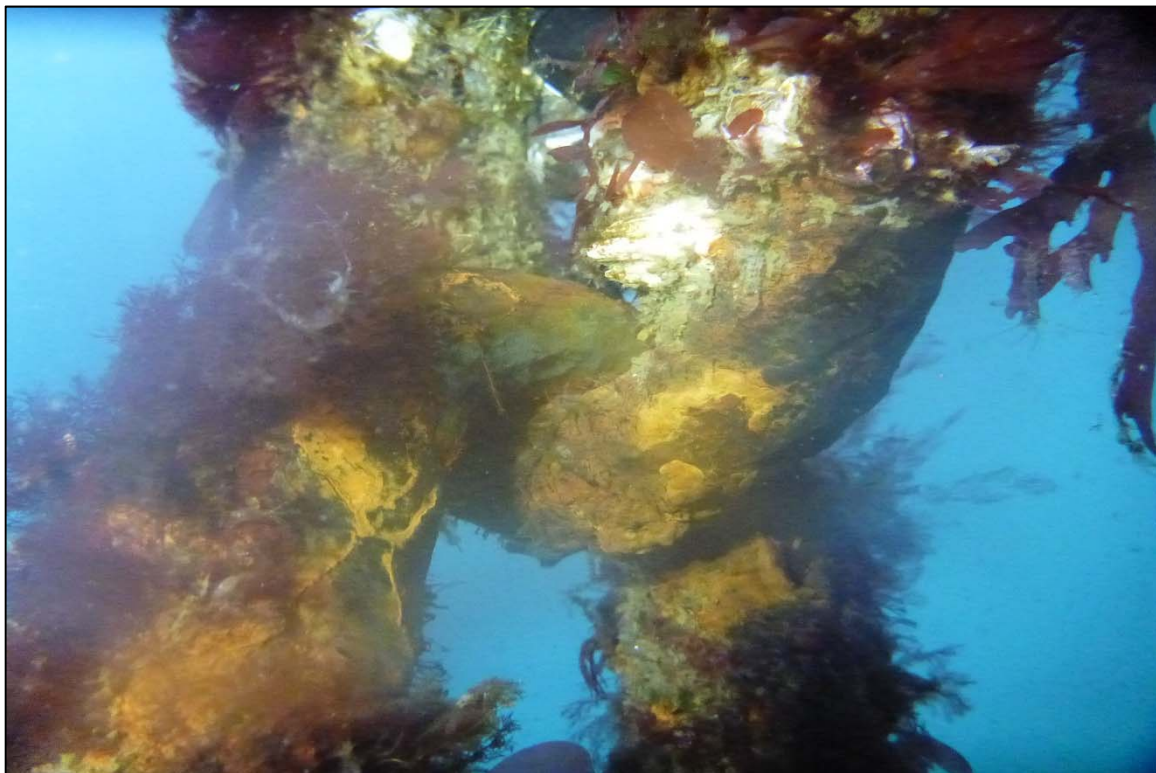
Photograph 51: View of the Exposed Anchor Resting on the Channel Bottom at Site 1 Anchor Line 13, Looking North.

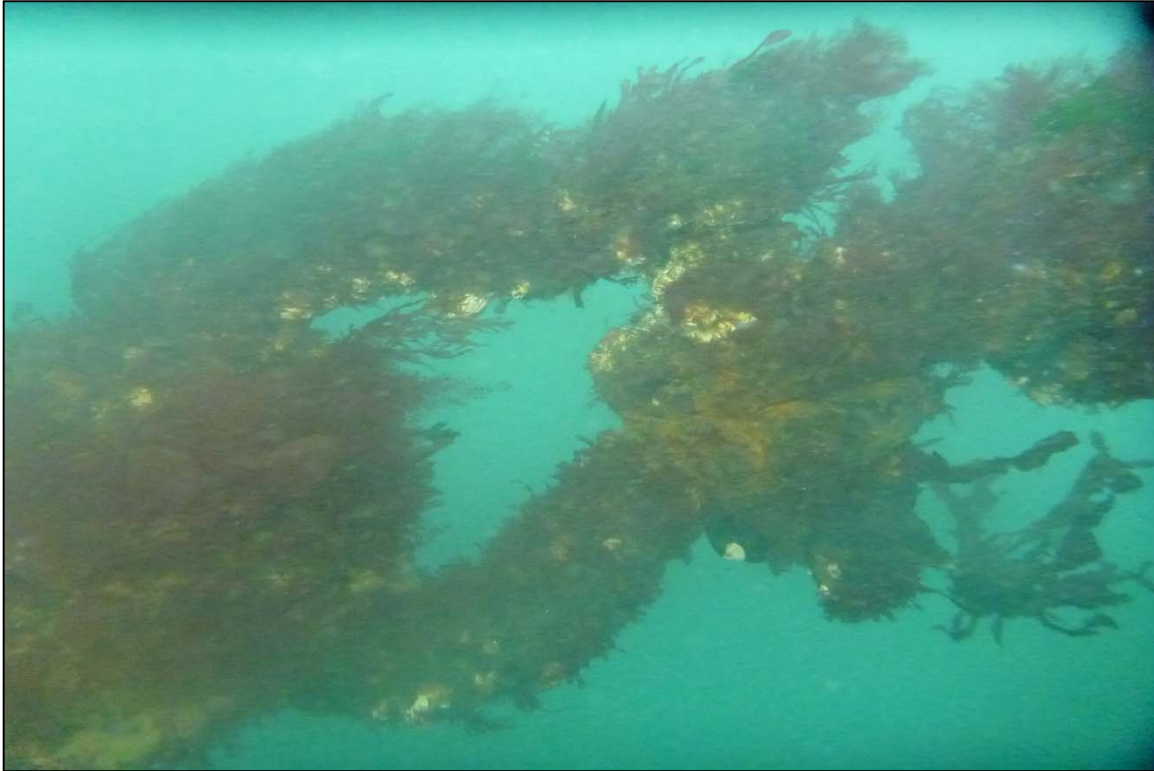
Photograph 52: View of the Moderate Surface Corrosion on the Upper Anchor Chain at Site 1 Anchor Chain 14, Looking Northwest.

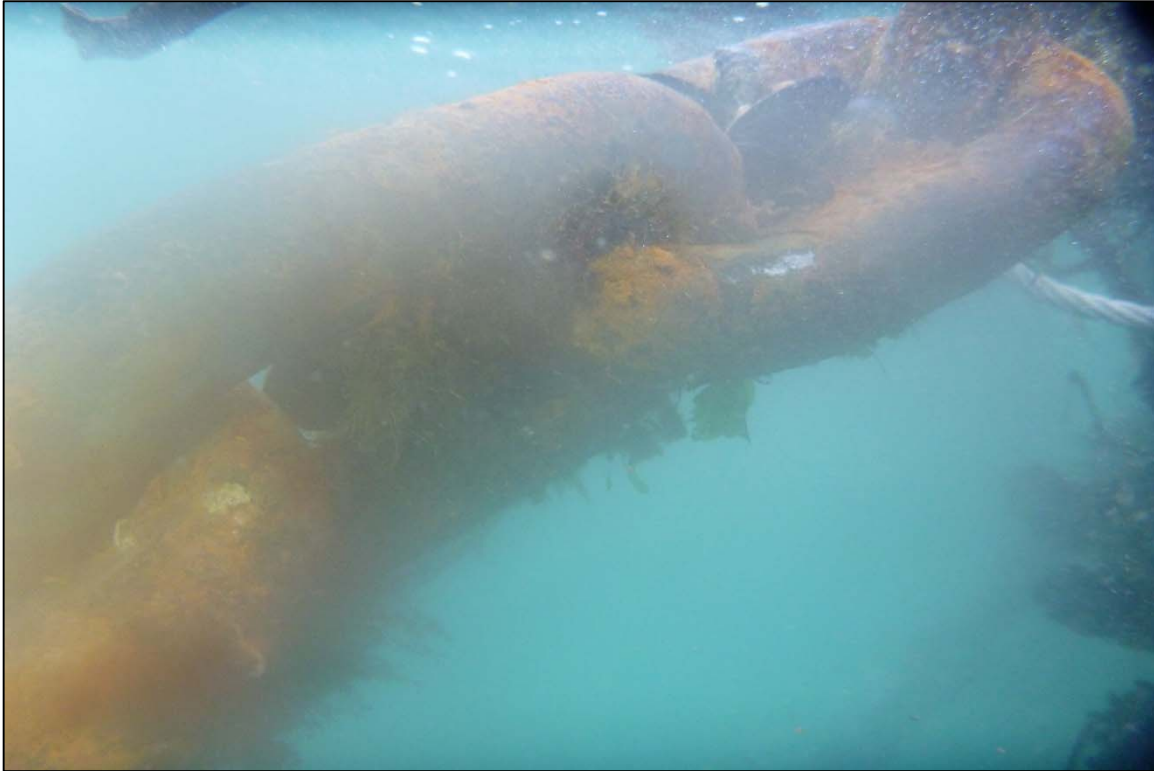
Photograph 54: View of the Light Surface Corrosion on the Upper Anchor Chain at Site 1 Anchor Chain 15, Looking North.

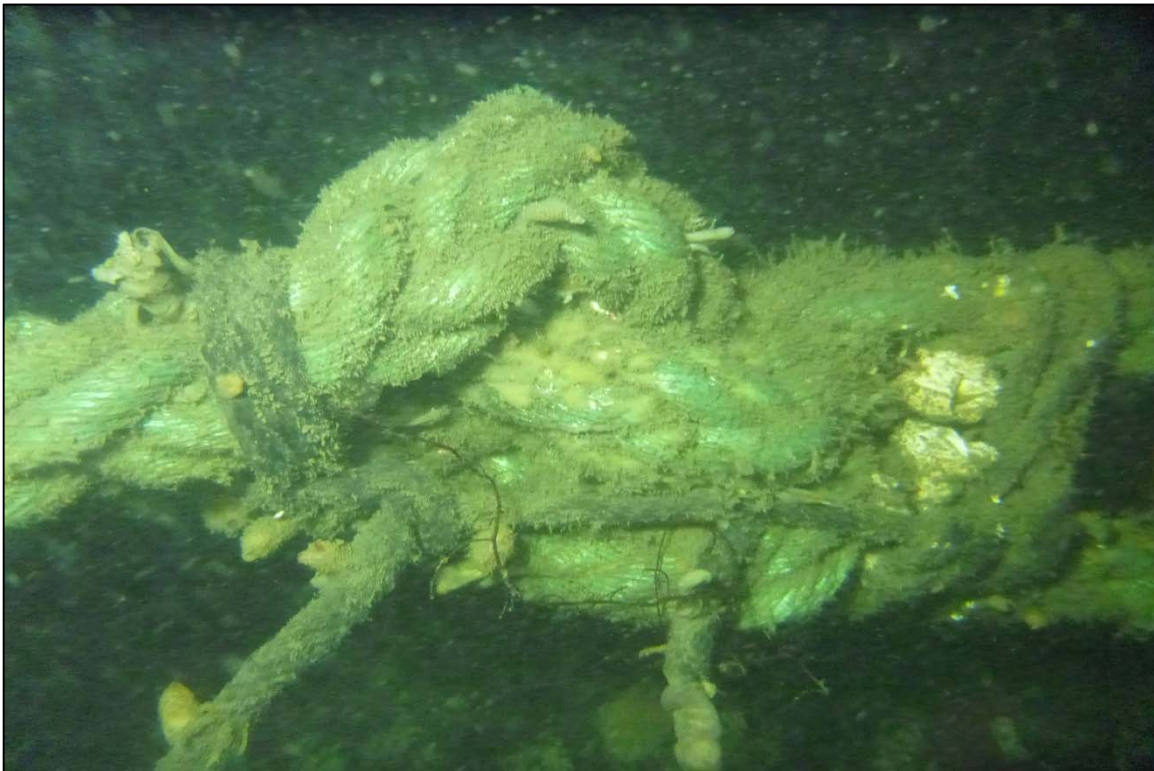
Photograph 57: View of the Severe Corrosion and Section Loss on the Buoy Chain at Site 1 Anchor Line 17, Looking North.

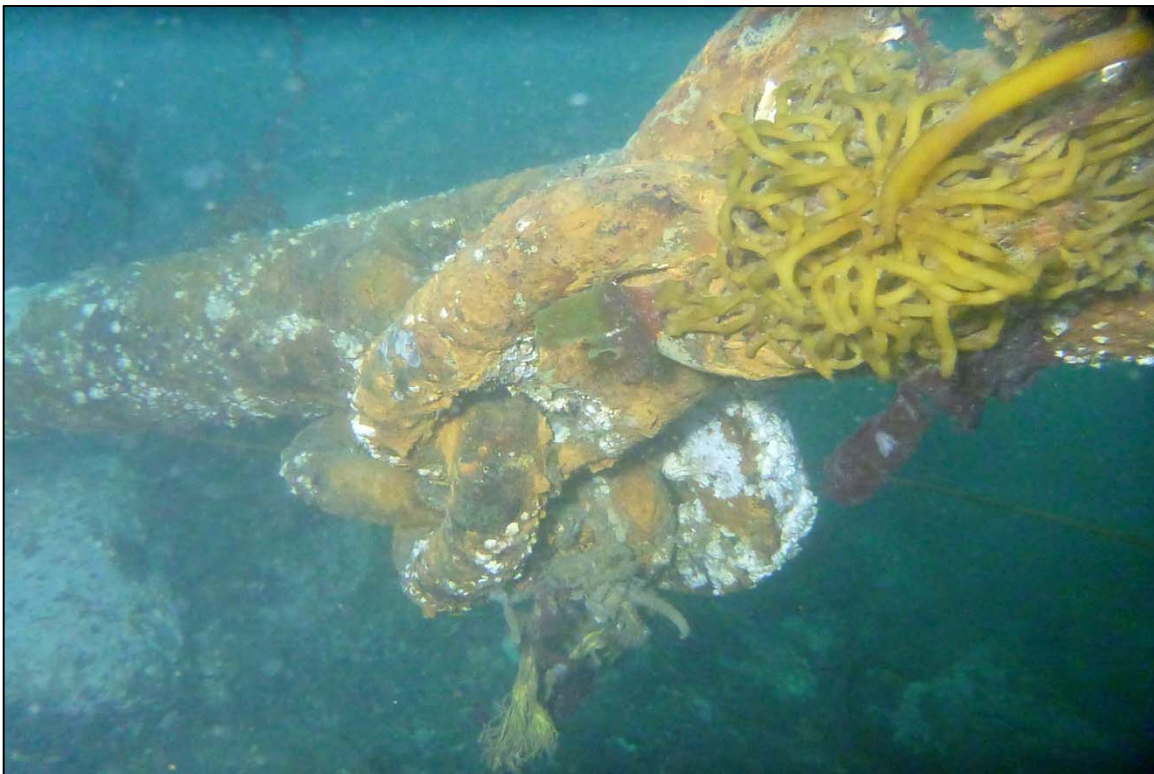
Photograph 63: View of Severe Corrosion on the Lower Anchor Chain at Site 1 Anchor Line 18, Looking Northeast.

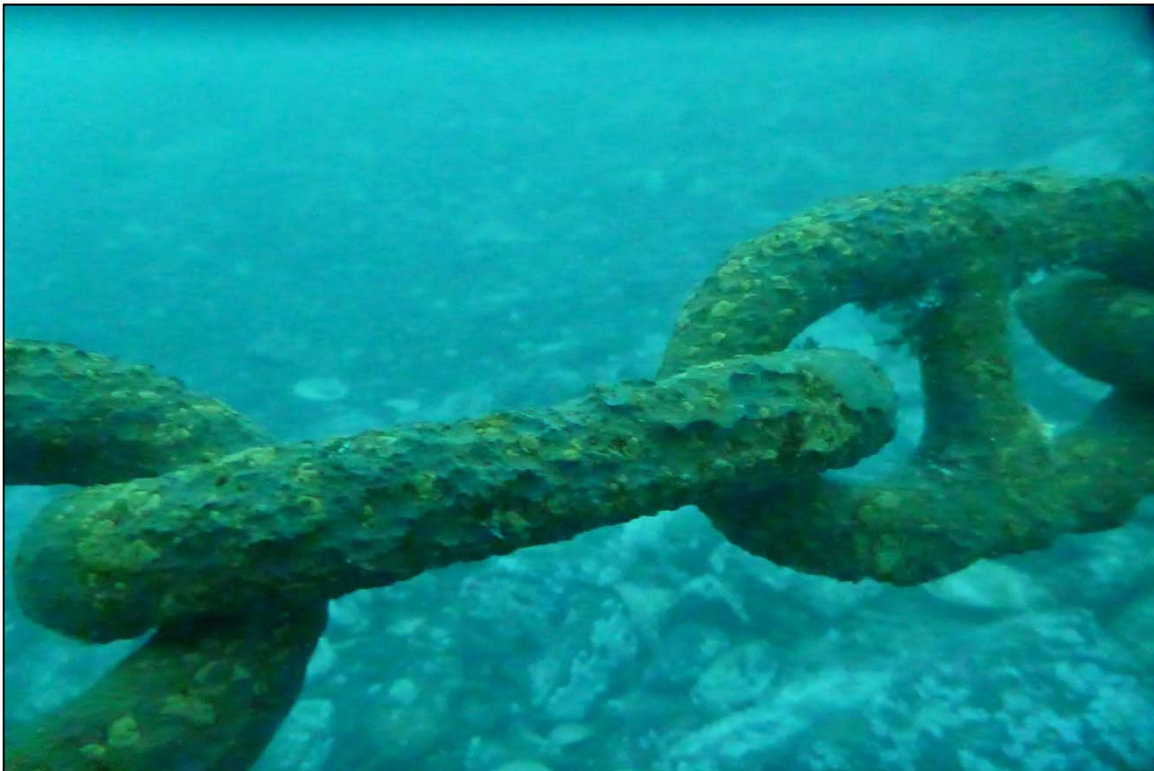
Photograph 69: View of the Failed Thimble at the Rope to Lower Anchor Chain Connection at Site 1 Anchor Line 20, Looking East.

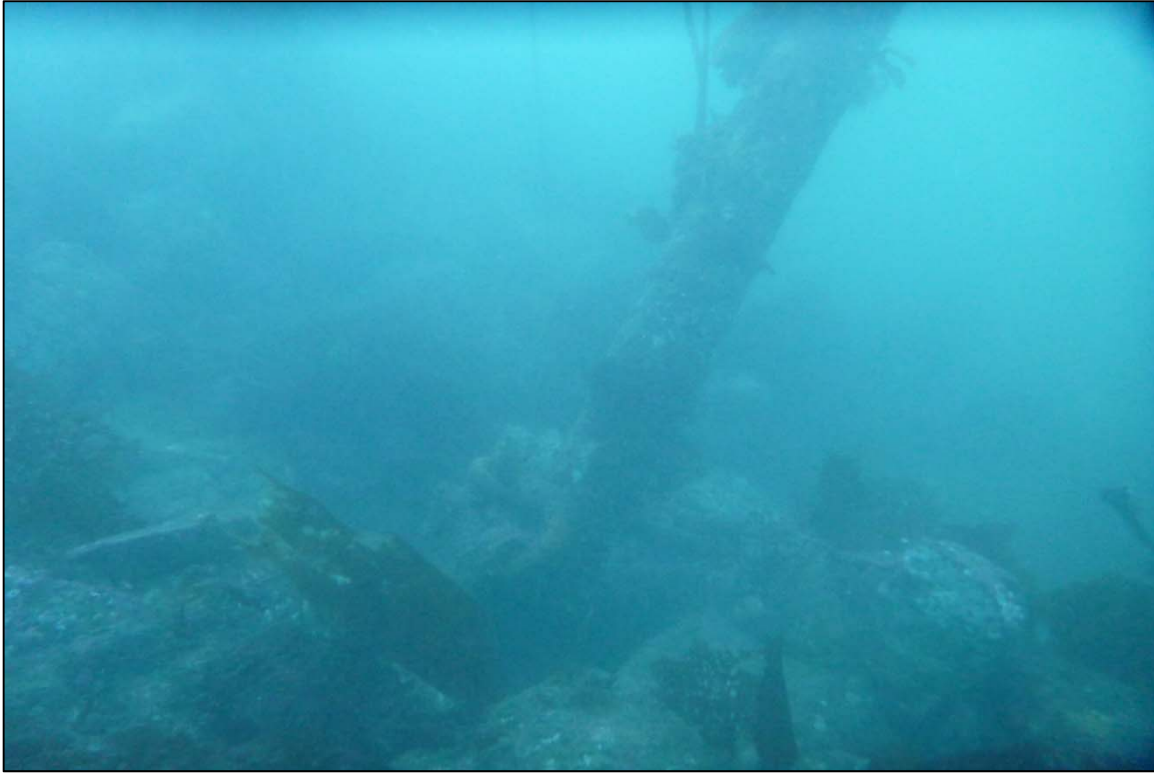
Photograph 70: View of Section Loss in the Lower Anchor Chain at Site 1 Anchor Chain 20, Looking East.

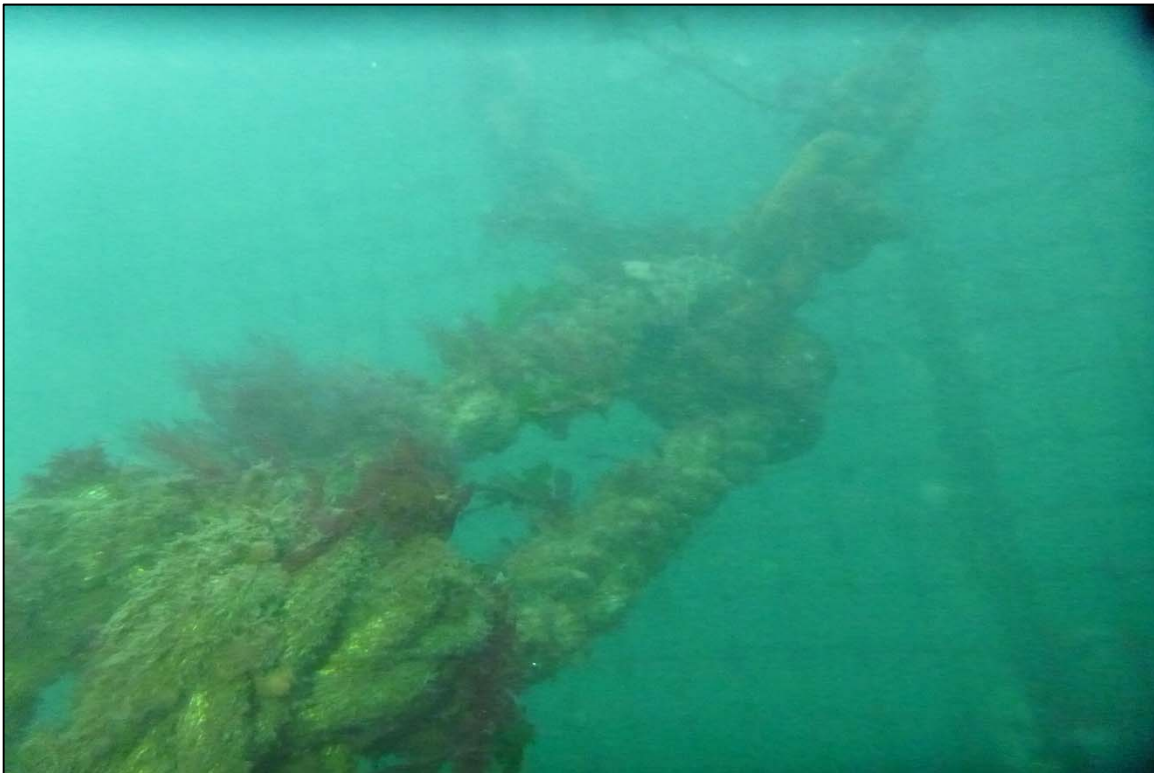
Photograph 71: View of the Tilt in the Pipe Anchor at Site 1 Anchor Line 20, Looking West.

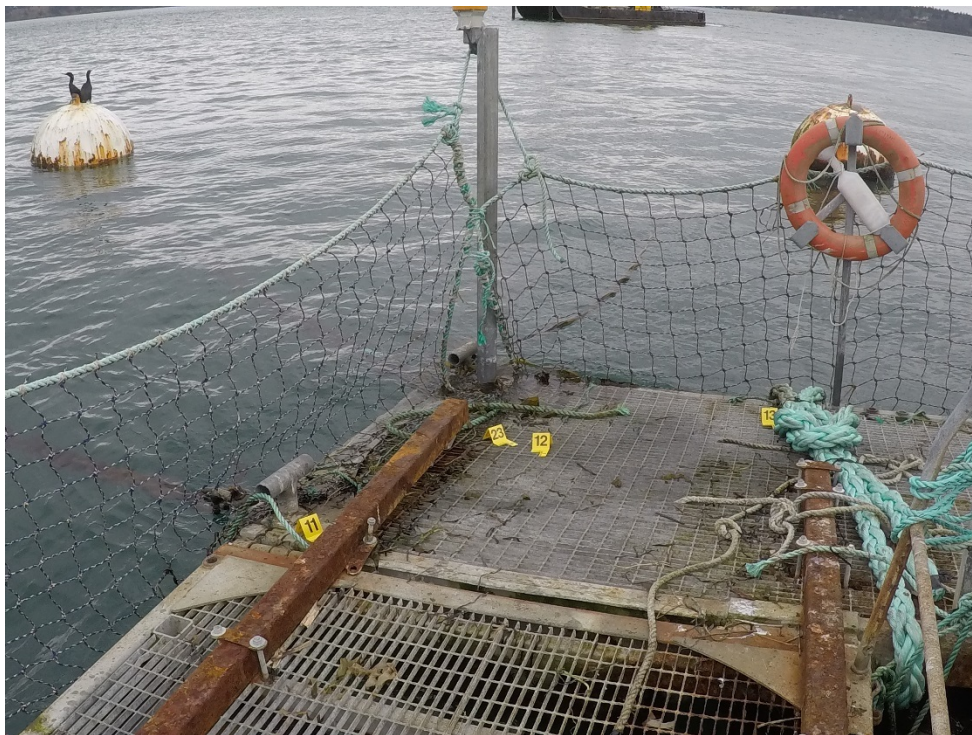
Figure C-12: Cypress Island Net Pen Site 1 – Northeast corner showing Anchor Lines 11, 12, 13, and 23 and inadequate flotation

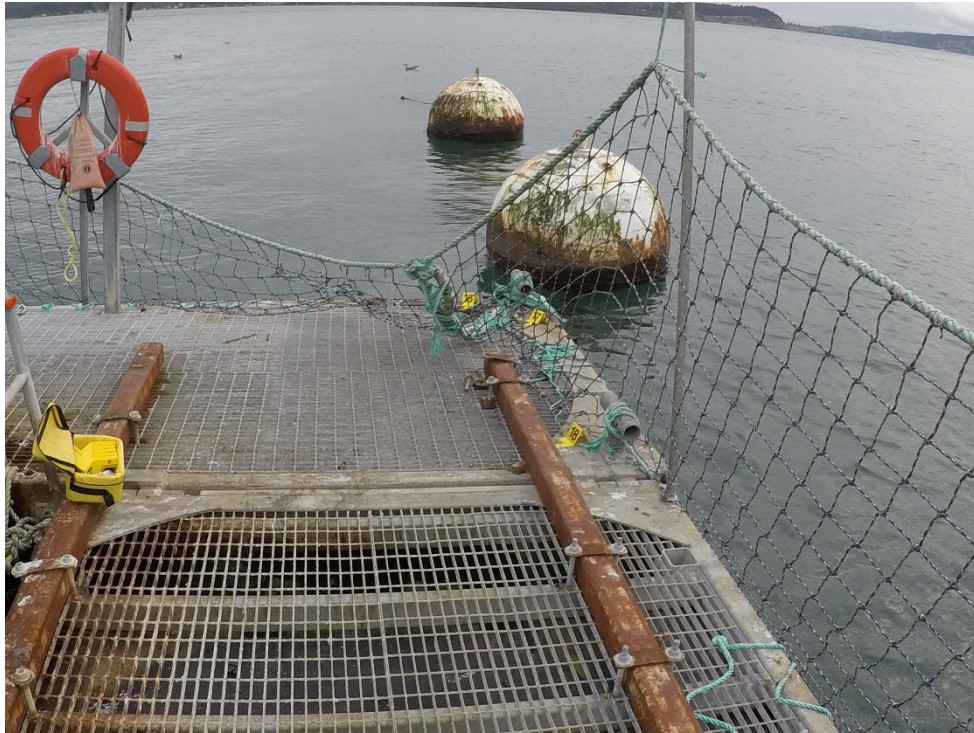
Figure C-15: Cypress Island Net Pen Site 1 – Southeast corner showing Anchor Lines 16, 17, and 18 and inadequate flotation

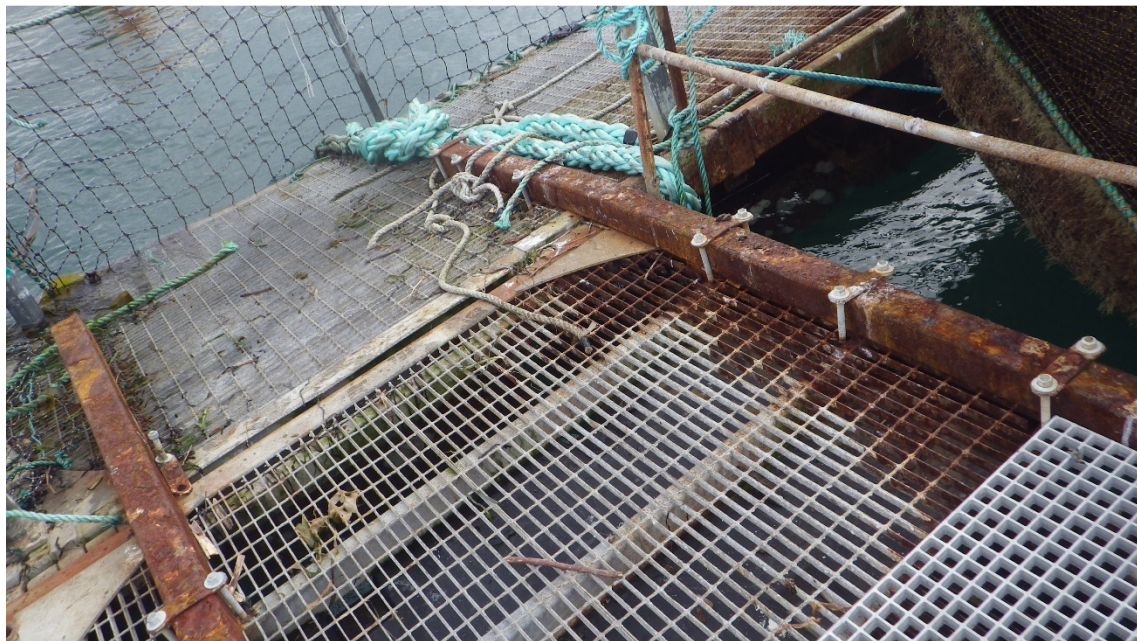
Figure C-21: Cypress Island Net Pen Site 1 – Repair with HSS on northeast corner

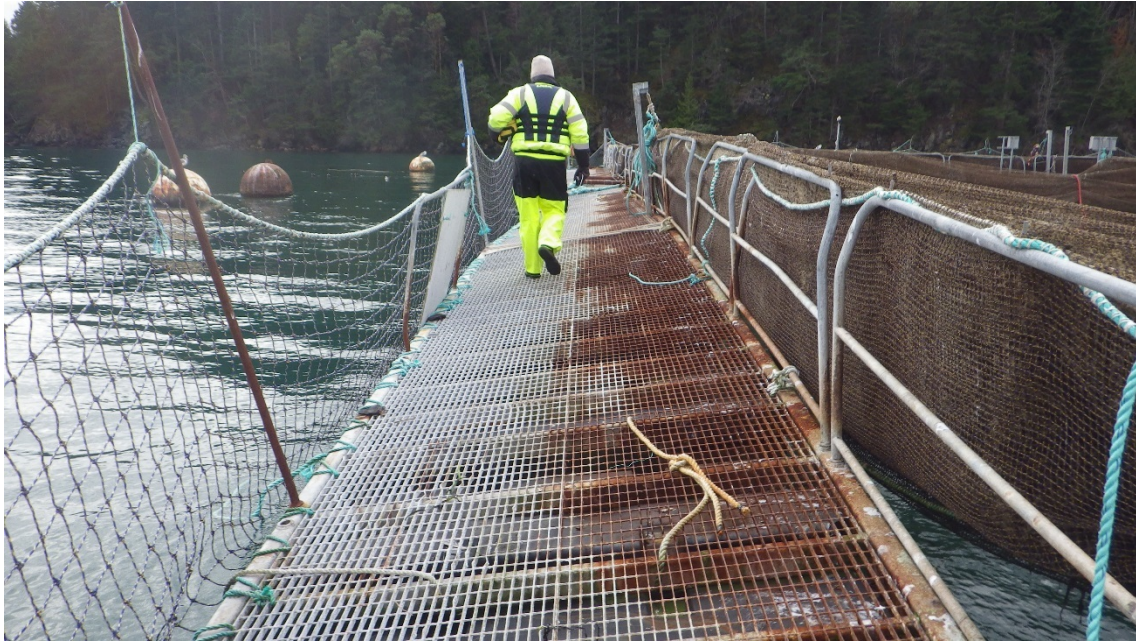
Figure C-22: Cypress Island Net Pen Site 1 – Severe listing of floats along east walkway

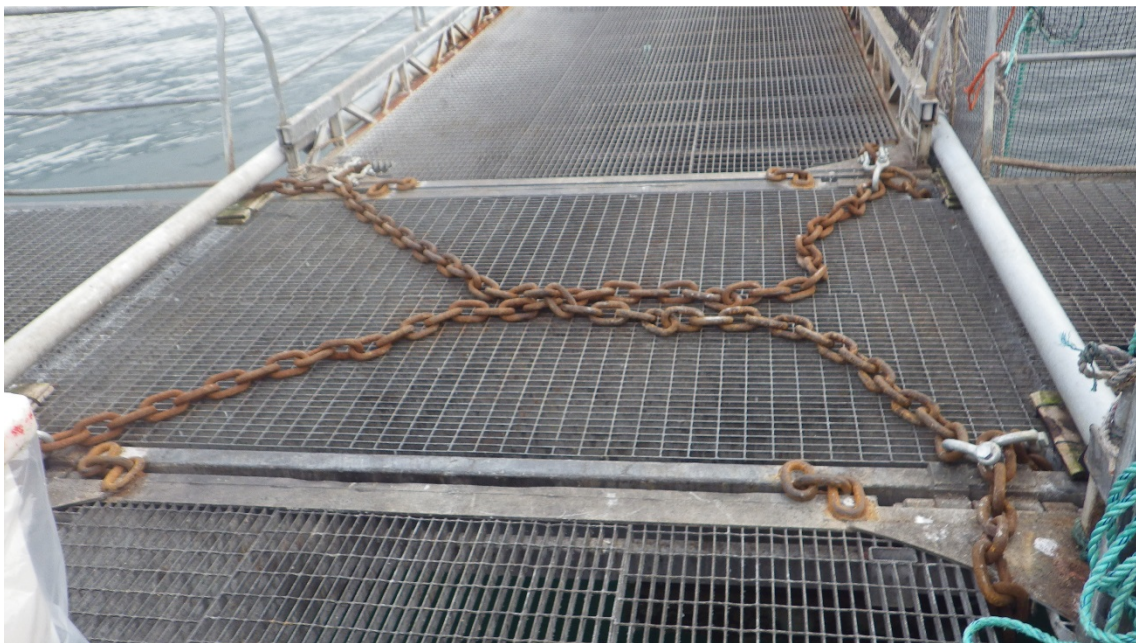
Figure C-23: Cypress Island Net Pen Site 1 – X-pattern chain repair to connect floats

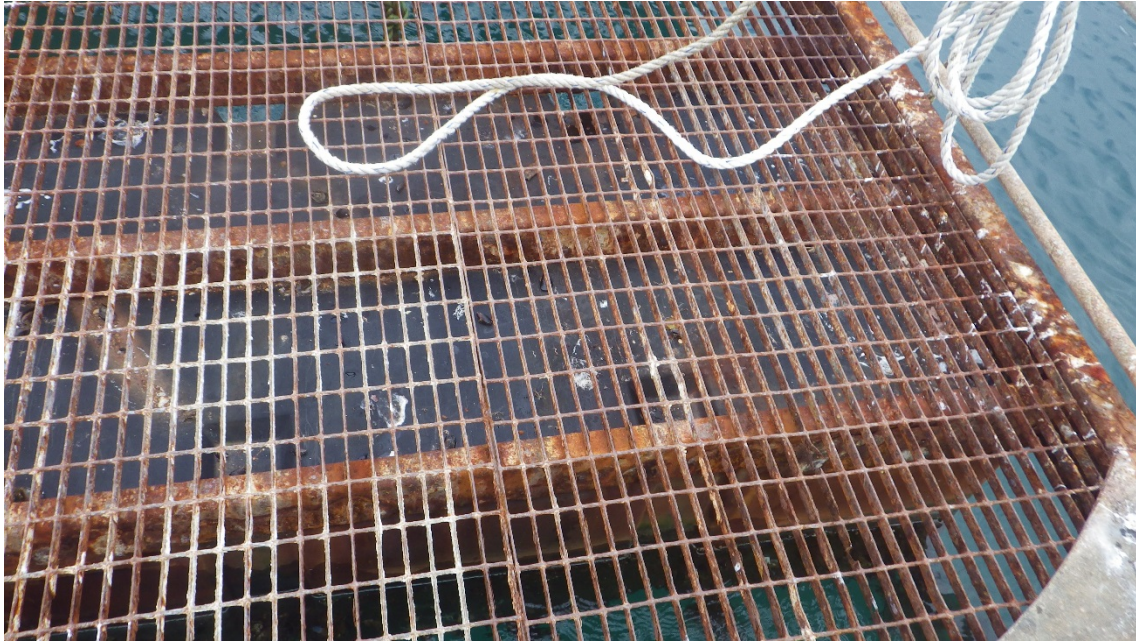
Figure C-24: Cypress Island Net Pen Site 1 – Severe corrosion in grating and framing members

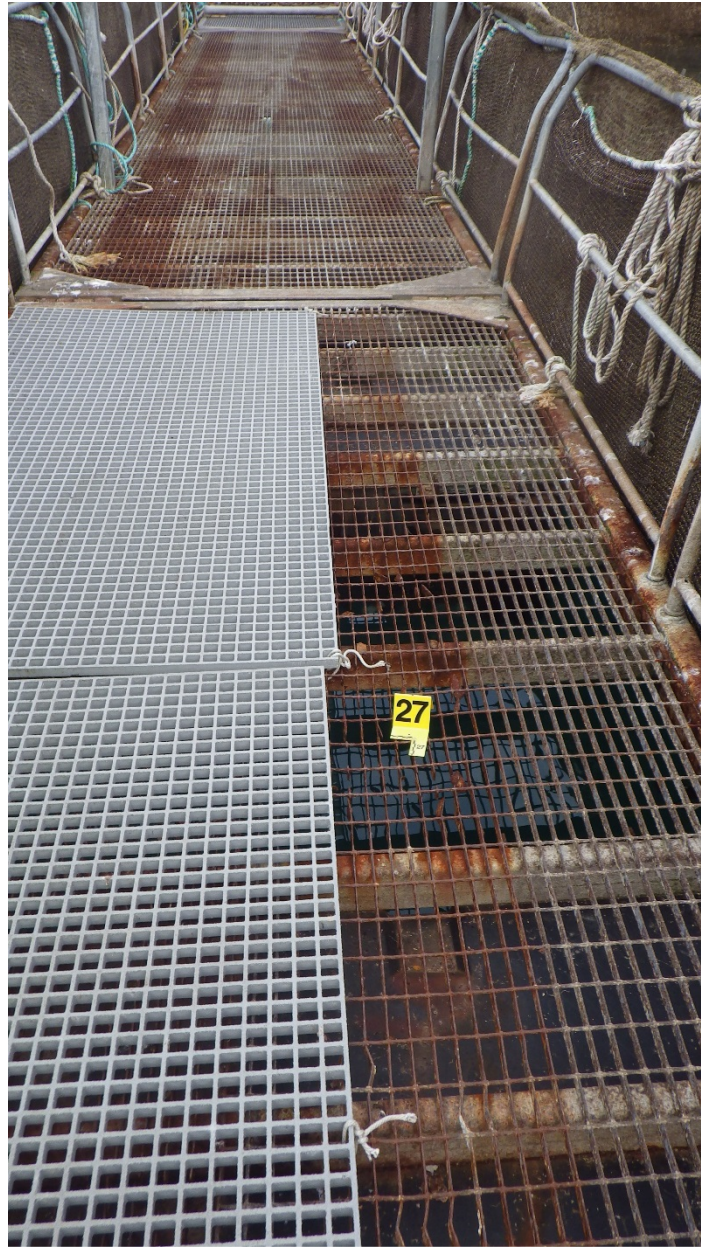
Figure C-25: Cypress Island Net Pen Site 1 – Fiberglass grating overlaid on walkway
