# **Cypress Island Site 1 Atlantic Salmon Net Pens Engineering Assessment**

January 29, 2018

**Document reference:** 391980 | 6 | b

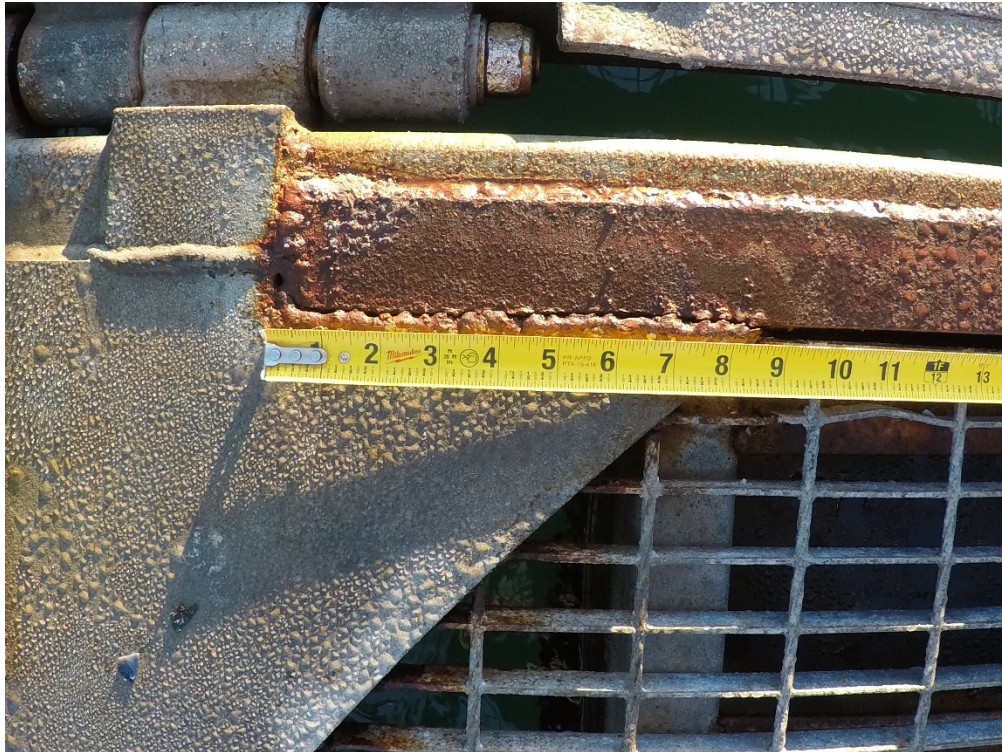
Figure C-26: Cypress Island Net Pen Site 1 – Crack in welded connection
