Cypress Island Site 3 Atlantic Salmon Net Pens Engineering Assessment

January 29, 2018

State of Washington
Department of Natural
Resources
1111 Washington Street SE
Olympia Washington 98504

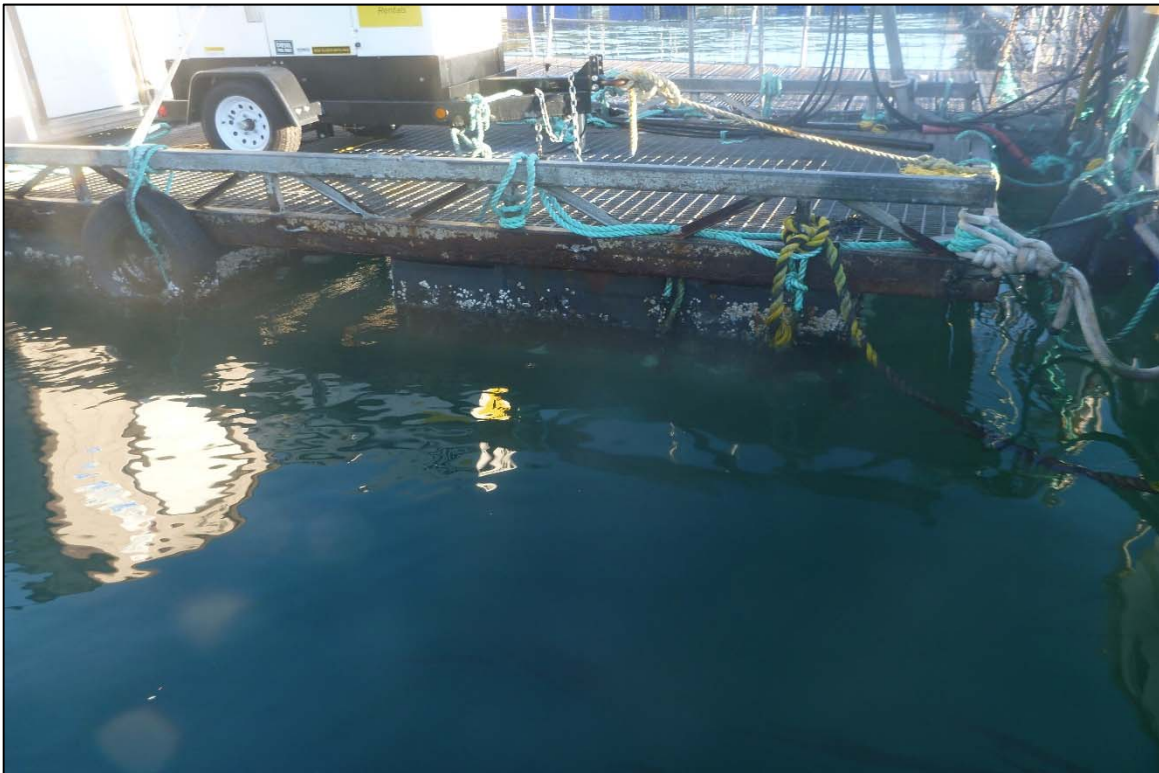
Photograph 7: View of the Float Condition at Site 3 Fish Net Pens System, Looking Northwest.

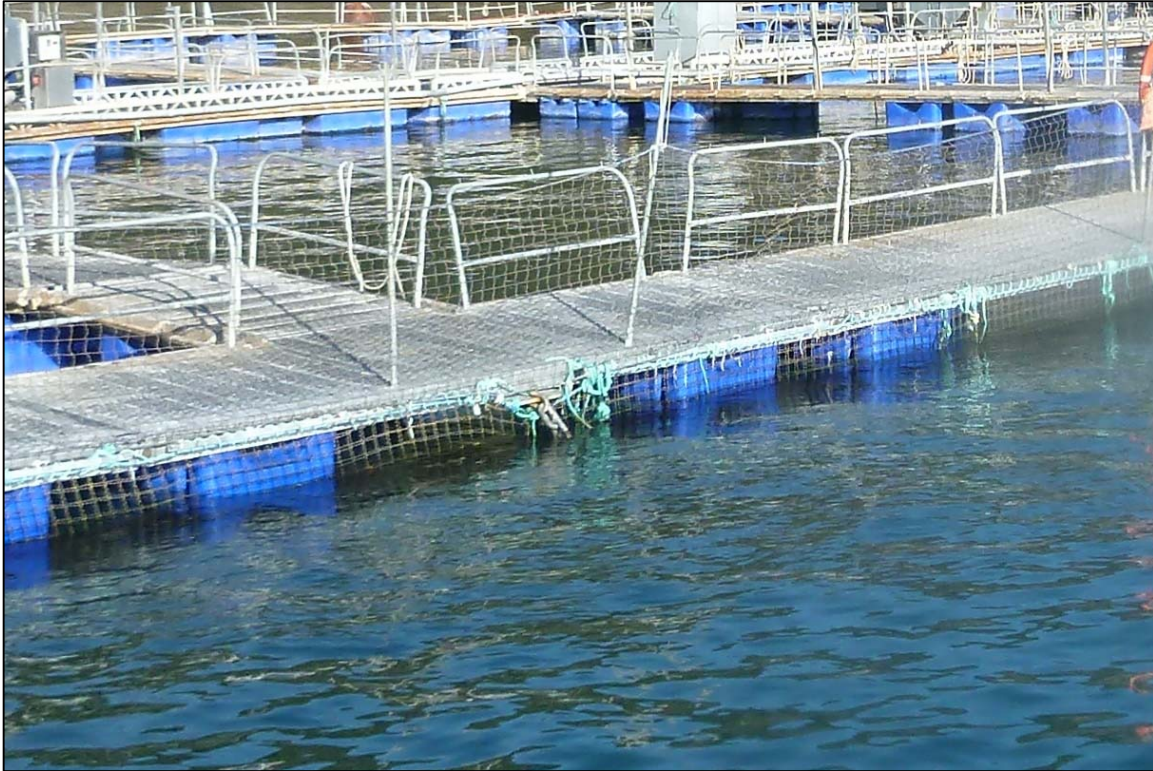
Photograph 8: View of the Float Condition at Site 3 Fish Net Pens System, Looking Northeast.

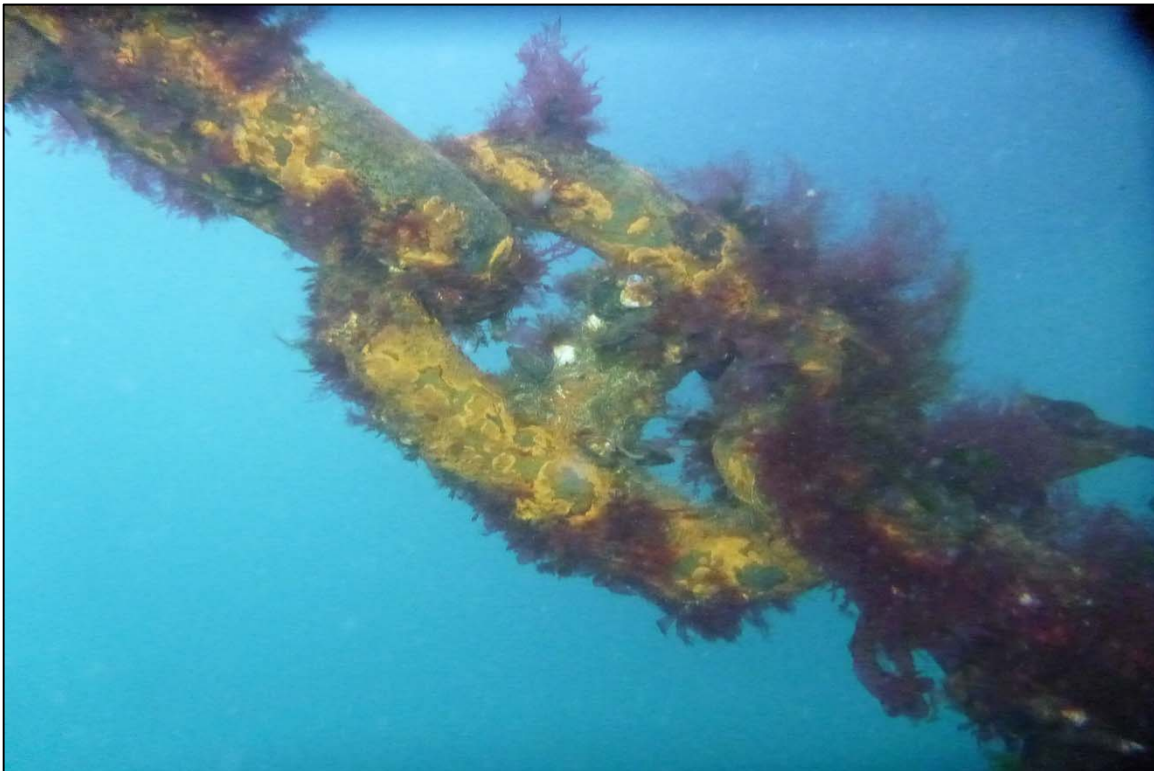
Photograph 11: View of Upper Anchor Chain to Float Connection at Site 3 Anchor Line 21, Looking Southwest.

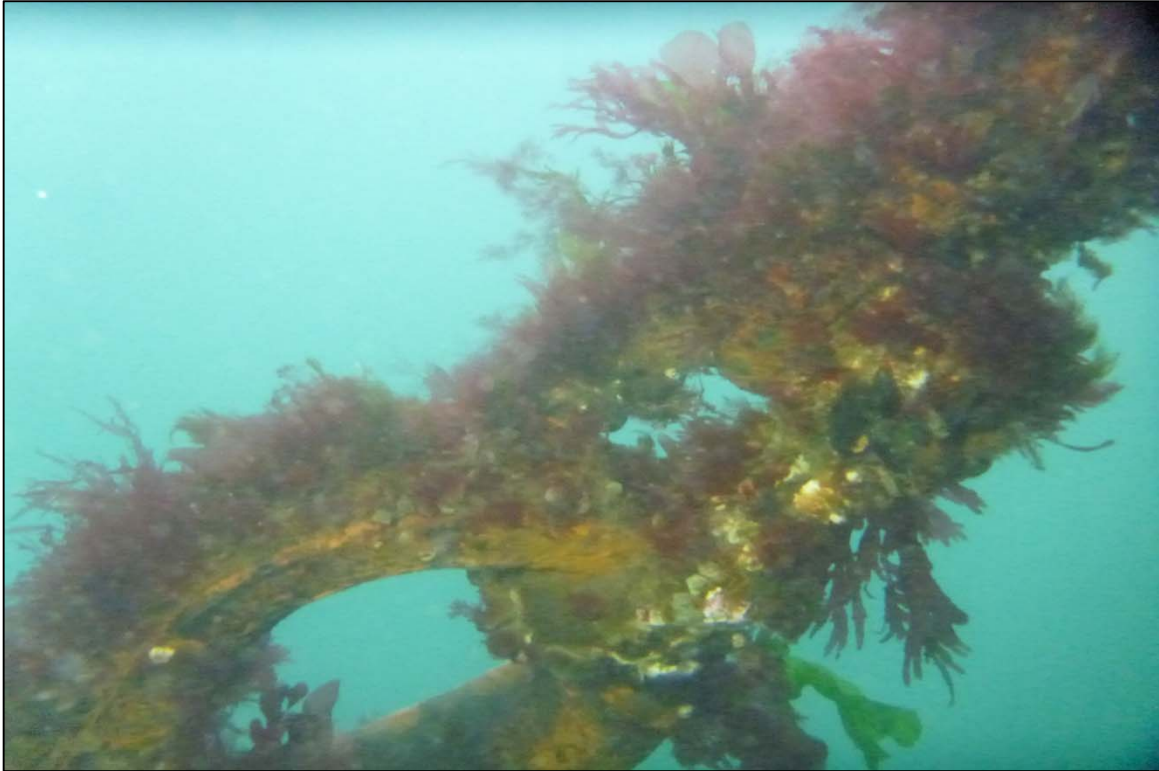
Photograph 12: View of Upper Anchor Chain Corrosion at Site 3 Anchor Line 1, Looking Northwest.

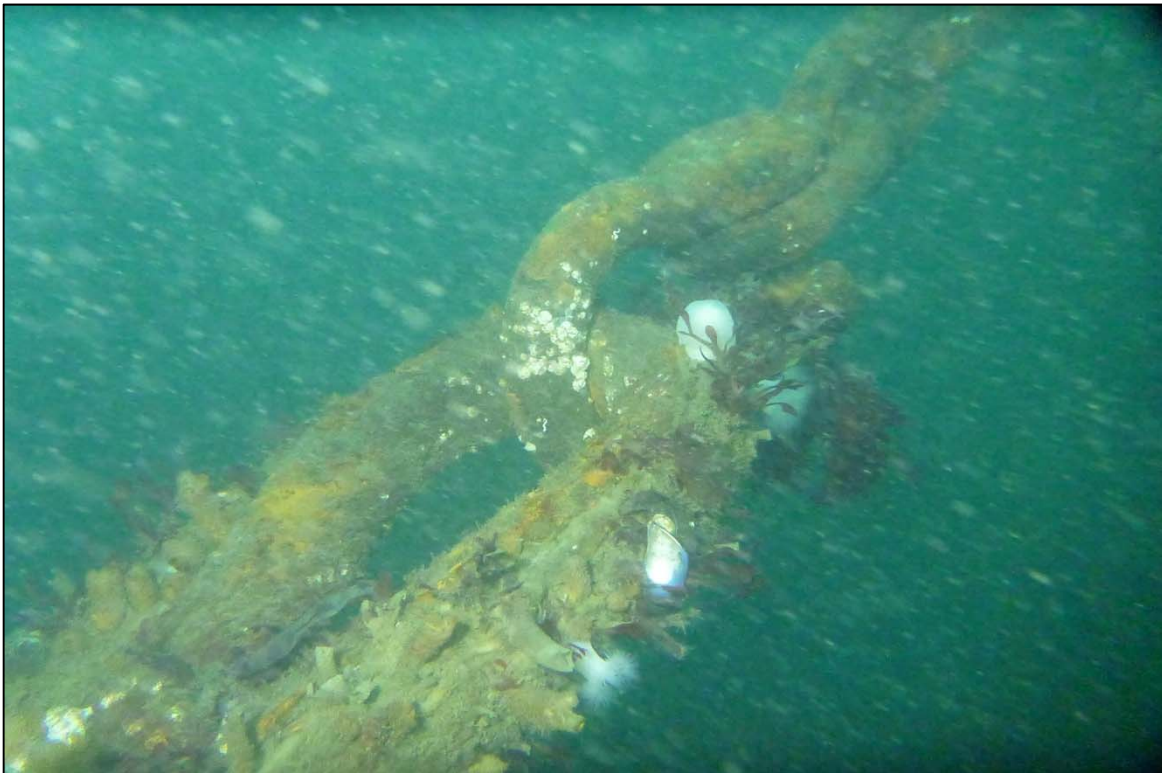
Photograph 15: View of Submerged Steel Buoy at Site 3 Anchor Line 2, Looking Northwest.

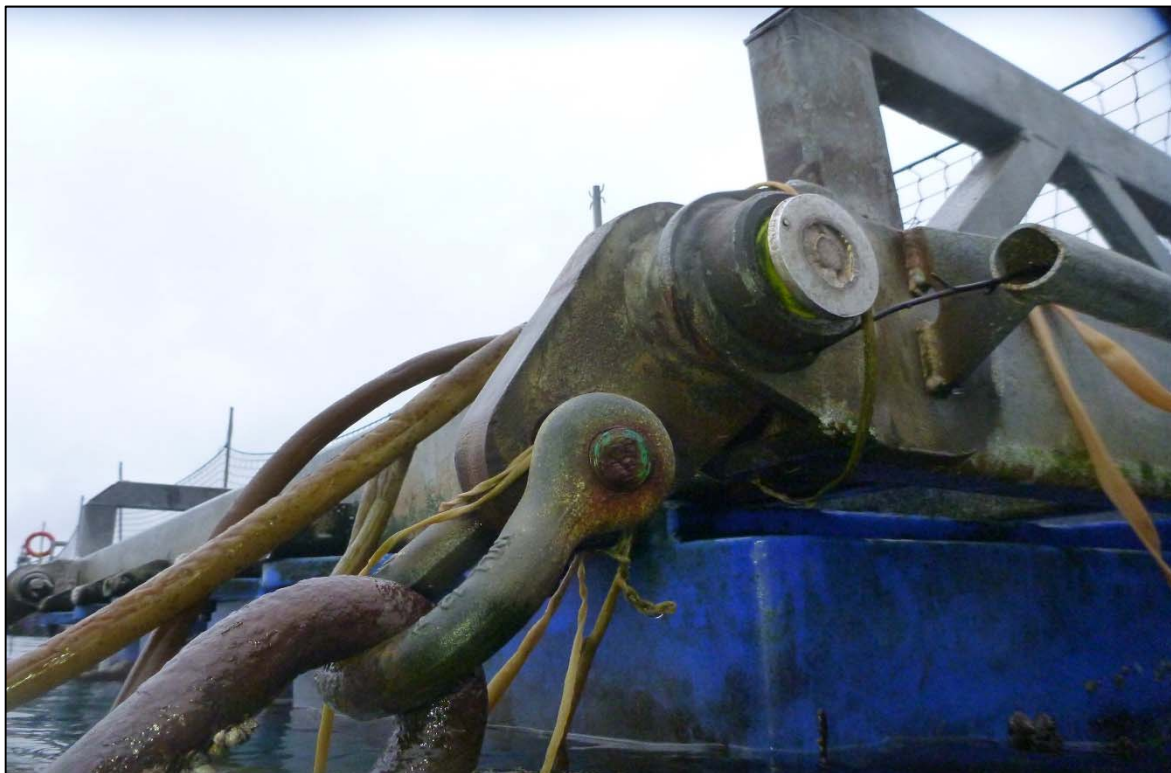
Photograph 17: View of Lower Anchor Chain to Anchor Stem Connection (Shackle) at Site 3 Anchor Line 2, Looking North.

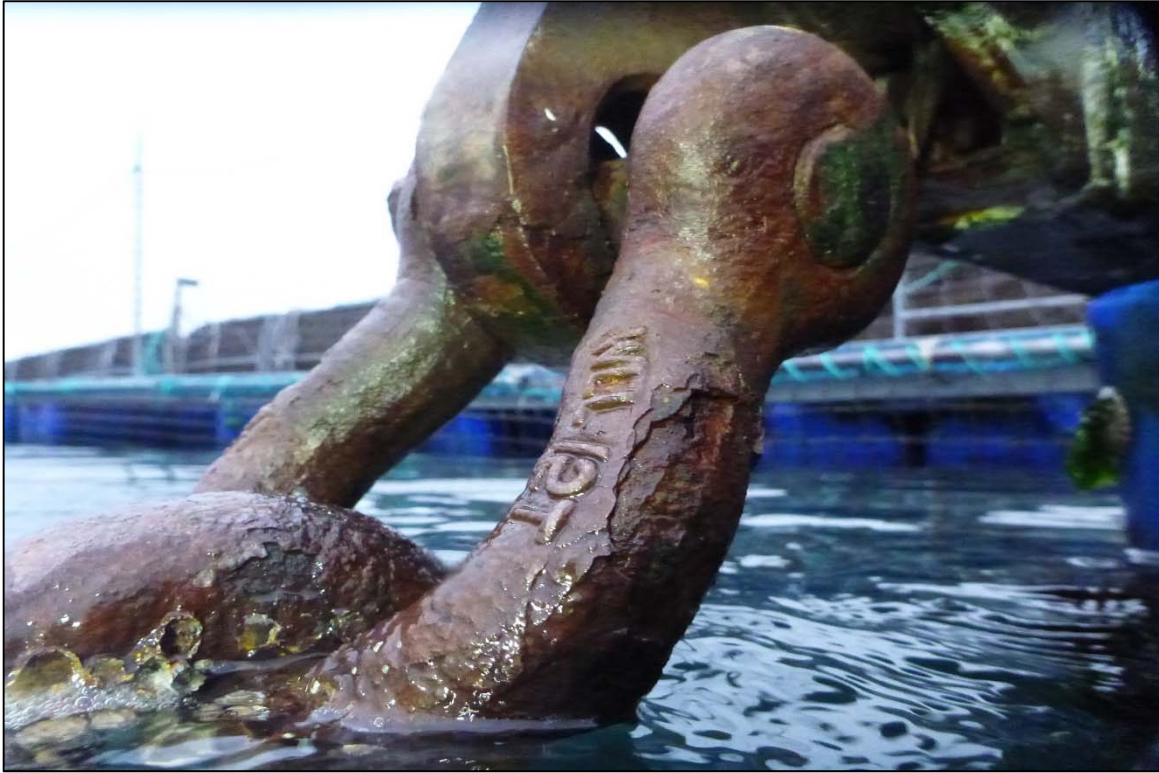
Photograph 20: View of Upper Anchor Chain to Rope Connection (Thimble) at Site 3 Anchor Line 3, Looking North.

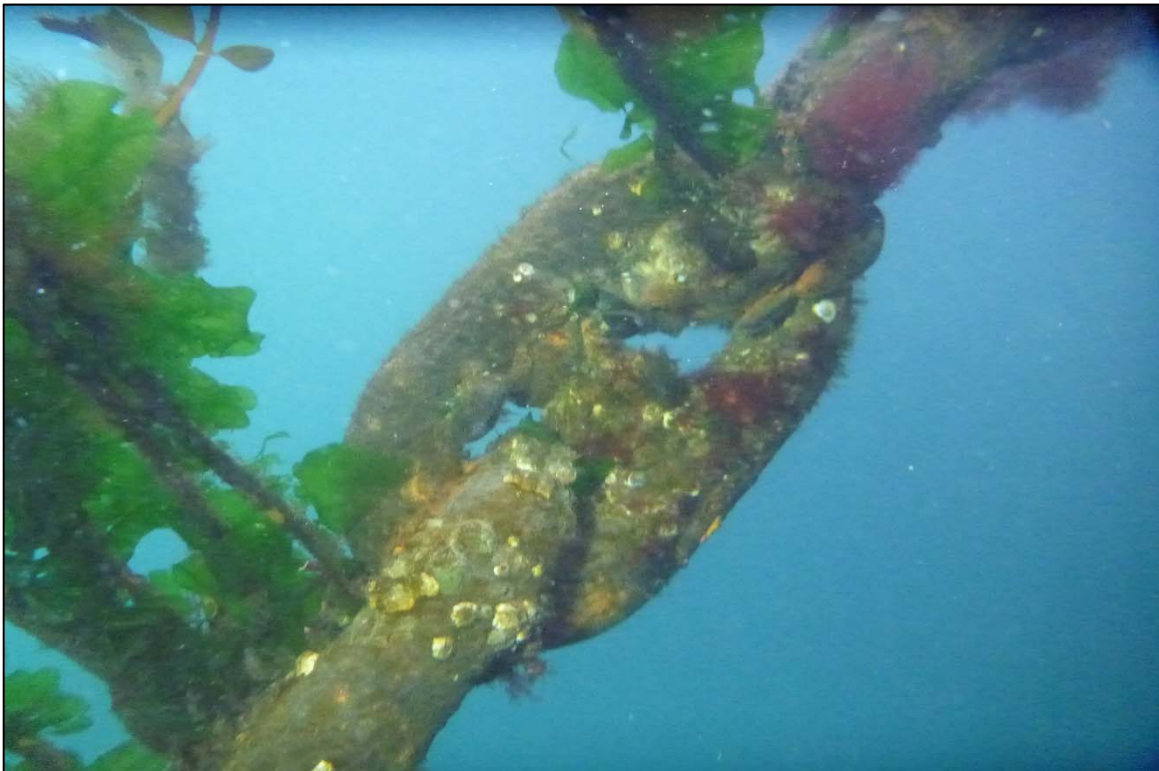
Photograph 21: View of Upper Chain to Float Connection Section Loss and Corrosion at Site 3 Anchor Line 4, Looking East.

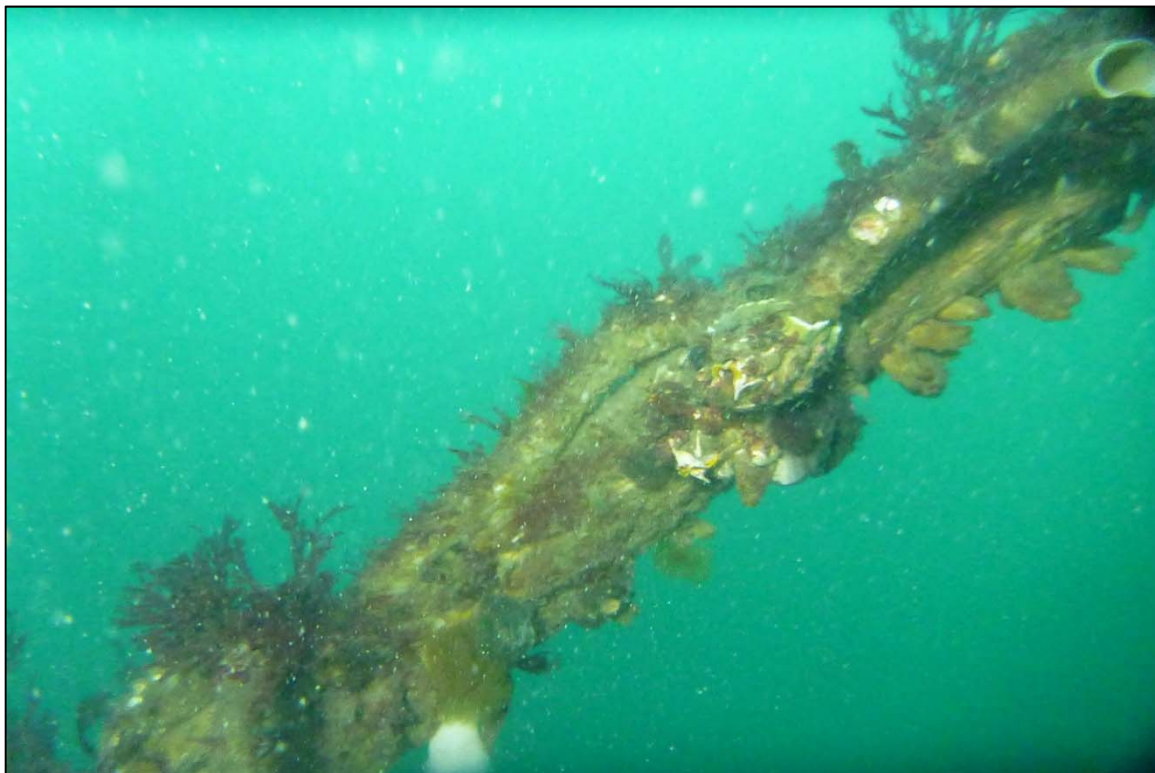
Photograph 23: View of Lower Chain to Chain Connection (Shackle) at Site 3 Anchor Line 4, Looking North.

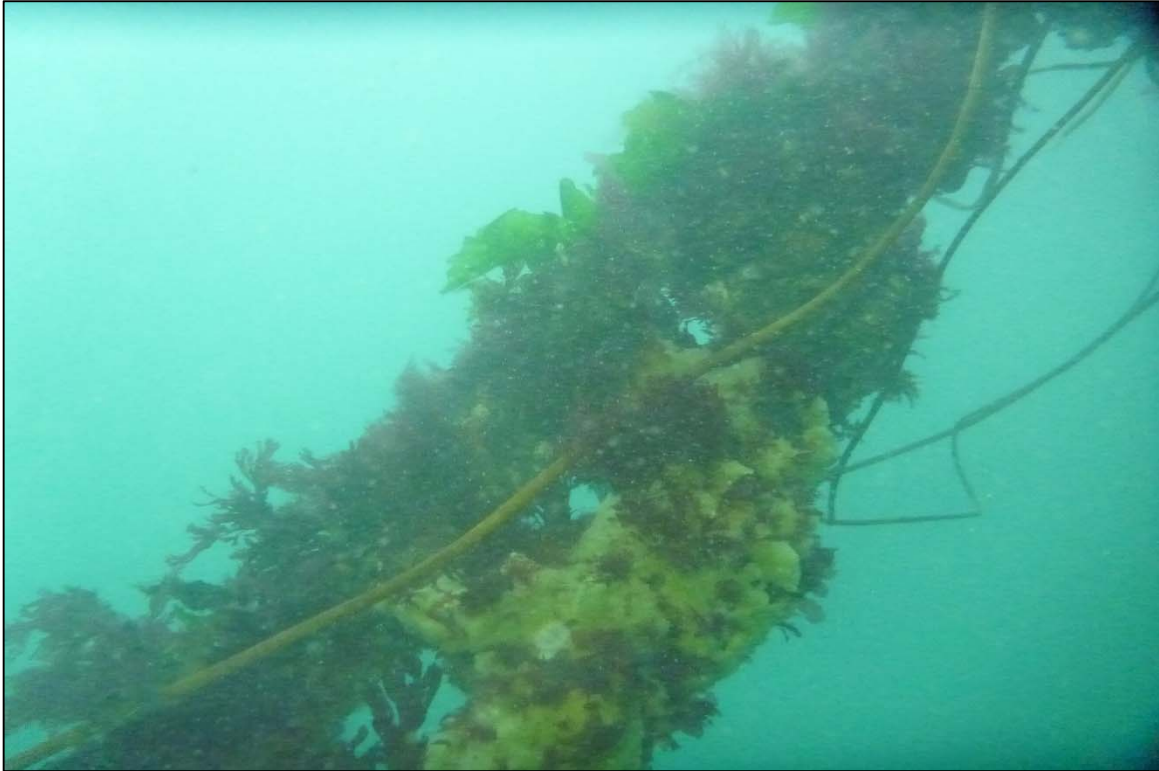
Photograph 24: View of Anchor Rope Condition at Site 3 Anchor Line 5, Looking North.

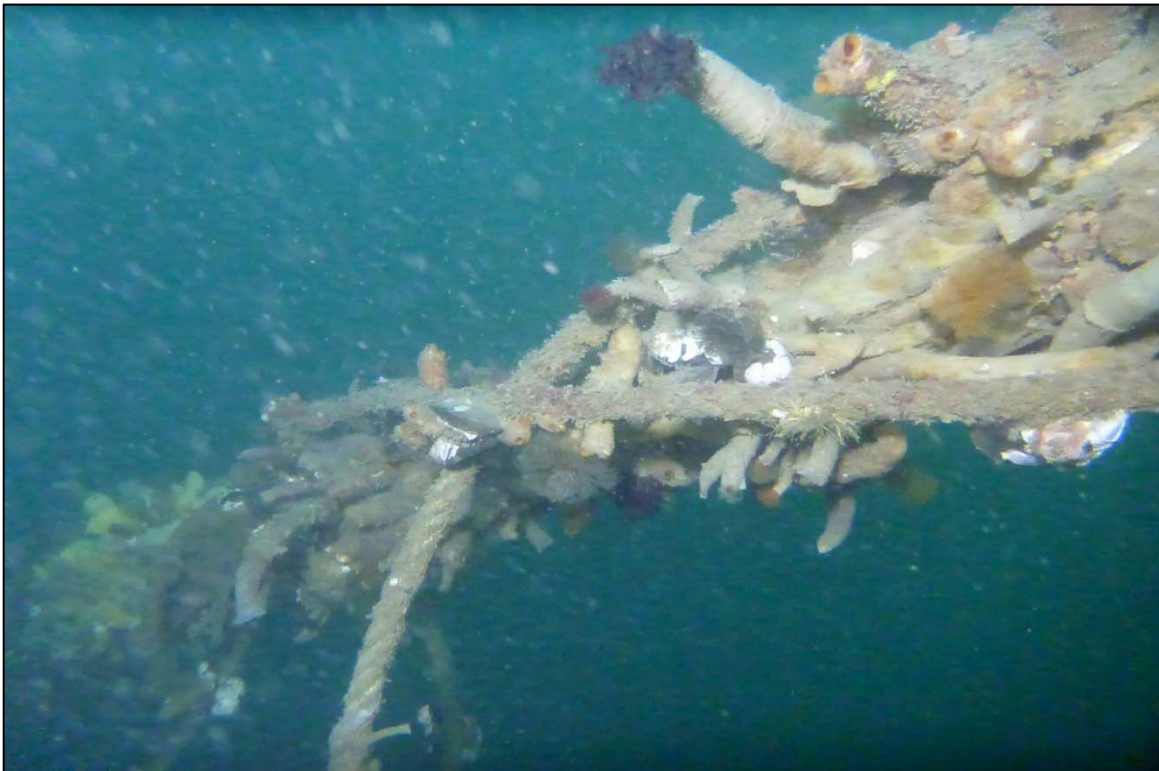
Photograph 25: View of Upper Anchor Chain Condition at Site 3 Anchor Line 5, Looking Northwest.

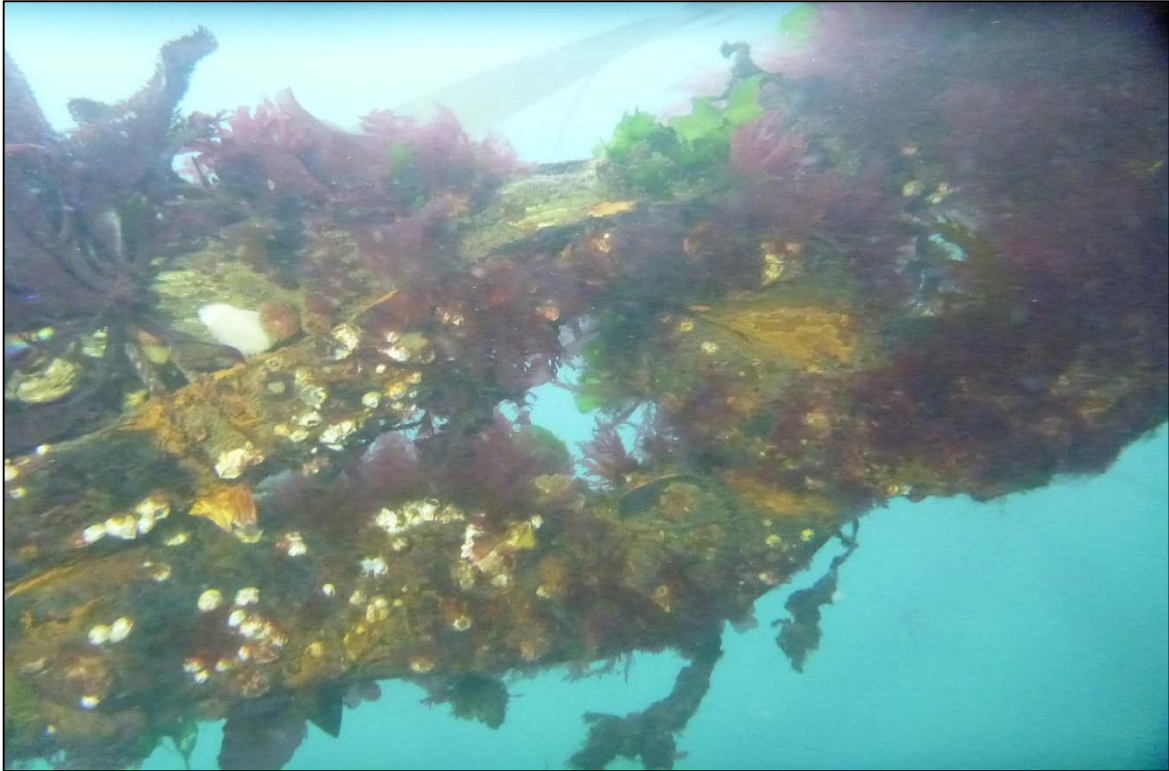
Photograph 26: View of Rope Debris on the Anchor Rope at Site 3 Anchor Line 5, Looking North.

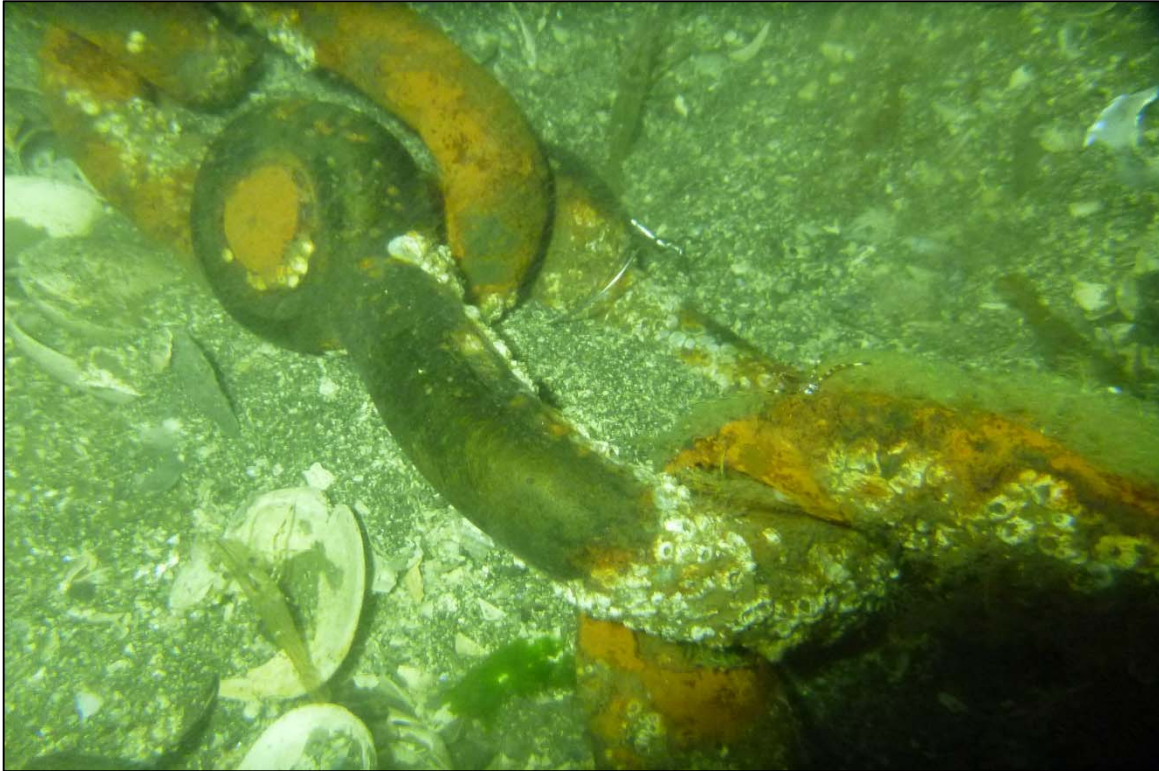
Photograph 30: View of Upper Anchor Chain at Site 3 Anchor Line 6A, Looking West.

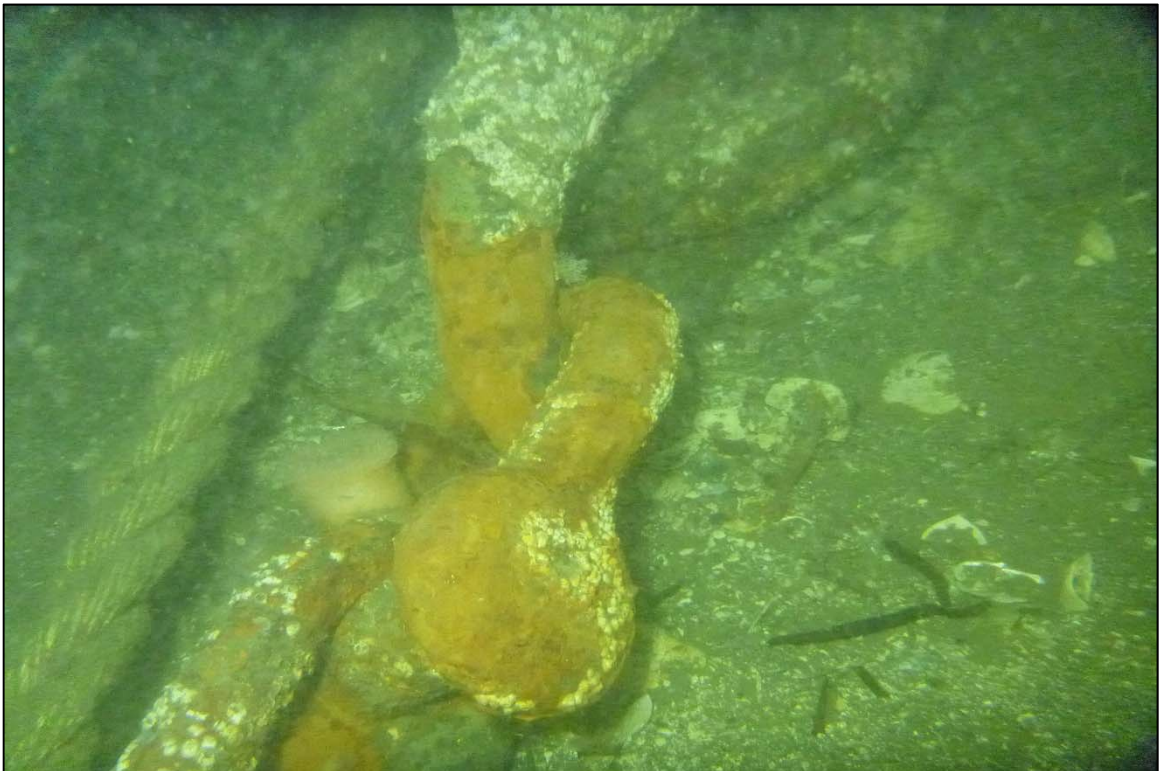
Photograph 31: View of Lower Anchor Rope to Anchor Chain Condition (Shackle and Thimble) at Site 3 Anchor Line 6A, Looking North.

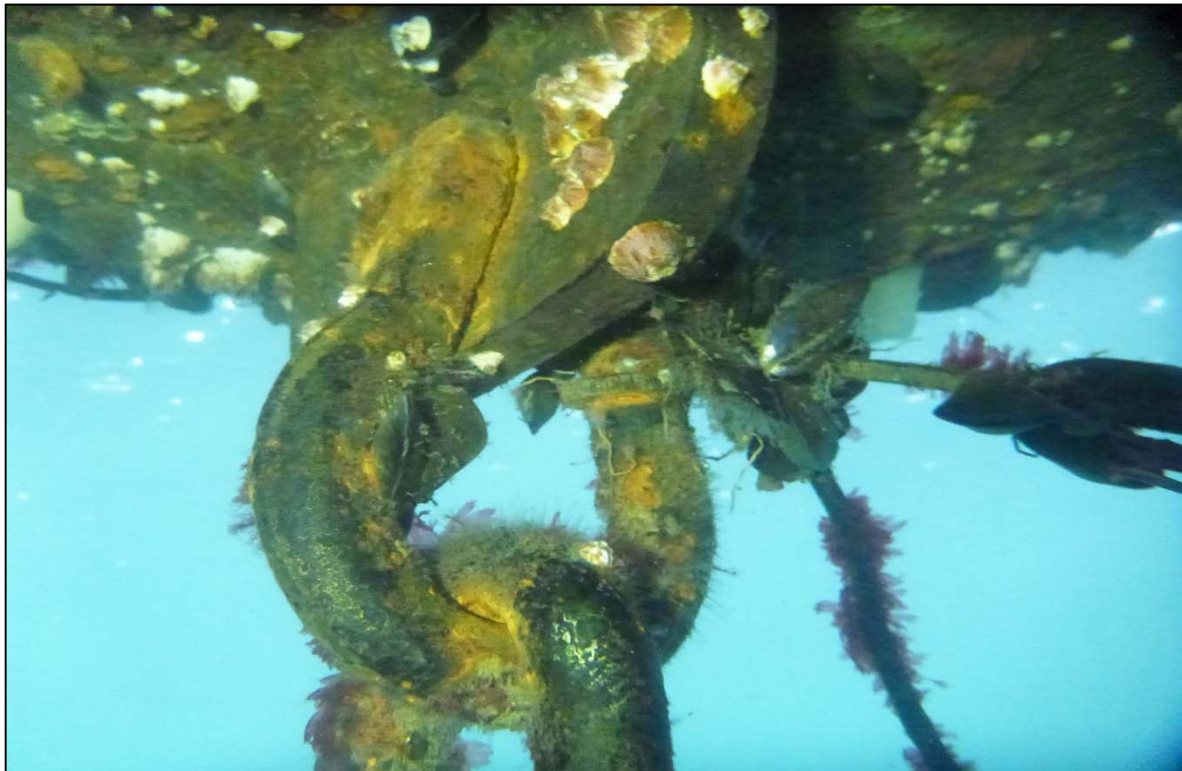
Photograph 33: View of Top of Exposed Anchor at Site 3 Anchor Line 6A, Looking East.

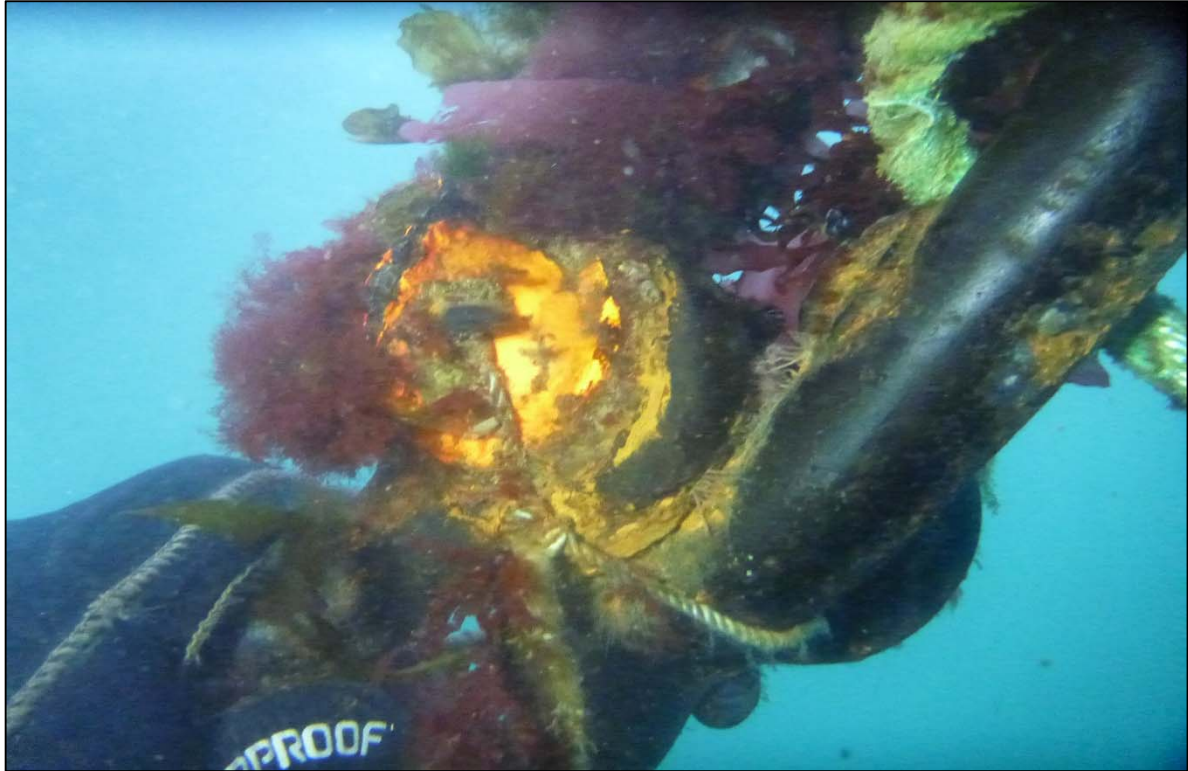
Photograph 34: View of Chain to Buoy (Shackle) at Fort Ward Anchor Line 7, Looking Southeast.

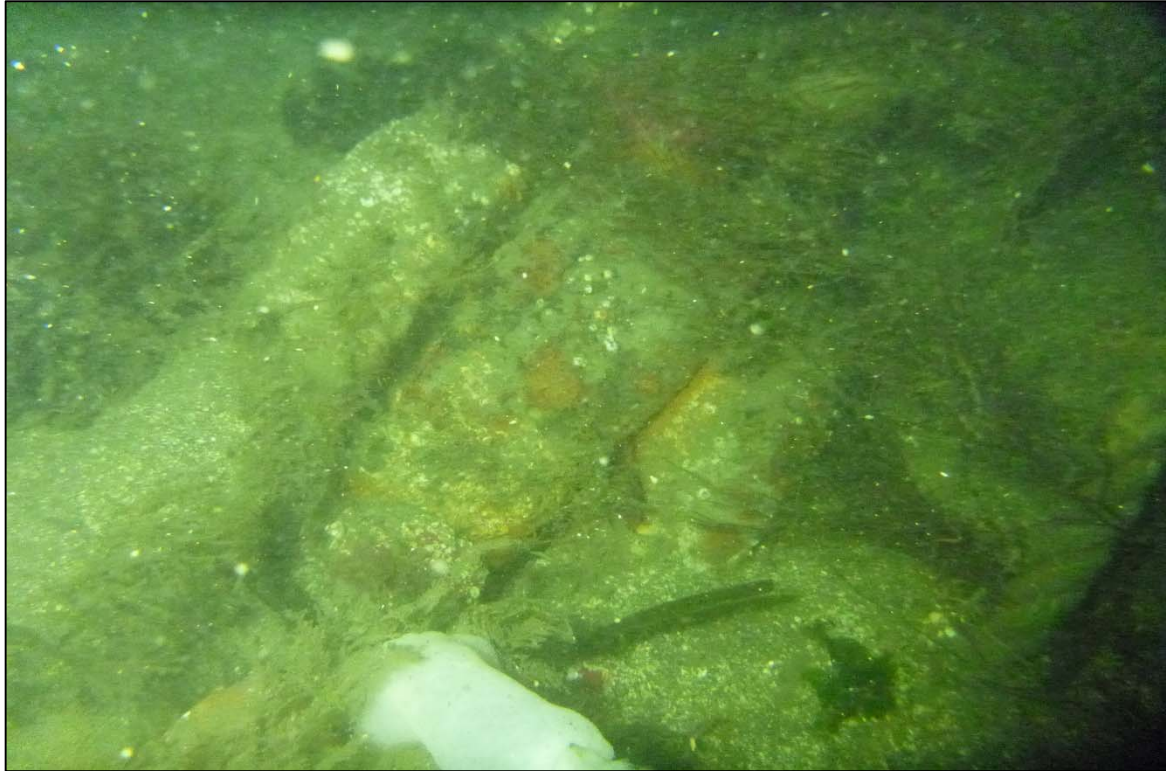
Photograph 36: View of Lower Anchor Chain laying on the Channel Bottom at Site 3 Anchor Line 7, Looking Southeast.

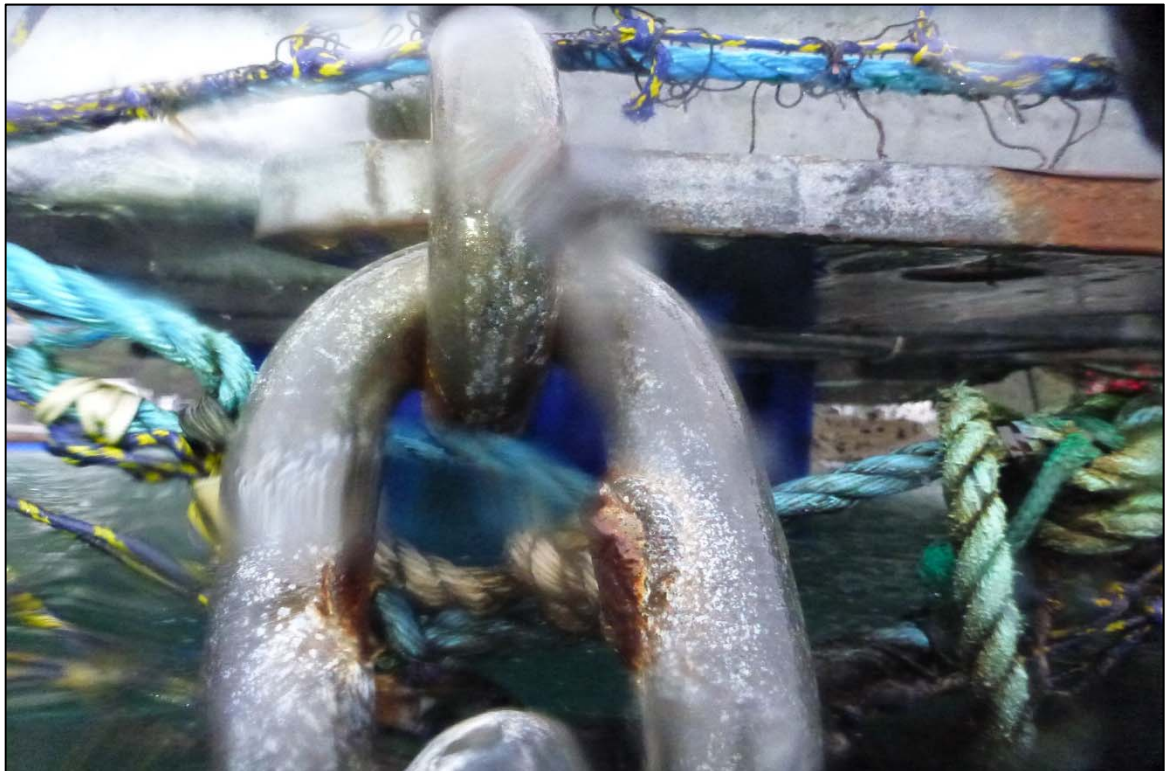
Photograph 37: View of Lower Chain to Anchor Connection (Shackle) on the Channel Bottom at Site 3 Anchor Line 7, Looking East.

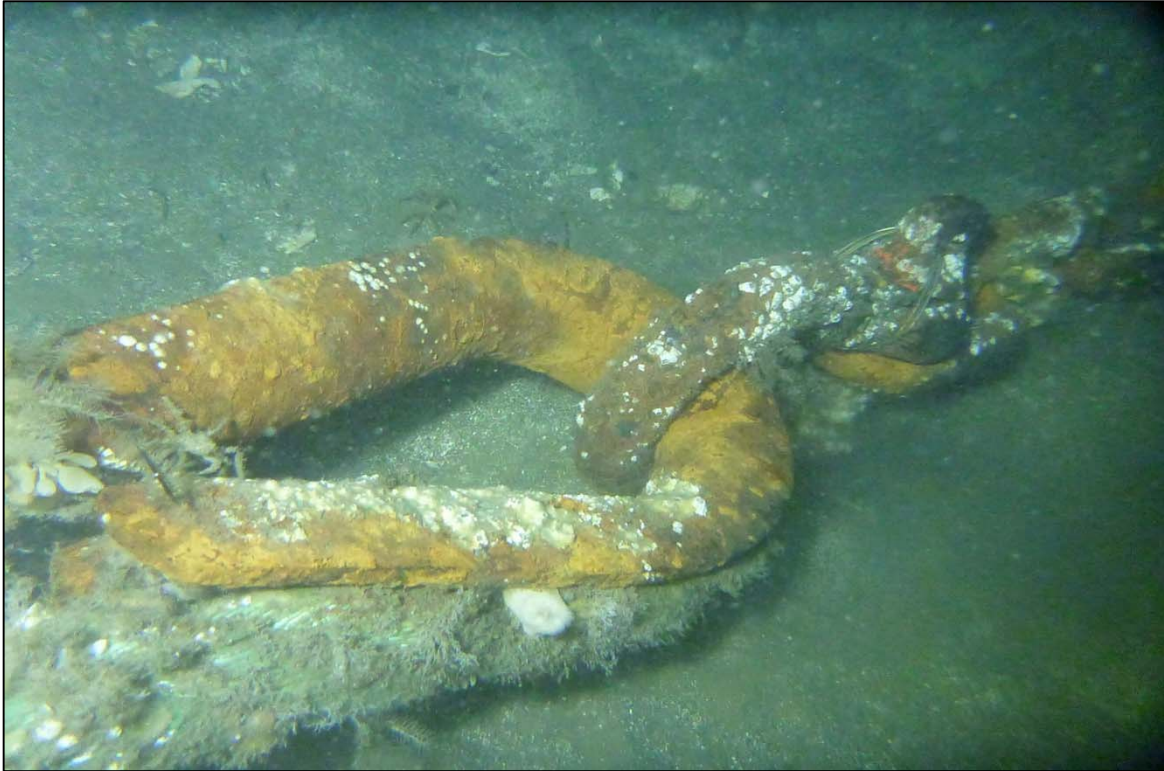
Photograph 38: View of Upper Anchor Chain Condition at Site 3 Anchor Line 8, Looking Northwest.

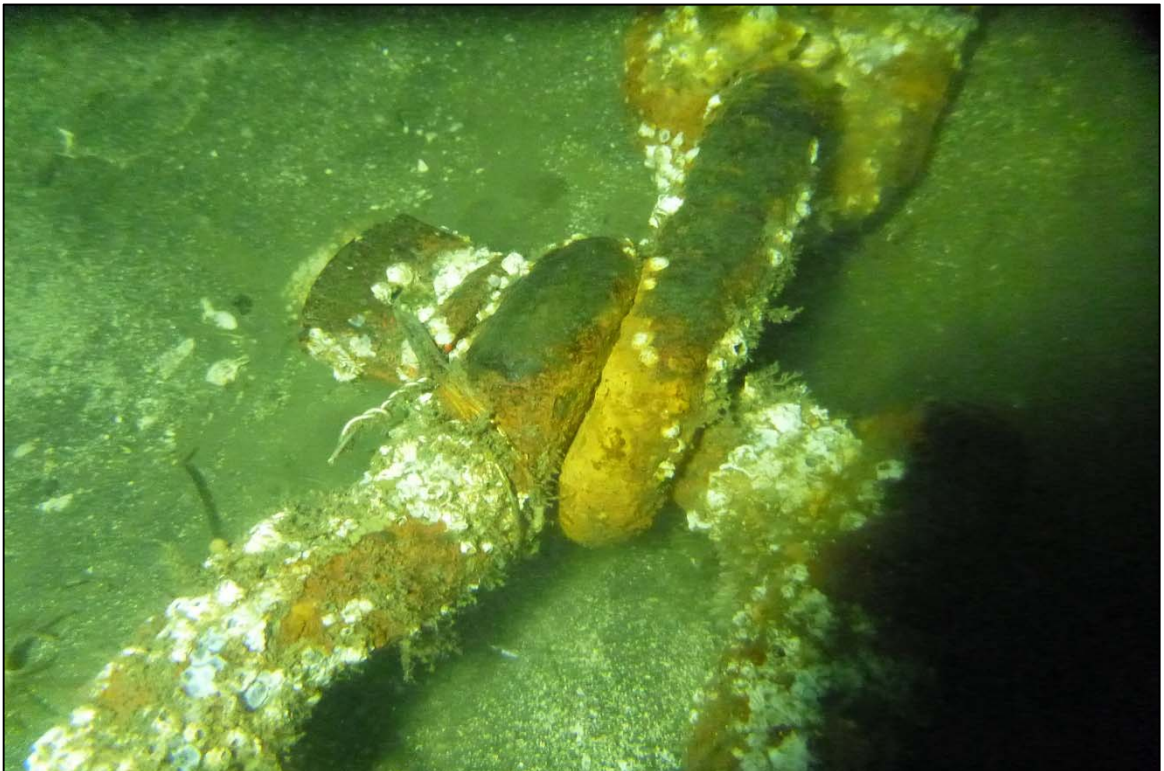
Photograph 39: View of Lower Anchor Chain to Rope Connection (Shackle and Thimble) at Site 3 Anchor Line 8, Looking North.

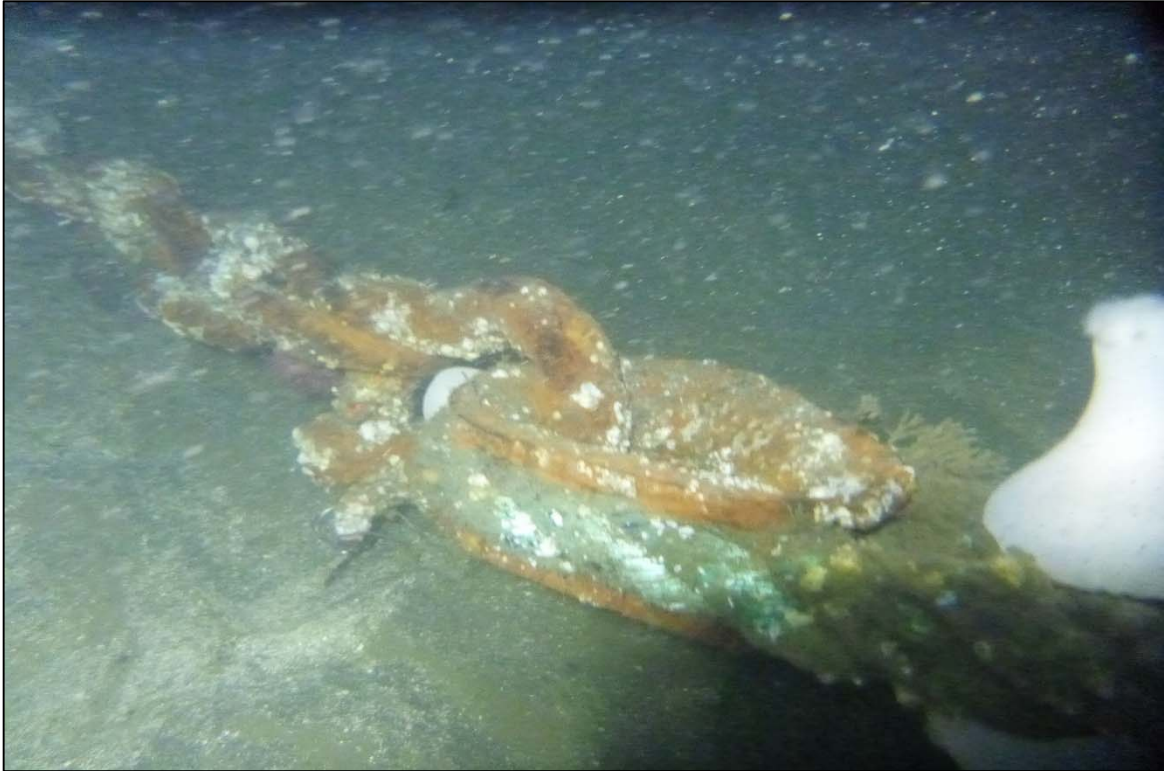
Photograph 48: View of Anchor Rope Heavy Marine Growth at Site 3 Anchor Line 11, Looking North.

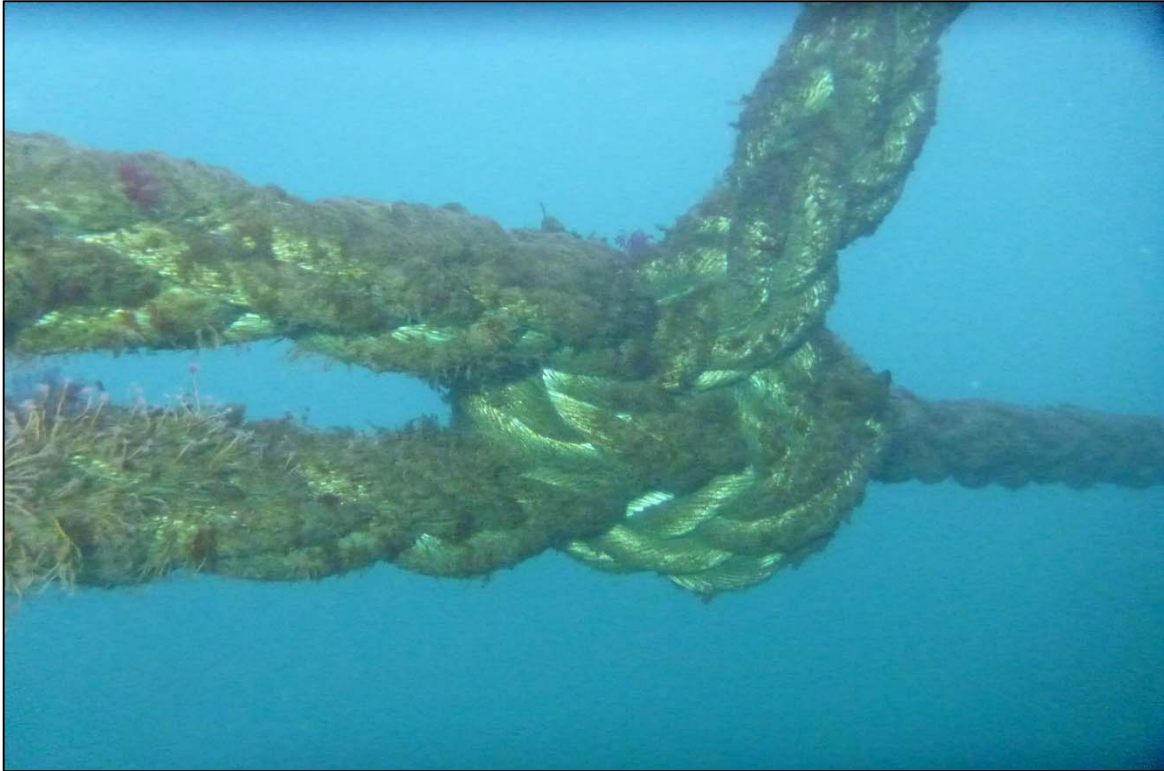
Photograph 50: View of Chain to Buoy Connection at Site 3 Anchor Line 12, Looking Northeast.

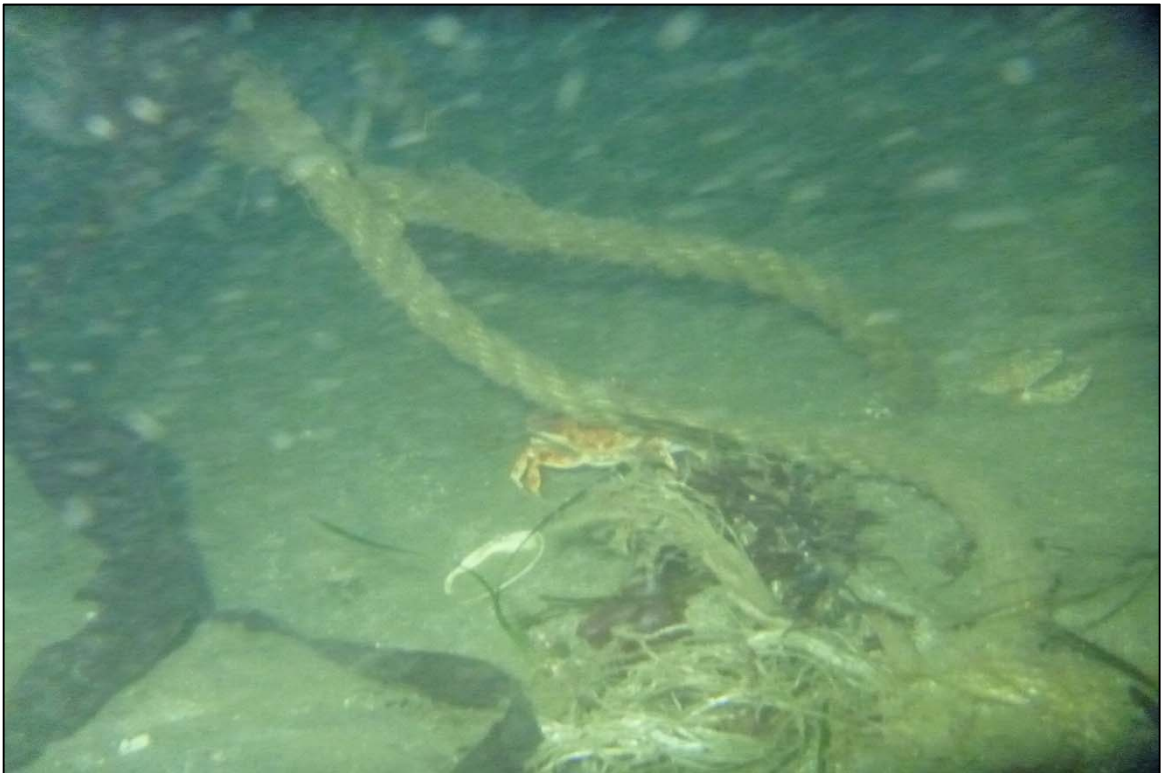
Photograph 51: View of Upper Anchor Rope Condition (Bowline Knot) at Site 3 Anchor Line 12, Looking Northeast.

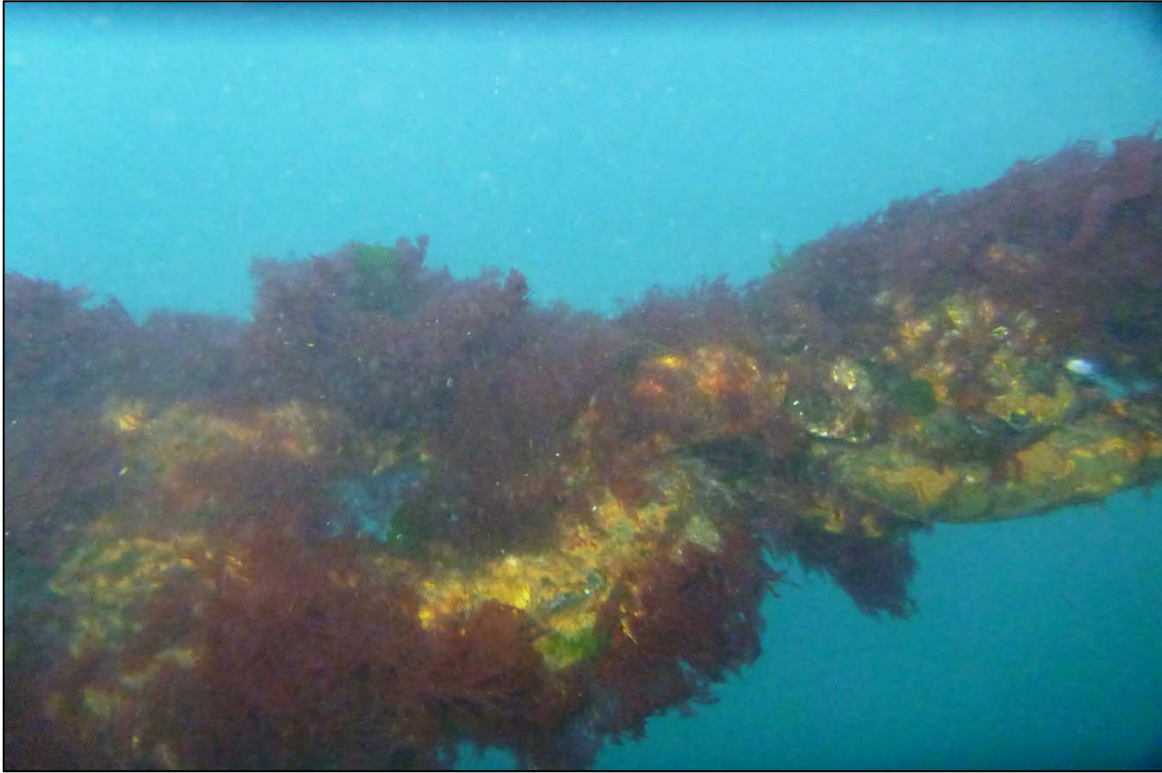
Photograph 52: View of Top of the Anchor at Site 3 Anchor Line 12, Looking Southeast.

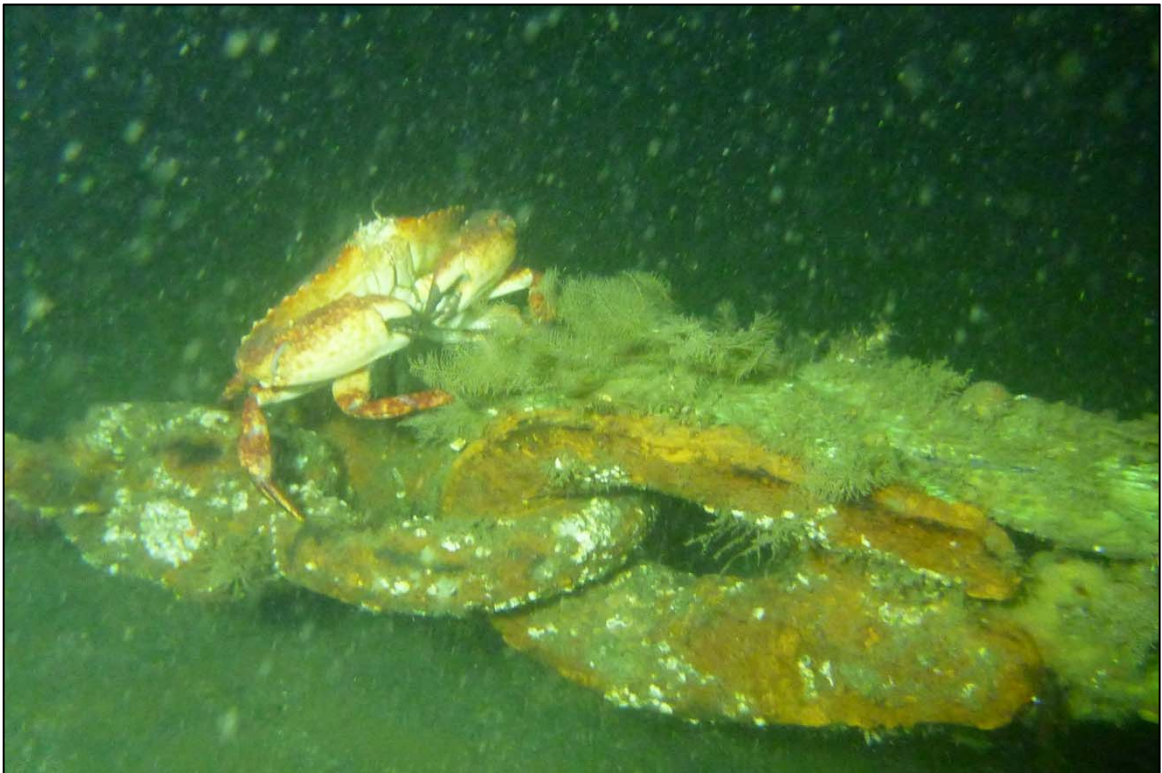
Photograph 53: View of Upper Anchor Chain to Anchor Rope Connection (Shackle and Thimble) at Site 3 Anchor Line 13, Looking North.
