Cypress Island Site 3 Atlantic Salmon Net Pens Engineering Assessment

January 29, 2018

State of Washington
Department of Natural
Resources
1111 Washington Street SE
Olympia Washington 98504

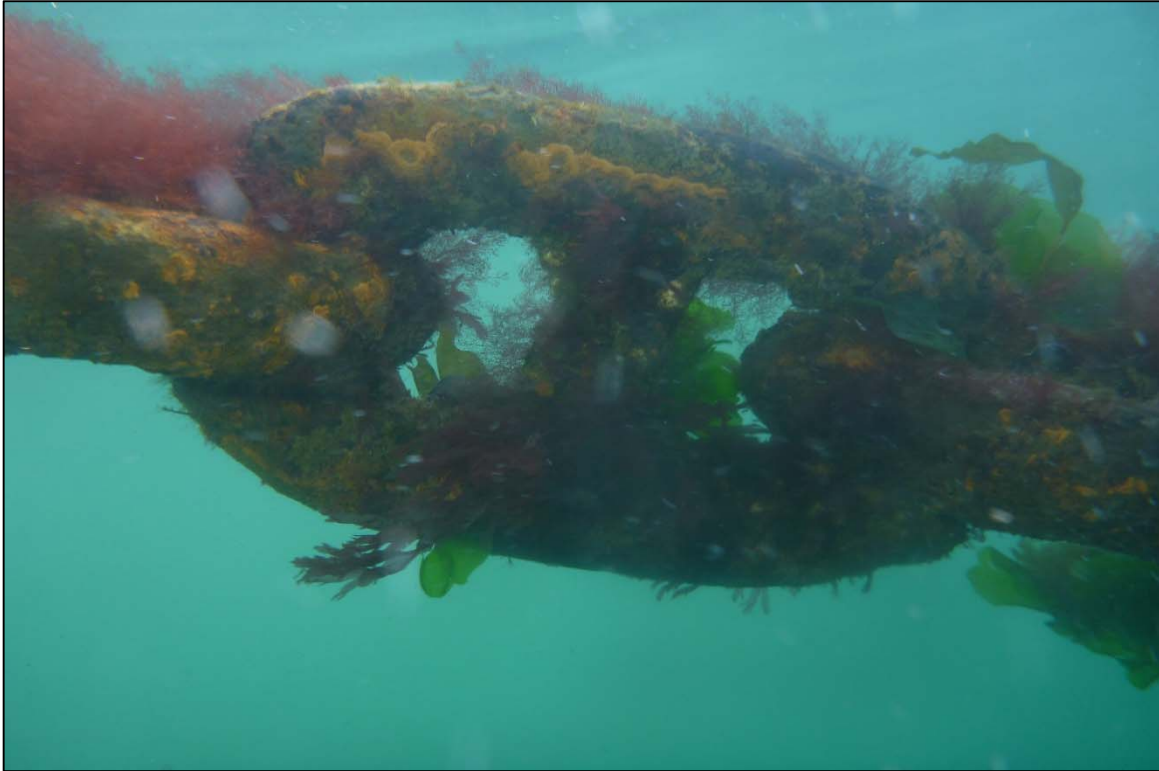
Photograph 54: View of Lower Anchor Chain to Anchor Rope Connection (Shackle and Thimble) at Site 3 Anchor Line 13, Looking North.

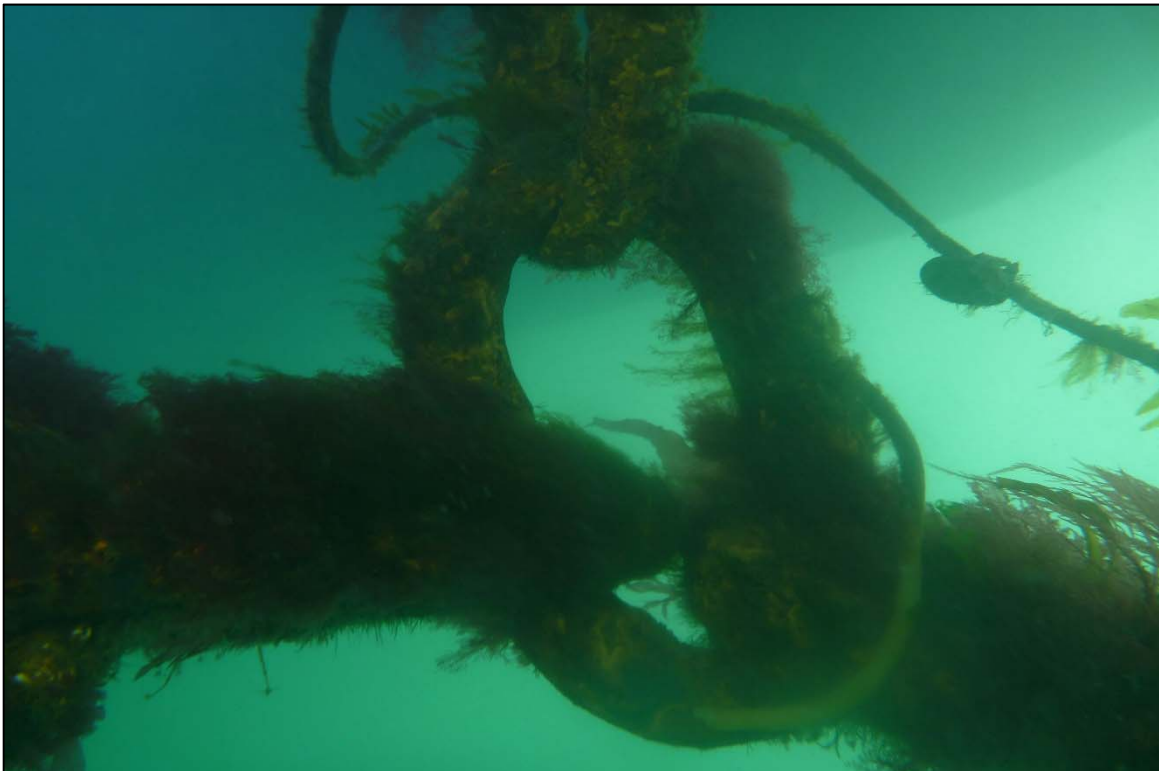
Photograph 55: View of Upper Anchor Chain Condition with Corrosion and Pitting at Site 3 Anchor Line 13A, Looking West.

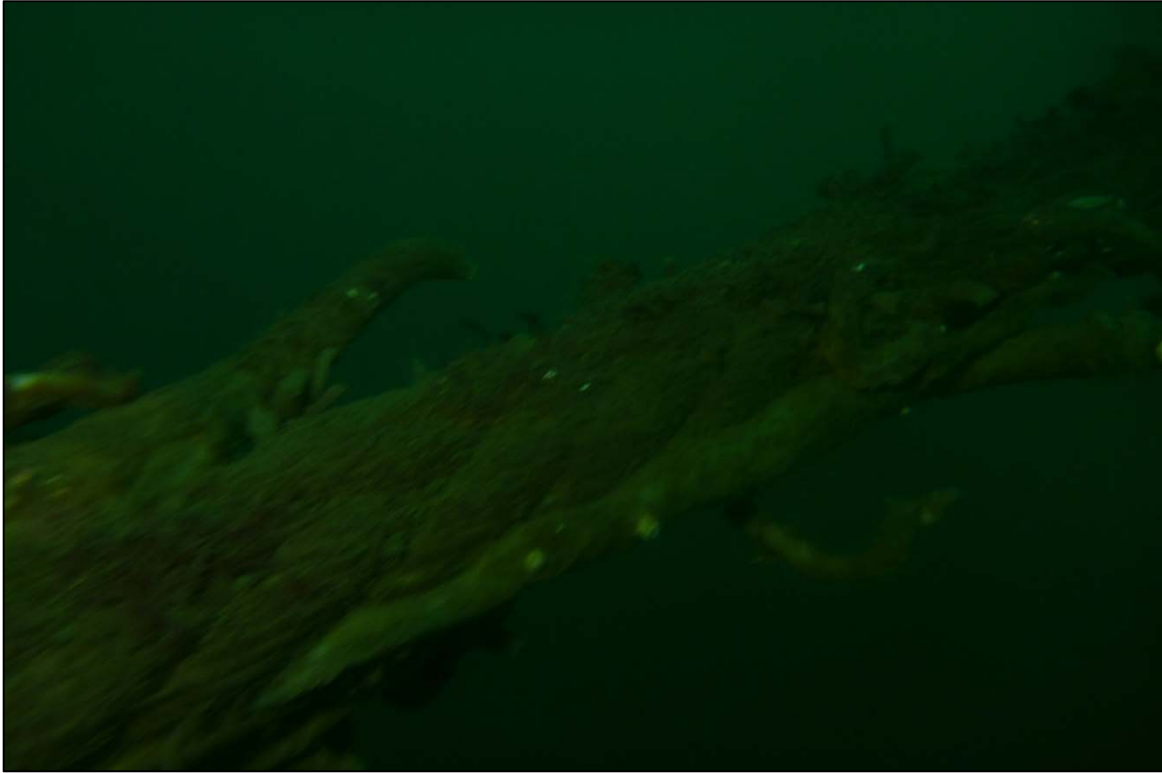
Photograph 56: View of Upper Anchor Chain to Buoy Chain Connection at Site 3 Anchor Line 13A, Looking West.

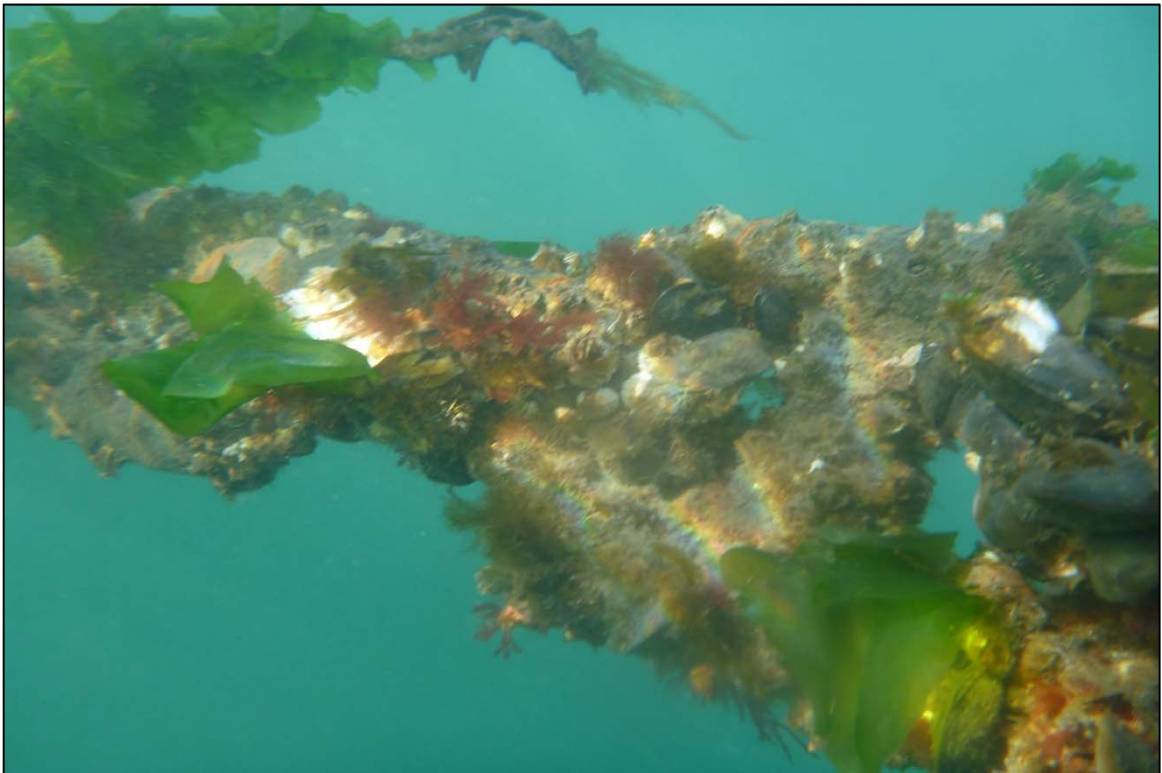
Photograph 57: View of Lower Anchor Rope Condition at Site 3 Anchor Line 14, Looking West.

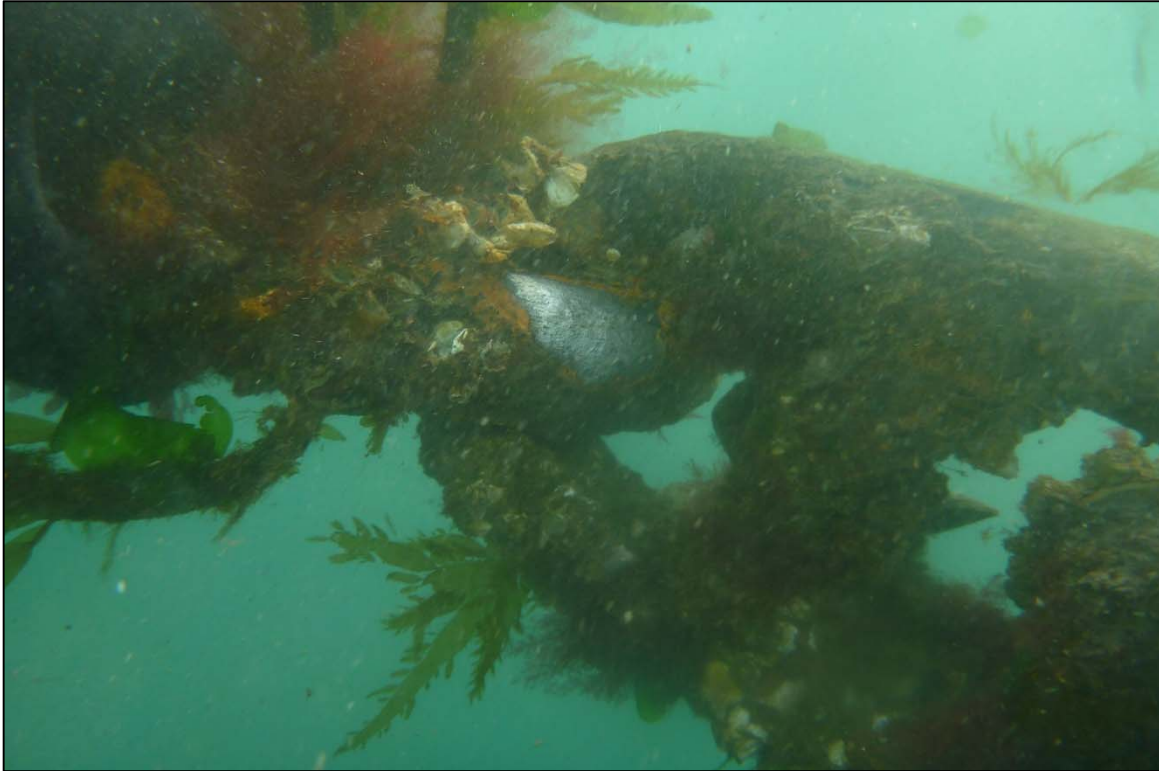
Photograph 58: View of Upper Anchor Chain to Anchor Rope Connection with Heavy Marine Growth at Site 3 Anchor Line 15, Looking Southwest.

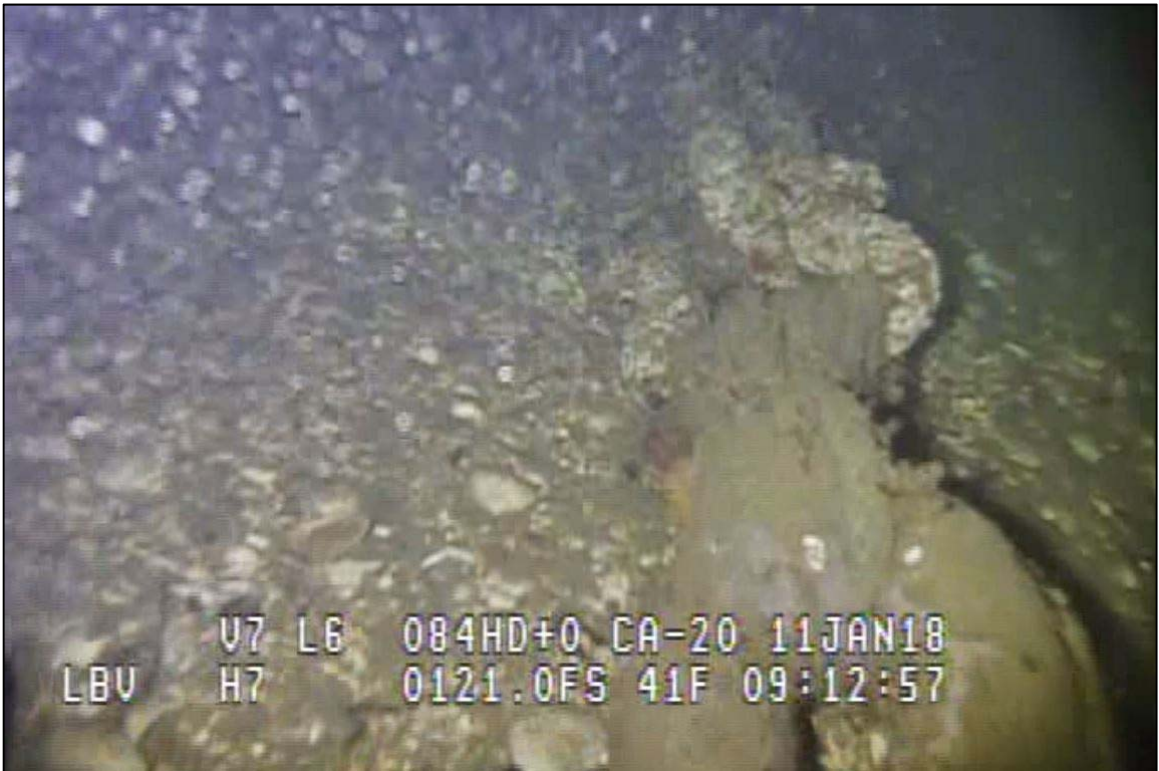
Photograph 59: View of Upper Anchor Chain Condition with Corrosion at Site 3 Anchor Line 16, Looking North.

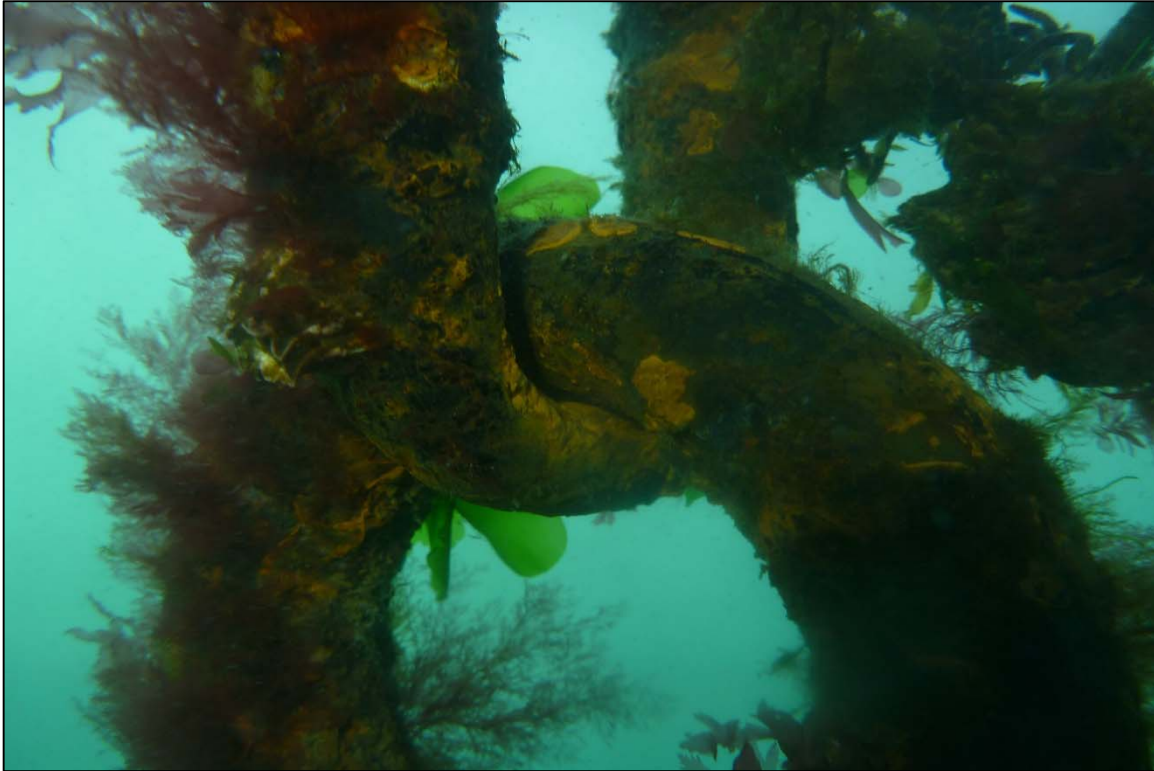
Photograph 60: View of Lower Anchor Chain to Anchor Rope Condition with Smaller Rope Lashing at Site 3 Anchor Line 16, Looking North.

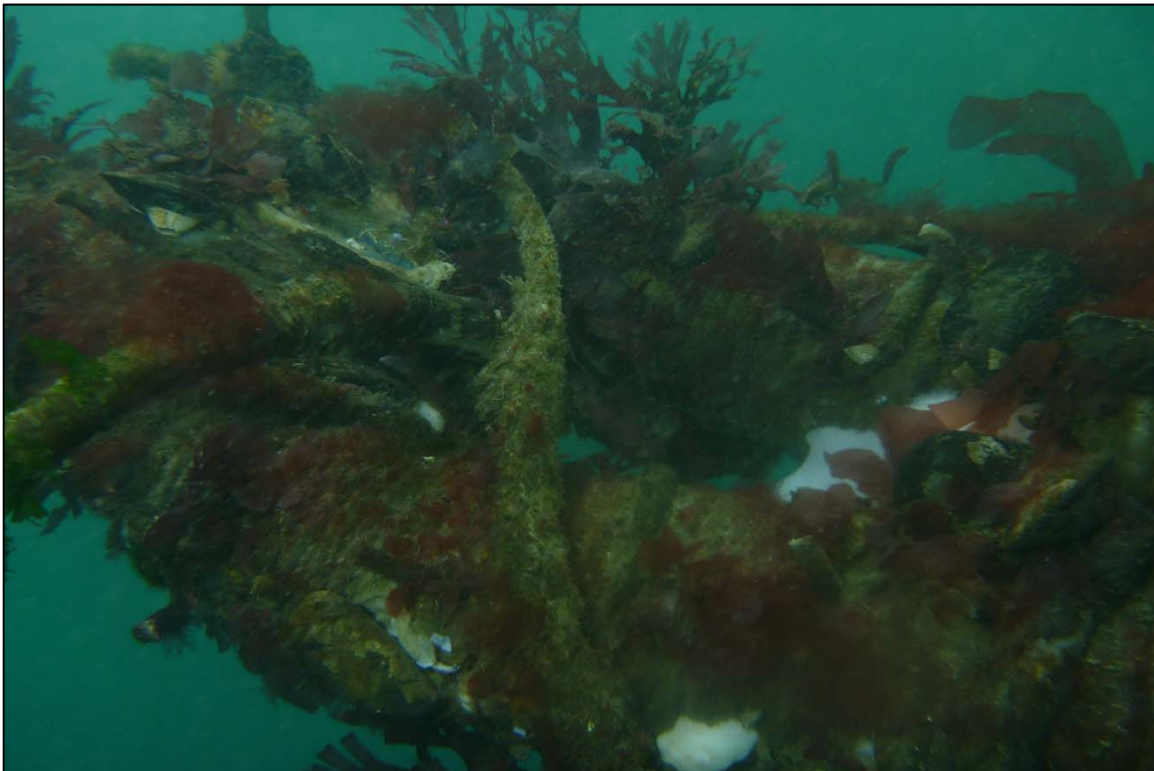
Photograph 61: View of Upper Anchor Chain Corrosion and Section Loss due to Abrasion at Site 3 Anchor Line 17, Looking Northwest.

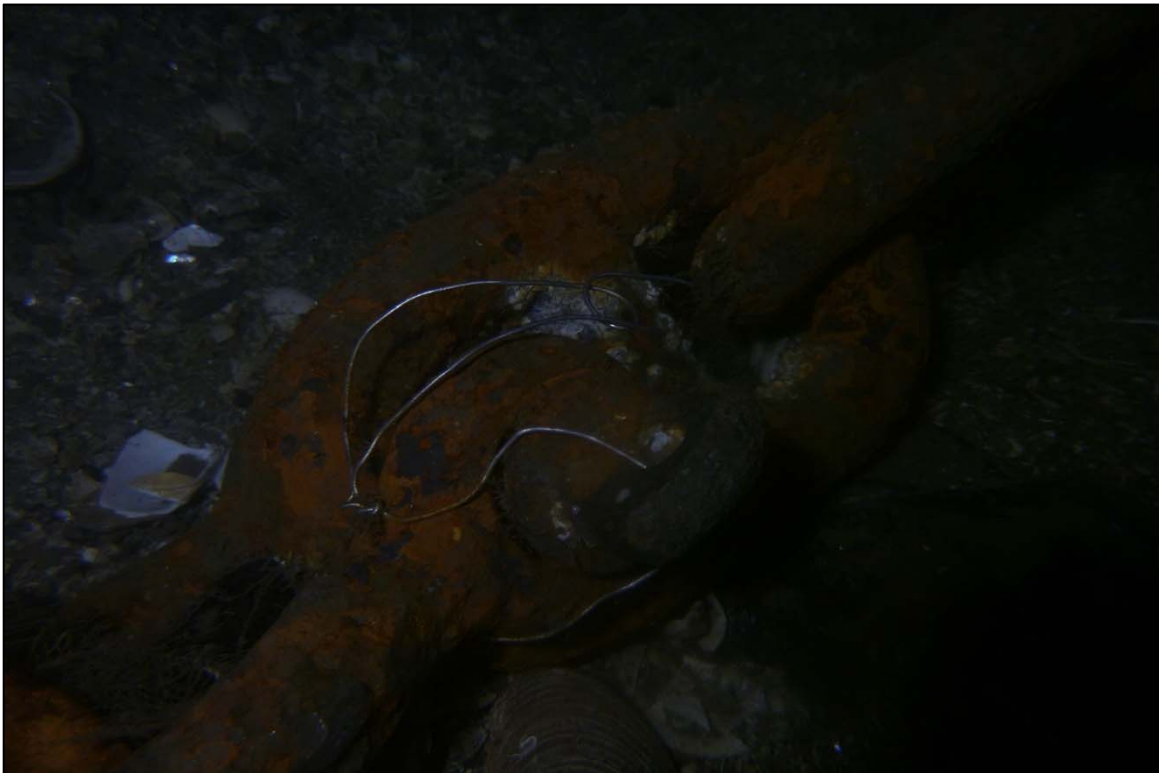
Photograph 65: View of Anchor Chain to Buoy Chain Connection (Shackle) with Corrosion and Pitting at Site 3 Anchor Line 19, Looking Northwest.

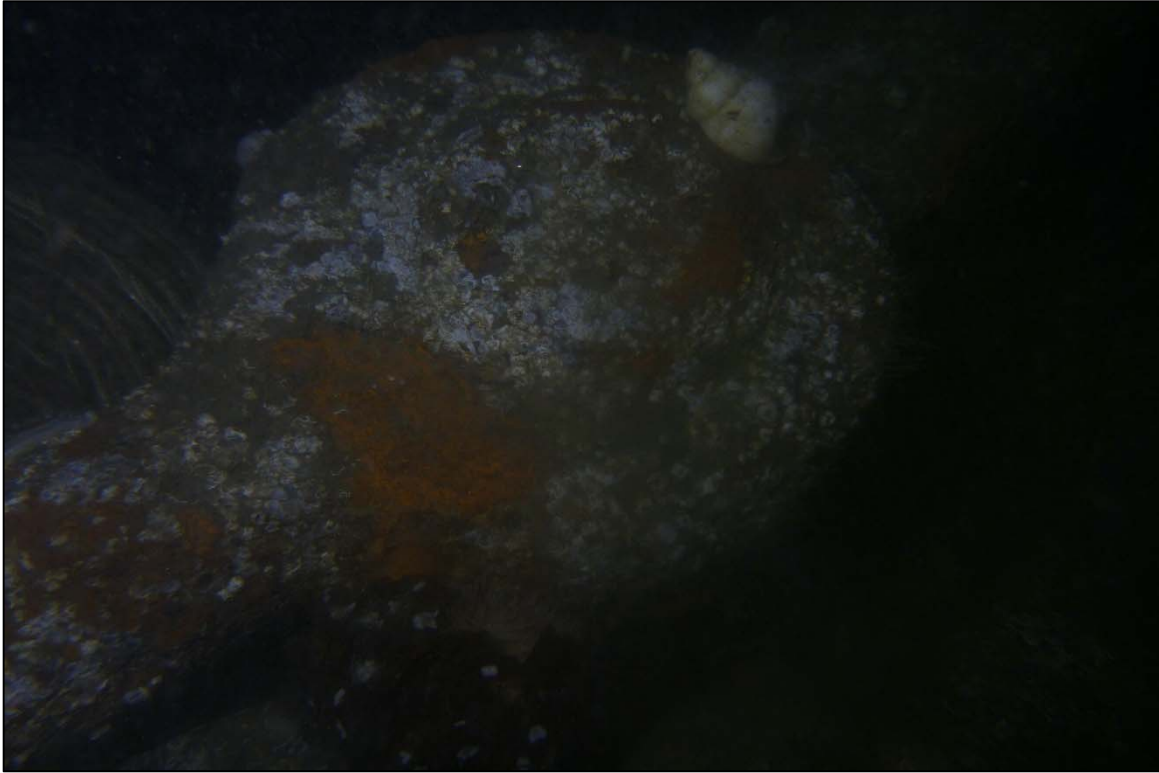
Photograph 66: View of Lower Anchor Chain Condition (Shackle) with Loose Safety Wire and Corrosion at Site 3 Anchor Line 19, Looking West.

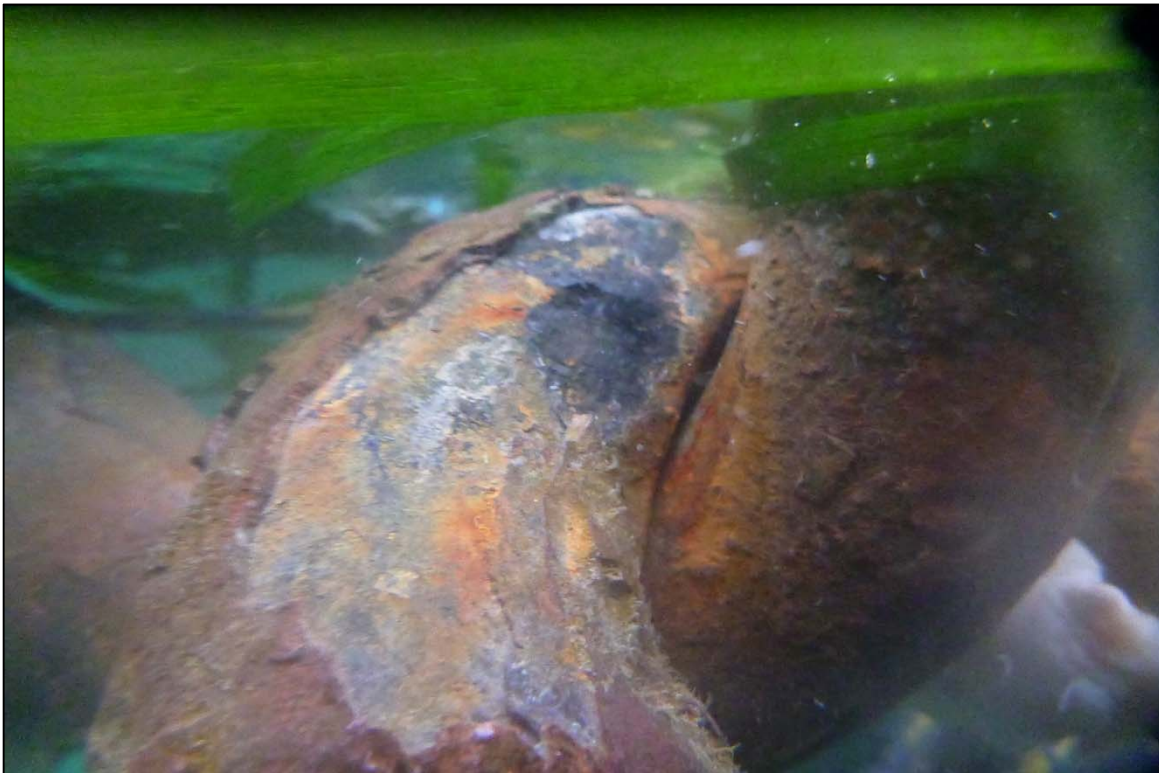
- The anchors are three different types: Danforth, Navy, and casing pins (steel piles).
- Most anchors were observed by the divers to be almost completely buried under the seabed with minimal exposure, as expected, except for the anchors at line 19. This anchor was out of alignment, and consequently, had only one anchor fluke and its peg embedded to some extent in the seabed.
- The buried anchors were not observed during the underwater inspection.
- None of the anchors showed any signs of appreciable movement along the seabed.
- All casing pins indicate a stable anchorage. The piles at anchor line 20 and 26 are inclined approximately 30° to 45° horizontal towards the fish pens. This appears to be the result of excessive load exerted on the anchor line. It appears that the steel yielded (deformed) rather than a deformation of the soil.

Photograph 67: View of Exposed Anchor Stem at Site 3 Anchor Line 19, Looking West.

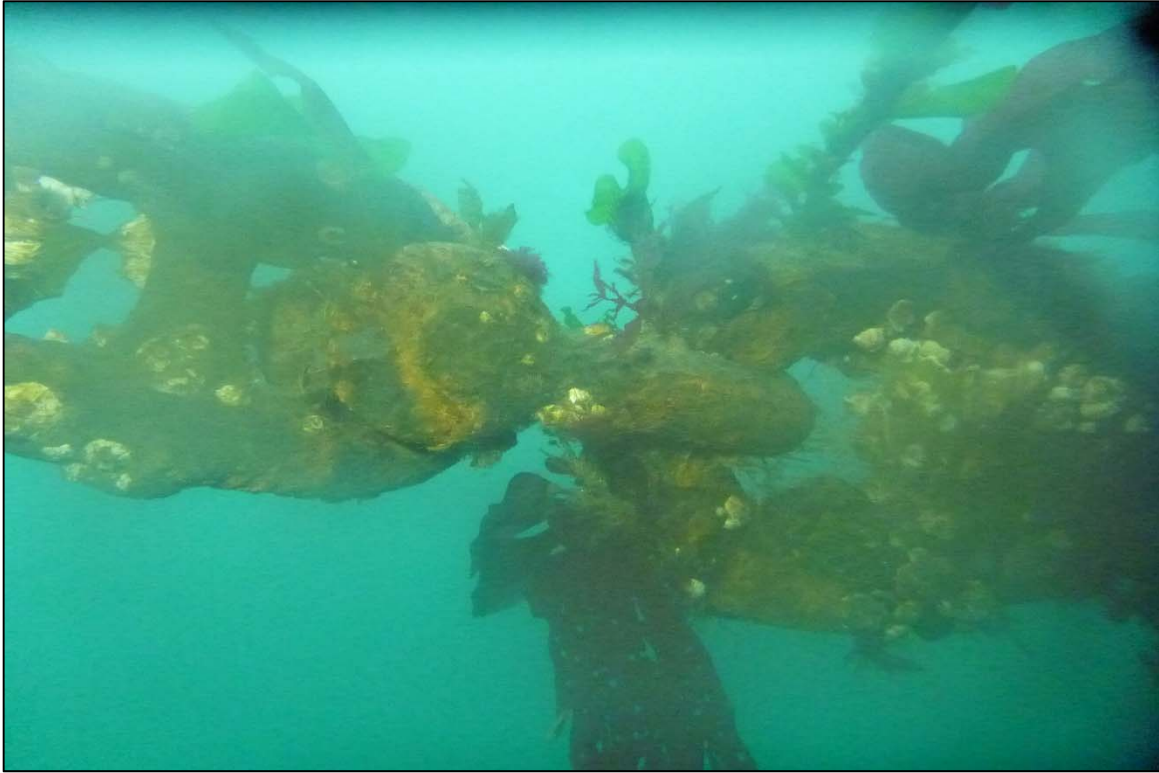
Photograph 68: View of Upper Anchor Chain at the Upper Connection with Corrosion and Pitting at Site 3 Anchor Line 20, Looking East.

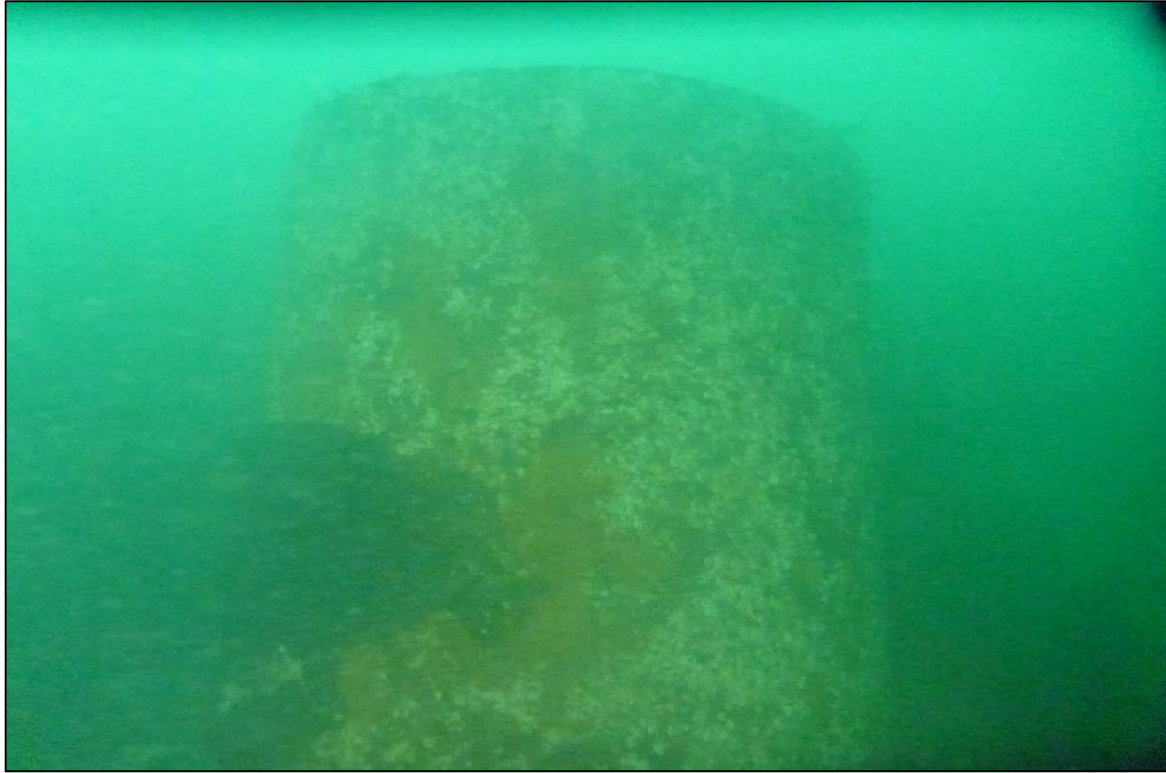
Photograph 72: View of Lower Anchor Chain to Anchor Rope Connection with Heavy Barnacle Growth (Thimble) at Site 3 Anchor Line 21, Looking Northeast.

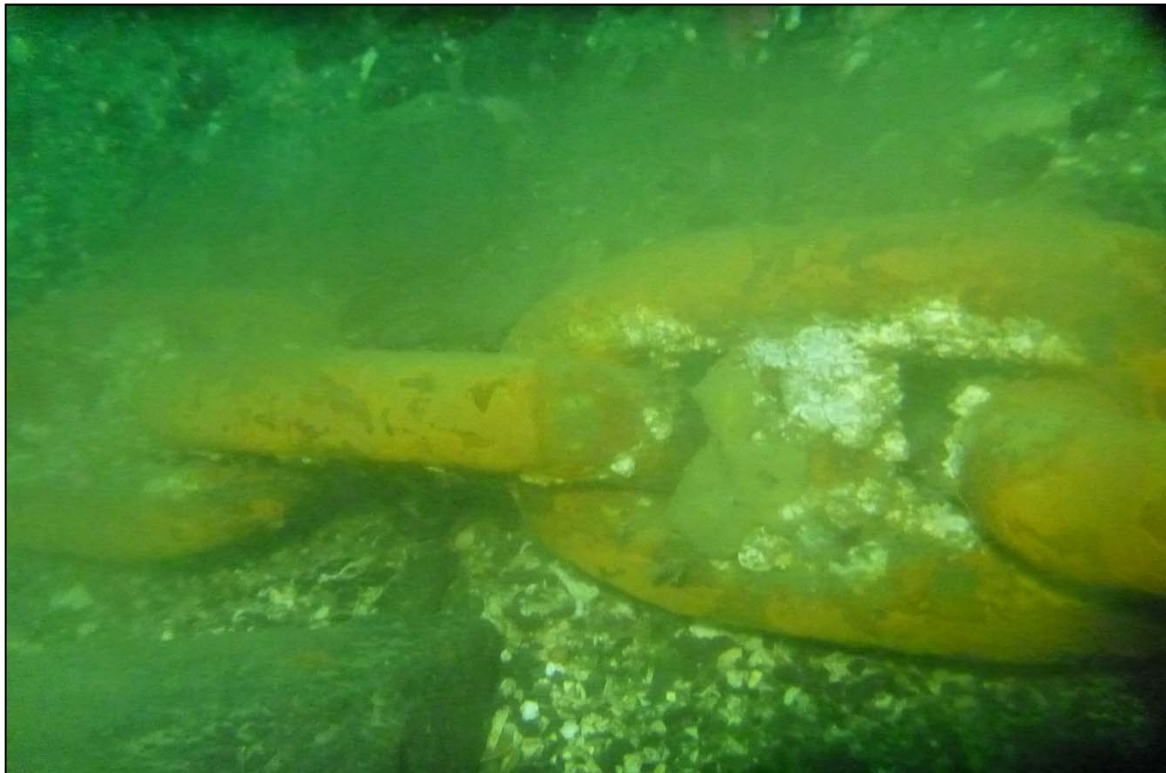
Photograph 73: View of Pile Anchor at Site 3 Anchor Line 21, Looking Northwest.

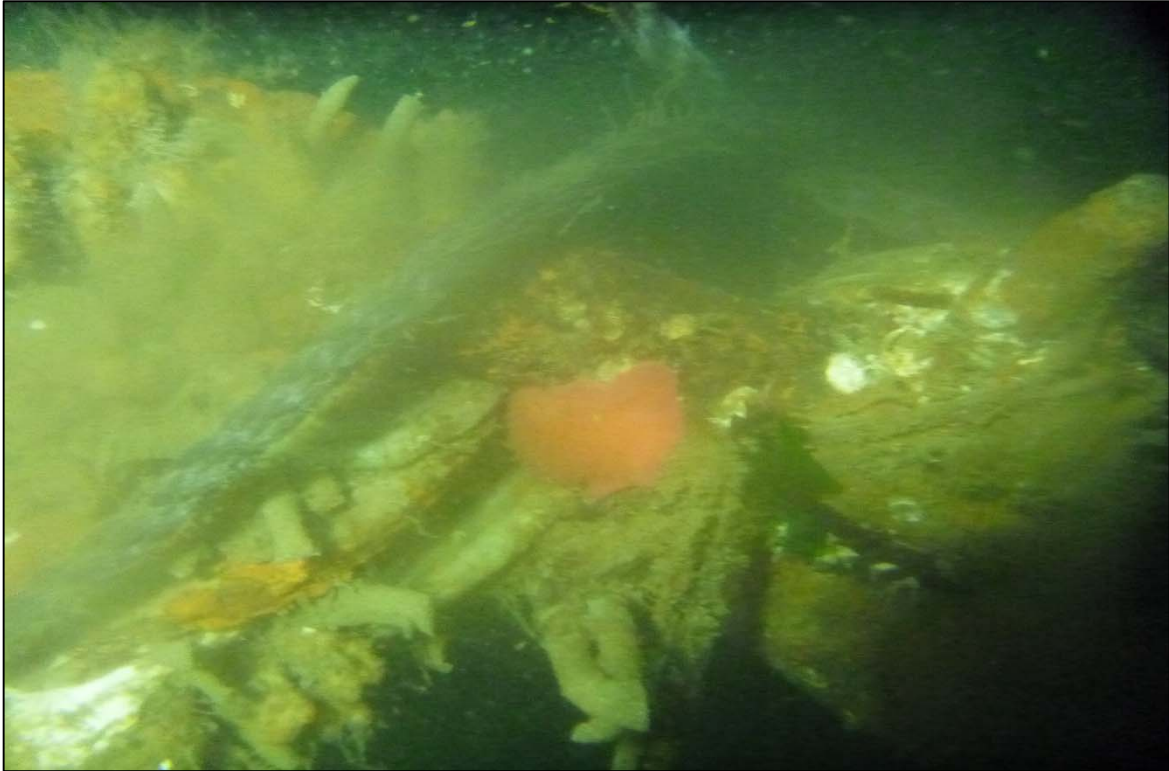
Photograph 74: View of Lower Anchor Chain on the Channel Bottom at Site 3 Anchor Line 22, Looking North.

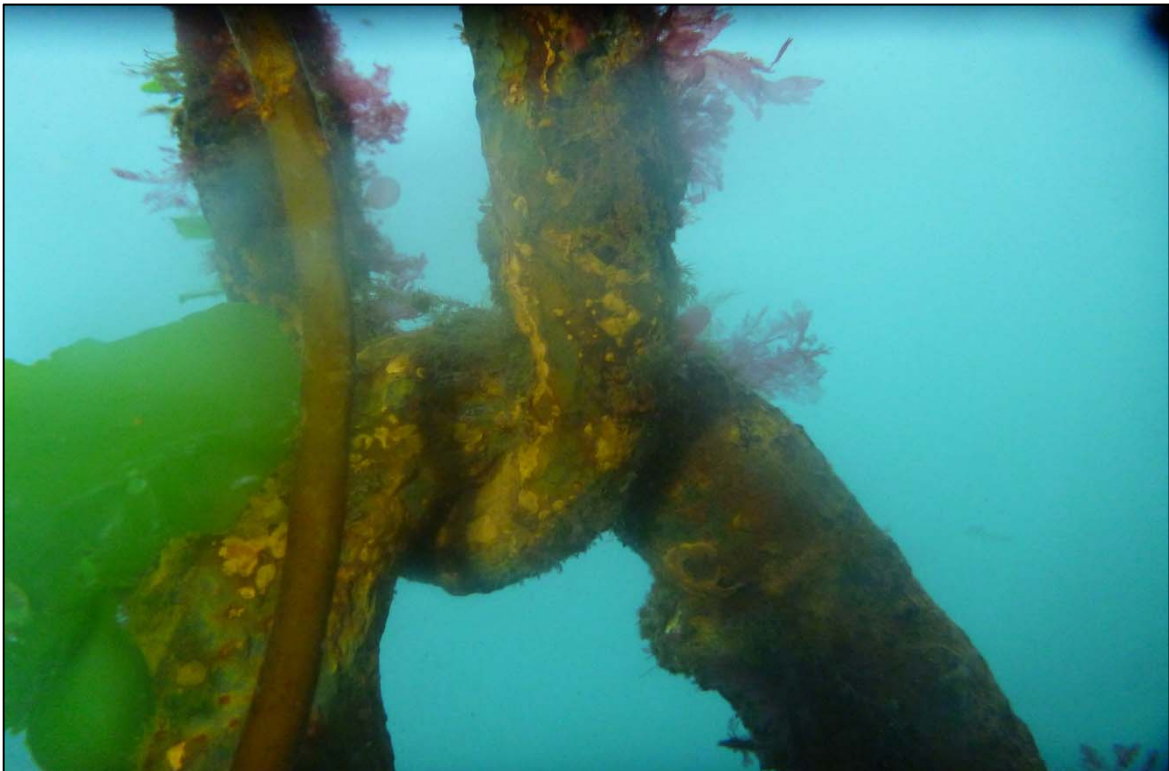
Photograph 75: View of Lower Anchor Chain to Anchor Rope Connection with Heavy Marine Growth (Thimble) at Site 3 Anchor Line 22, Looking Northeast.

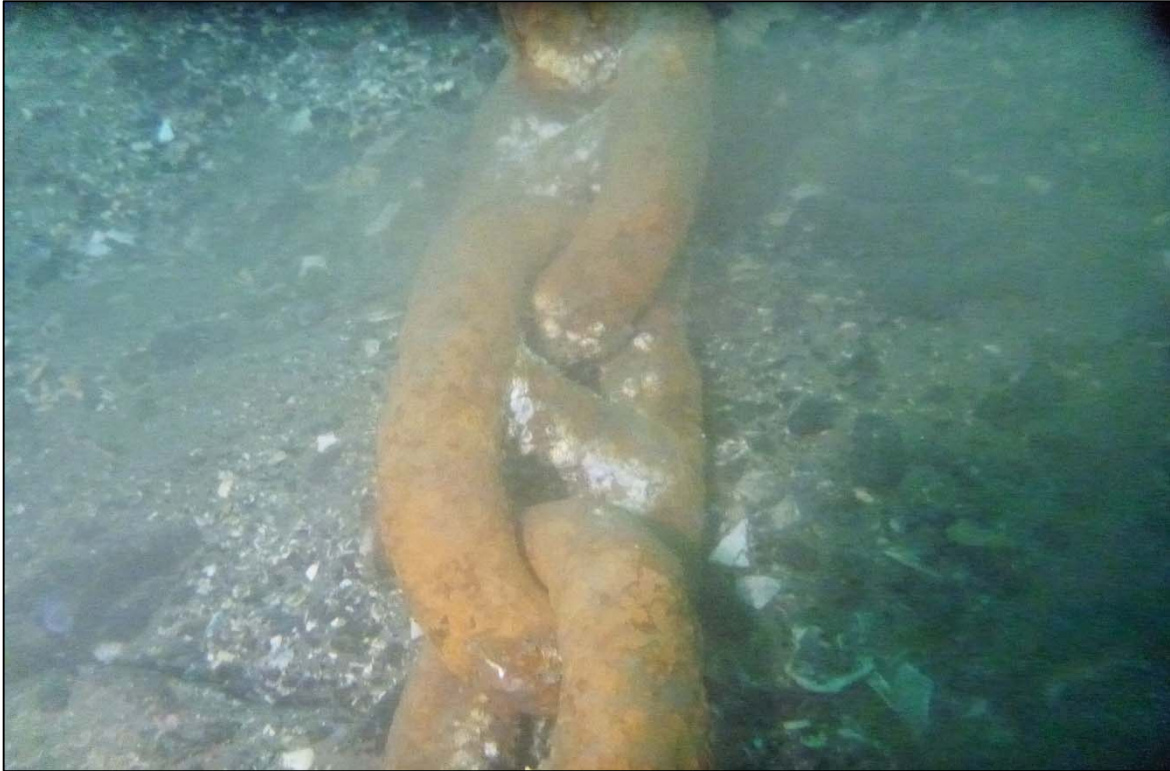
Photograph 76: View of Section Loss on the Buoy Chain due to Abrasion between the Links at Site 3 Anchor Line 23, Looking North.

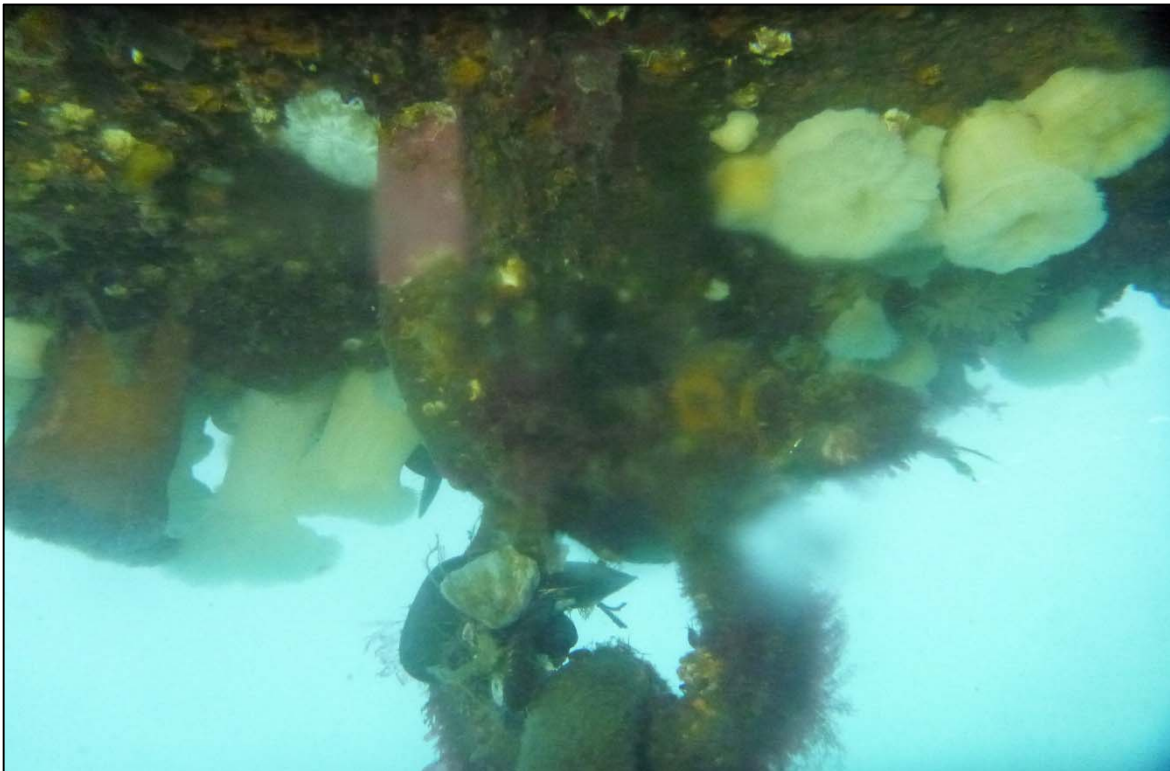
Photograph 77: View of Lower Anchor on the Channel Bottom at Site 3 Anchor Line 23, Looking Northwest.

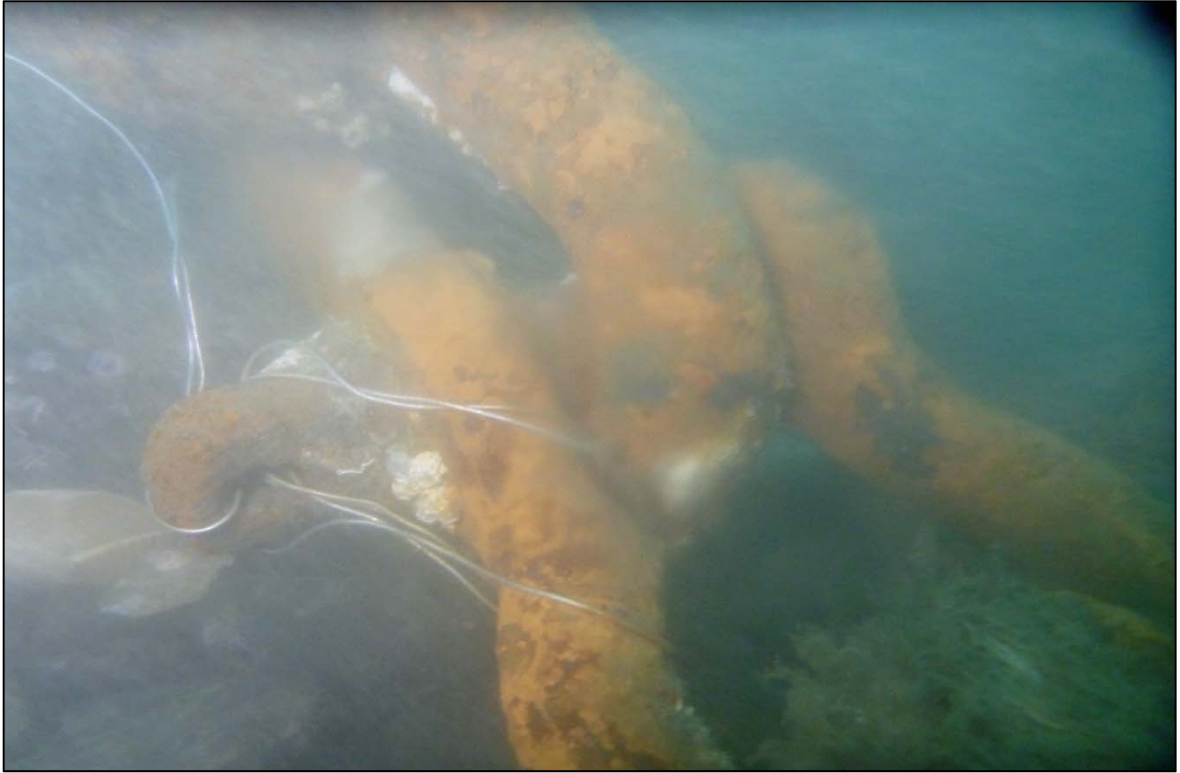
Photograph 78: View of Buoy to Chain Connection at Site 3 Anchor Line 24, Looking Northeast.

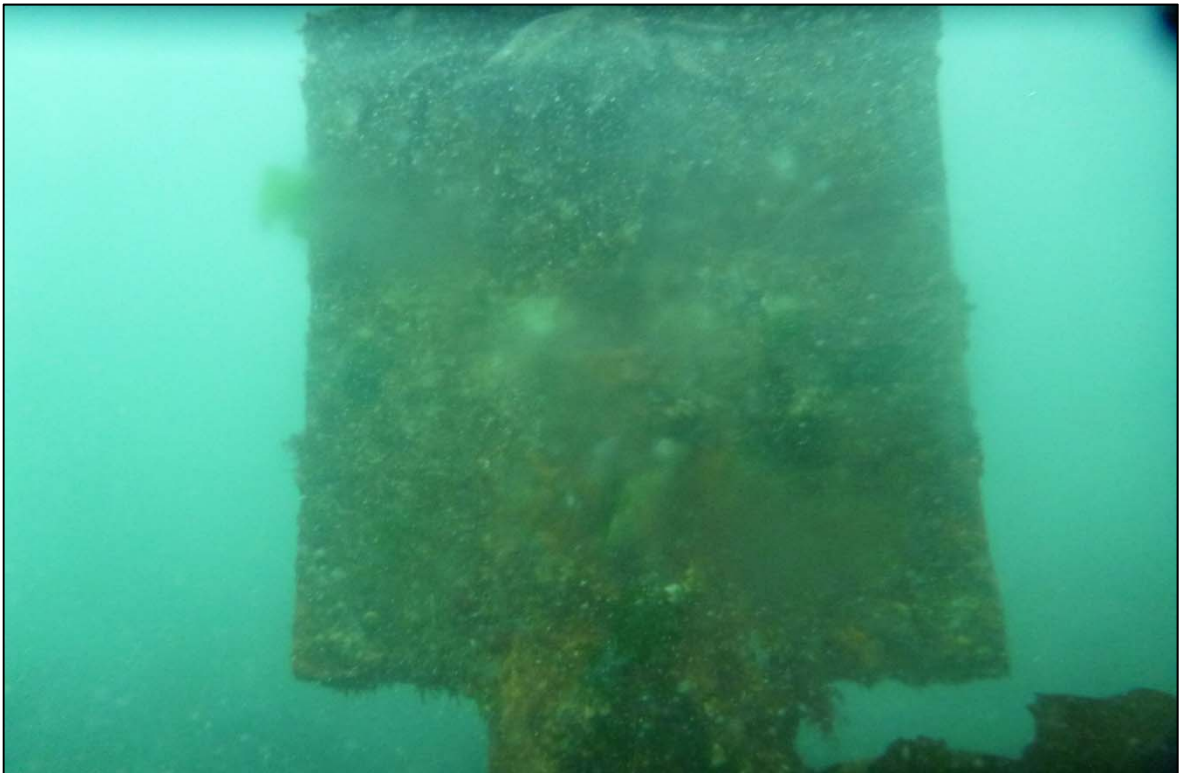
Photograph 79: View of Lower Anchor Chain to Anchor Rope Connection with Loose Safety Wire (Shackle) at Site 3 Anchor Line 24, Looking West.

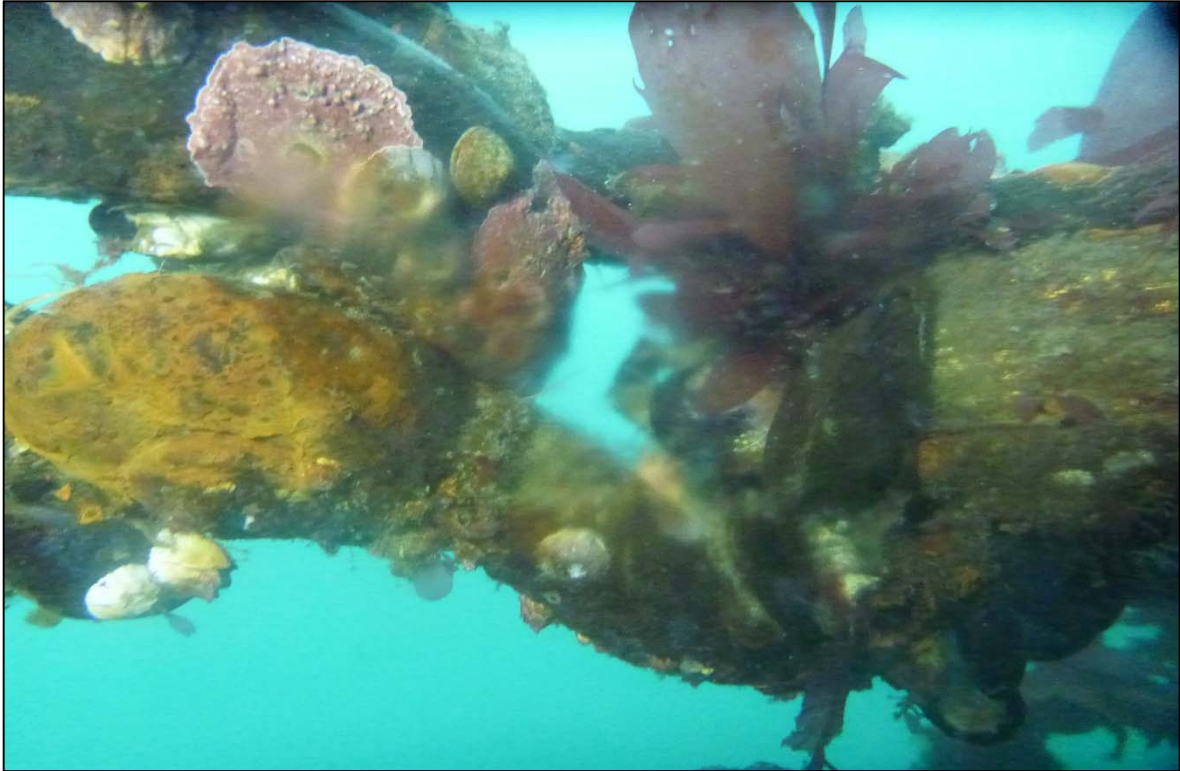
Photograph 80: View of Top of Anchor Pin at Site 3 Anchor Line 24, Looking Northwest.

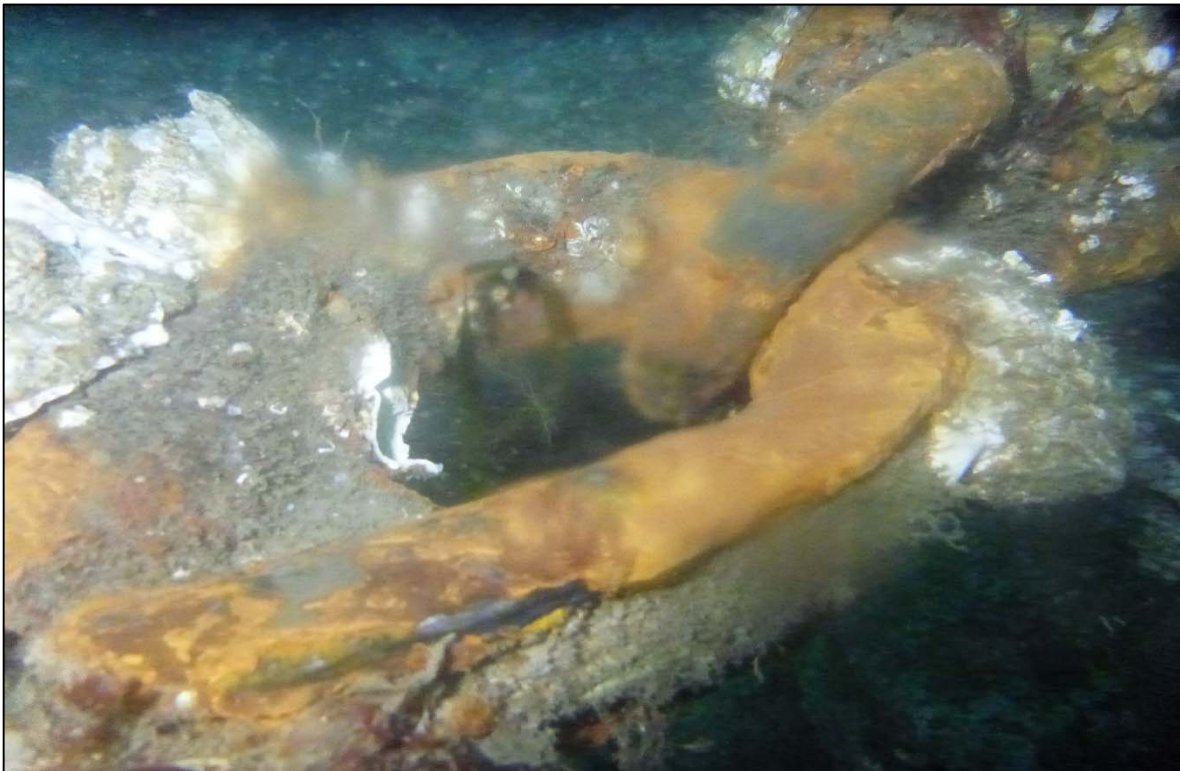
Photograph 81: View of Upper Anchor Chain to Anchor Rope Connection with Corrosion and Pitting (Shackle and Thimble) at Site 3 Anchor Line 25, Looking North.

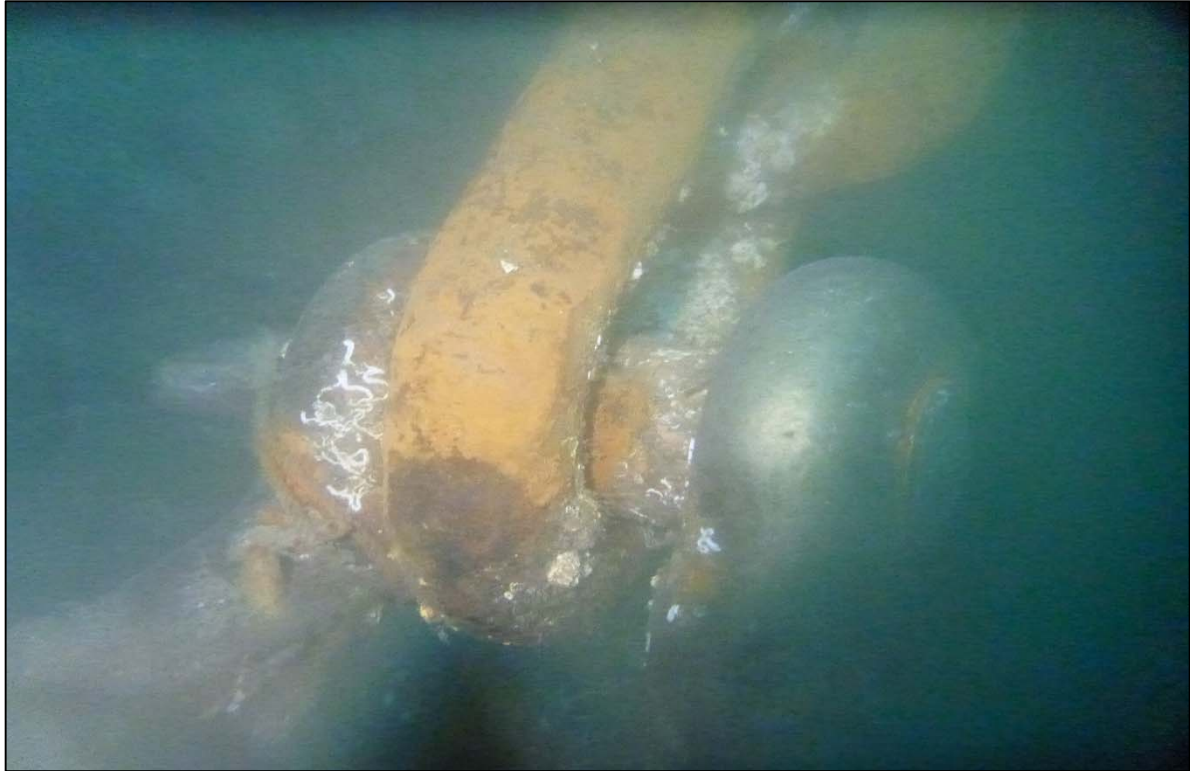
Photograph 82: View of Lower Anchor Chain to Anchor Rope Connection with Corrosion and Pitting (Thimble) at Site 3 Anchor Line 25, Looking Northwest.

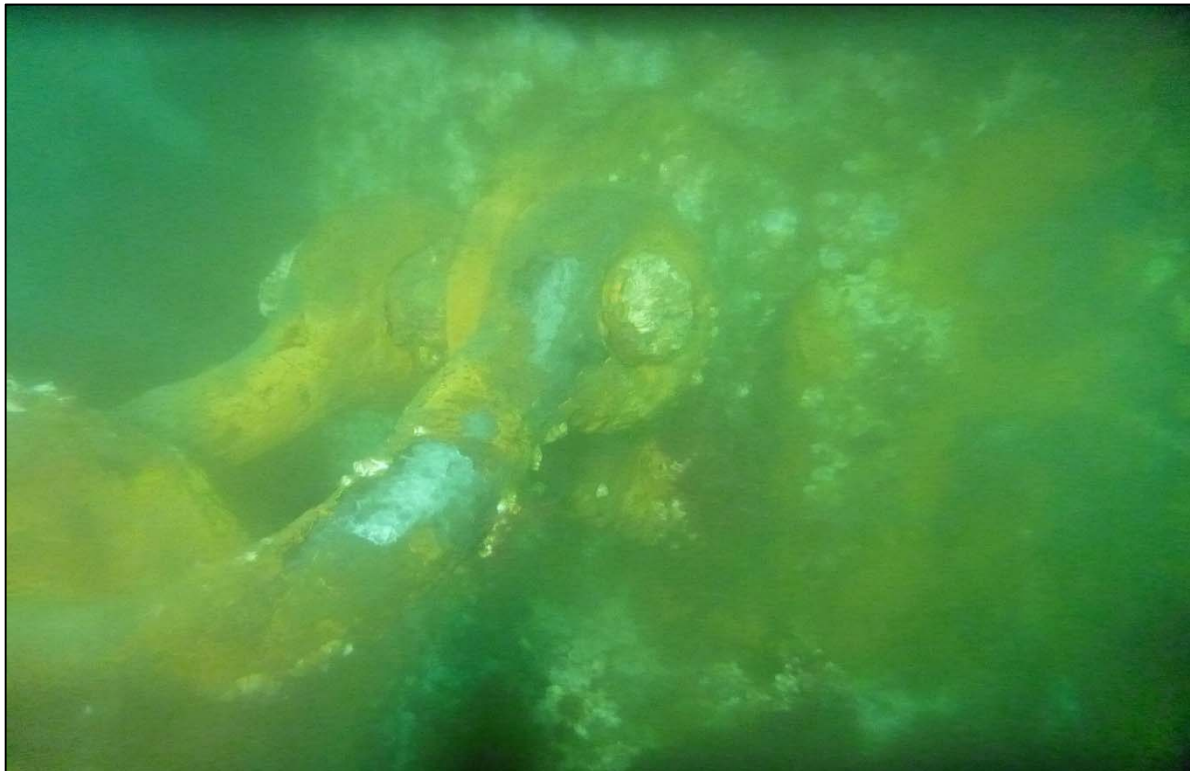
Photograph 83: View of Lower Anchor Chain to Anchor Rope Connection with Corrosion (Shackle) at Site 3 Anchor Line 27, Looking Northwest.
