Cypress Island Site 3 Atlantic Salmon Net Pens Engineering Assessment

January 29, 2018

State of Washington
Department of Natural
Resources
1111 Washington Street SE
Olympia Washington 98504

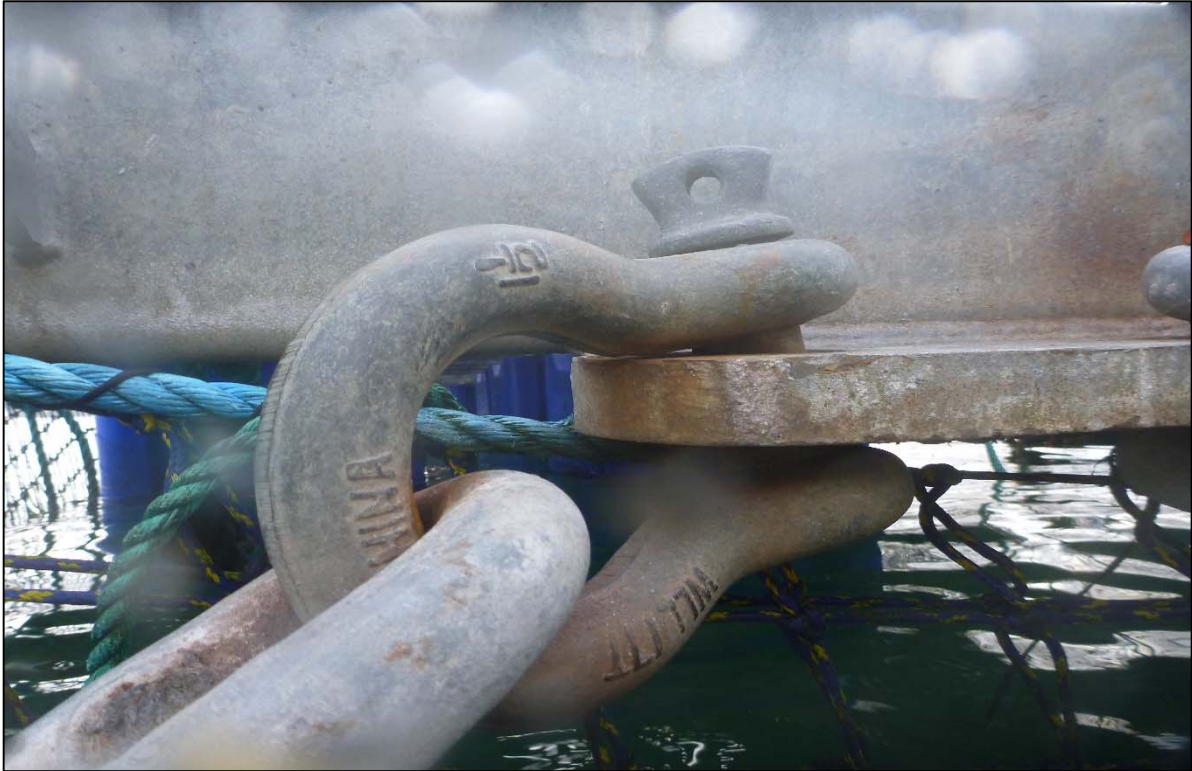
Photograph 84: View of Lower Anchor Chain to Anchor Connection with (Shackle) at Site 3 Anchor Line 27, Looking North.

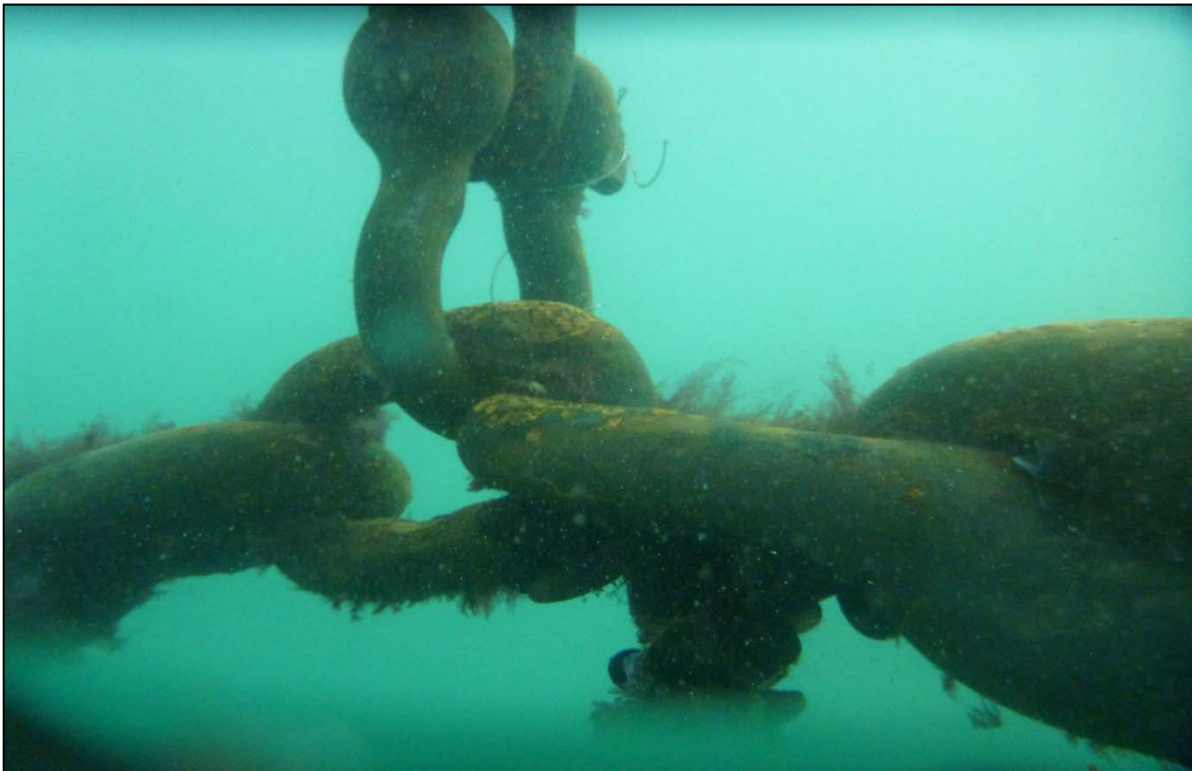
Photograph 85: View of Upper Anchor Chain to Float Connection with (Shackle) at Site 3 Anchor Line 28, Looking Southeast.
